Subject: **CCAP State Com # 6H Battery Release
Unit Letter H, Section 16, Township 22 South, Range 27 East
Eddy County, New Mexico
Incident ID nAB1714554320**

Re: Closure Letter
CCAP State Com #6H Battery
API #: 30-015-42880
RP#: 2RP-4223
Unit Letter H Section 16, Township 22S, Range 27E
Eddy County, NM

Report Type: Work Plan 2RP-4223

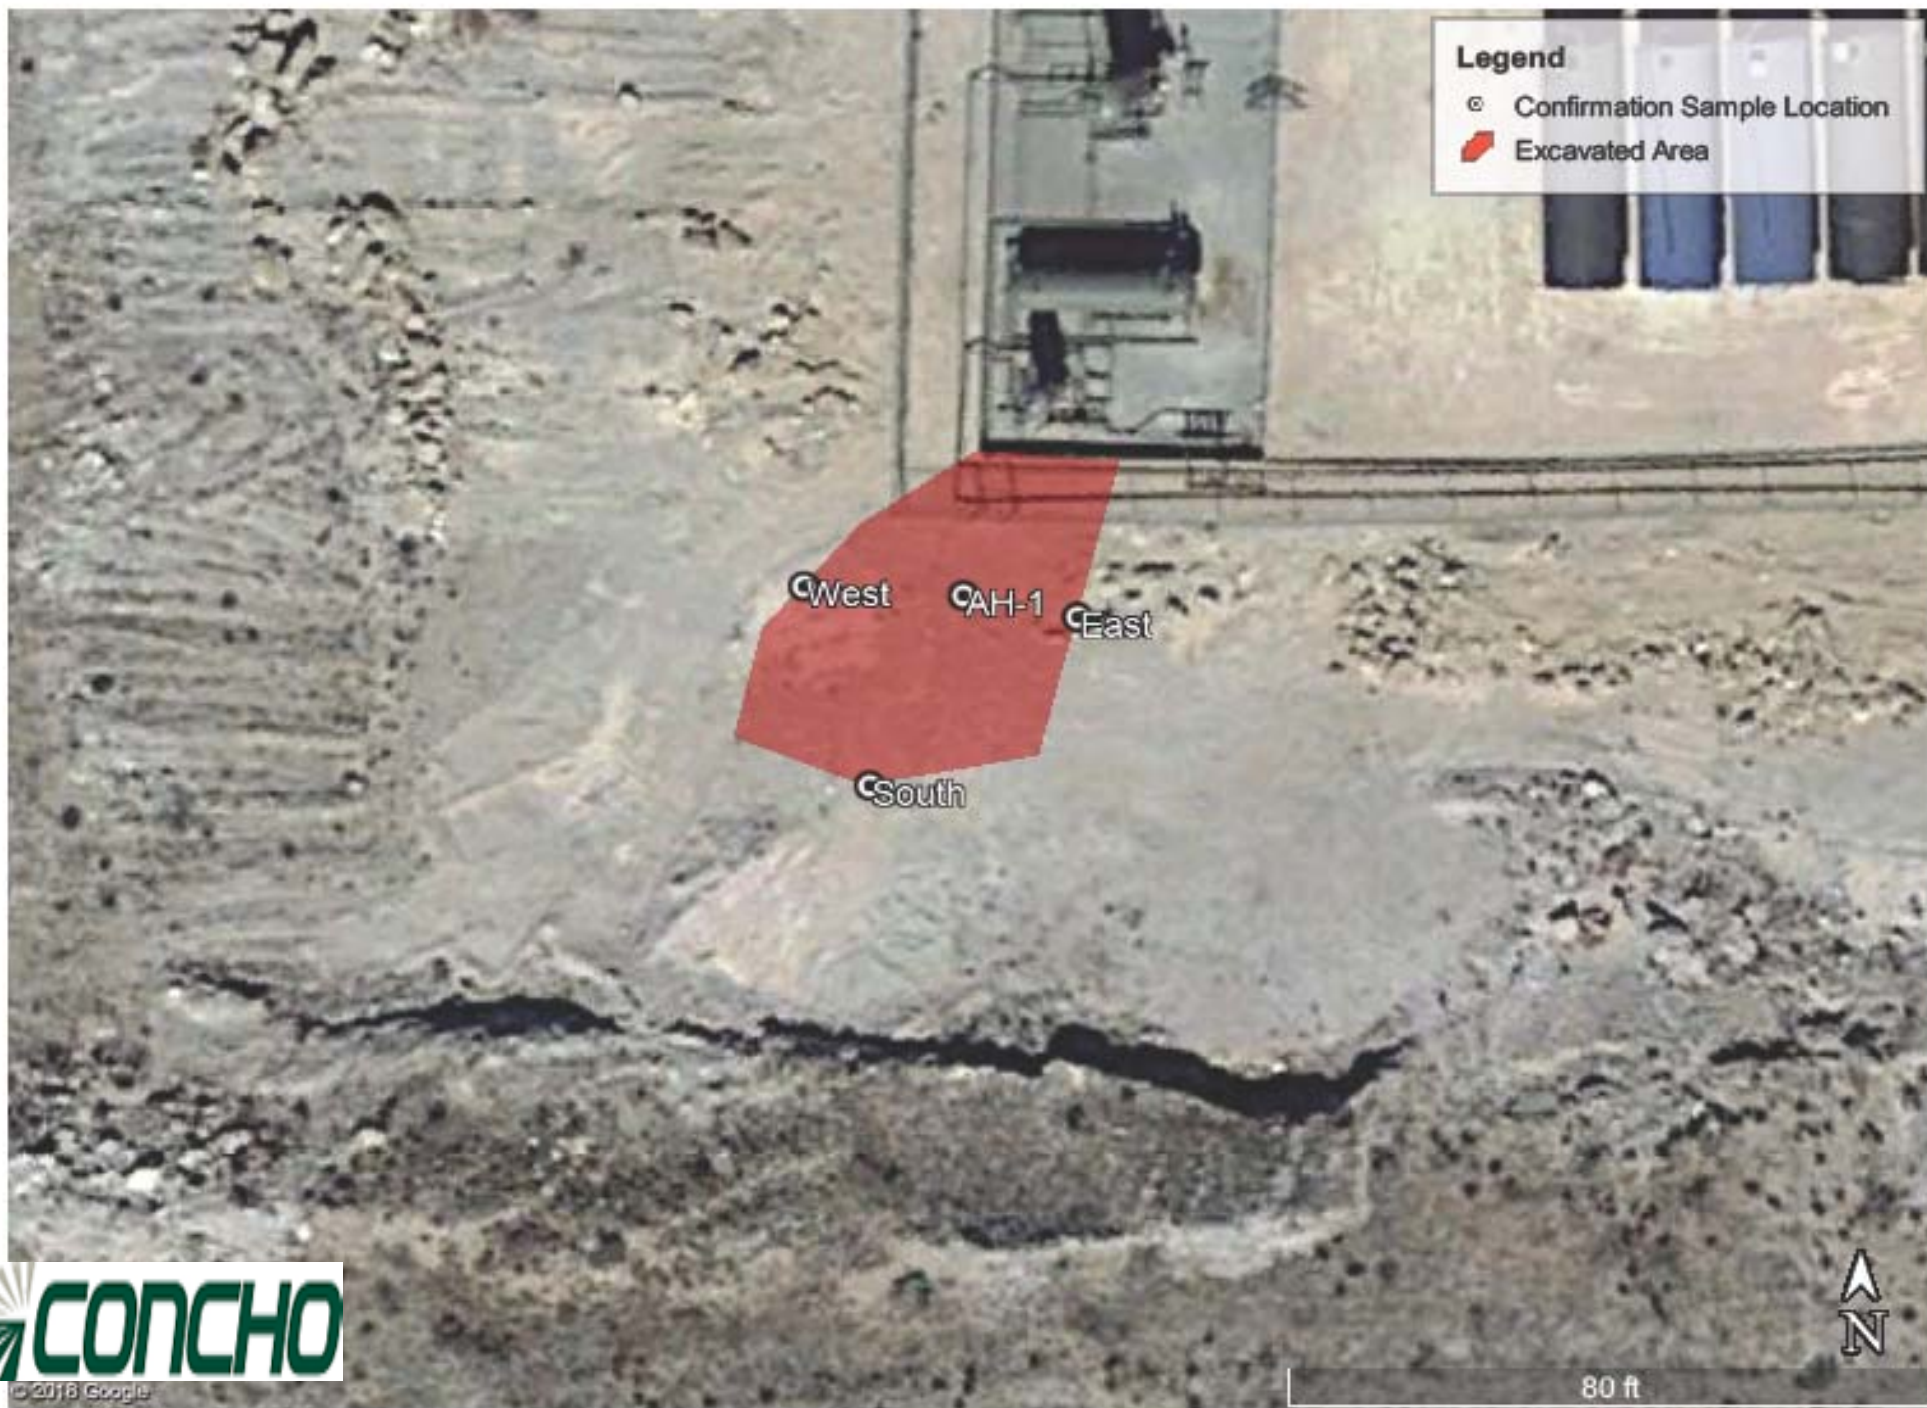
APPENDIX I

CCAP State Com #006H Battery

On February 12, 2018, remediation activities began in accordance with the approved work plan. The analytical results from the NMOCD stipulated confirmation soil sampling activities are summarized in the table below. A site diagram of the excavated area is presented in appendix I.

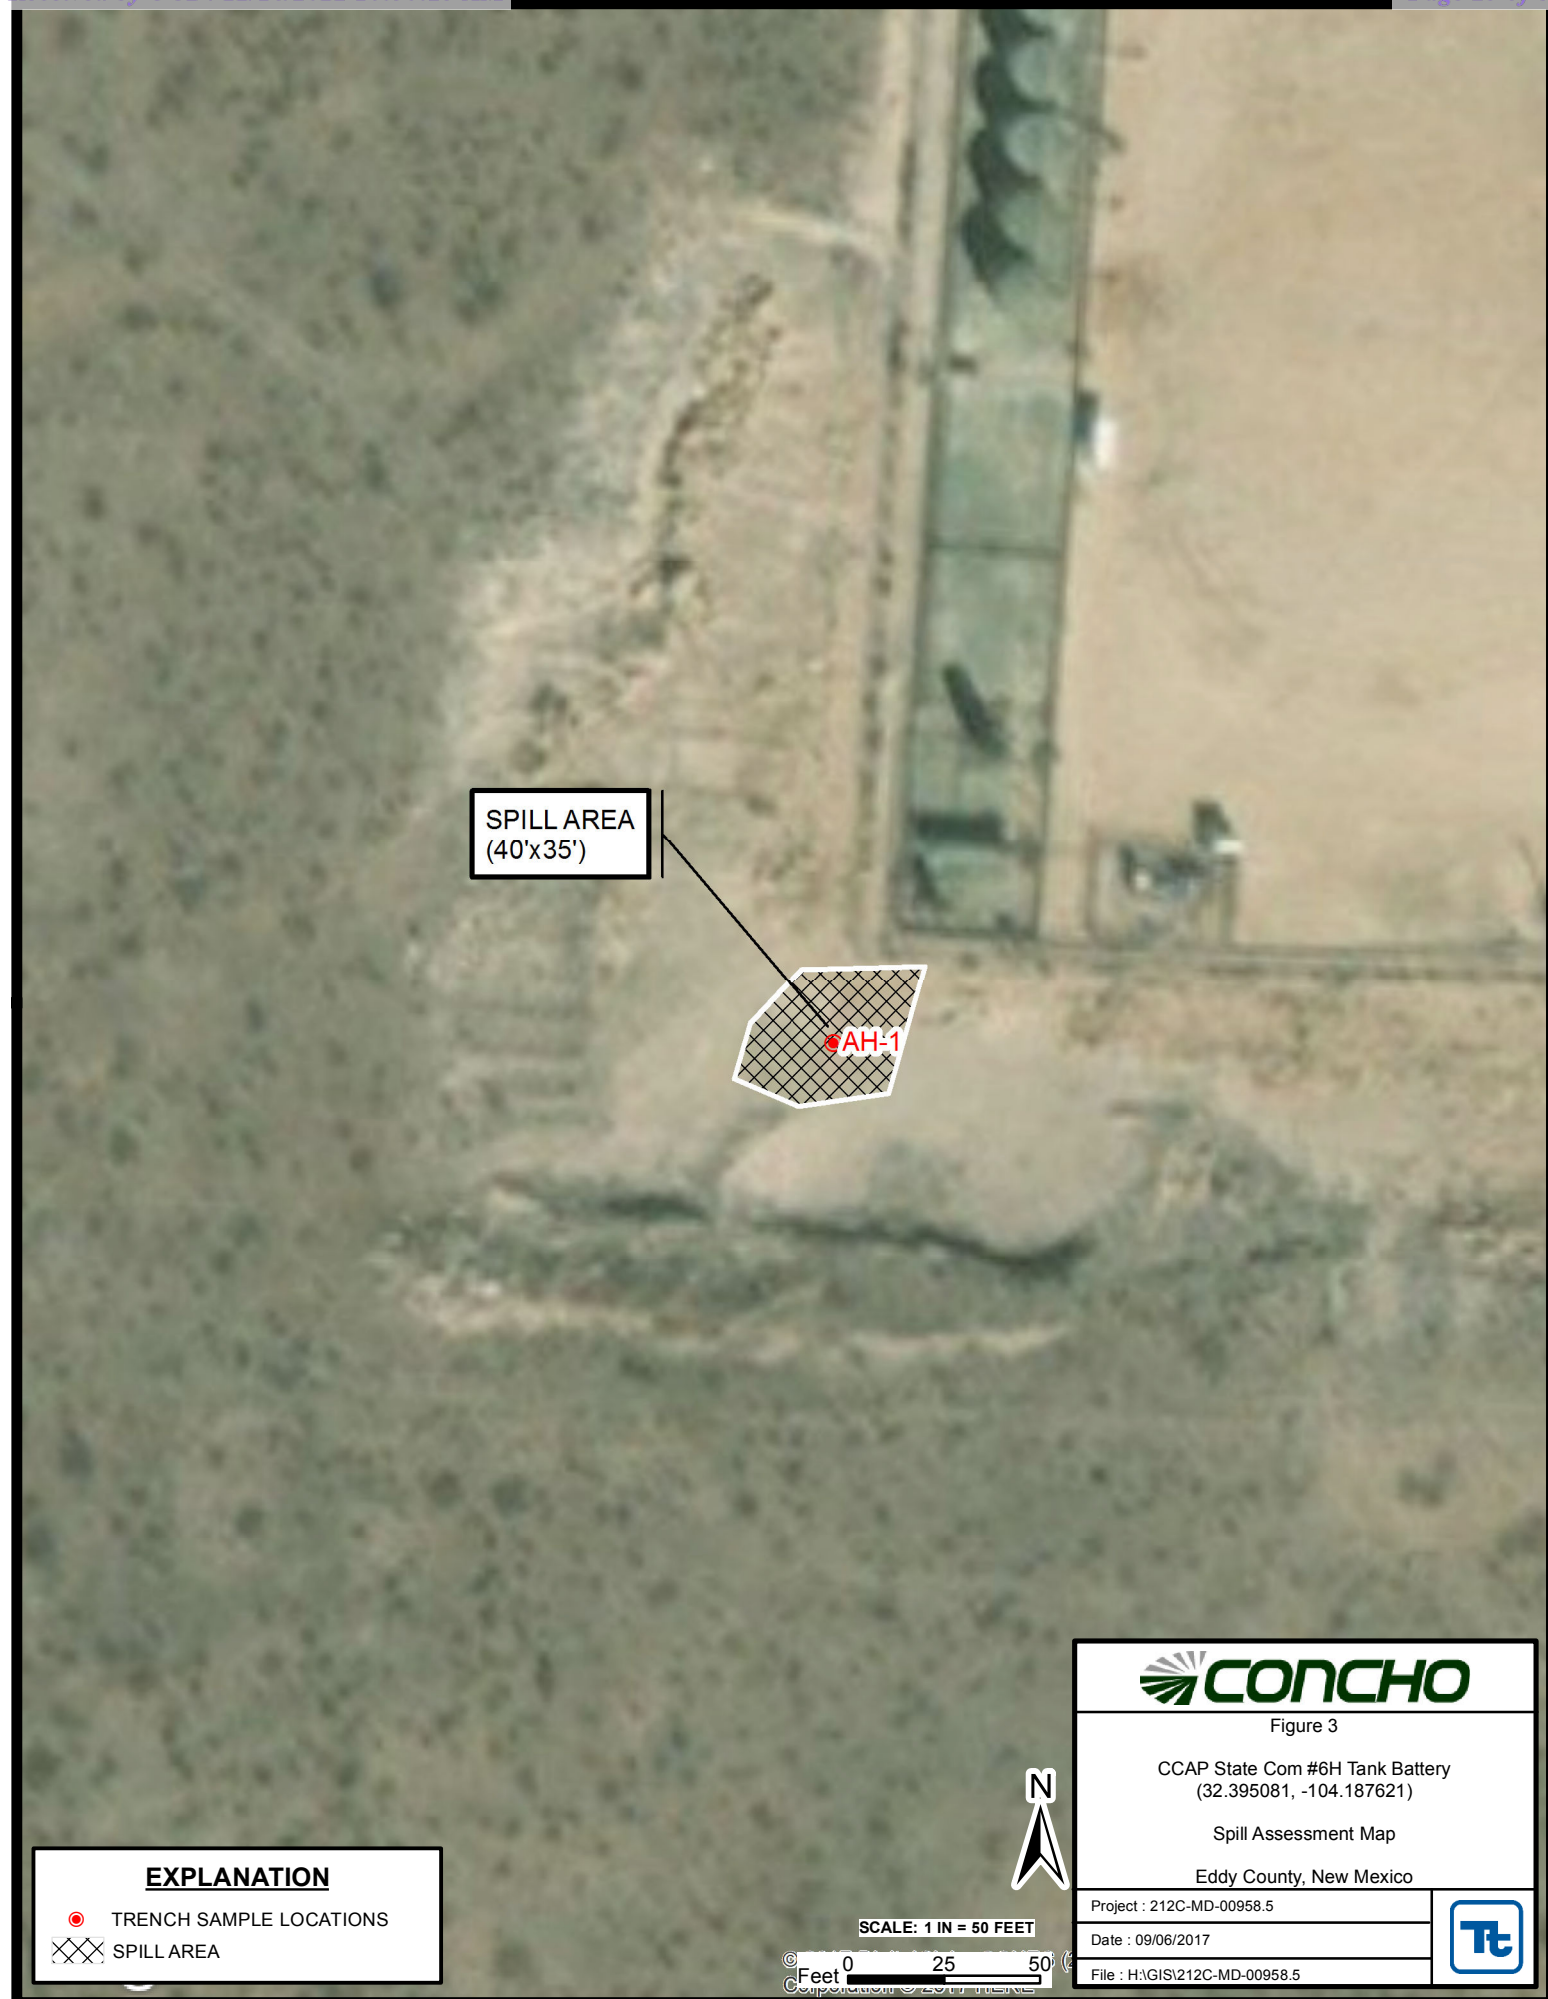
On June 22, 2017, COG personnel were onsite to evaluate and sample the release area. One (1) auger hole (AH-1) was installed in the release area using a stainless steel hand auger, to a total depth of 1.0' below surface. Deeper samples could not be collected due to a dense formation in the area. Selected samples were analyzed for TPH analysis by EPA method 8015 modified, BTEX by EPA Method 8021B and chloride by EPA method 300.0. Copies of laboratory analysis and chain-of-custody documentation are included in Appendix C. The sampling results are summarized in Table 1. The auger hole location is shown on Figure 3.

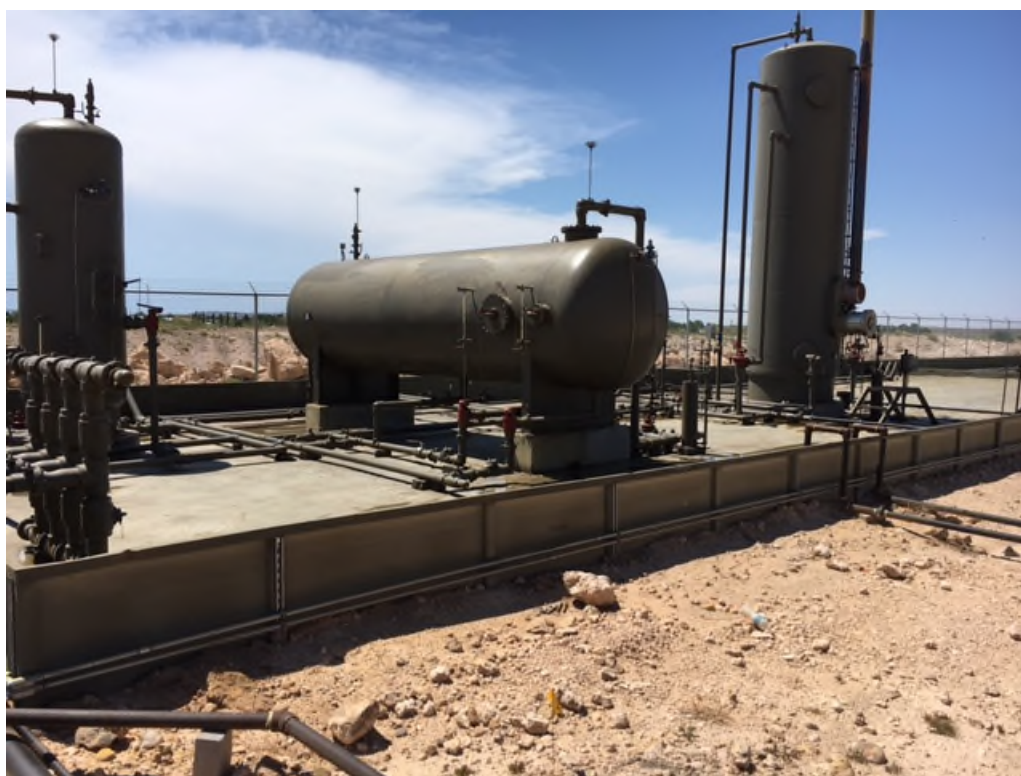
View West – Release area inside lined containment

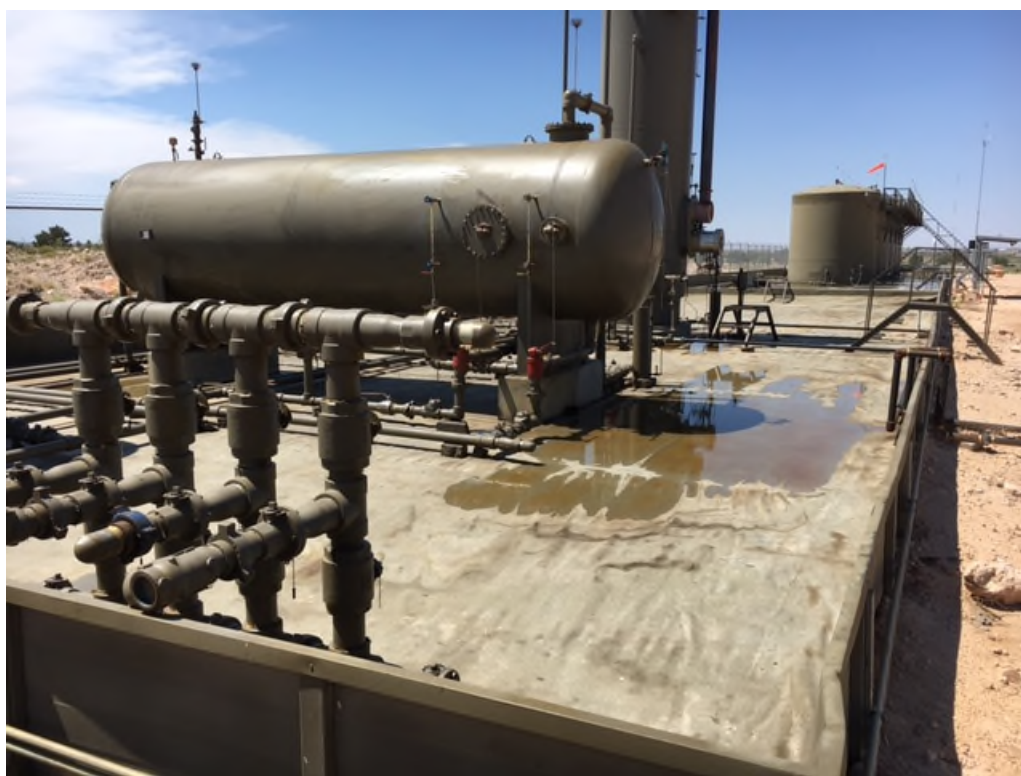
View North - Release area inside lined containment

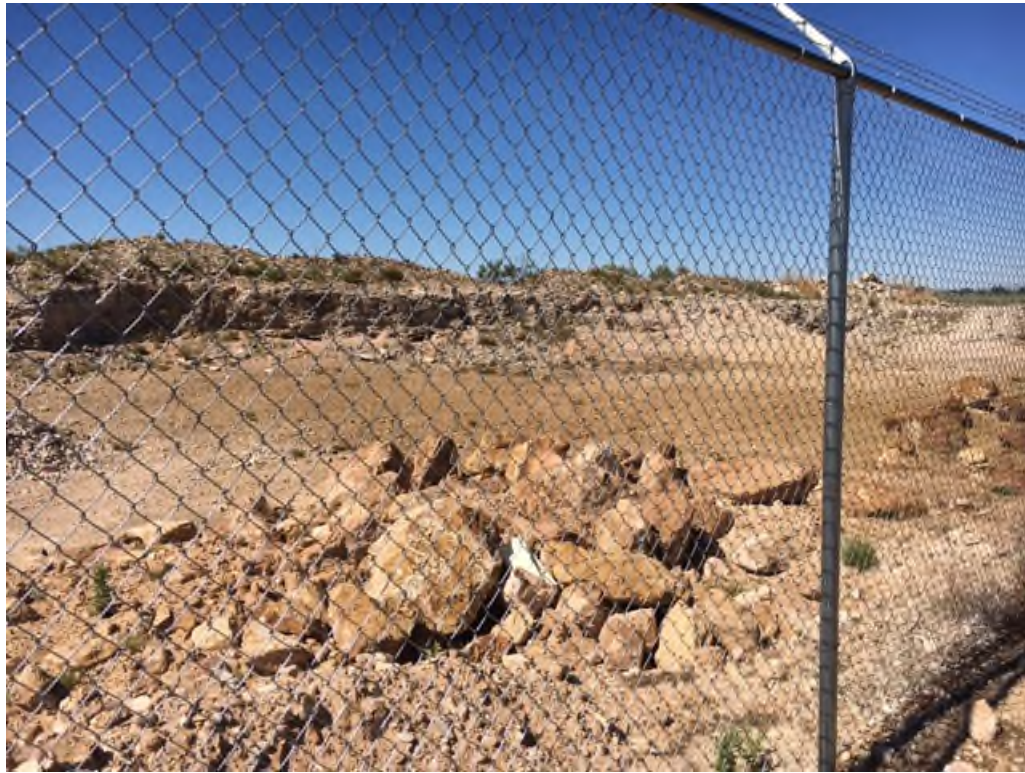
View Southwest – Release area in the pasture
