## Closure Report

Cotton Draw Unit #089

Eddy County, New Mexico

**Incident #s nMLB1128636288, nAB1522442205,  
nAB1616231629, and nAB1711551324**

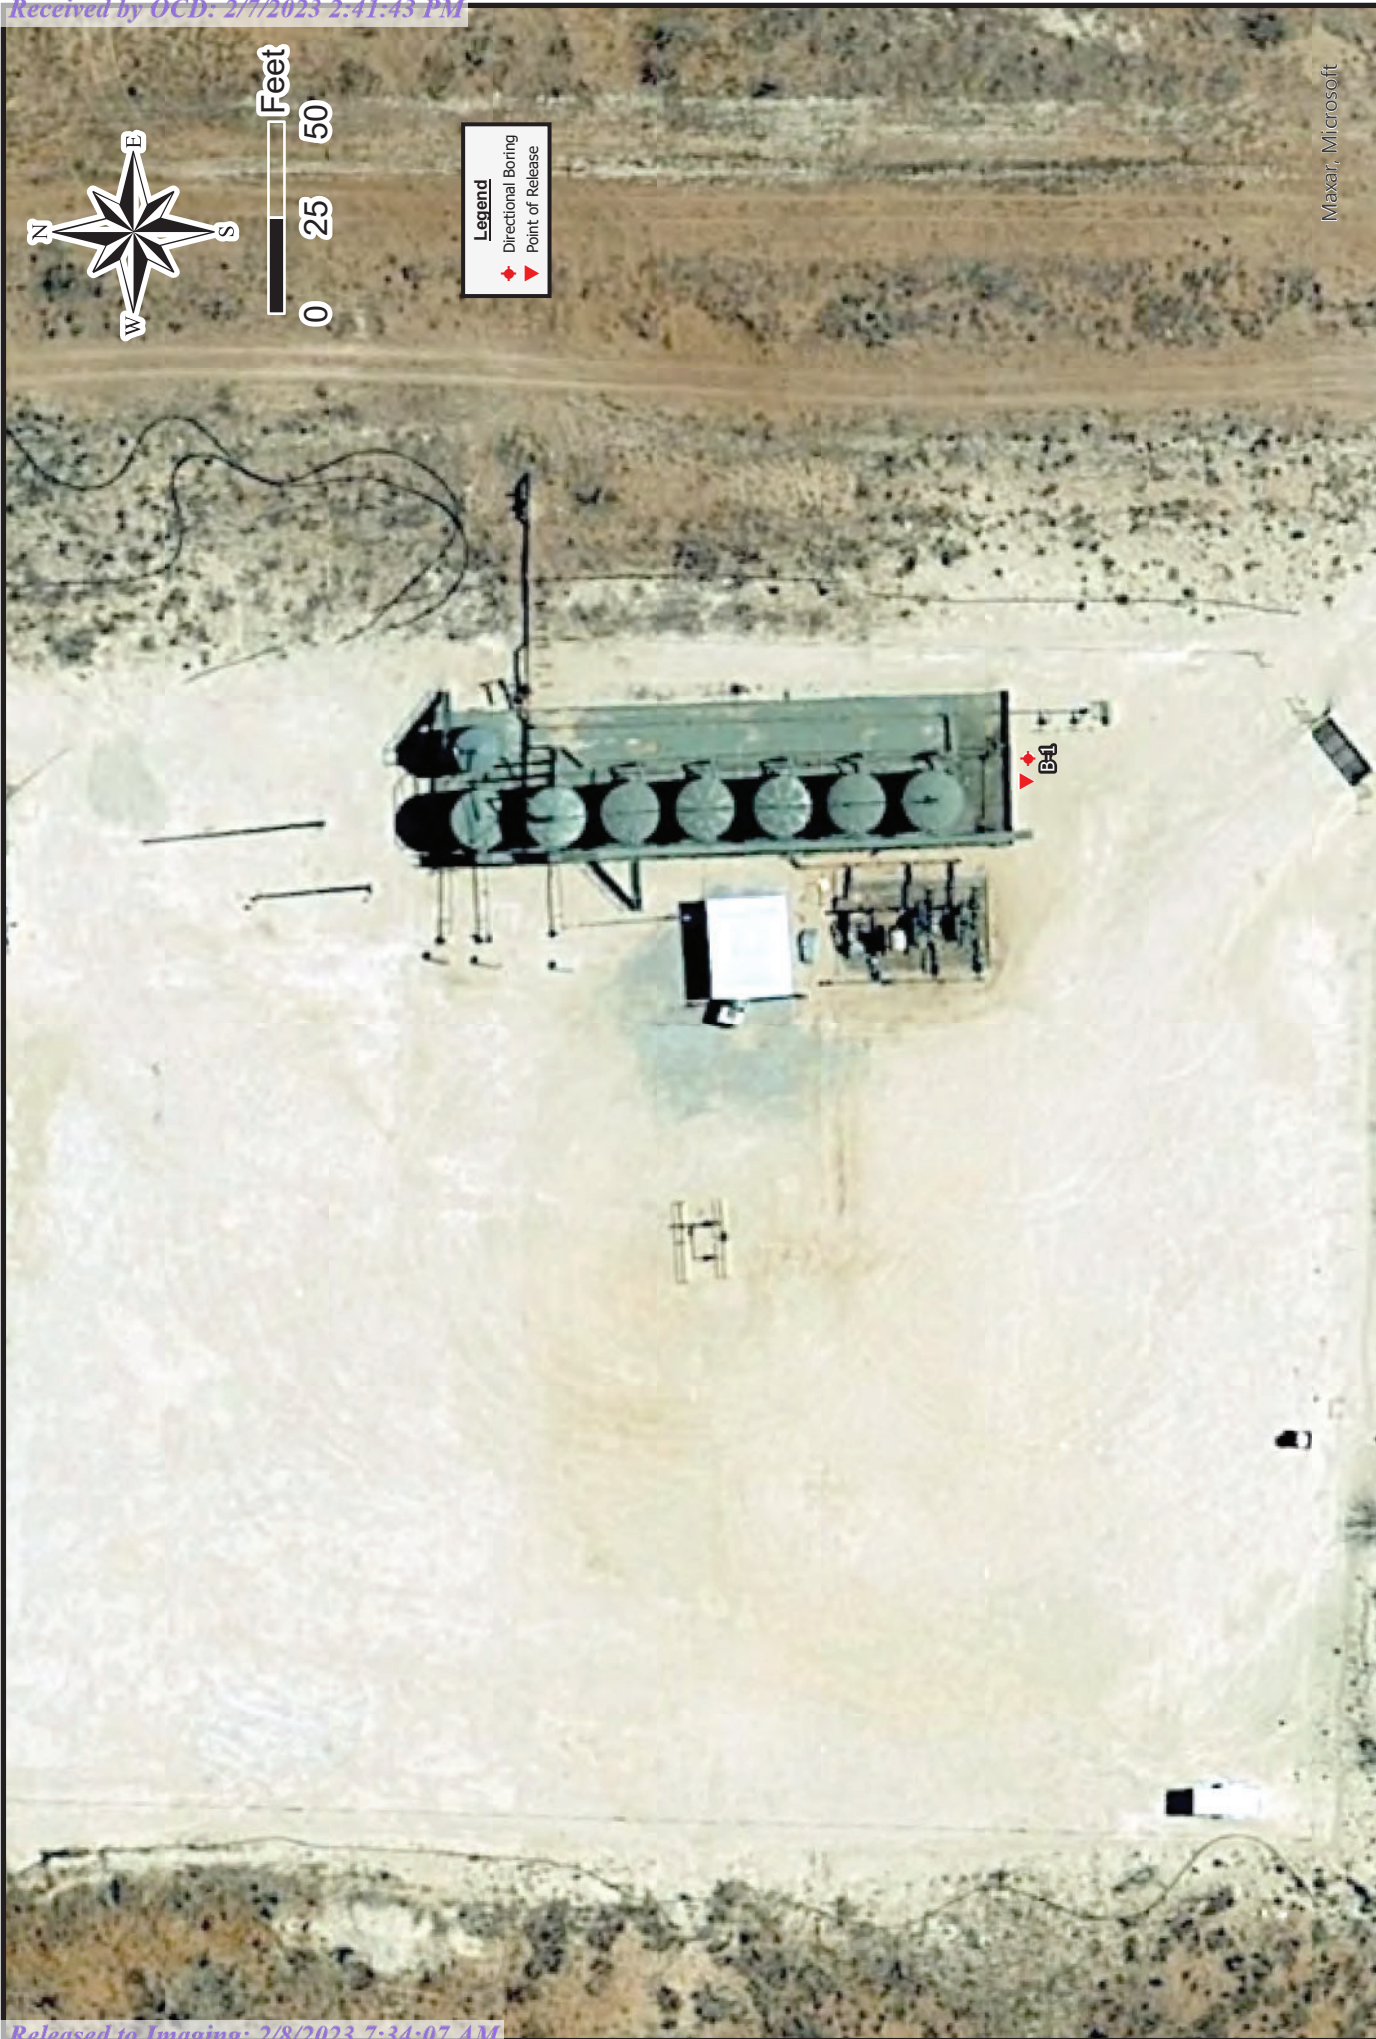
Devon Energy Corporation  
Devon Energy Cotton Draw Unit #089  
Eddy County, NM  
Figure 1A - nMLB11268636288 Site Assessment

Results from the assessment sampling events are presented in the following data tables and the complete laboratory reports can be found in [Appendix V](#). Sample locations are shown on the attached Figure 1a through Figure 1c in [Appendix I](#).

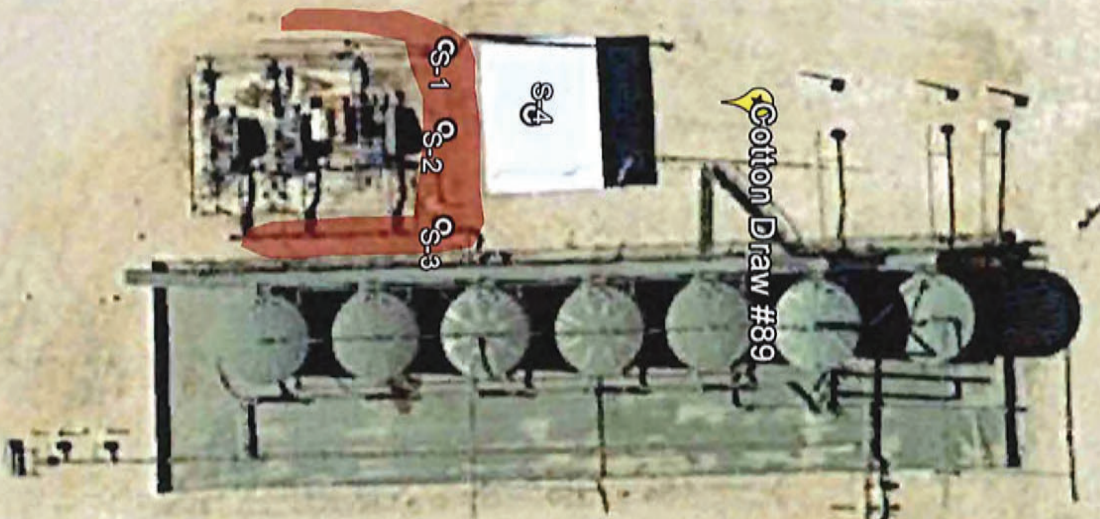
Sample Locations

On May 10, 2017 a filter screen plug was missing on the triplex pump causing 16 barrels of produced waste to be released outside of the containment. A vac truck was called to the location and recovered 5 barrels of fluid. The main supply valve feeding the pump was closed and the plug was replaced. A site plan is presented in [Appendix I](#) which illustrates the impacted area. See initial C-141 in [Appendix II](#).

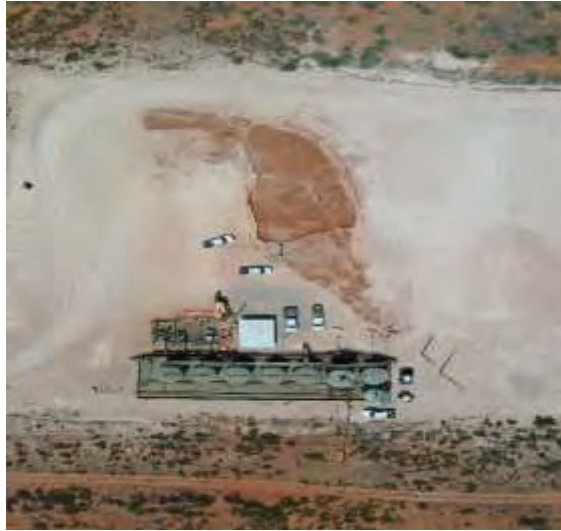
Excavation 2RP-3198/2RP-3728

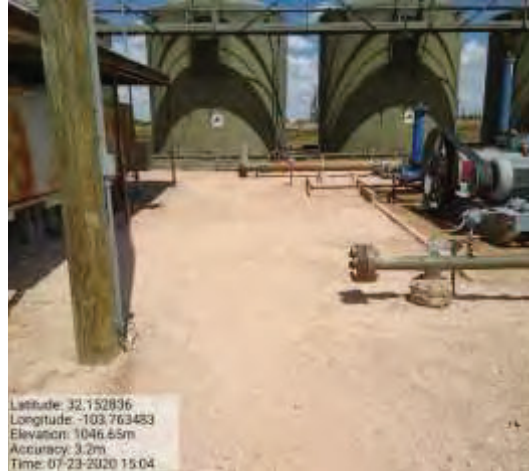
Completion 2RP-4186
