Re: Site Assessment, Liner Inspection, and Closure Report
Rio Blanco 4 Federal Com #003
API No. 30-025-36425
GPS: Latitude 32.3309593 Longitude -103.4718094
UL -- J, 4, T23S, R34E
Lea County, NM
NMOCD Ref. No. NT01415447716

Pima Environmental Services, LLC. (Pima) has been contracted by Devon Energy Production Company, LP (Devon) to perform a liner inspection, spill assessment, remediation activities, and to submit this closure report for a produced water release that occurred at the Rio Blanco 4 Federal Com #003 (Rio Blanco). The initial C-141 was submitted on June 30, 2014 (Appendix C). This incident was assigned Incident ID NTO1415447716 by the New Mexico Oil Conservation Division (NMOCD).

**SITE PHOTOGRAPHS
DEVON ENERGY
RIO BLANCO 4 FED COM 3**

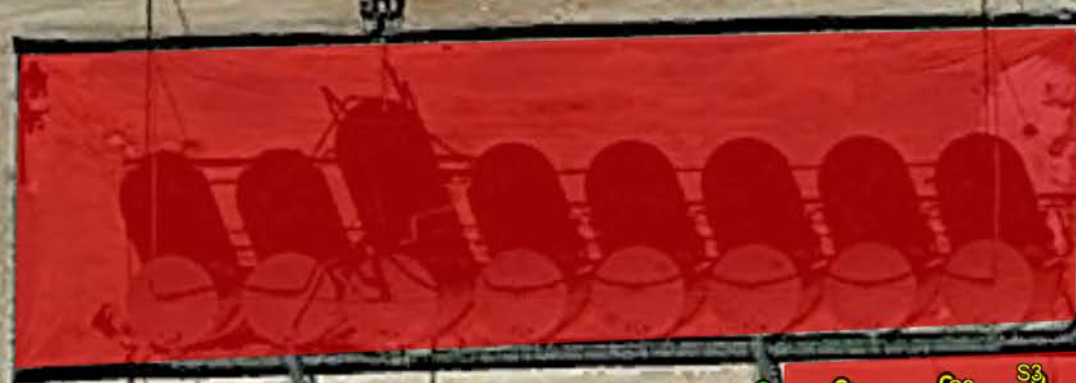
4-Site Map

On January 11, 2023, Pima mobilized personnel to the site to assess the area. We sampled the impacted area. Laboratory results of this sampling event can be found in the following data table. A Site Map can be found in Figure 4.

Devon Energy
API#30-025-36425
Lea County, NM
Site Map
nto1415447716
Google image from=2014

CSW1 CS1 CS2 S3 CSW4
CSW2 CSW3

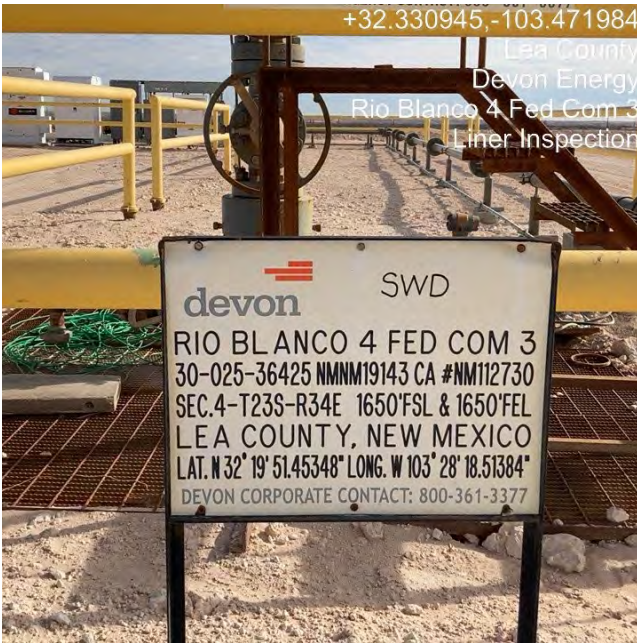
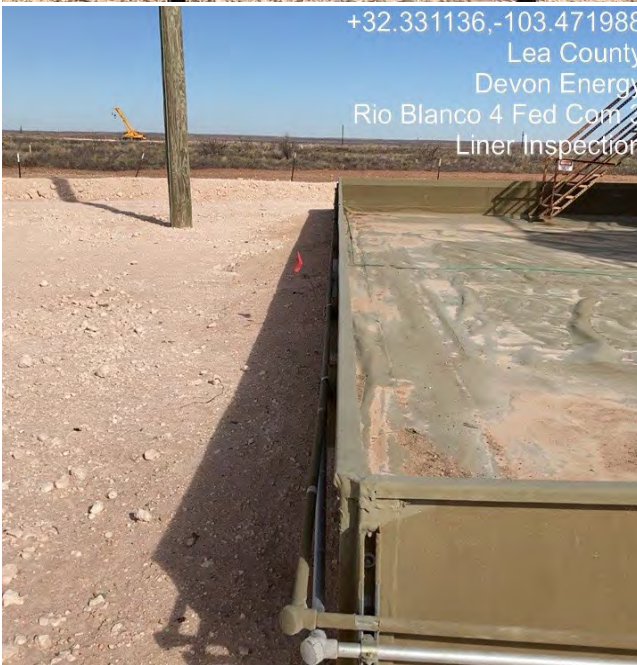
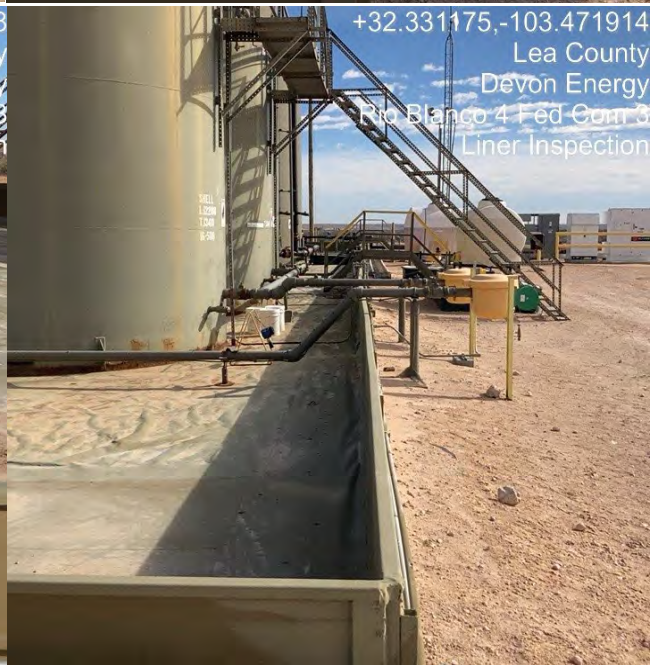
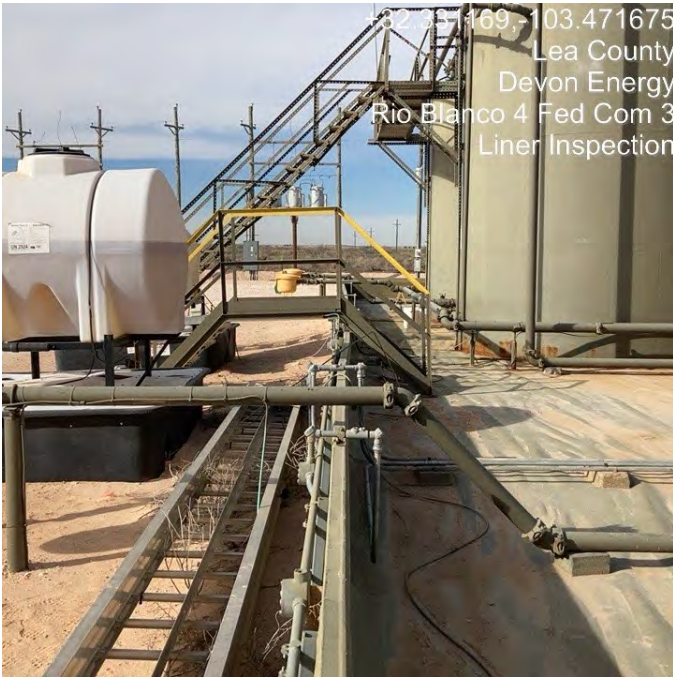
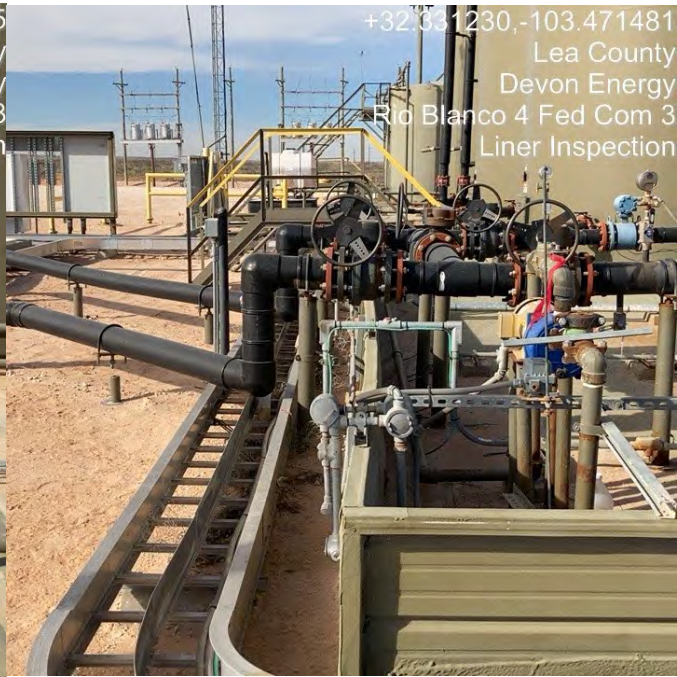
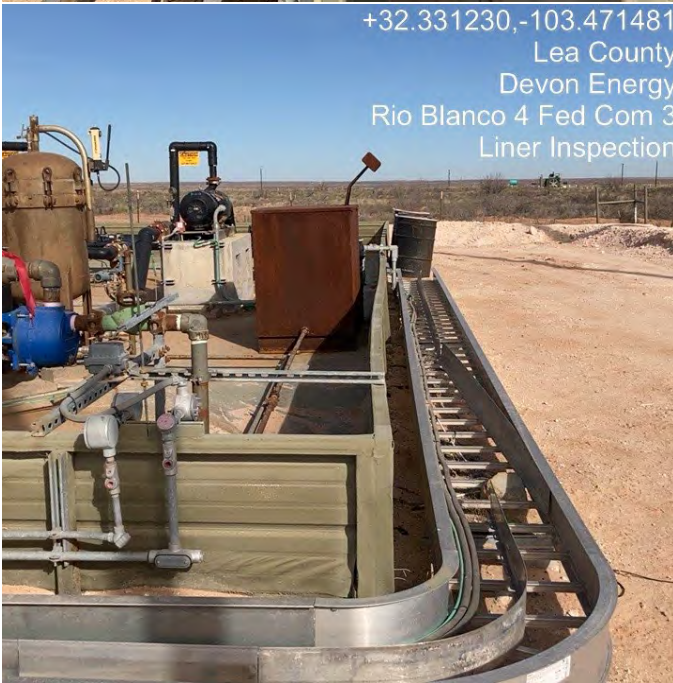
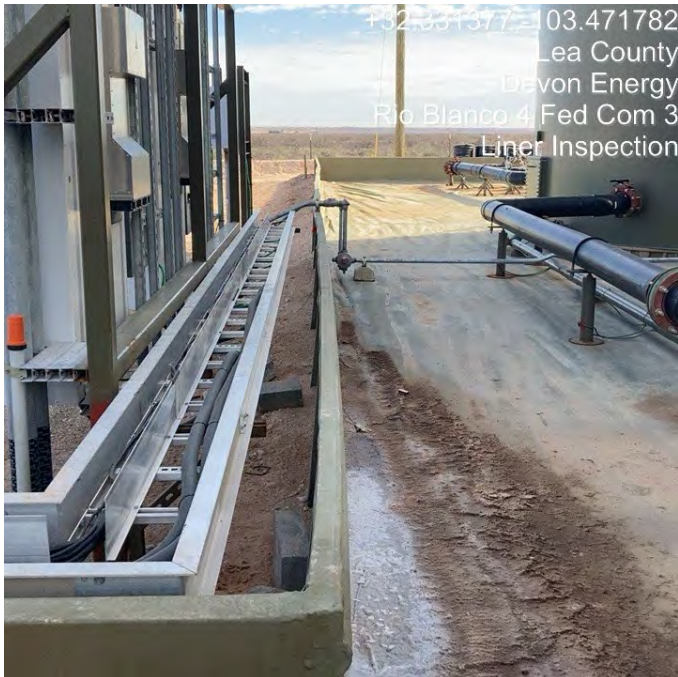
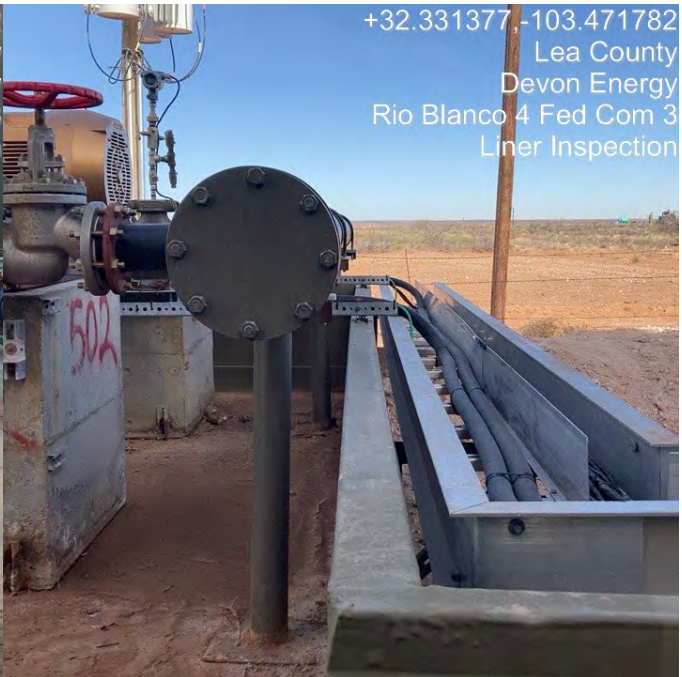
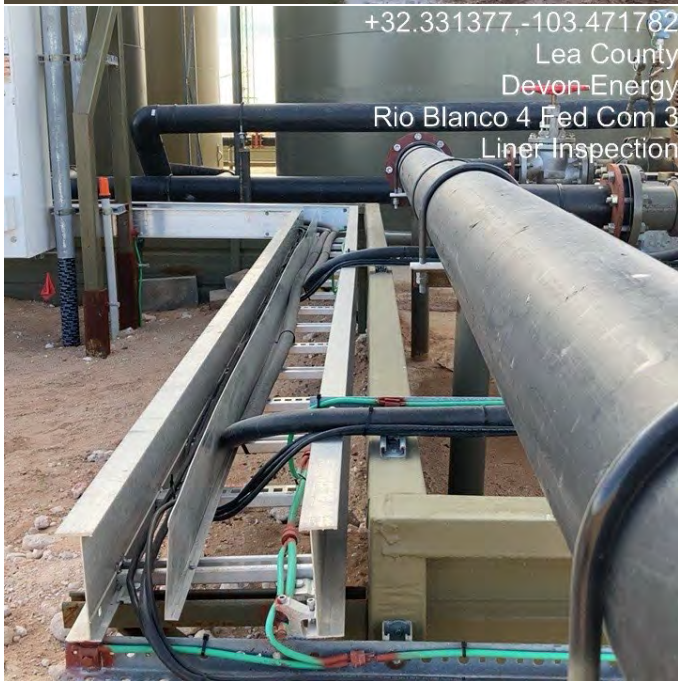
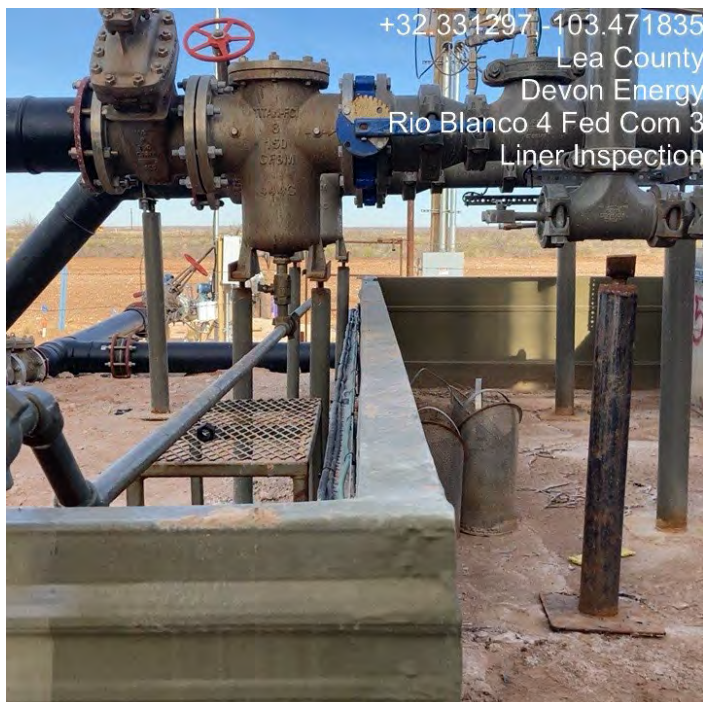
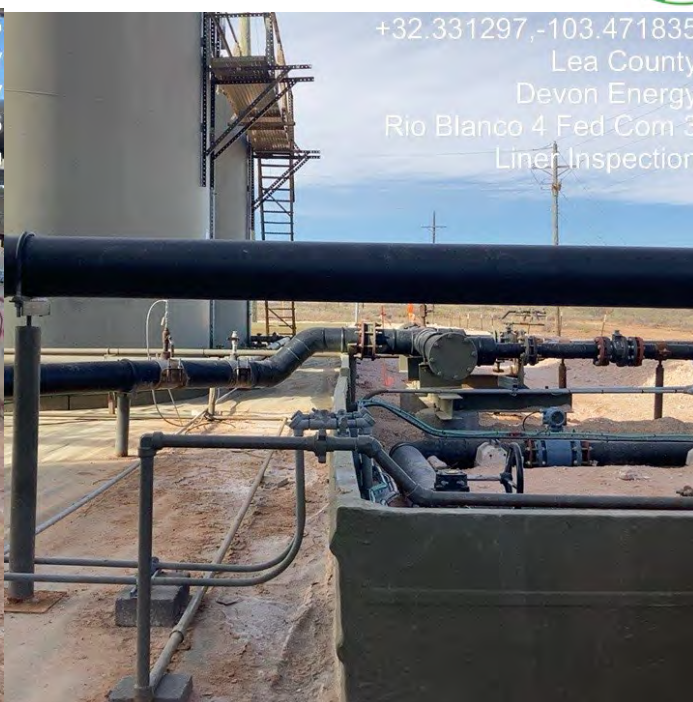
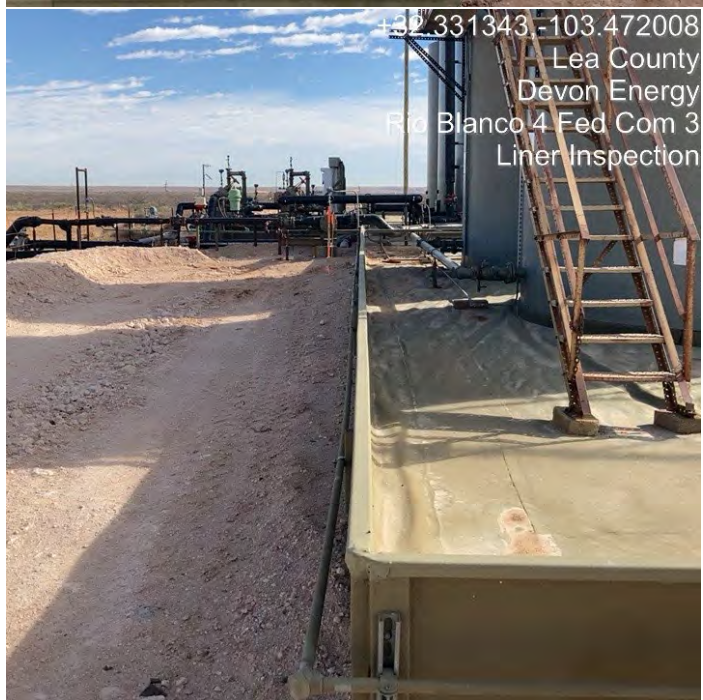
On January 14, 2023, after sending the 48-hour Notification (Appendix C) via email, Pima Environmental conducted a liner inspection at this location. We concluded that this liner and containment maintained its integrity and was able to retain the fluids. The Liner Inspection Form and photographic documentation can be found in Appendix D.

Visualization	Yes	No	Comments
Is there a tear in the liner?		X	
Are there holes in the liner?		X	
Is the liner retaining any fluids?		X	
Does the liner have integrity to contain a leak?	X
