September 14, 2021

**Subject: Closure Request
 ConocoPhillips (Heritage Concho)
 Burch Keely Unit #205 Release
 PLSS Unit Letter O, Section 26, Township 17S, Range 29 East
 Eddy County, New Mexico
 2RP-1834
 Incident ID nJMW1322830932**

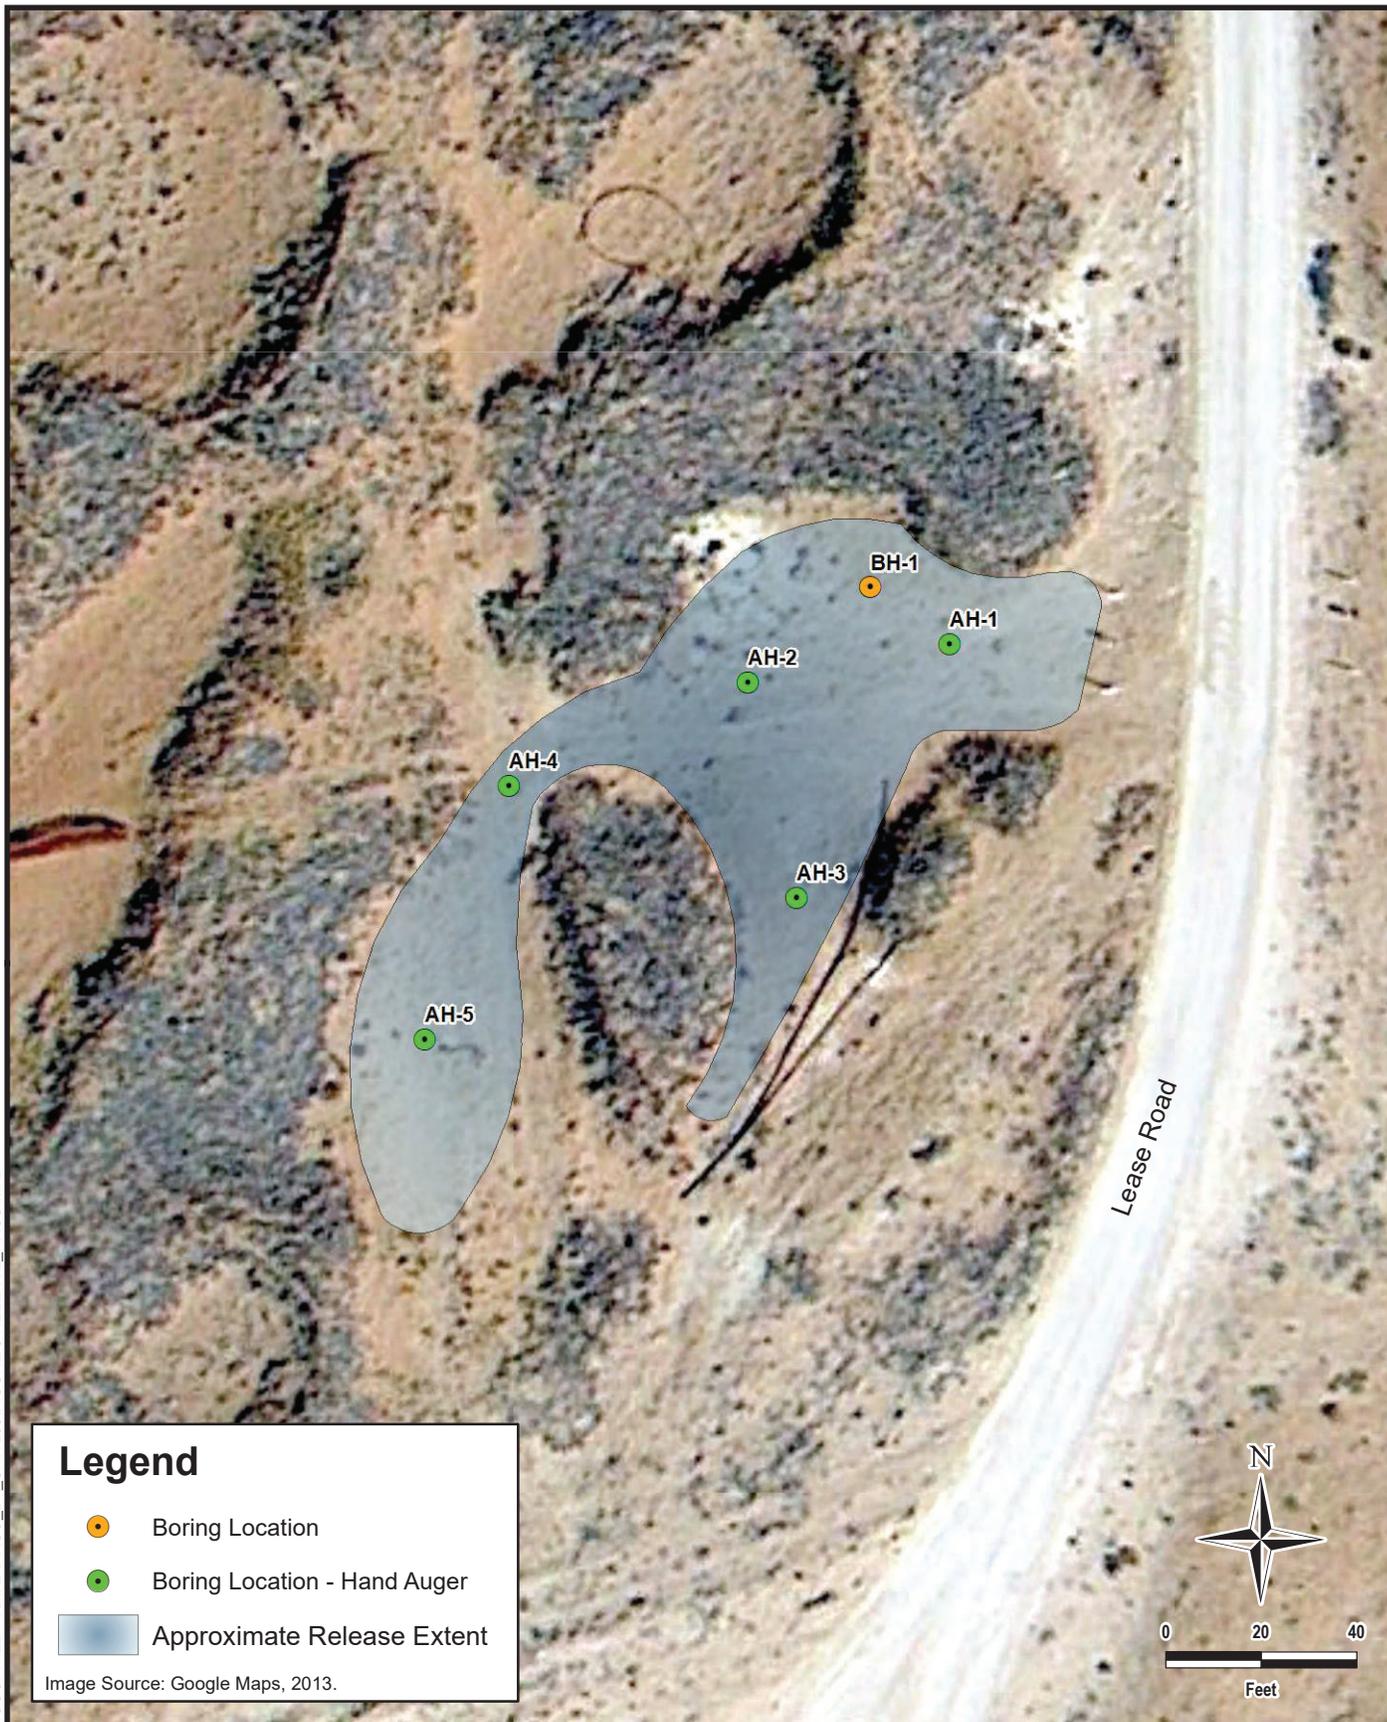
On September 3, 2013, Tetra Tech personnel installed five (5) hand auger borings (AH-1 through AH-5) within the combined release area to assess the impacted soils. To complete vertical delineation of chloride impacts, an additional boring (BH-1) was installed using an air rotary drill rig on June 18, 2014. Boring locations are presented in Figure 3.

In accordance with the approved Work Plan, Tetra Tech supervised the removed of impacted soils in October 2014. Soils in the vicinity of boring locations BH-1, AH-1, and AH-2 were excavated to a depth of approximately 3.5 feet below the surrounding surface. Once excavated, those areas were then lined with a 40-mil liner to cap the remaining impacted soils. Additionally, the areas around boring locations AH-3, AH-4, and AH-5 were excavated to depths of 4 feet bgs, 6 feet bgs, and 3 feet bgs, respectively. Remediation extents are presented in Figure 4. A total of 380 cubic yards of impacted soils were transported to an approved disposal facility and the excavated areas were backfilled with clean soil to surface grade.

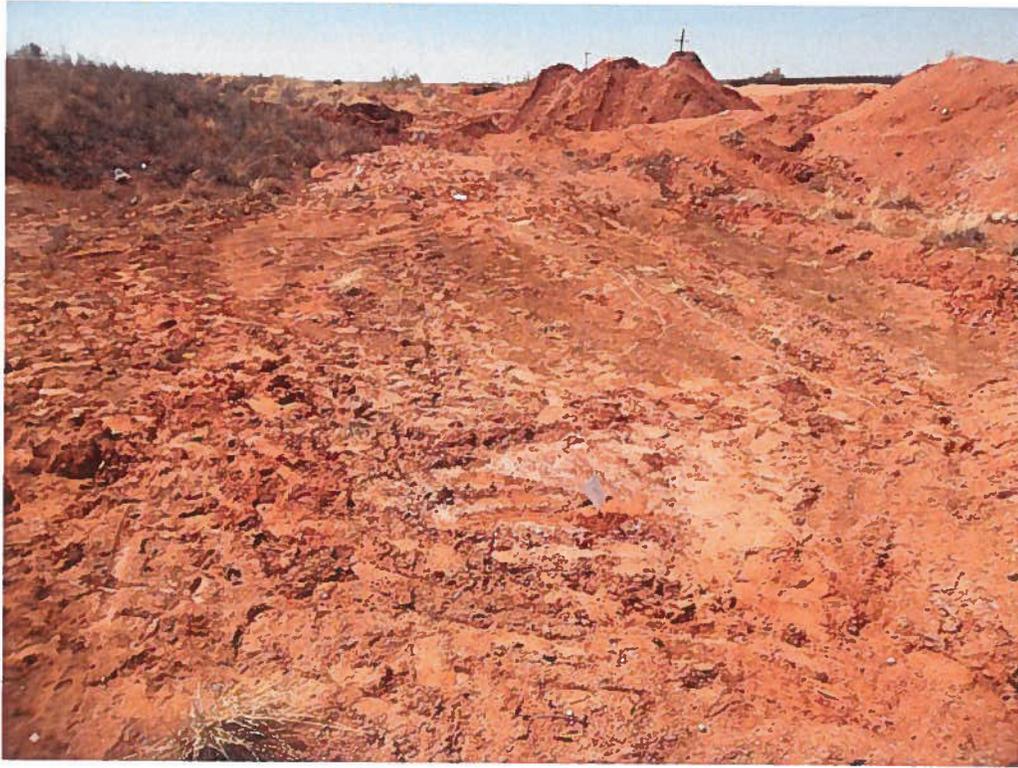
View West – Area of AH-1 and AH-2

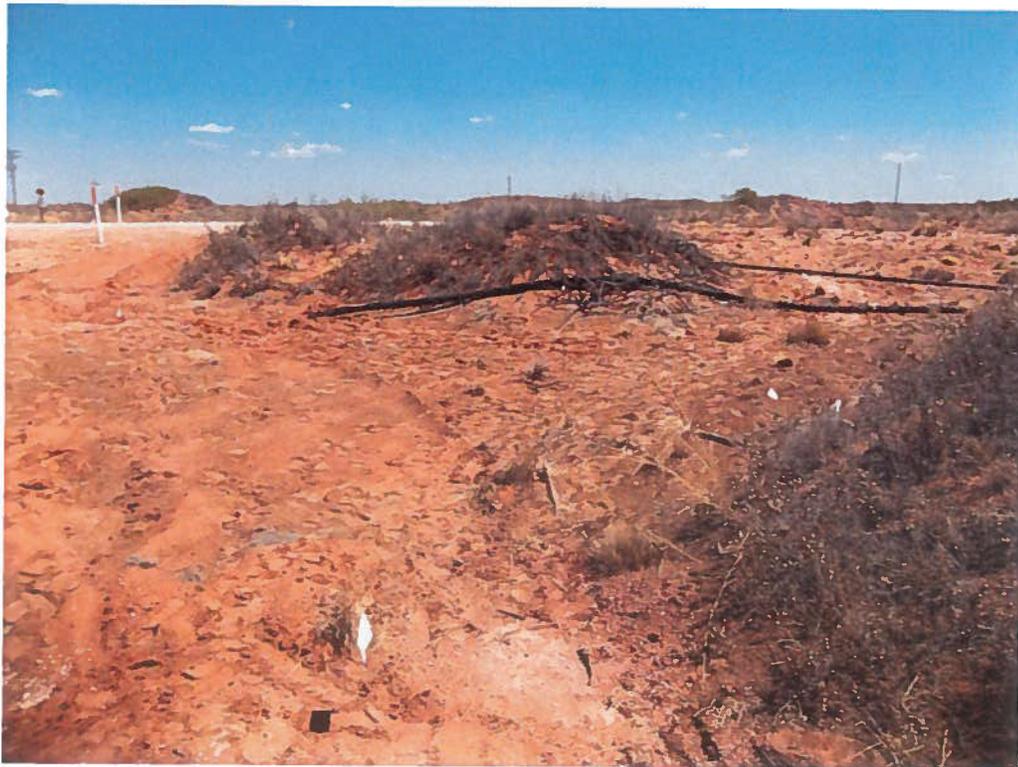
View East – Areas of AH-2 and AH-3

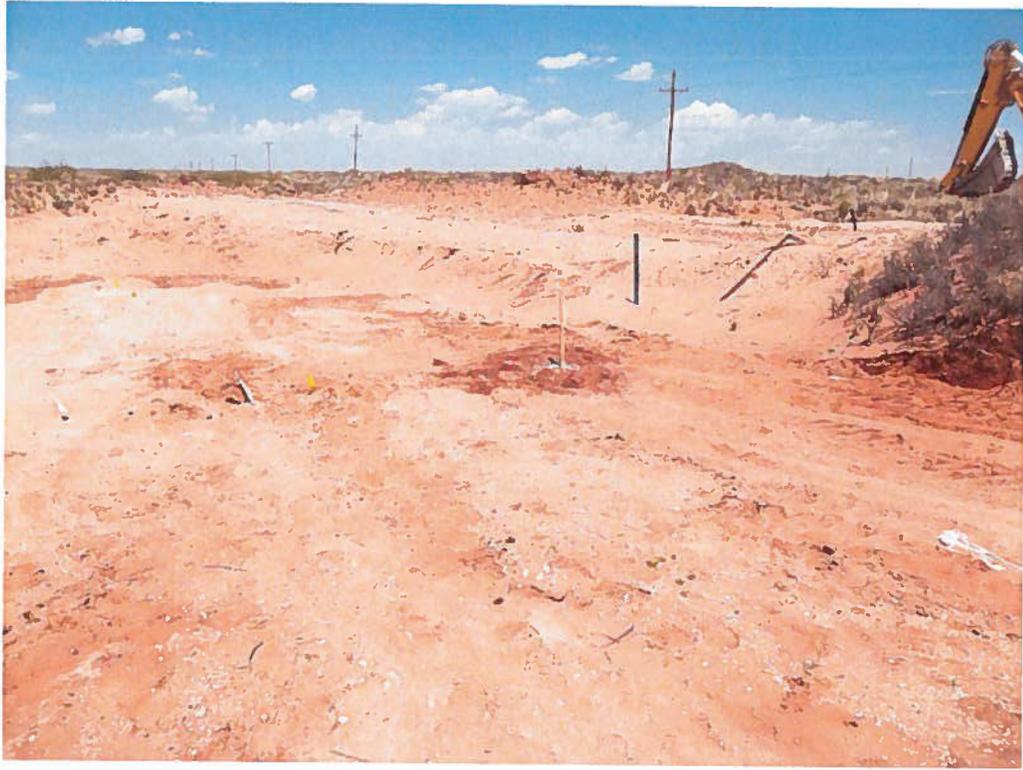
View North – Area of BH-1

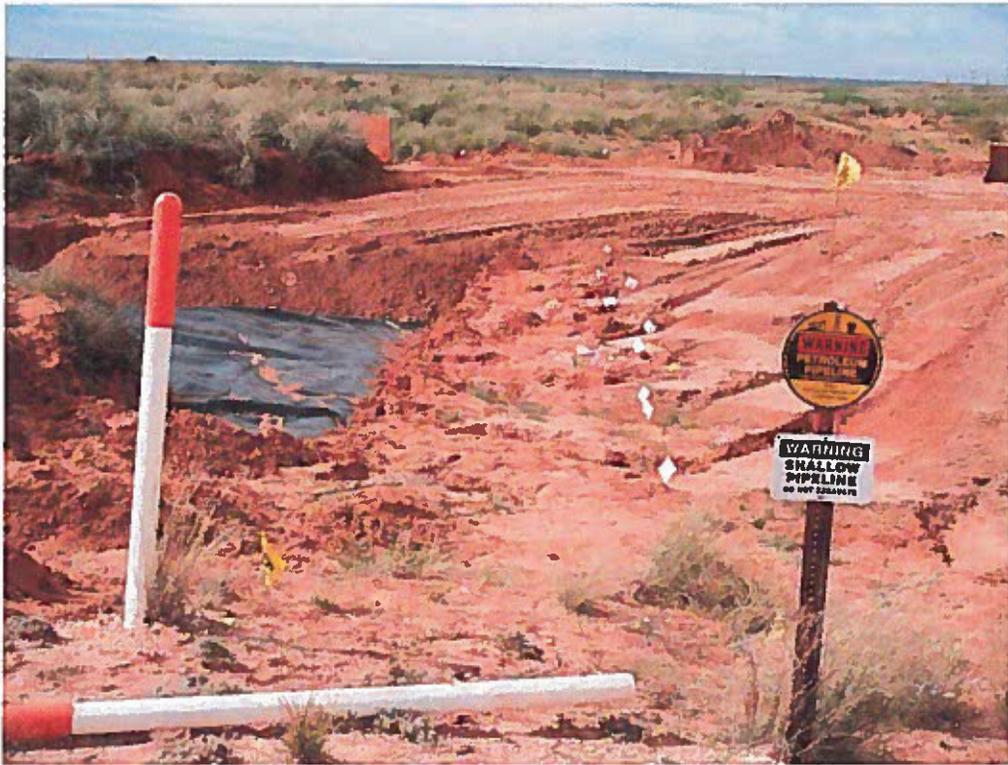
View West – Area of AH-1 and AH-2 backfilled on North side of pipeline

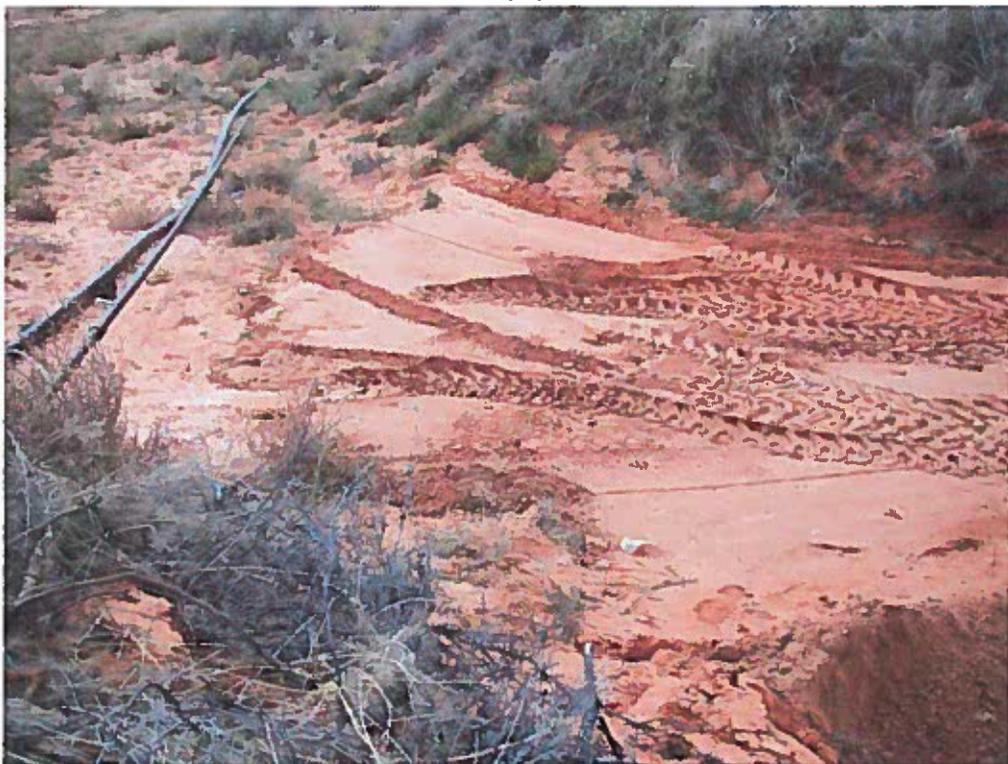
View South – Areas of AH-3 backfilled

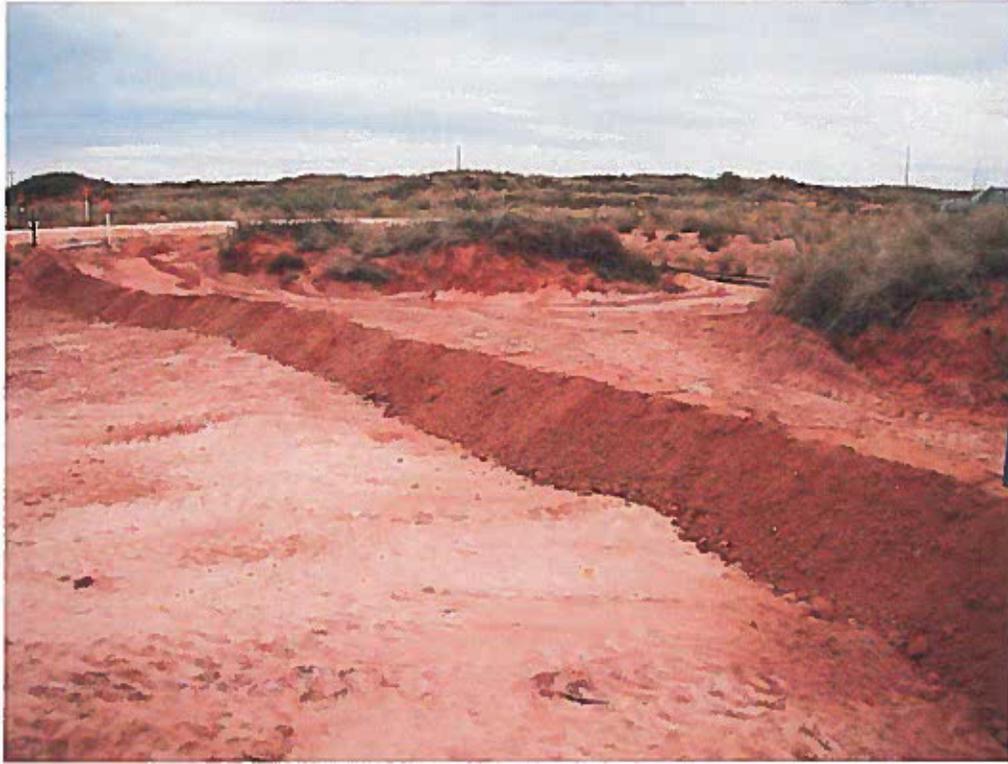
View East – Area of AH 1-AH 3 backfilled with DCP shallow line outlined in berm.

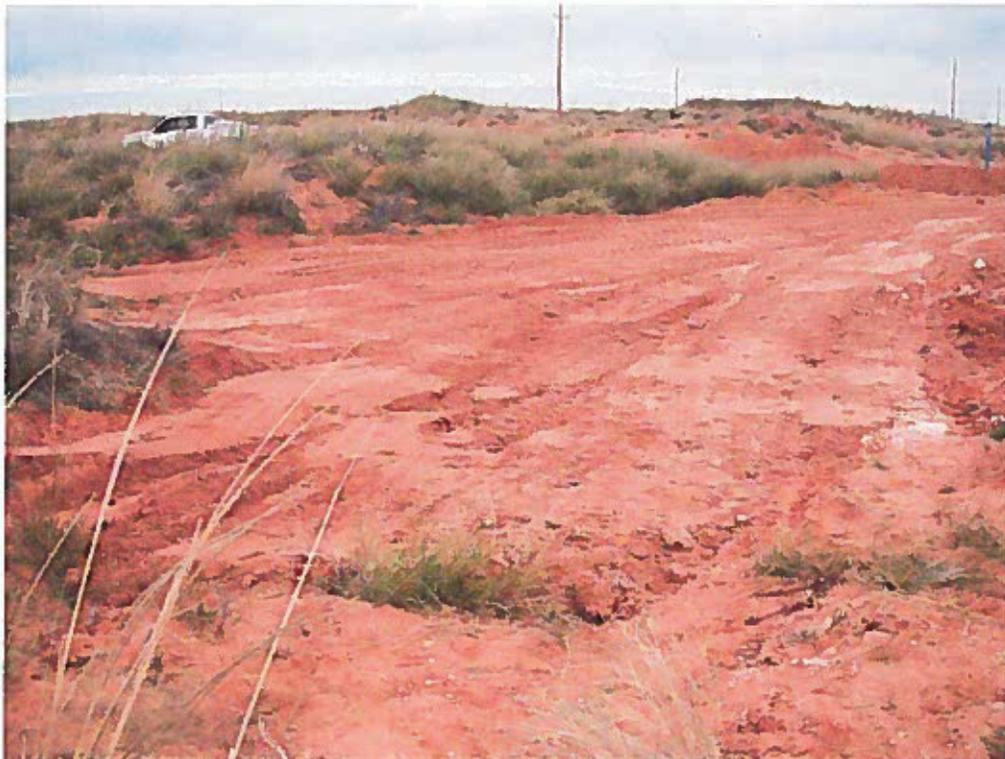
View North – Area of AH 4 and AH 5 backfilled
