Re: Site Assessment, Remediation, and Closure Report
Huber Federal #11H
API No. 30-015-44709
GPS: Latitude 32.611063 Longitude -104.471129
UL "O", Sec. 34, T19S, R25E
Eddy County, NM
NMOCD Ref. No. NRH2003443103

Paragon Environmental, LLC (Paragon) has been contracted by Spur Energy Partners (Spur) to perform a spill assessment and remediation activities for the Release Site known as the Huber Federal #11H (Huber). Details of the release are summarized below:

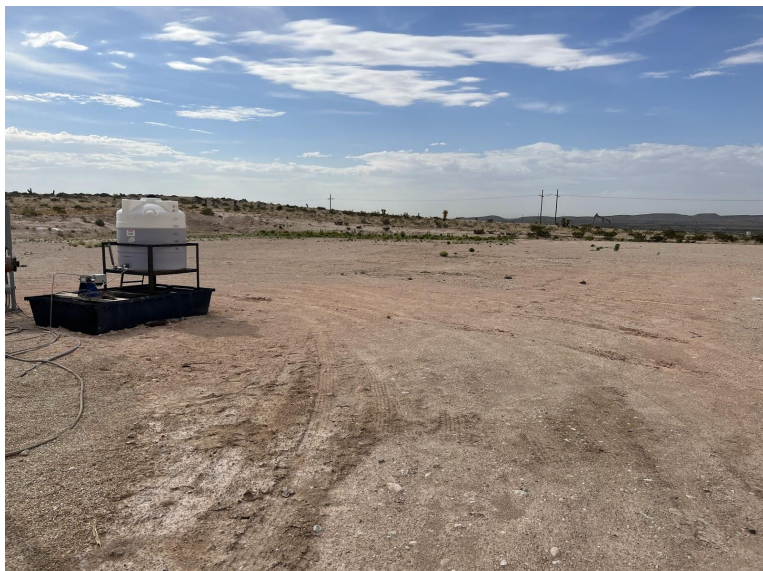
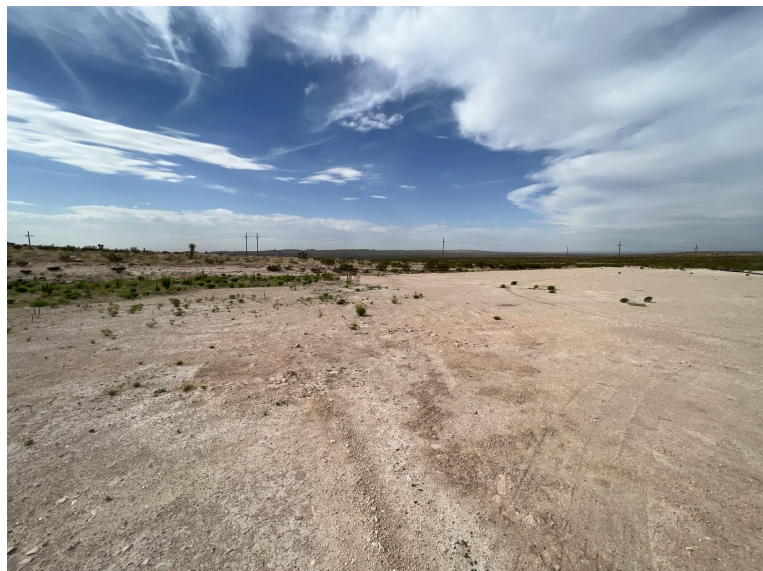
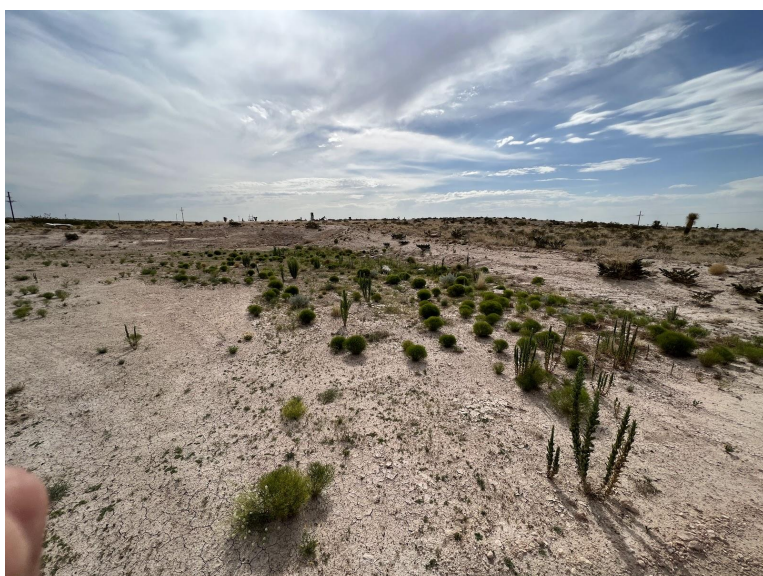
**Photographic Documentation
Before Remediation**

WELL HEAD PIPING BEFORE THE BPV (BACK PRESSURE VALVE) CAUSED APPROX. 5BBLs OF OIL TO BE RELEASED ONTO THE PAD. A VACUUM TRUCK WAS DISPATCHED OUT TO RECOVER APPROX. 3BBLs OF FLUID AND HAULED TO DISPOSAL.
