CLOSURE REPORT

Right Hand Canyon 35 1

**Eddy County, New Mexico
32.431998° N, 104.473860° W
NMOCD Incident ID: nKMW1110138117
RP No.: 2RP-728
API No.: 30-015-26126**

October 17, 2022
Ensolum Project No. 03B1417038

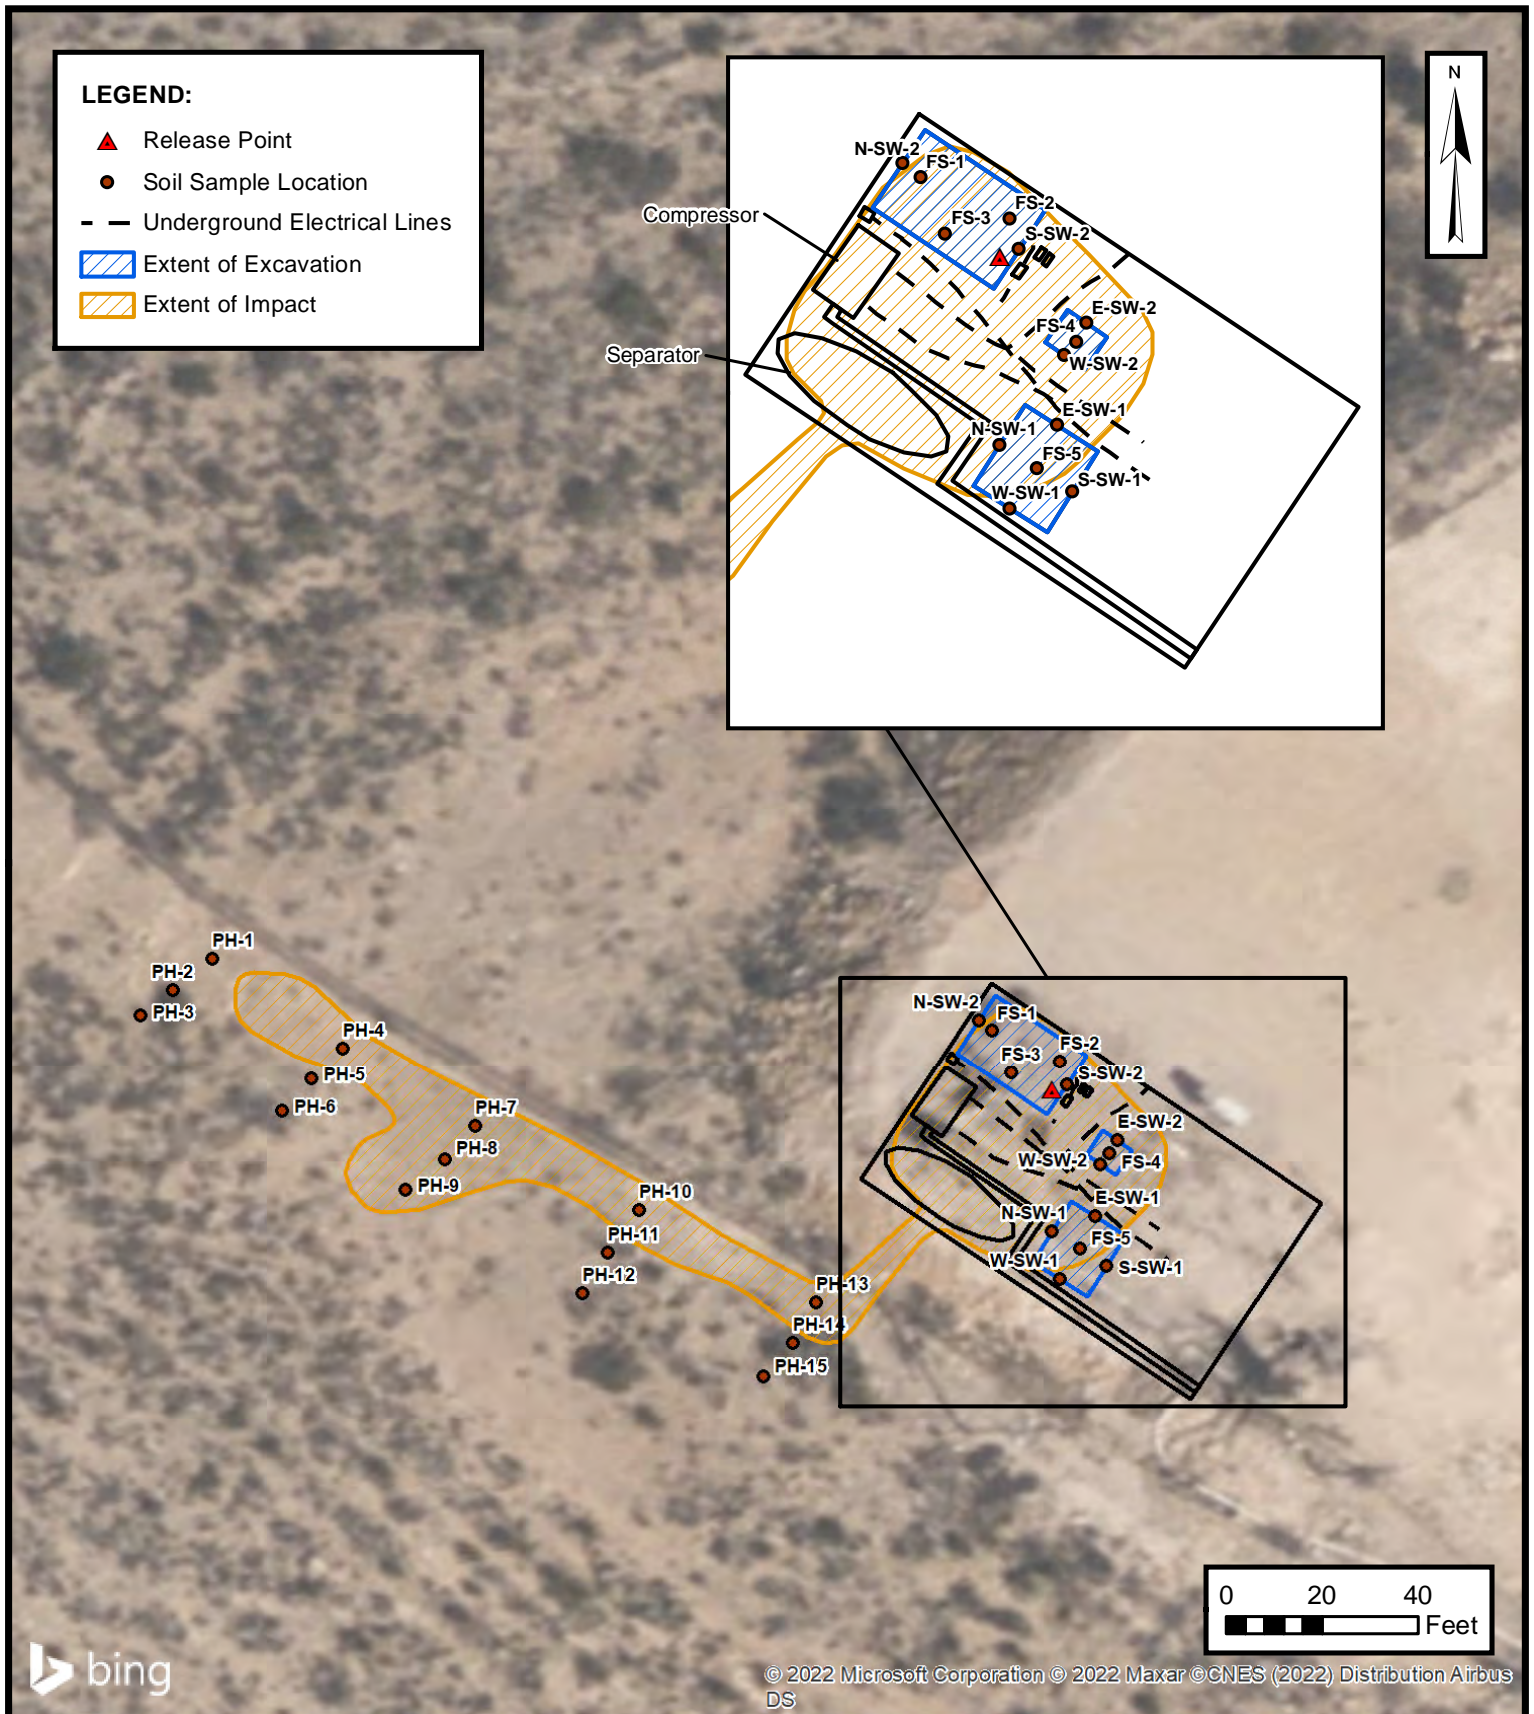
FIGURE**3**

**SITE MAP**

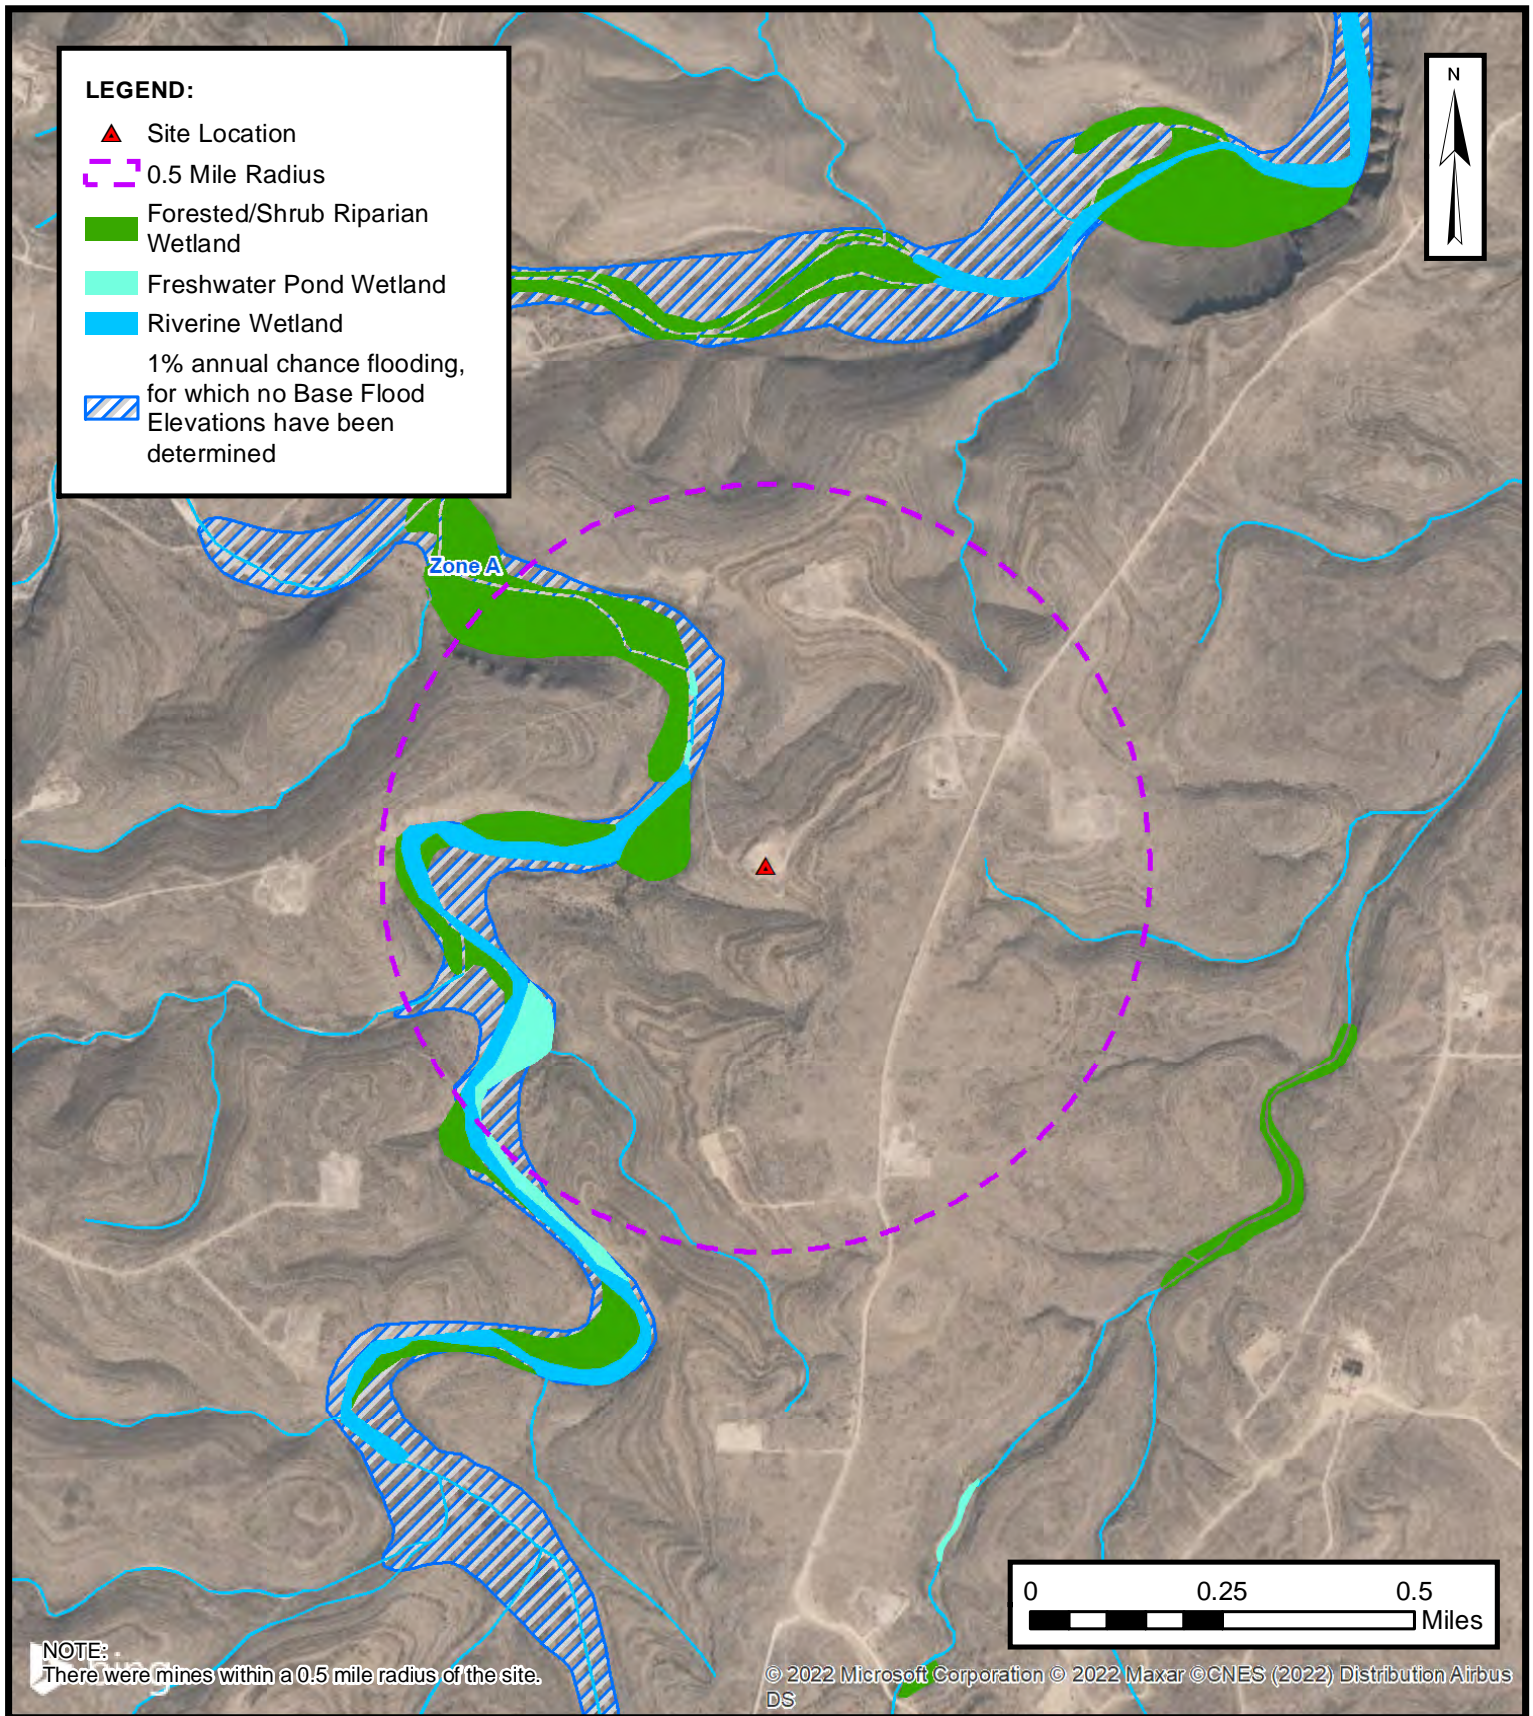
**CLOSURE CRITERIA MAP**

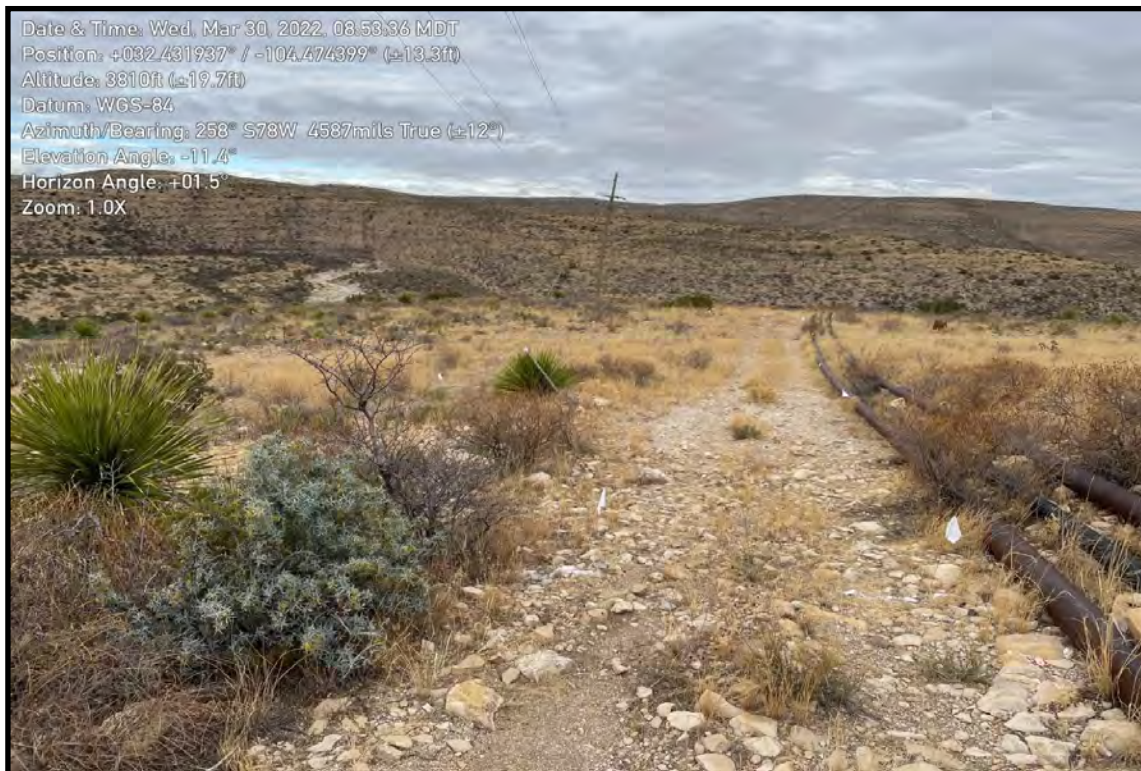
View of the release area, facing southwest.

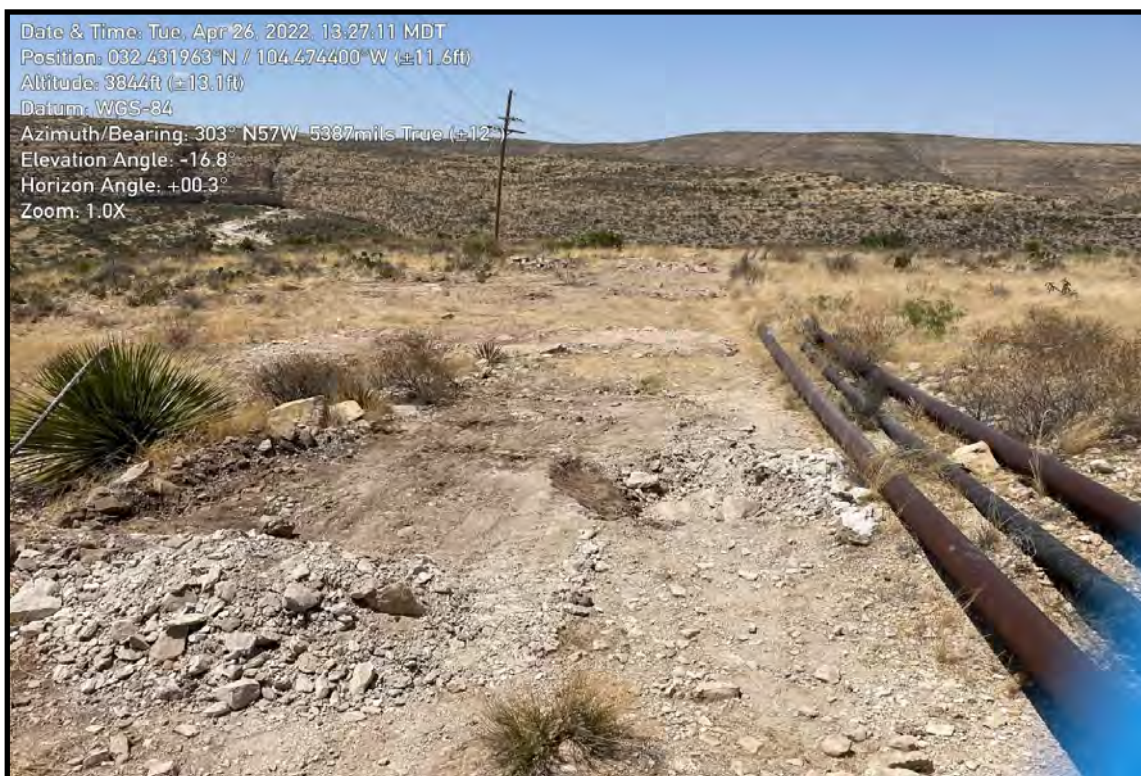
View of the release area, facing northwest.

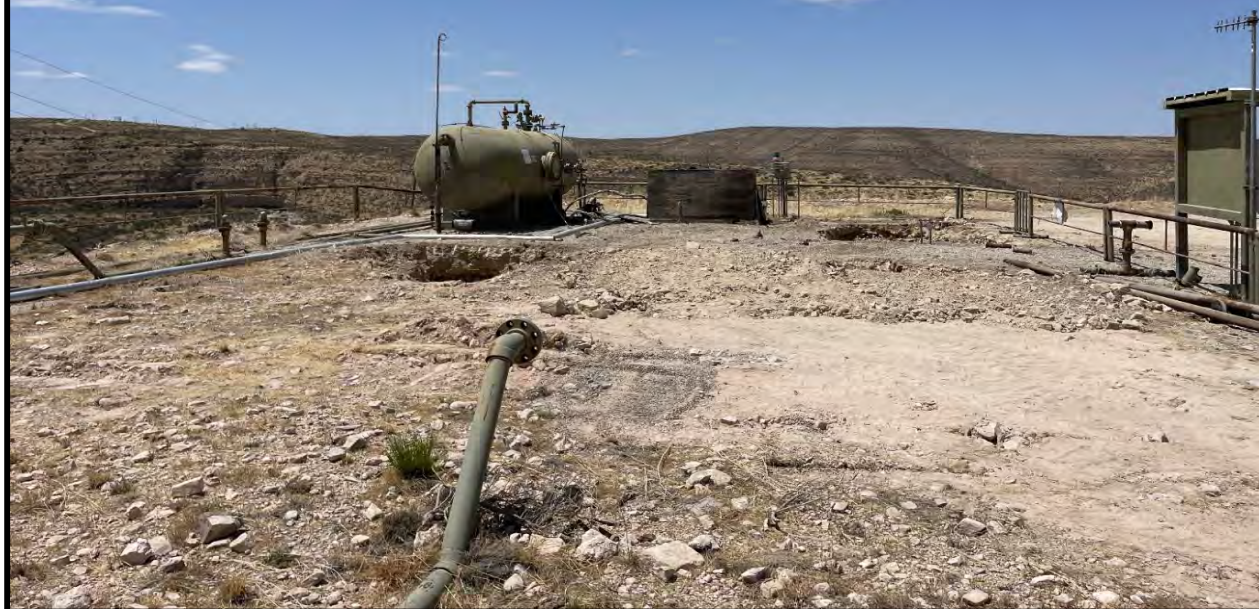
View of the release area, facing northwest.

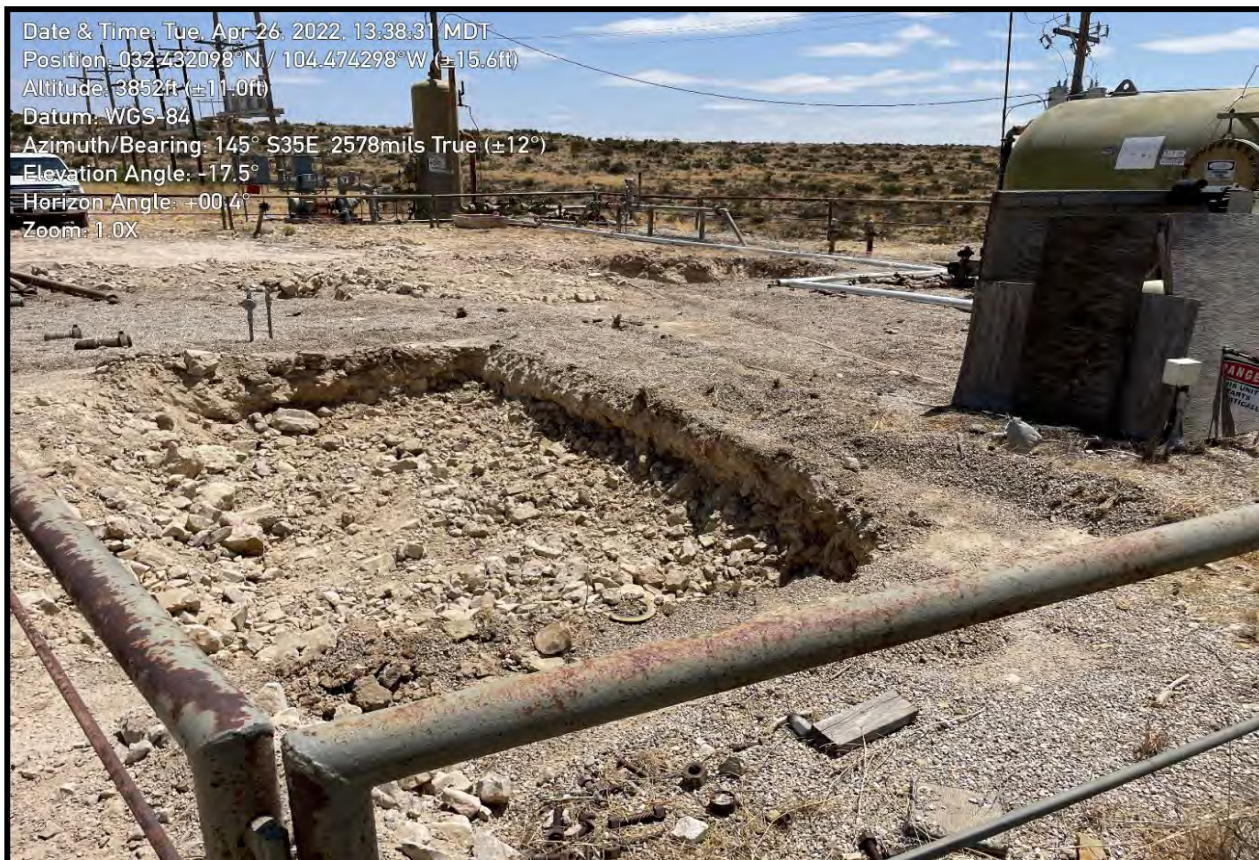
View of the excavated release area, facing southeast.
