NMOCD Incident No. nOY1706630747  
UL "M", Sec. 13, T14S, R33E  
33.0982437°, -103.5753937°  
Lea County, New Mexico

Tasman, Inc. (Tasman) is pleased to submit this Remediation Action Plan for the Chalupa #4 SWD – South Release Area (Site) on behalf of Foundation Energy Management, LLC (FEM), documenting the results of field activities conducted in response to a release of natural gas and natural gas condensate to environmental media.

**Foundation Energy Management**  
**Chalupa #4 SWD - South Release Area**  
UL "M", Section 13, Township 14 South, Range 33 East  
Lea County, New Mexico

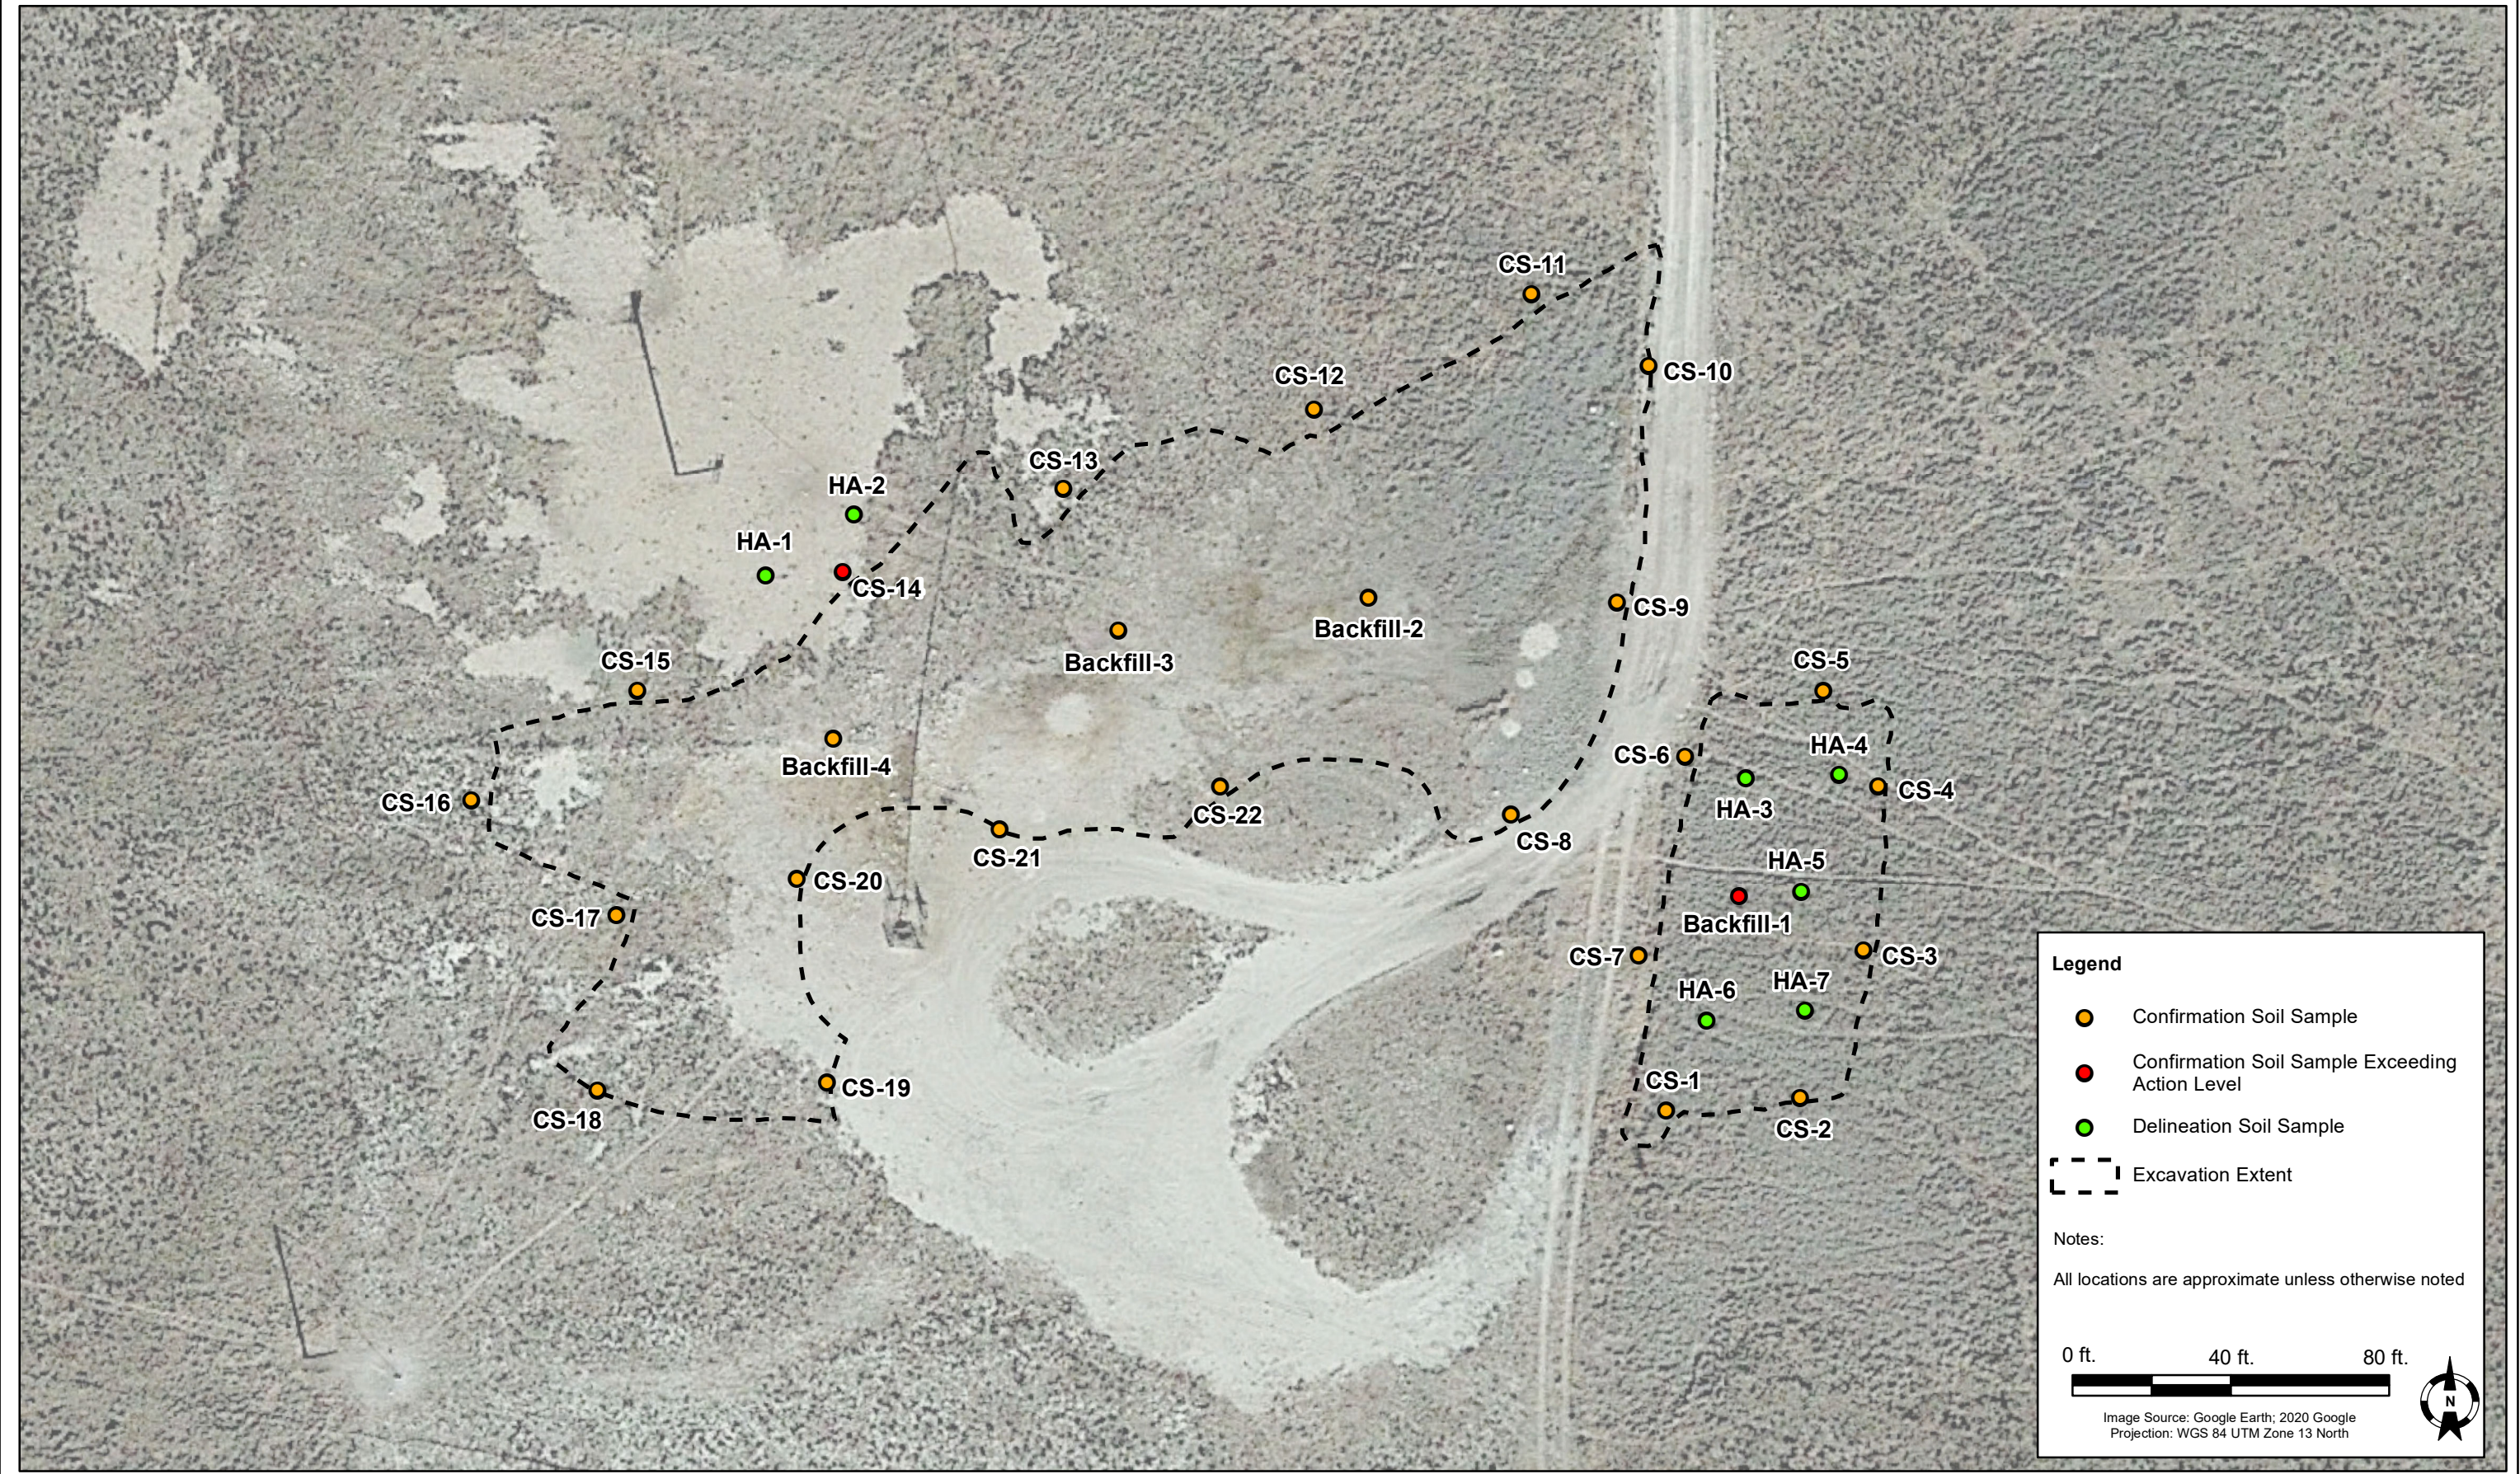
depth of 3.5 feet bgs. Samples were collected above the liner to prevent damage. Sample locations are illustrated on Figure 2 and a photographic log is provided as Appendix B.

On December 30, 2022, Tasman mobilized to the Site to further delineate remaining chloride impacts in the area of exceedances observed during the November 2022 confirmation sampling even. A total of seven soil borings (HA-1 through HA-7) were advanced using a hand auger to a depth of 4 feet bgs or geologic refusal. Sample locations are illustrated on Figure 2.

Tasman proposes to perform additional characterization of the areas surrounding soil borings CS-14, HA-1, and HA-2 advanced during the November and December 2022 assessment events. Due to challenging geologic conditions, delineation will be conducted by advancing vertical trenches
