**RE: Site Assessment, Remediation, and Closure Report**  
**Serene Sisters 25 Federal #004H**  
**API No. 30-015-38312**  
**GPS: Latitude 32.711242 Longitude -103.831272**  
**UL "N", Section 25, Township 18S, Range 31E,**  
**Eddy County, NM**  
**NMOCD Reference No. NAB1520255168**

Raybaw Operating, LLC (Raybaw) has contracted Pima Environmental Services, LLC (Pima) to perform a site assessment, remediation, and prepare this closure report for a produced water release that happened west of the Serene Sisters 25 Federal #004H (Serene). An initial C-141 was submitted on July 20, 2015, and can be found in Appendix C. This incident was assigned Incident ID NAB1520255168, by the New Mexico Oil Conservation Division (NMOCD).

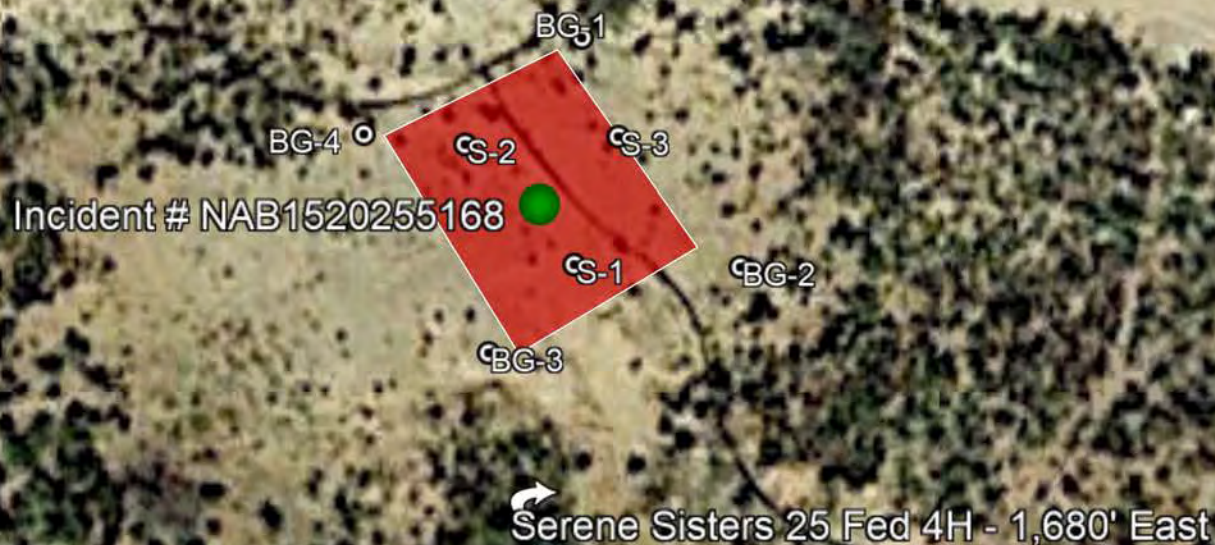
Raybaw Operating  
API #30-015-38312  
Eddy County, NM  
Site Map

On July 1, 2020, Pima personnel mobilized to the site to conduct a follow-up assessment and collect new data from the spill area. We collected samples from the area mainly to find out if any previous remediation activities had taken place. The samples were field-screened, and the results can be seen in the following data table. A Site Map can be found in Figure 4.

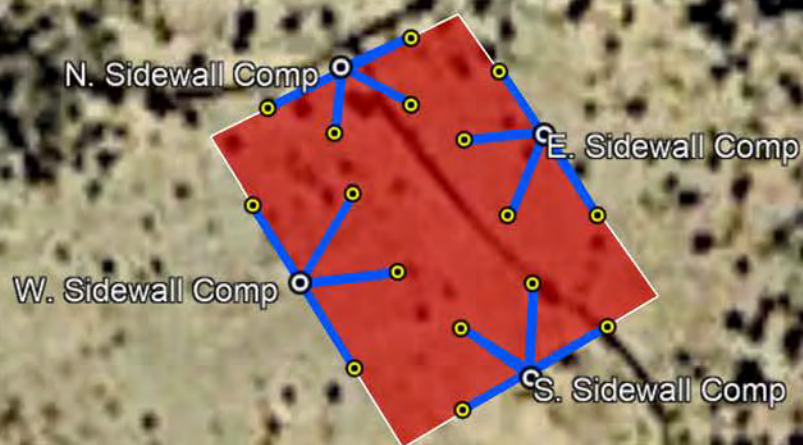
Raybaw Operating  
API #30-015-38312  
Eddy County, NM  
Confirmation Sample Map

On July 17, 2020, Pima personnel returned to the site to load up and haul off the stockpiled contaminated soil. Stockpiles 3, 4, and 6 were hauled to Lea Land, LLC, an NMOCD-approved disposal facility. A poly liner was installed at the bottom of the excavation. The excavation was then backfilled with the remaining stockpiled material. Clean, fresh topsoil was brought in and used to finish backfilling the top 1.5' of the excavation. The area was then machine compacted and contoured to match the surrounding terrain. A Confirmation Sample Map can be found in Figure 5.

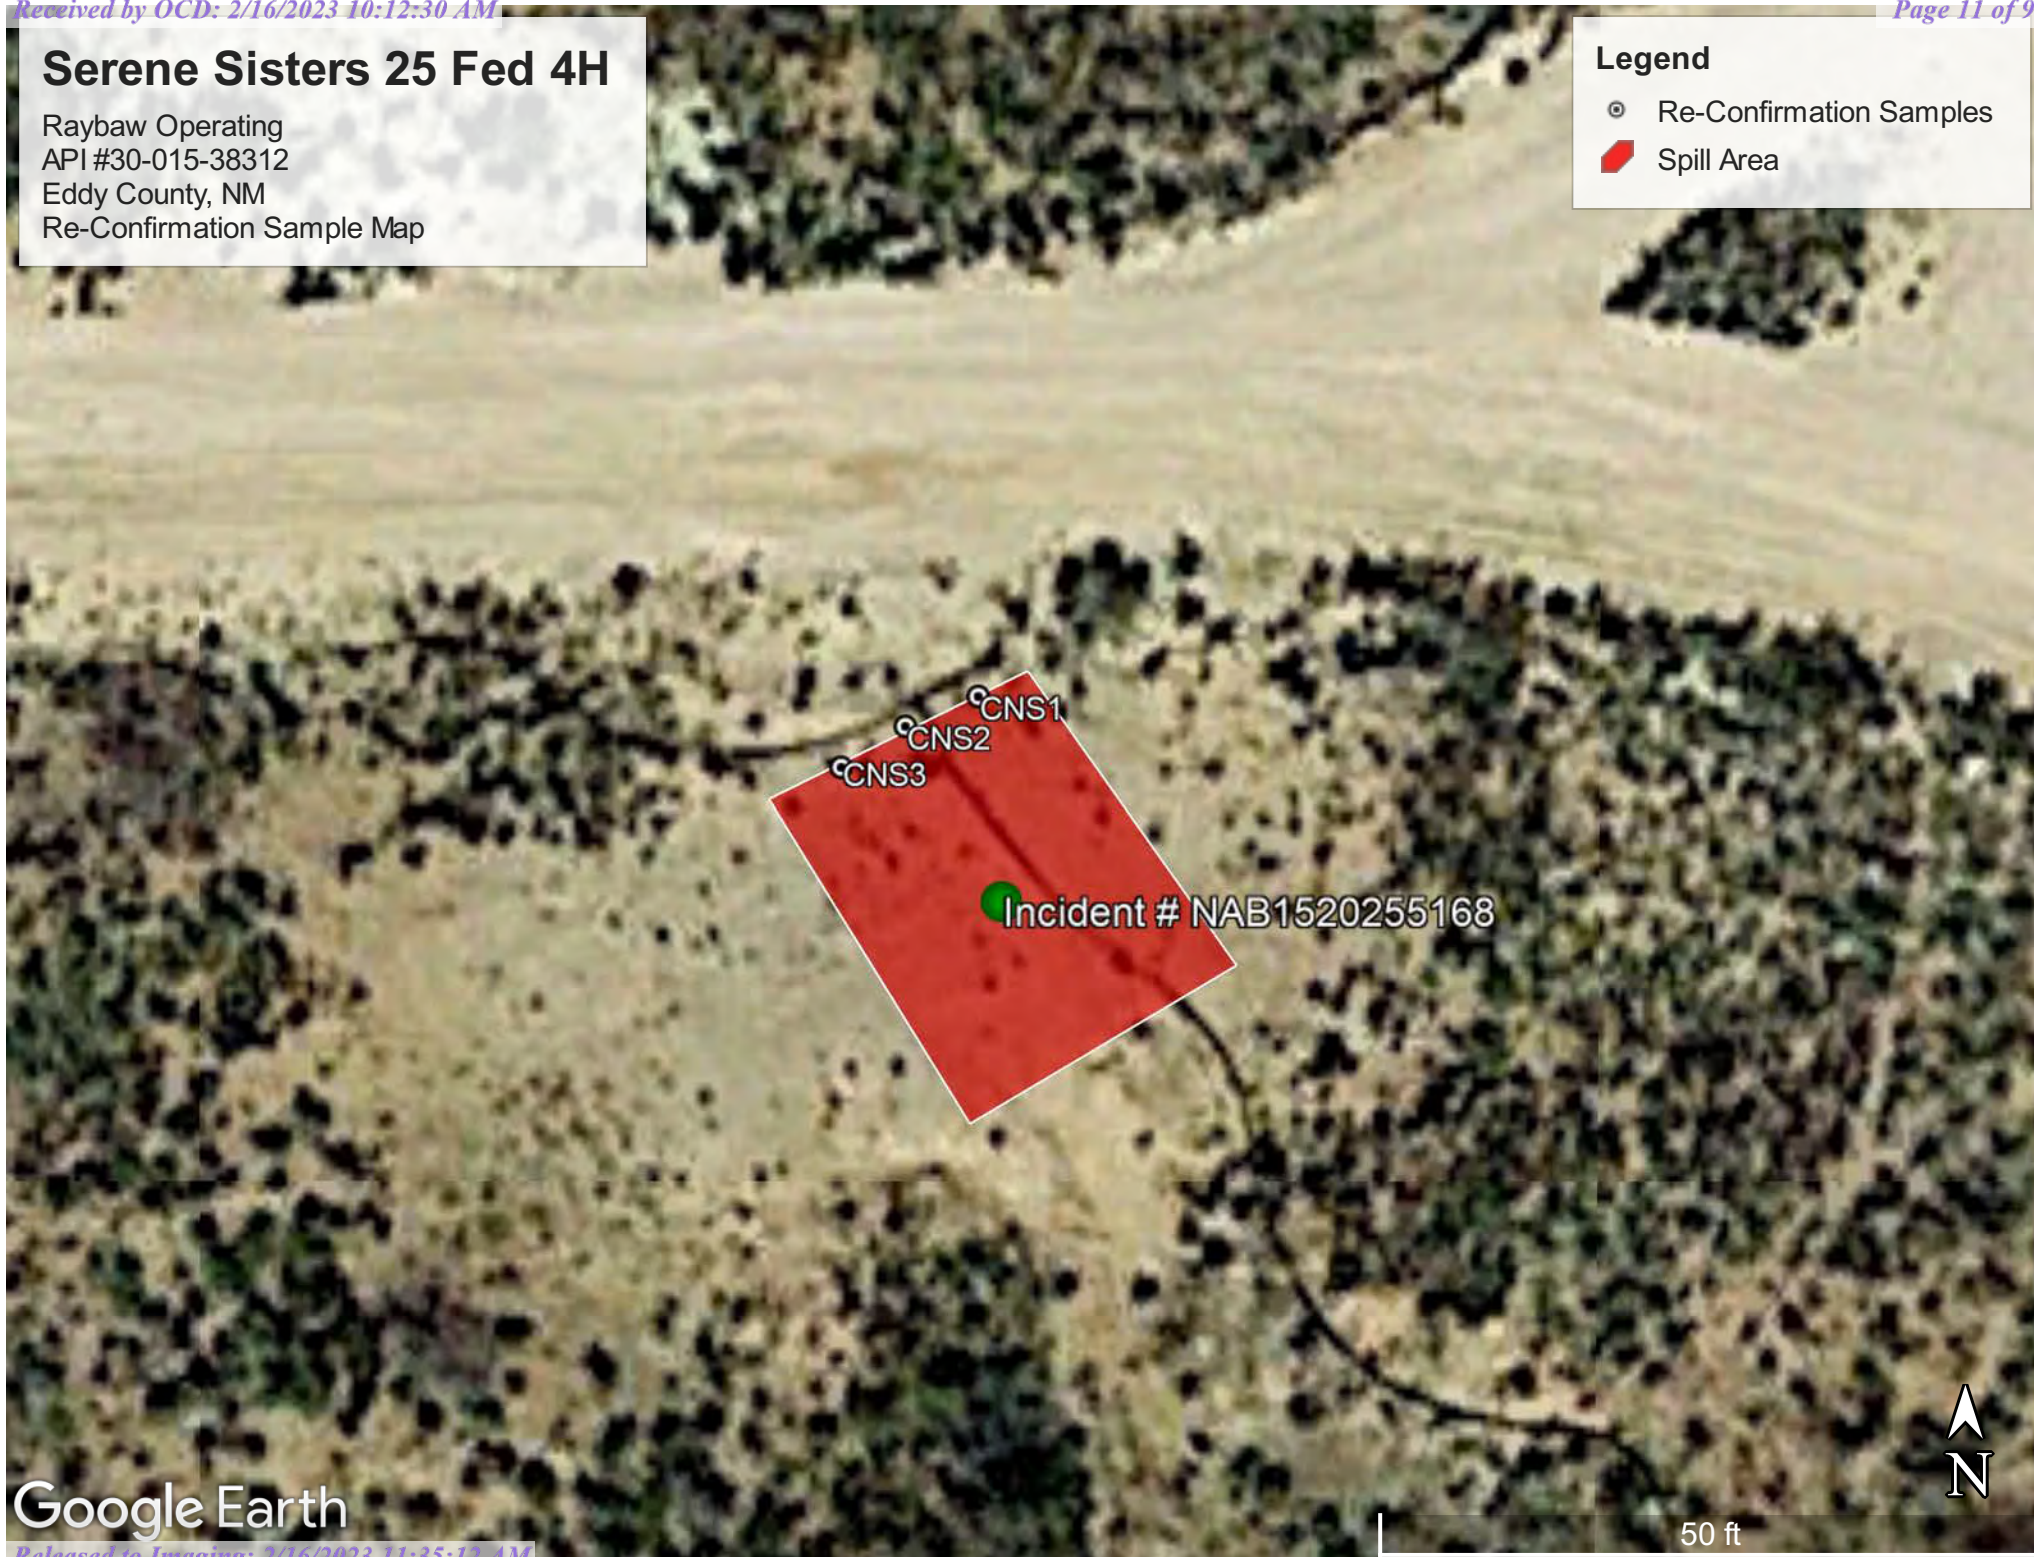
Raybaw Operating  
API #30-015-38312  
Eddy County, NM  
Re-Confirmation Sample Map

On February 9, 2023, due to contamination still being present at the N. Sidewall Comp area, Pima personnel returned to the site to collect re-confirmation samples from that area. The following data table represents the sample results collected from this sampling event. A Re-Confirmation Sample Map can be found in Figure 6.

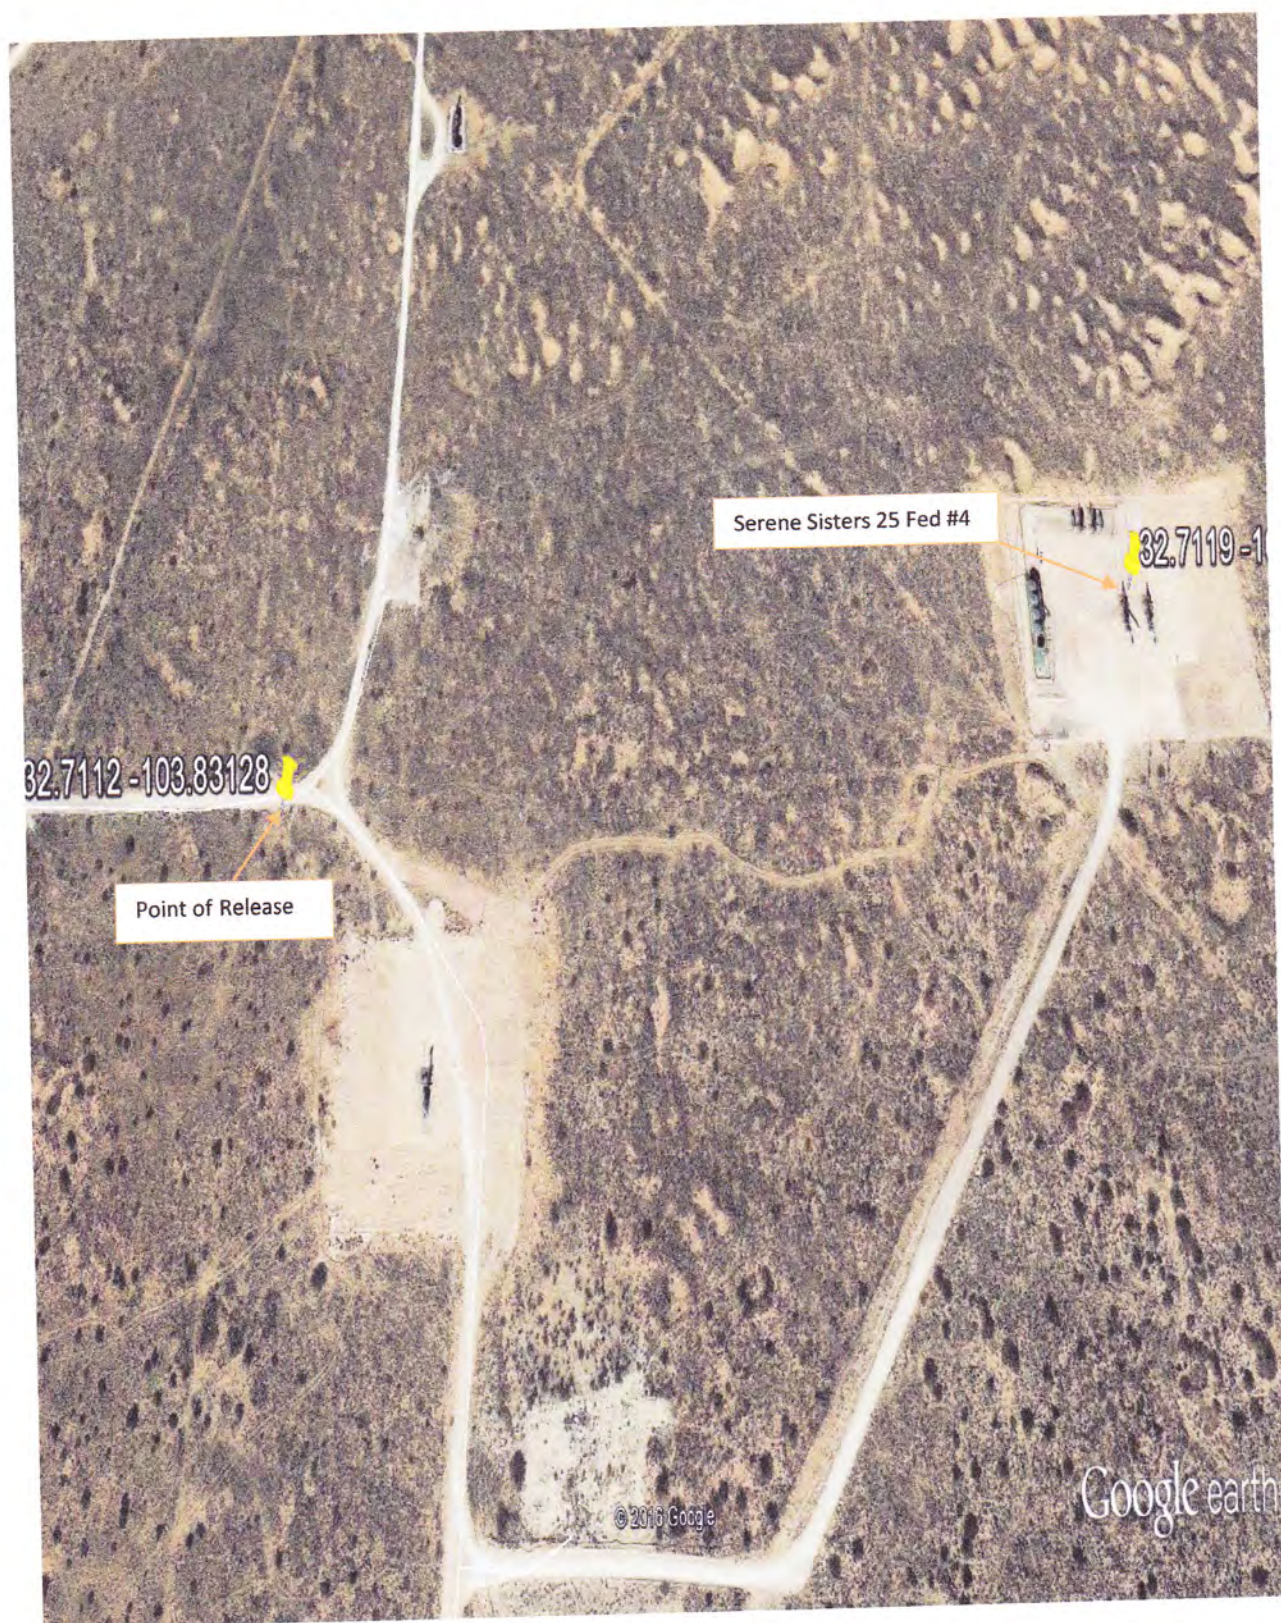
Devon Energy Production Company-Serene Sisters 25 Fed #4

Point of Release is 570 yards west/southwest of well site near lease road intersection.

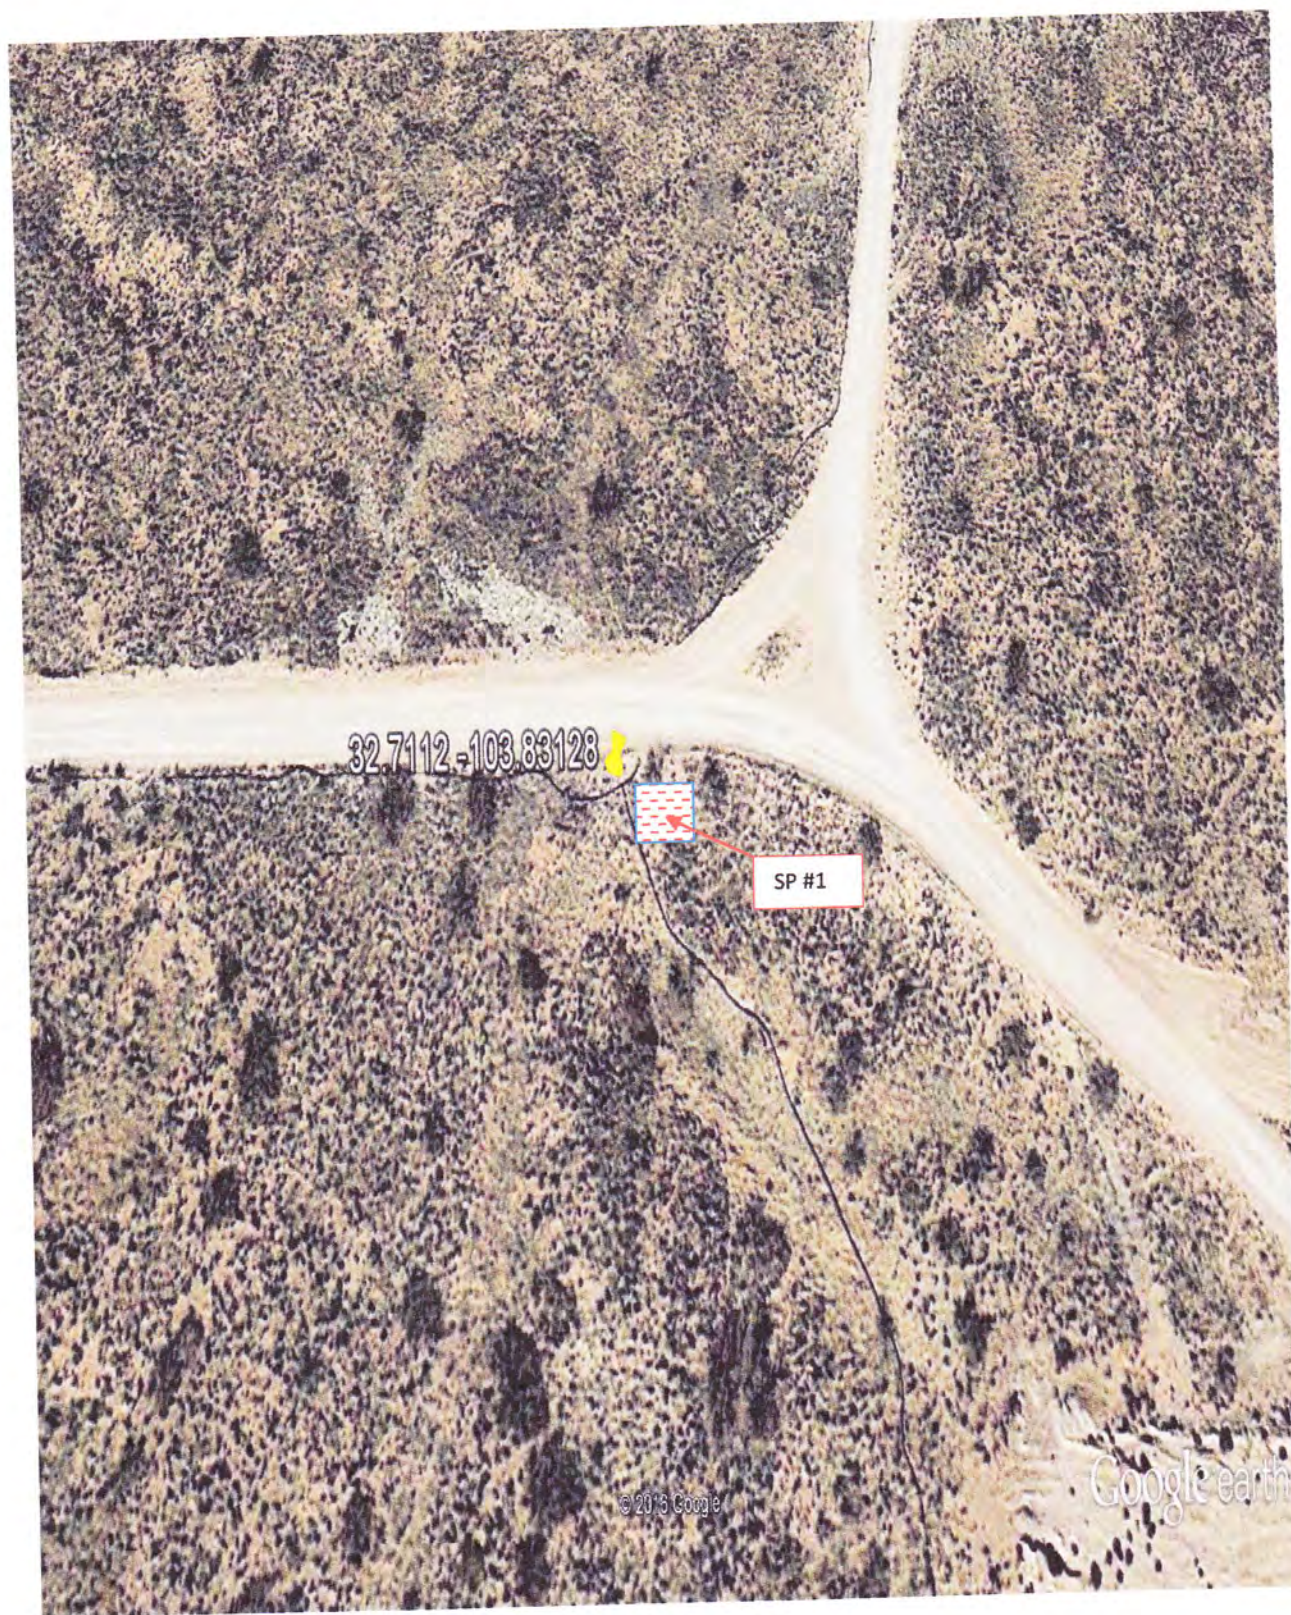
Devon Energy Production Company-Serene Sisters 25 Fed #4

Impacted area is approximately 30' x 30'.
