Incident ID	nAPP2213659126
District RP	
Facility ID	
Application ID

Based on laboratory analytical results and field activities conducted to date, Etech recommends Mewbourne Oil Company provide copies of this *Remediation Summary & Soil Closure Request* to the appropriate agencies and request closure be granted to the Aureus-Zuma Frac Line release site.

Project: Aureus-Zuma Fracture

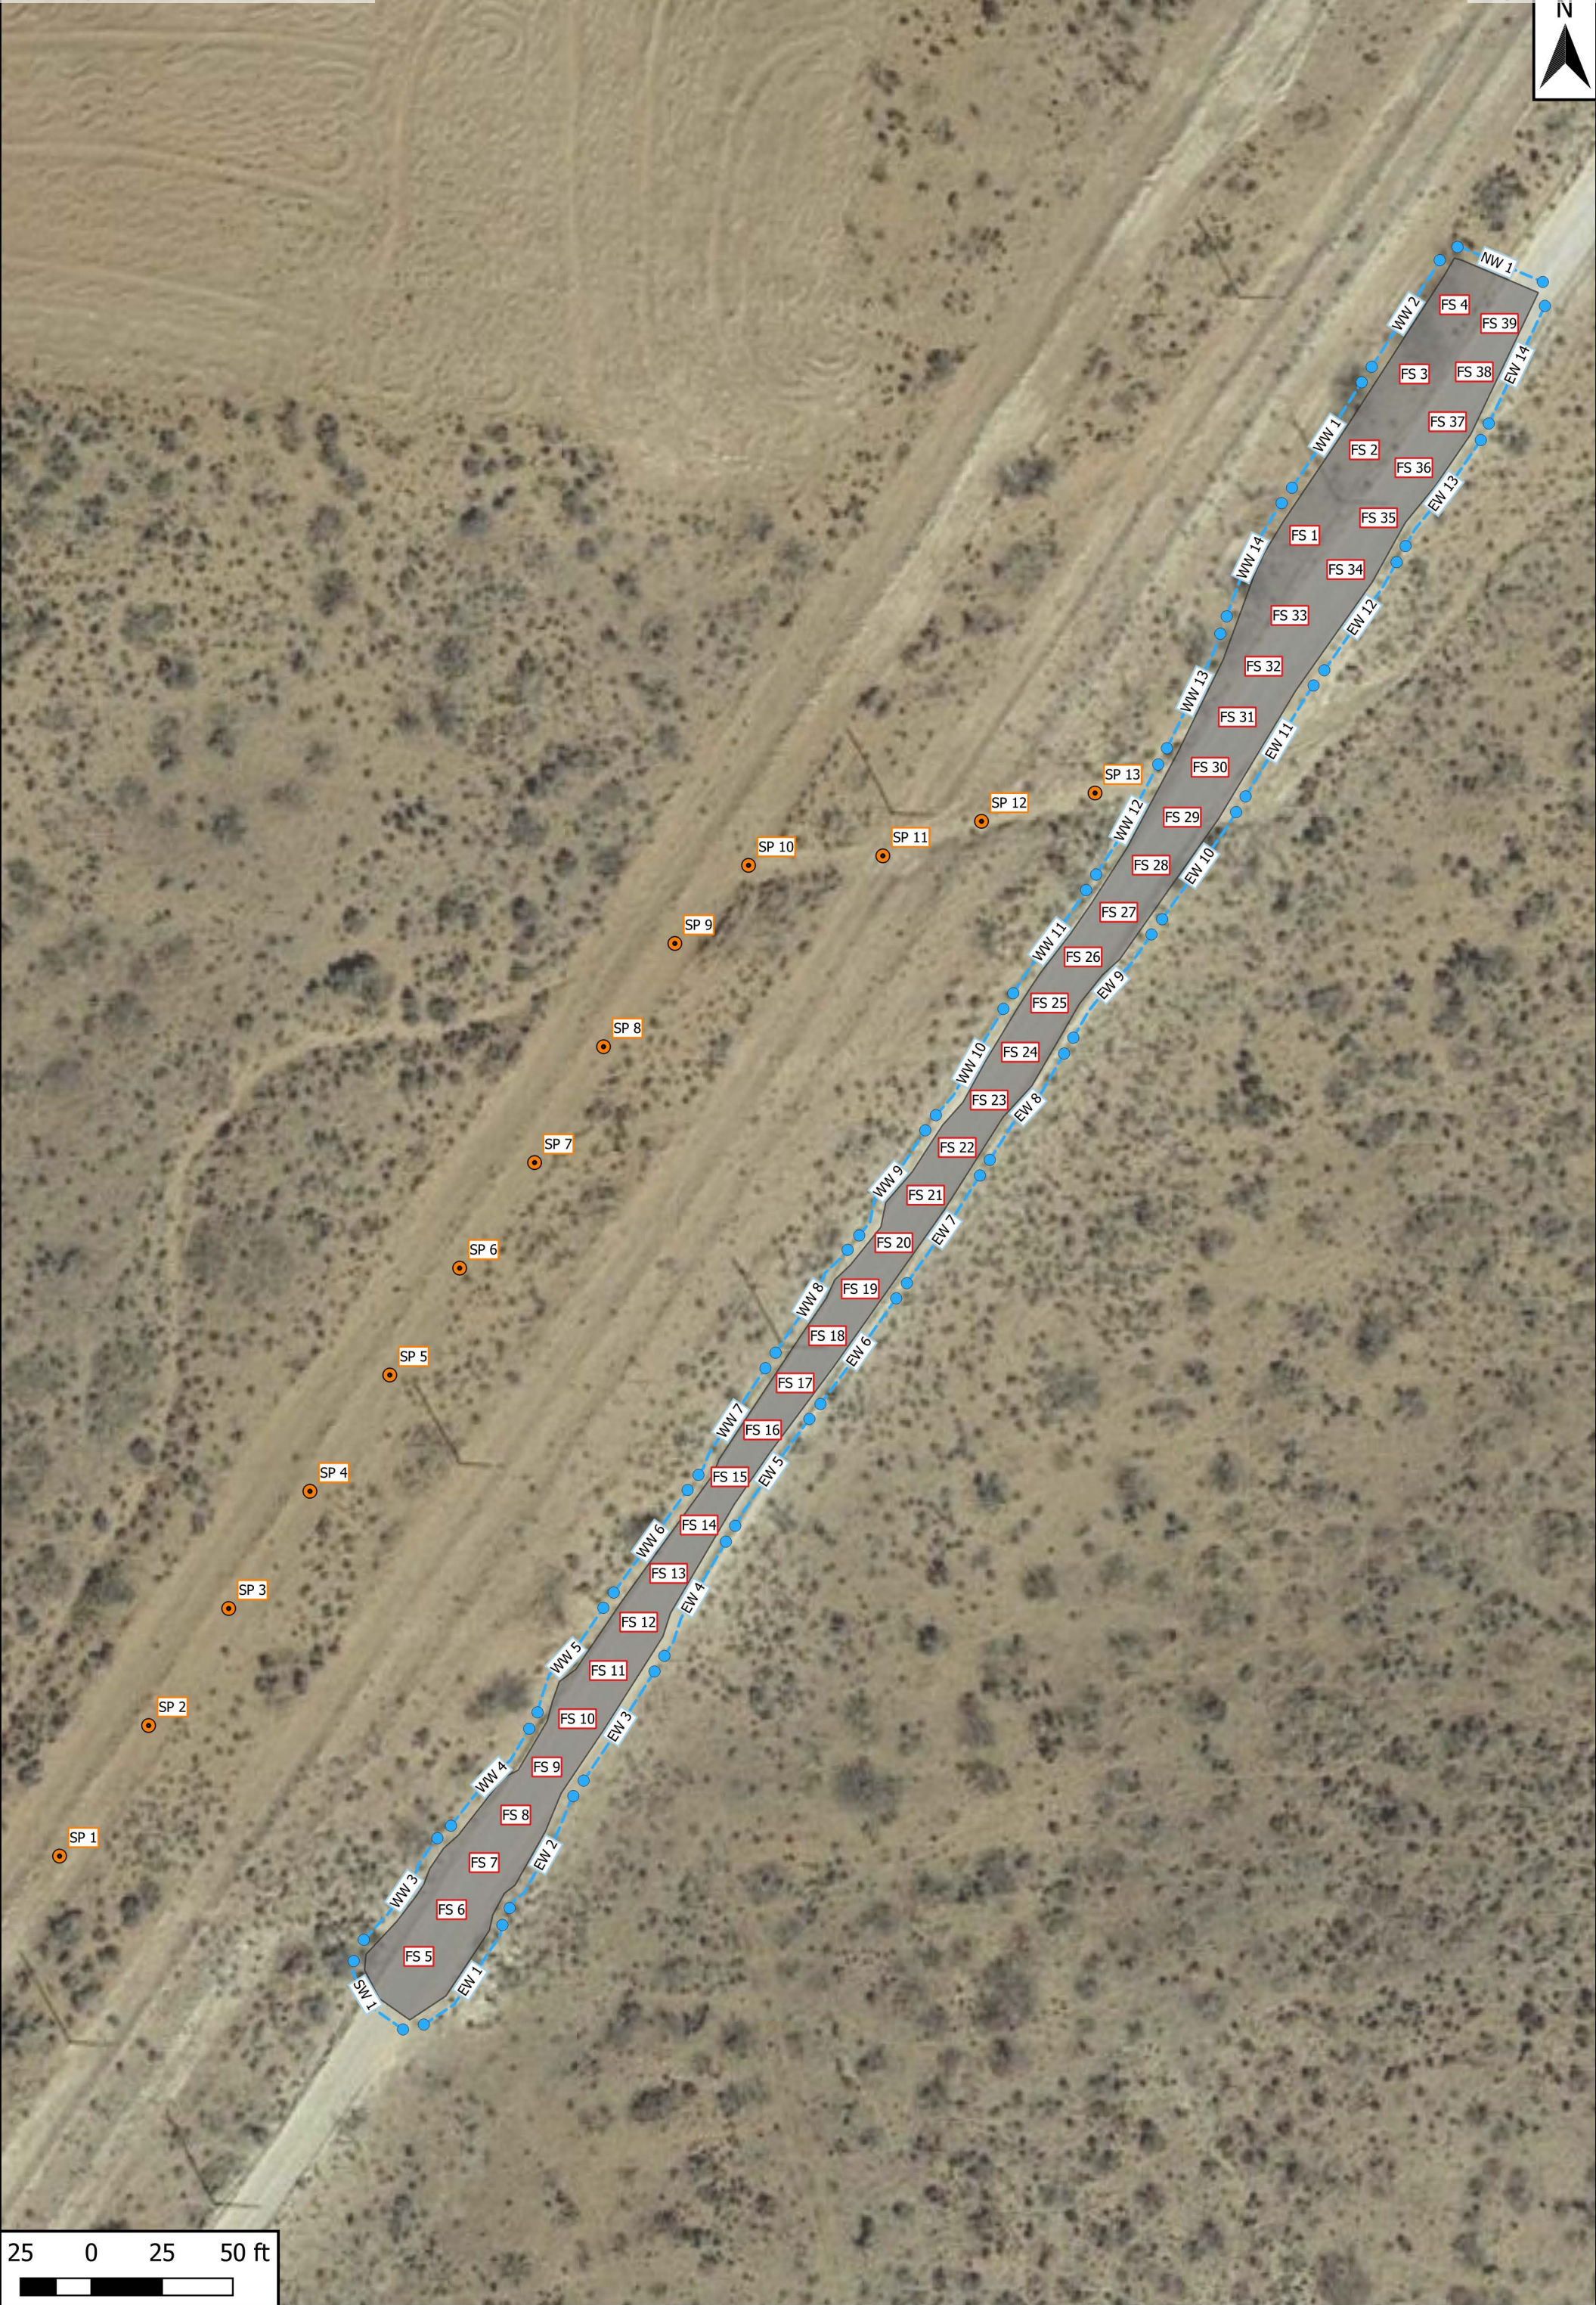
Figure 3

Site & Sample Location Map

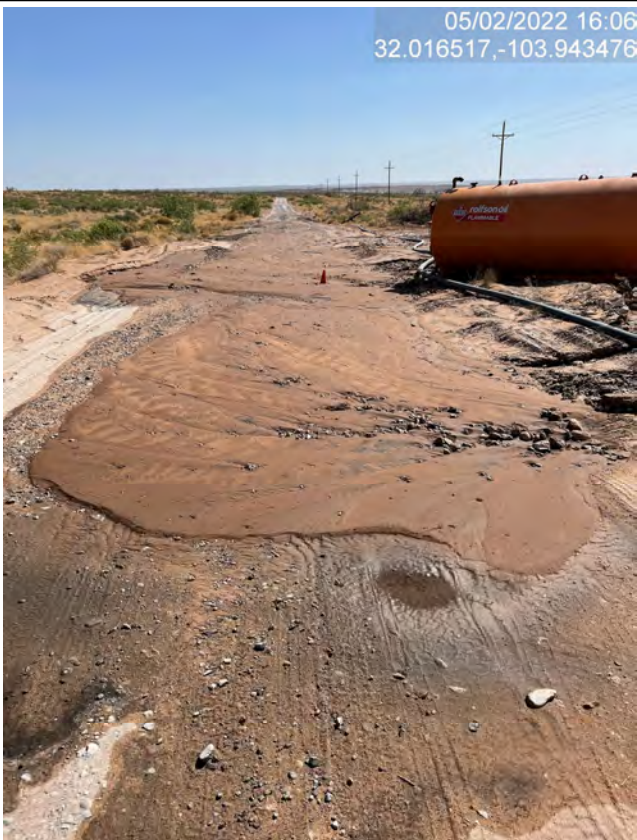
Photo Number: 1

A photograph showing a muddy, brownish area in the foreground, likely a spill or erosion. In the background, there is a large orange cylindrical tank. The sky is clear and blue. The photo has a timestamp in the top right corner: 05/02/2022 16:06 and coordinates 32.016517, -103.943476.
Photo Direction: Southwest	
Photo Description: View of the affected area.

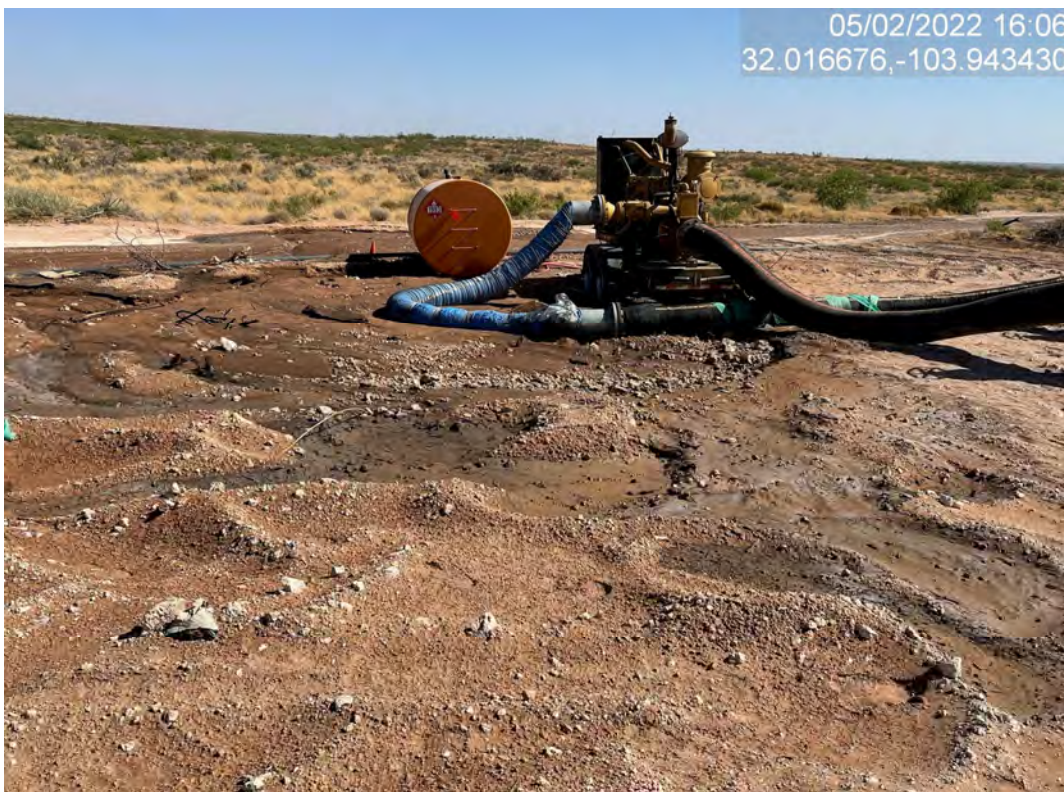
Photo Number: 2

A photograph showing a muddy area with a pump and hoses. The pump is yellow and black, and there are blue and black hoses connected to it. A large orange cylindrical tank is visible in the background. The sky is clear and blue. The photo has a timestamp in the top right corner: 05/02/2022 16:06 and coordinates 32.016676, -103.943430.
Photo Direction: South	
Photo Description: View of the affected area.

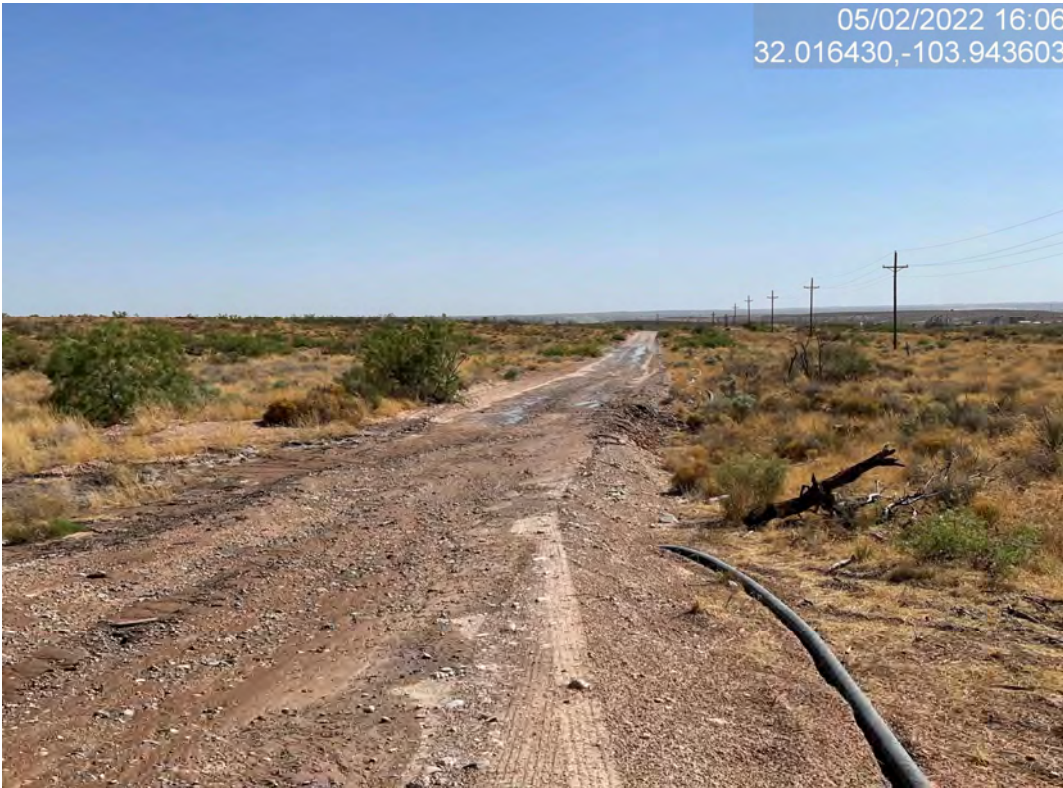
Photo Number: 3

Photo Direction: South-Southwest	
Photo Description: View of the affected area.

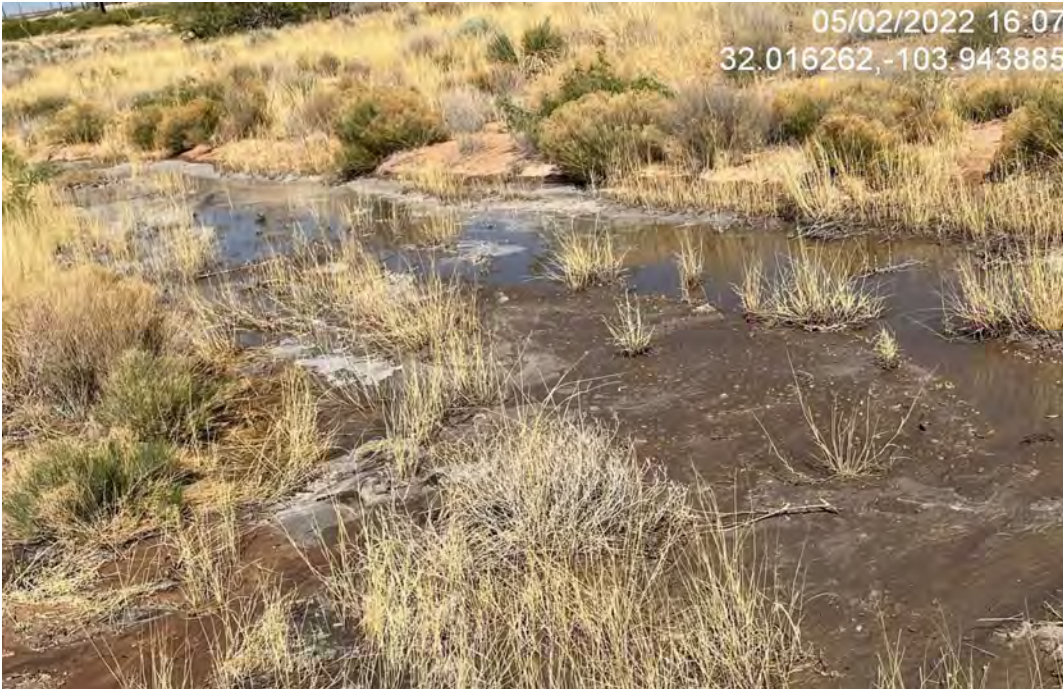
Photo Number: 4

Photo Direction: East-Southeast	
Photo Description: View of the affected area.

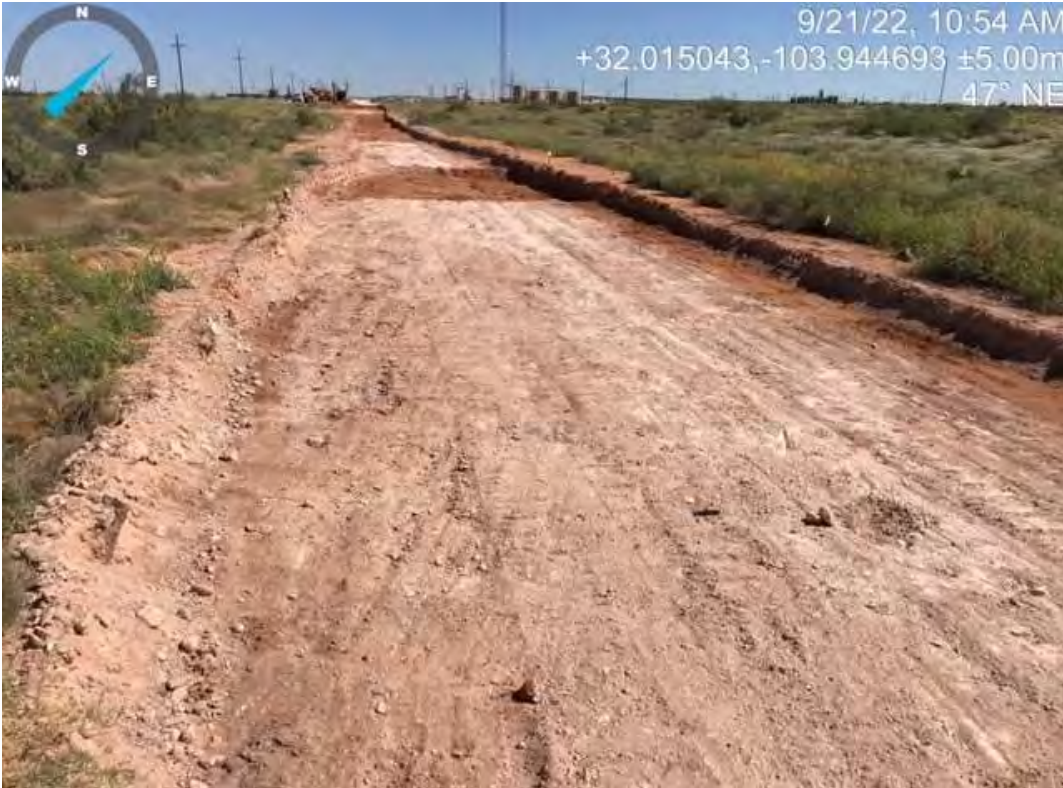
Photo Number: 10

Photo Direction: Northeast	
Photo Description: View of the excavated area.

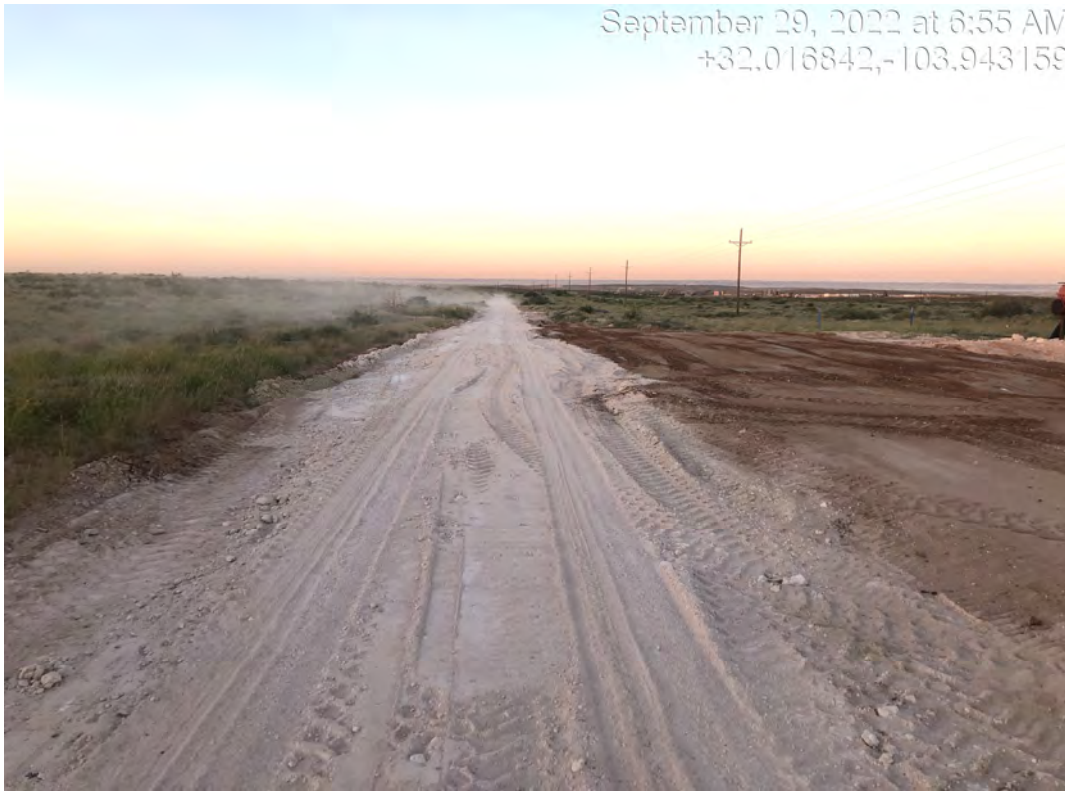
Photo Number: 11

Photo Direction: Southwest	
Photo Description: View of the remediation area after backfill and regrading.

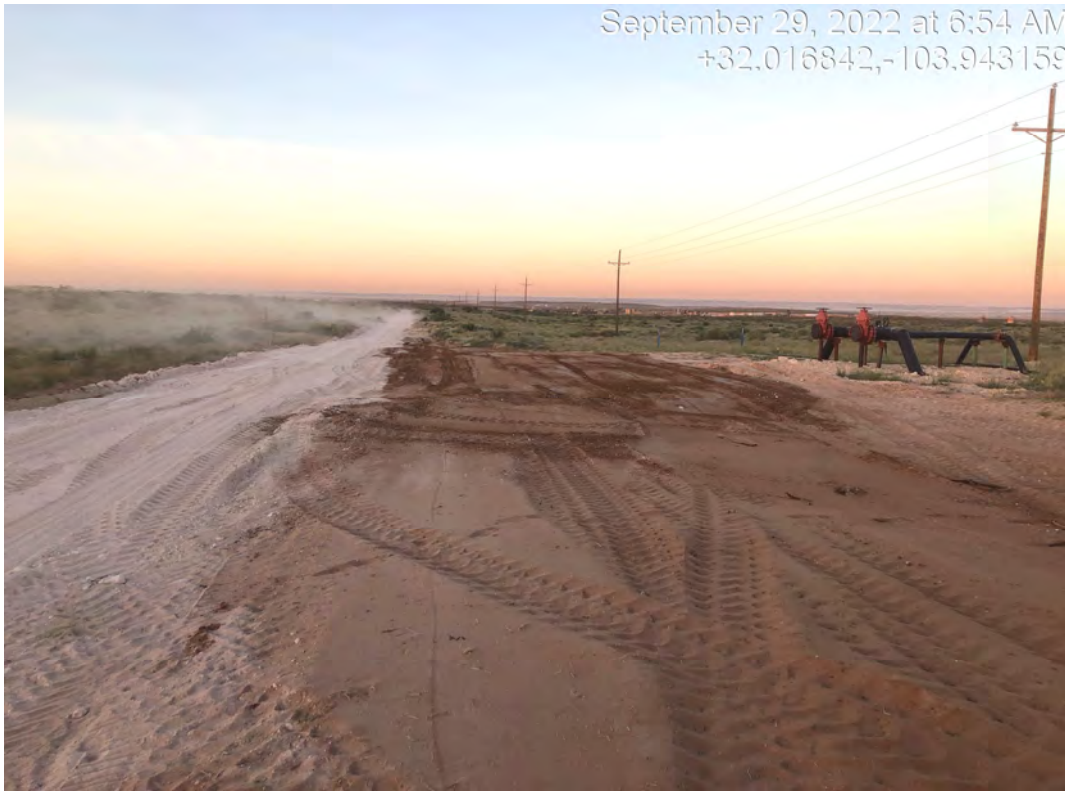
Photo Number: 12

Photo Direction: Southwest	
Photo Description: View of the remediation area after backfill and regrading.
