**Re: Liner Inspection and Closure Request  
ConocoPhillips (Heritage Concho)  
Lusk Deep Unit A #024H Release  
Unit Letter D, Section 19, Township 19 South, Range 32 East  
Lea County, New Mexico  
Incident ID# nJXK1613027690**

Liner Inspection and Closure Report  
February 10, 2023

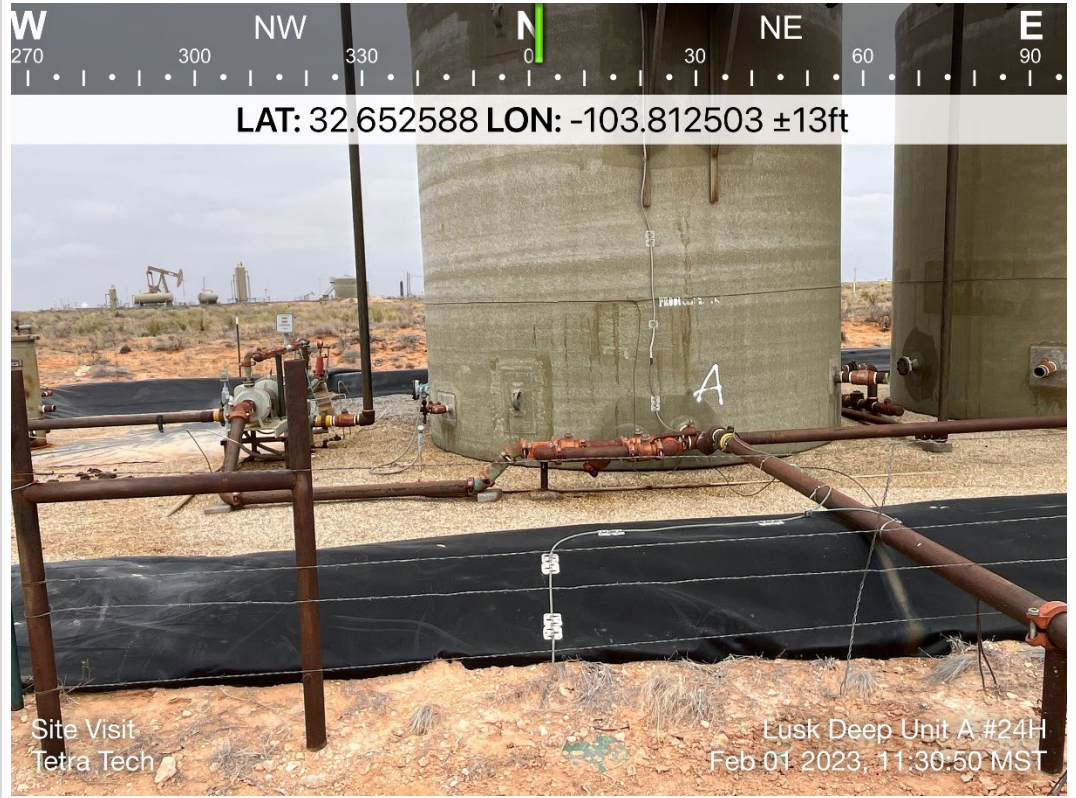
TETRA TECH, INC. PROJECT NO. 212C-MD-02983	DESCRIPTION	View north. View of production equipment and liner visible.	2
	SITE NAME	Lusk Deep Unit A #24H	2/1/2023

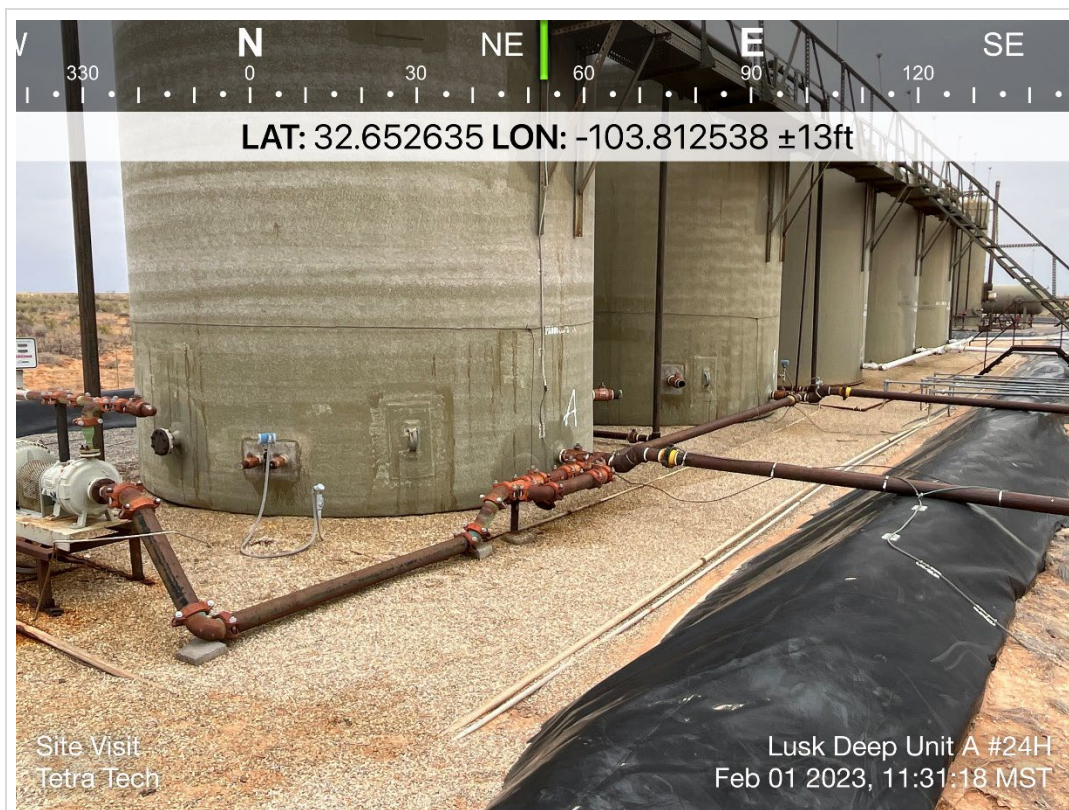
TETRA TECH, INC. PROJECT NO. 212C-MD-02983	DESCRIPTION	View northeast. Liner visible and raised lines. Production equipment present.	3
	SITE NAME	Lusk Deep Unit A #24H	3/18/2023

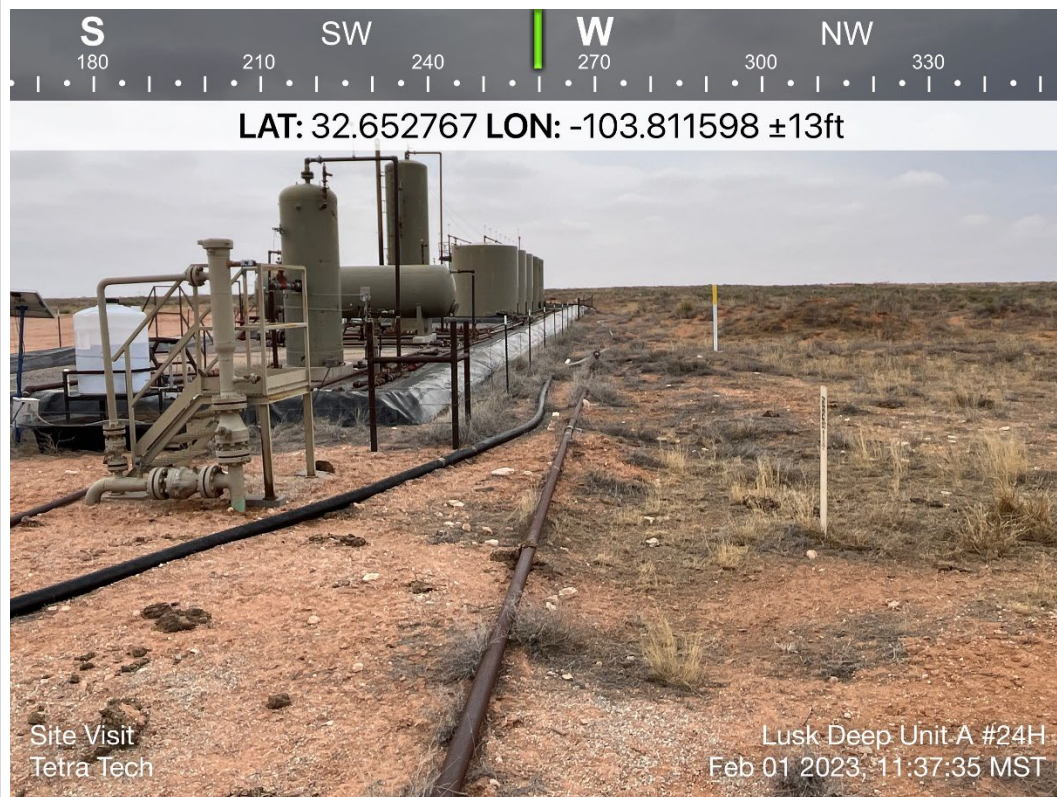
TETRA TECH, INC. PROJECT NO. 212C-MD-02983	DESCRIPTION	View west. Steel line and poly line present. Area behind facility vegetated with liner visible.	4
	SITE NAME	Lusk Deep Unit A #24H	2/1/2023

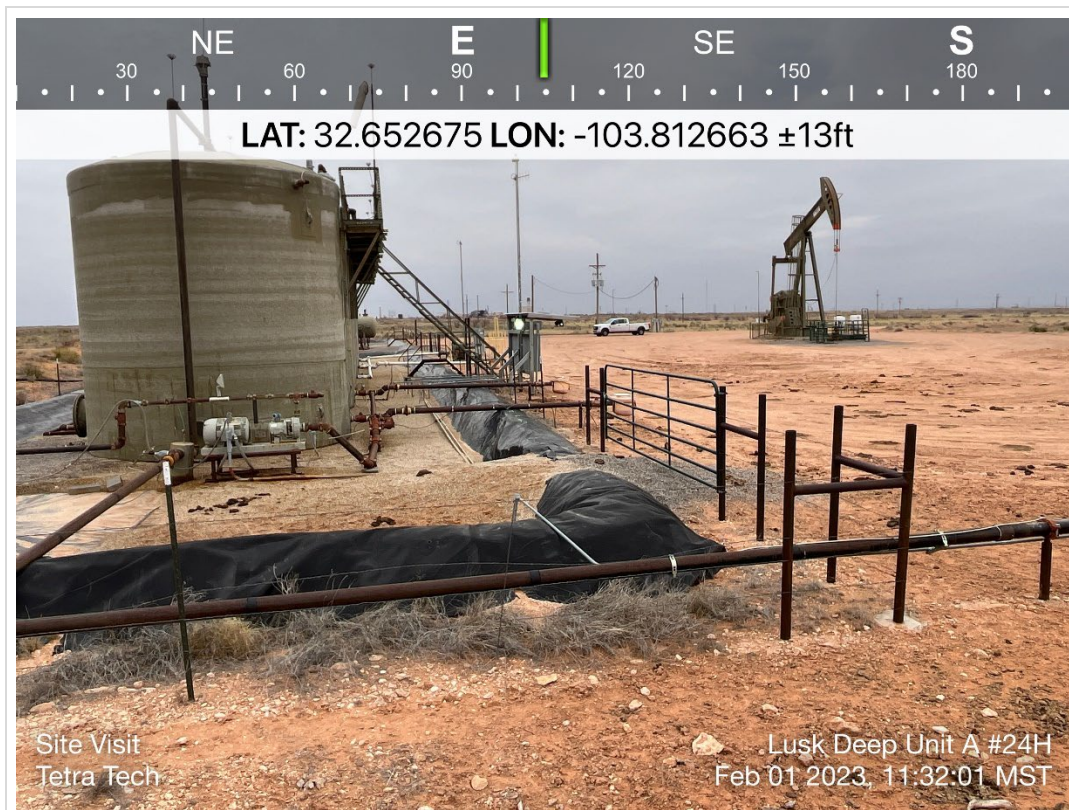
TETRA TECH, INC. PROJECT NO. 212C-MD-02983	DESCRIPTION	View east. Approximate release point area. Liner visible in the facility. View of wellhead.	5
	SITE NAME	Lusk Deep Unit A #24H	2/1/2023

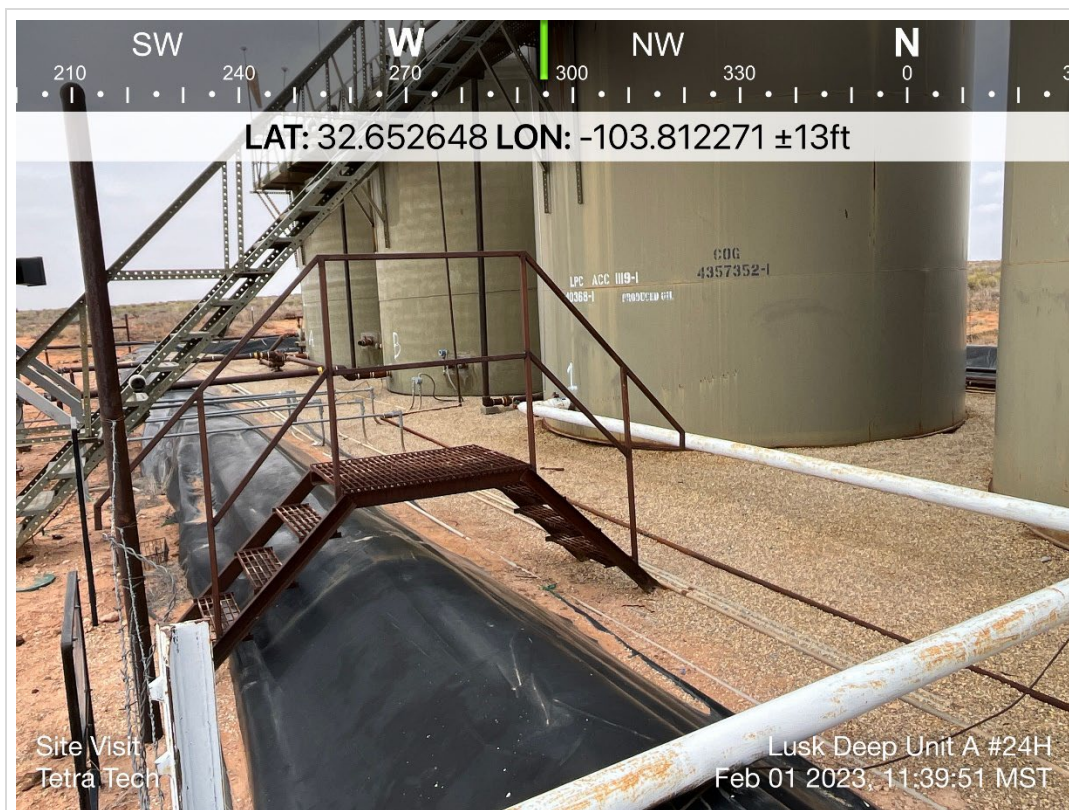
On February 1, 2023, Tetra Tech personnel performed an inspection of the liner within the secondary containment of the Lusk Deep Unit A #024H Release. The liner was observed as appearing to underlie the entirety of the tank battery secondary containment area. As mentioned above, the material atop the liner was not removed during the inspection. The visible liner was intact with no visible rips or tears. The liner sat atop the earthen berm, extended up over the outside edge and appeared anchored in. At the time of the inspection, the liner was intact and had the ability to contain the volume of the historical leak in question. Photographic documentation of the liner inspection is included in Appendix C.

TETRA TECH, INC. PROJECT NO. 212C-MD-02983	DESCRIPTION	View west. View of inside facility. Liner visible and intact.	7
	SITE NAME	Lusk Deep Unit A #24H	2/1/2023

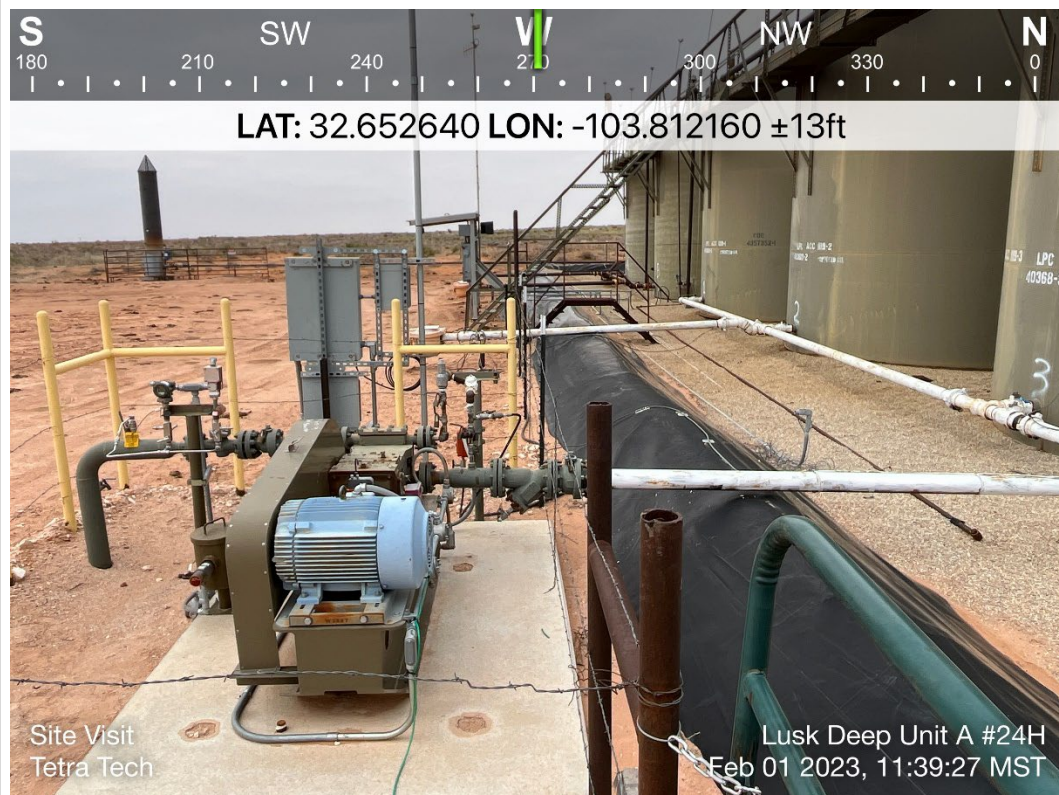
TETRA TECH, INC. PROJECT NO. 212C-MD-02983	DESCRIPTION	View west. View of facility and production equipment. Visible liner.	8
	SITE NAME	Lusk Deep Unit A #24H	2/1/2023

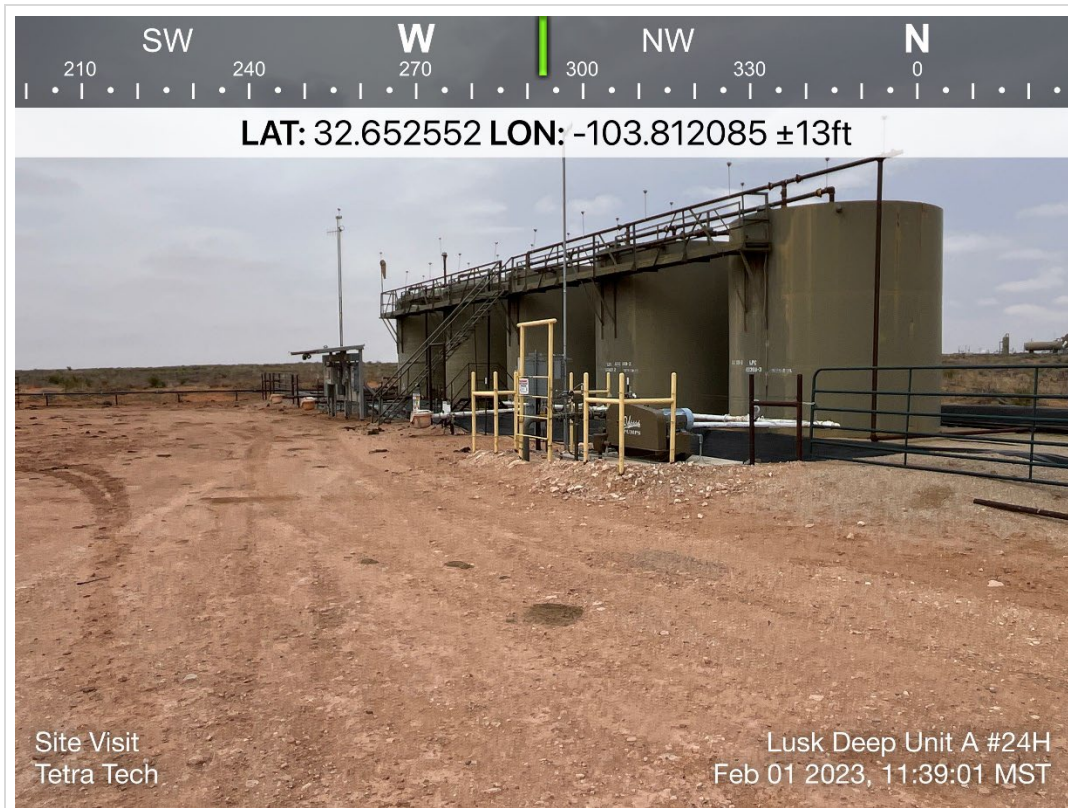
TETRA TECH, INC. PROJECT NO. 212C-MD-02983	DESCRIPTION	View west northwest. View facility.	9
	SITE NAME	Lusk Deep Unit A #24H	2/1/2023

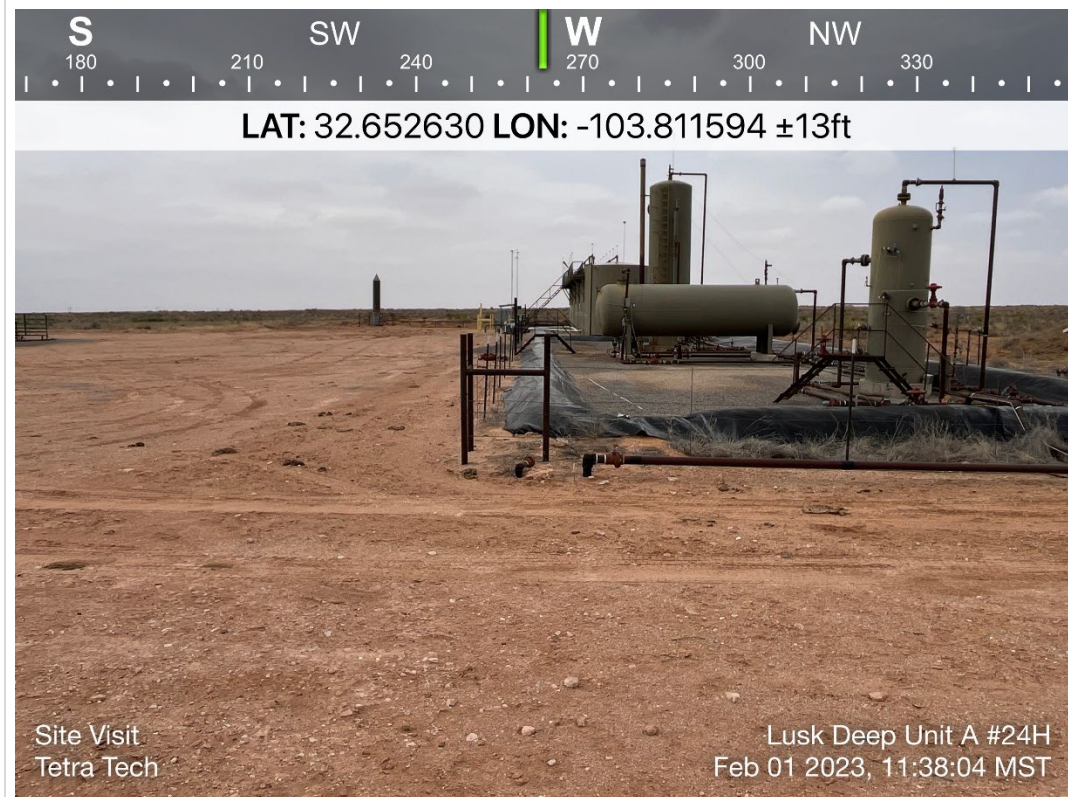
TETRA TECH, INC. PROJECT NO. 212C-MD-02983	DESCRIPTION	View west. View of facility from the east while facing west.	10
	SITE NAME	Lusk Deep Unit A #24H	2/1/2023
