**RE: Closure Request
Big Eddy Unit #74 Tank Battery
Remediation Permit Numbers 2RP-2664 and 2RP-3213
Eddy County, New Mexico**

LT Environmental, Inc. (LTE), on behalf of XTO Energy, Inc. (XTO), presents the following Closure Request report detailing soil sampling and excavation activities at the Big Eddy Unit #74 Tank Battery (Site) in Unit B, Section 25, Township 21 South, Range 28 East, in Eddy County, New Mexico (Figure 1). The purpose of the soil sampling and excavation activities was to address impacts to soil following two separate events that caused the release of produced water and crude oil at the Site. Based on the excavation activities and results of the soil sampling events, XTO is submitting this Closure Request, describing remediation that has occurred and requesting no further action for the release events.

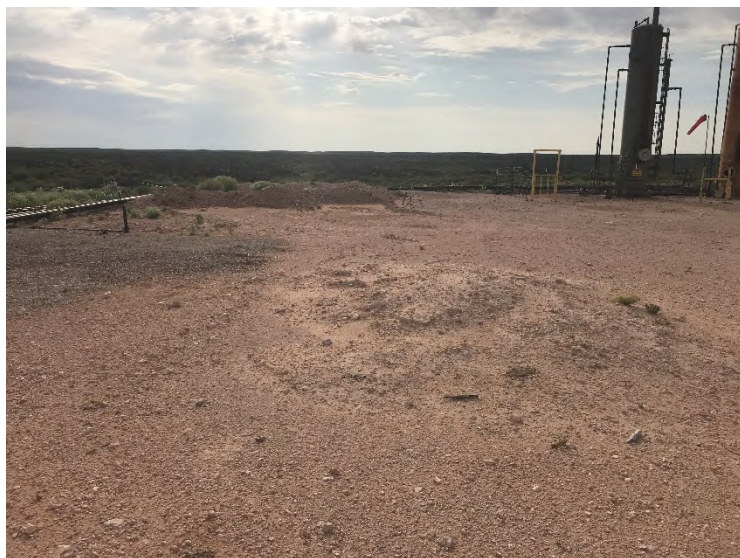
Photograph 1: View northeast corner of pad and release location (2RP-2664).

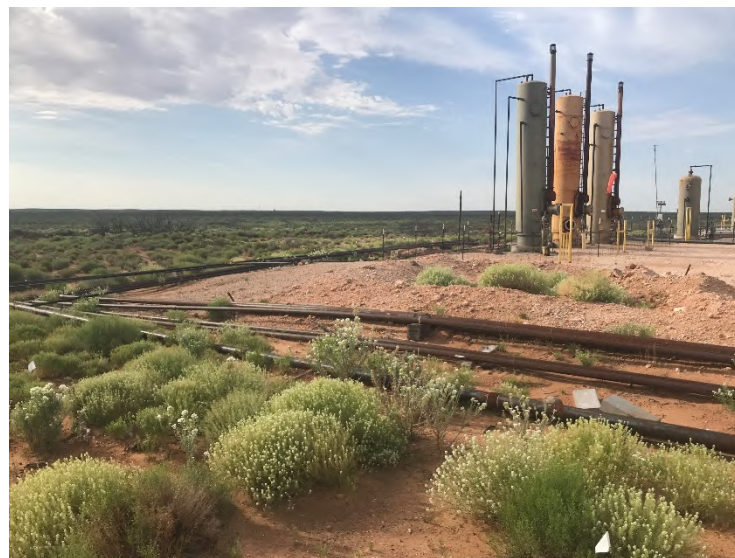
Photograph 2: View of the release location (2RP-2664) facing southeast.

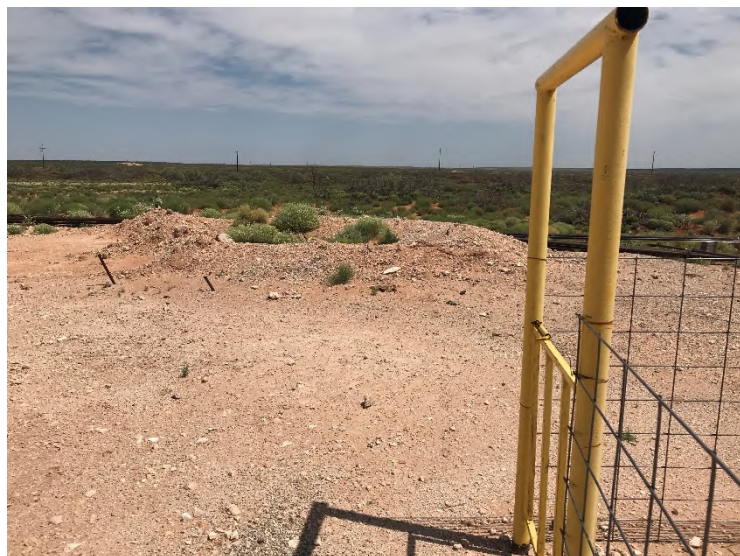
Photograph 3: View of release location (2RP-2664) facing north.

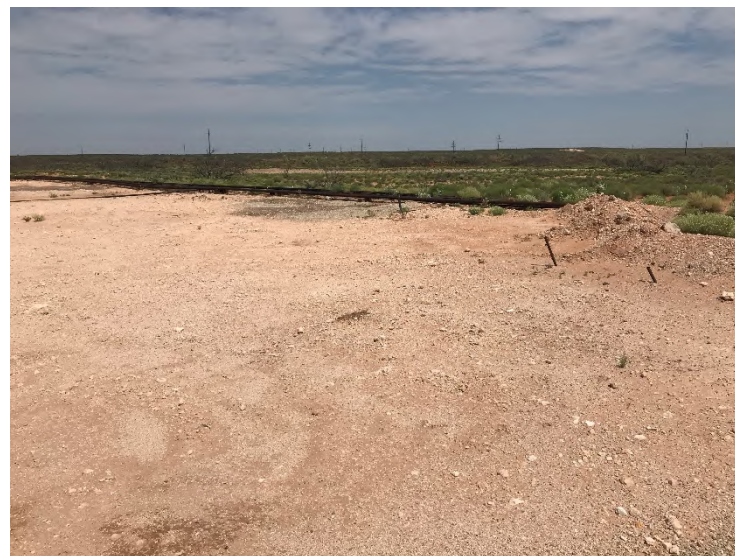
Photograph 4: View of release location (2RP-2664) facing northwest.

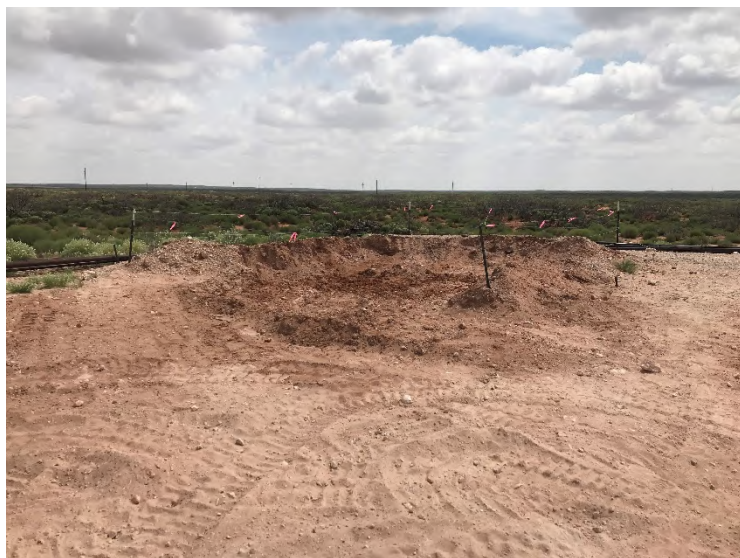
Photograph 5: View of excavated location (2RP-2664) facing northeast.

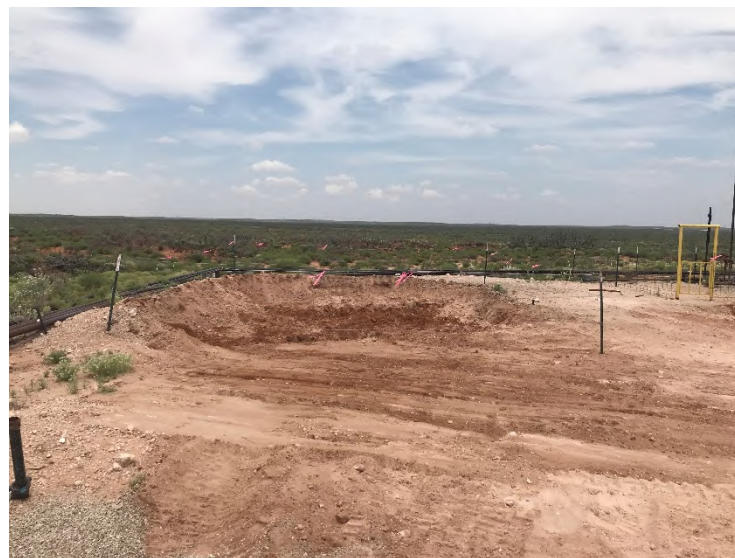
Photograph 6: View of excavated location (2RP-2664) facing west.

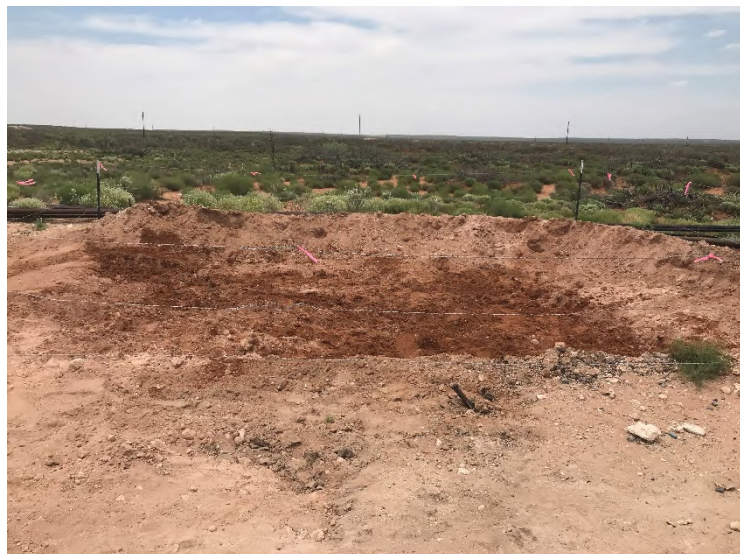
Photograph 7: View of excavated location (2RP-2664) facing north.

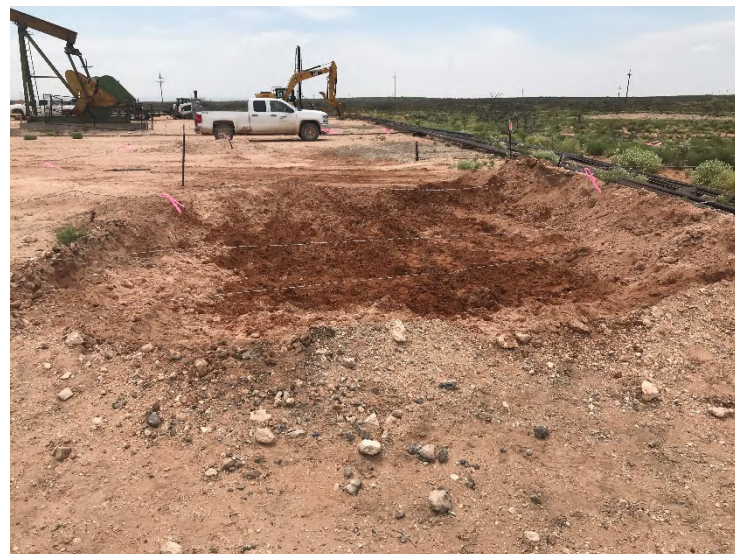
Photograph 8: View of completed excavation (2RP-2664) facing west.

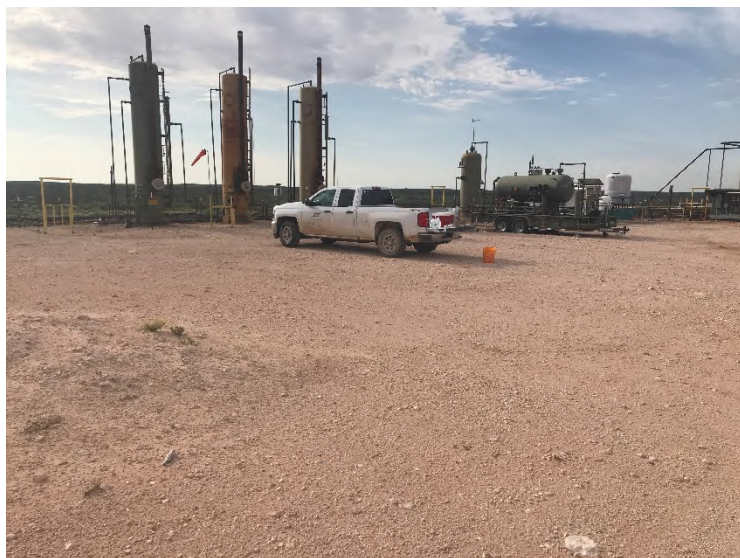
Photograph 9: View eastern portion of pad and release location (2RP-3213).

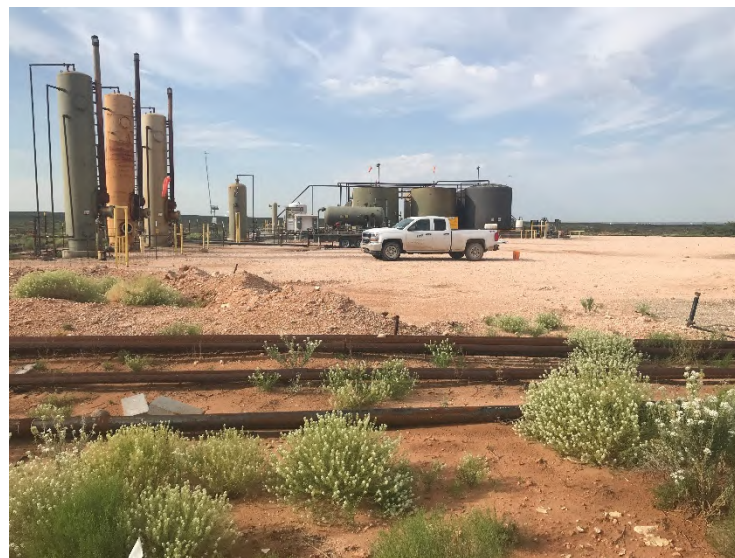
Photograph 10: View of release location (2RP-3213) facing south.

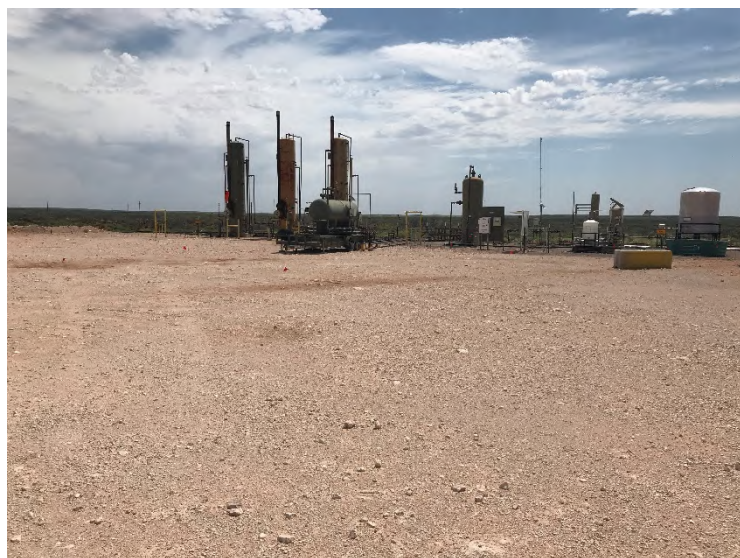
Photograph 11: View of release location (2RP-3213) facing northeast.

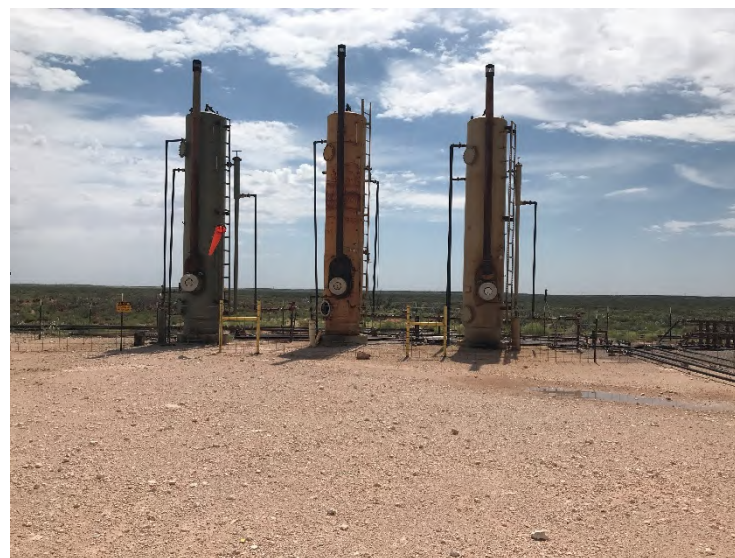
Photograph 12: View of release location (2RP-3213) facing east.

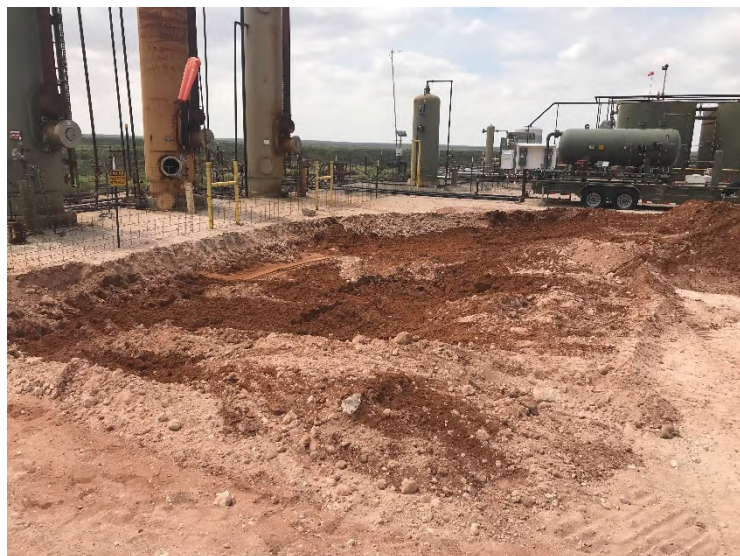
Photograph 13: View of excavated location (2RP-3213) facing southeast.

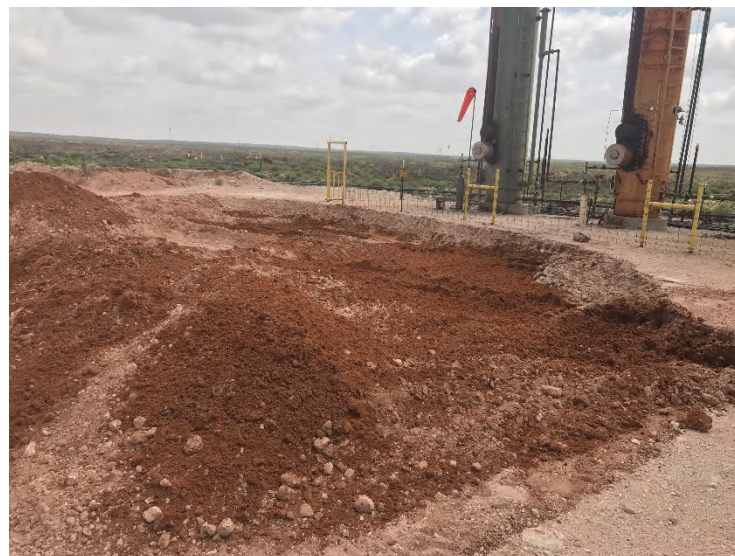
Photograph 14: View of excavated location (2RP-3213) facing northeast.

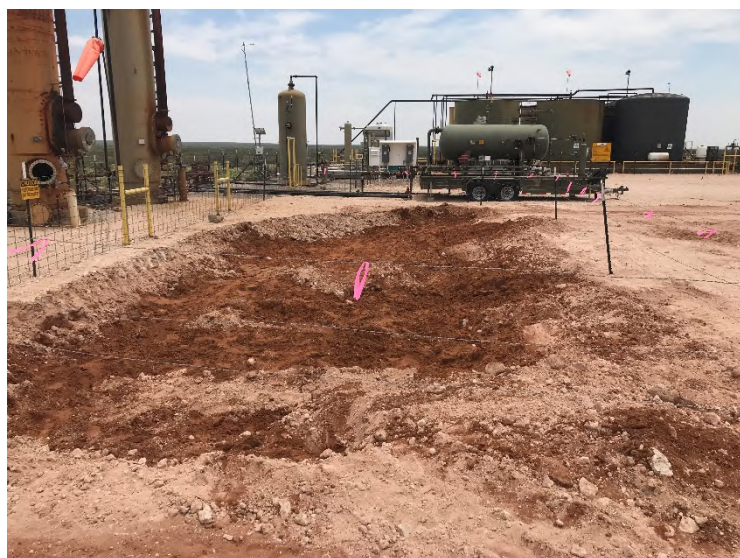
Photograph 15: View of excavated location (2RP-3213).

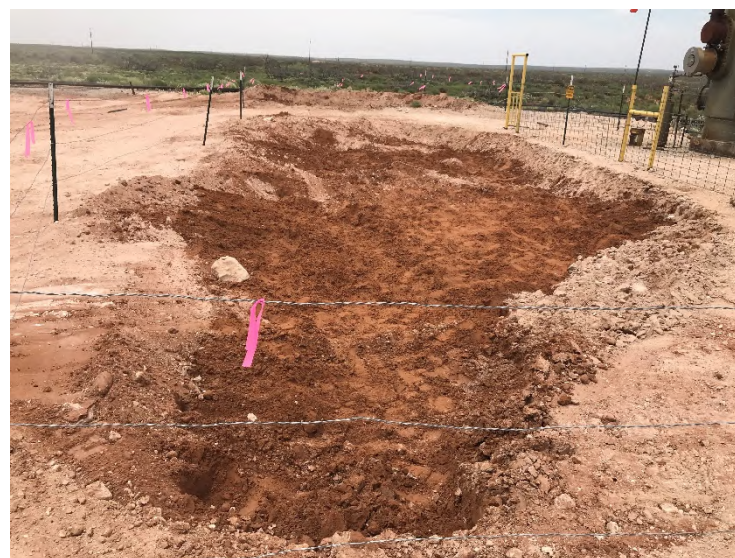
Photograph 16: View of completed excavated location (2RP-3213) facing north.
