## Remediation Summary and Closure Request

**Great Western Drilling Co.**

**South Carter SA Unit #501**

**NMOCD Incident # nJXK1613933289**

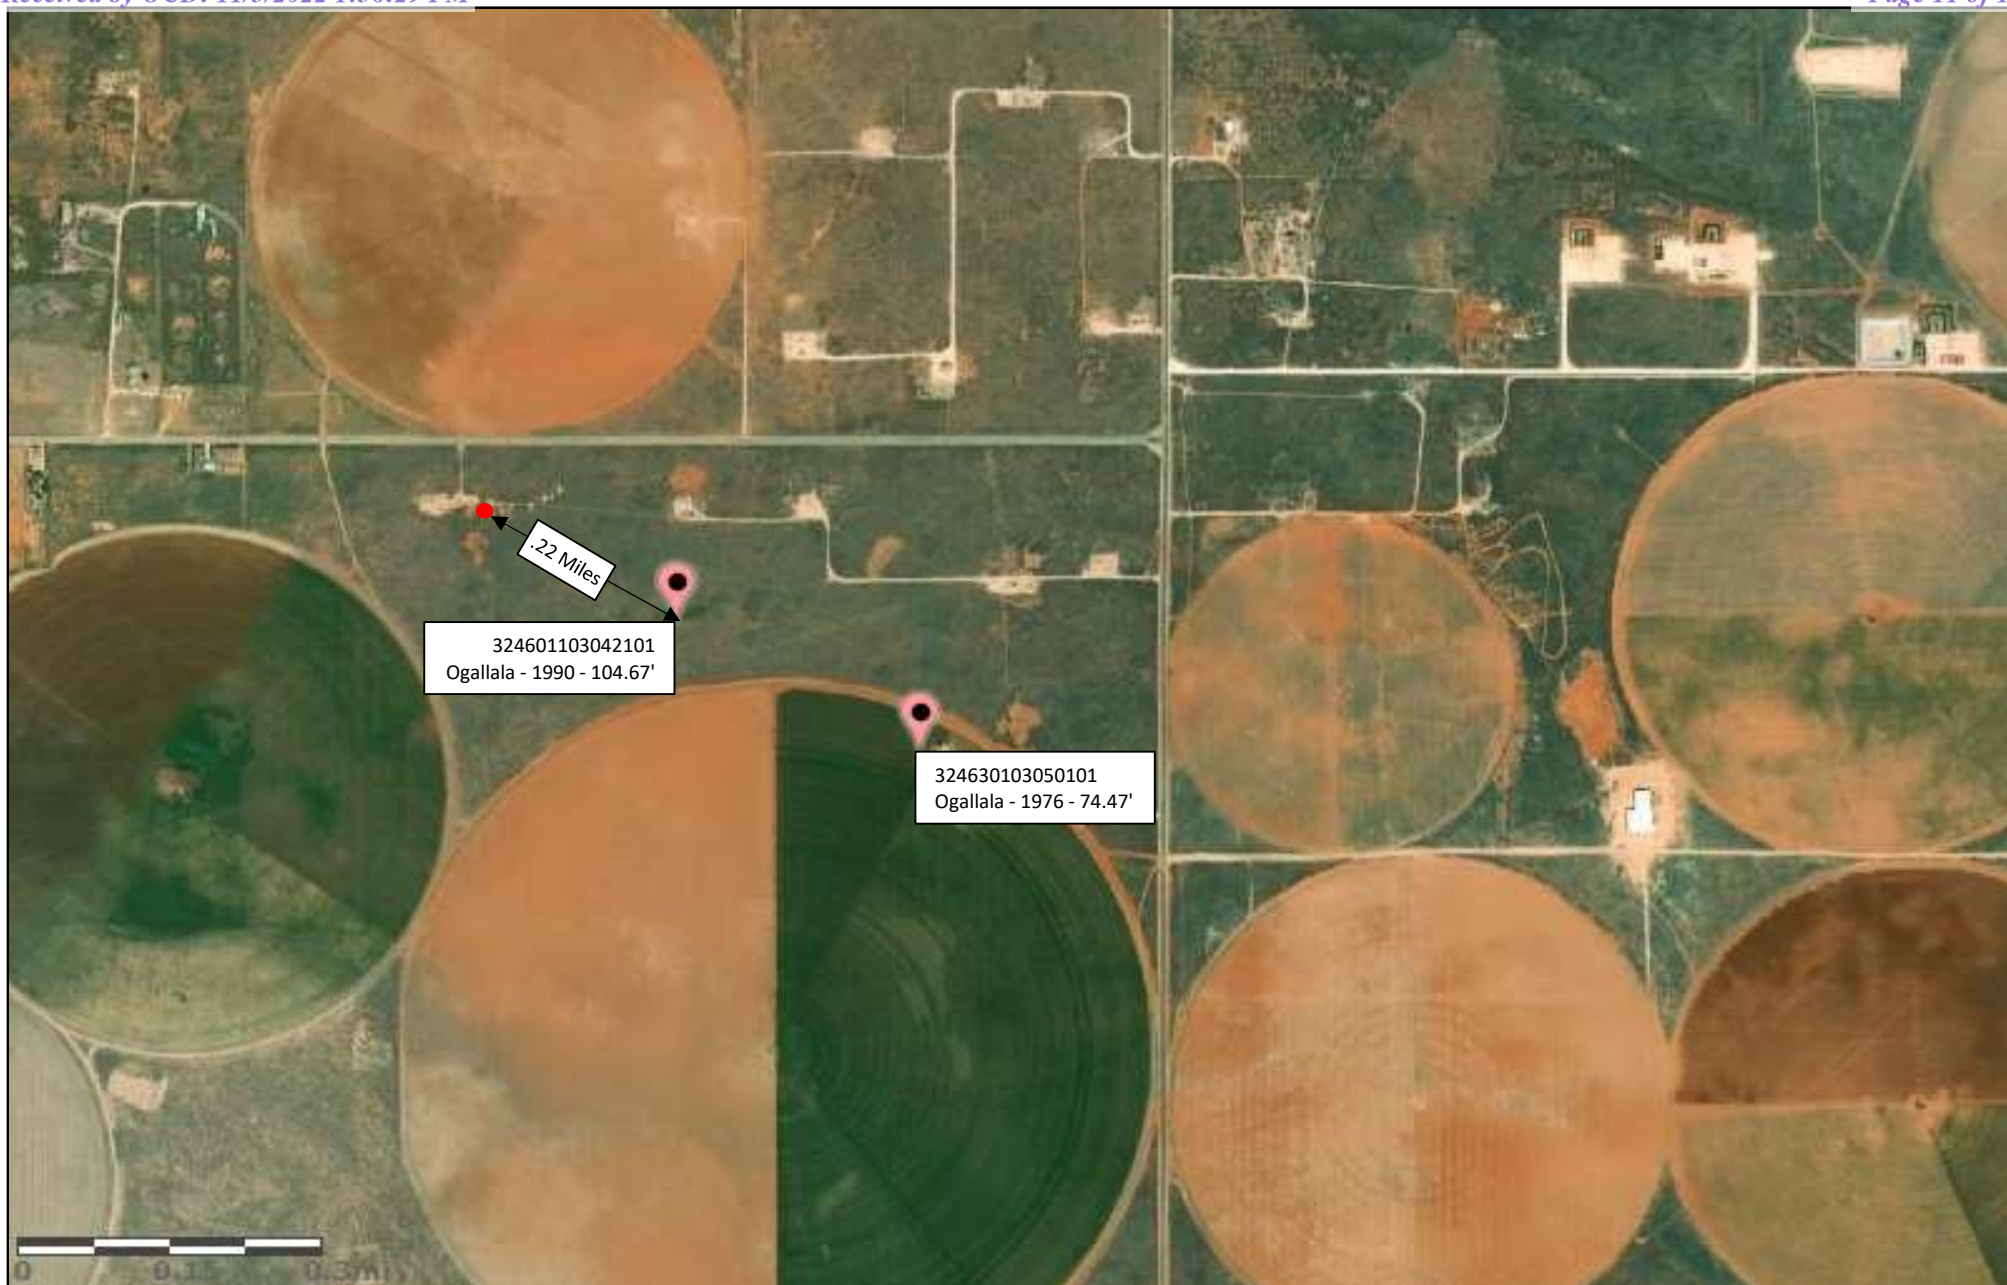
**Figure 3**

USGS Well Locations Map  
Great Western Drilling  
South Carter SA Unit #501  
GPS: 32.768517, -103.076546  
Lea County

The site is located in Unit Letter A (NE/NE), Section 7, Township 18 South, Range 39 East, approximately 4.5 miles northeast of Hobbs, in Lea County, New Mexico. The property is privately owned. Topographic Map, OSE POD Locations Map, and USGS Well Locations Map are included as Figure 1, Figure 2, and Figure 3, respectively.

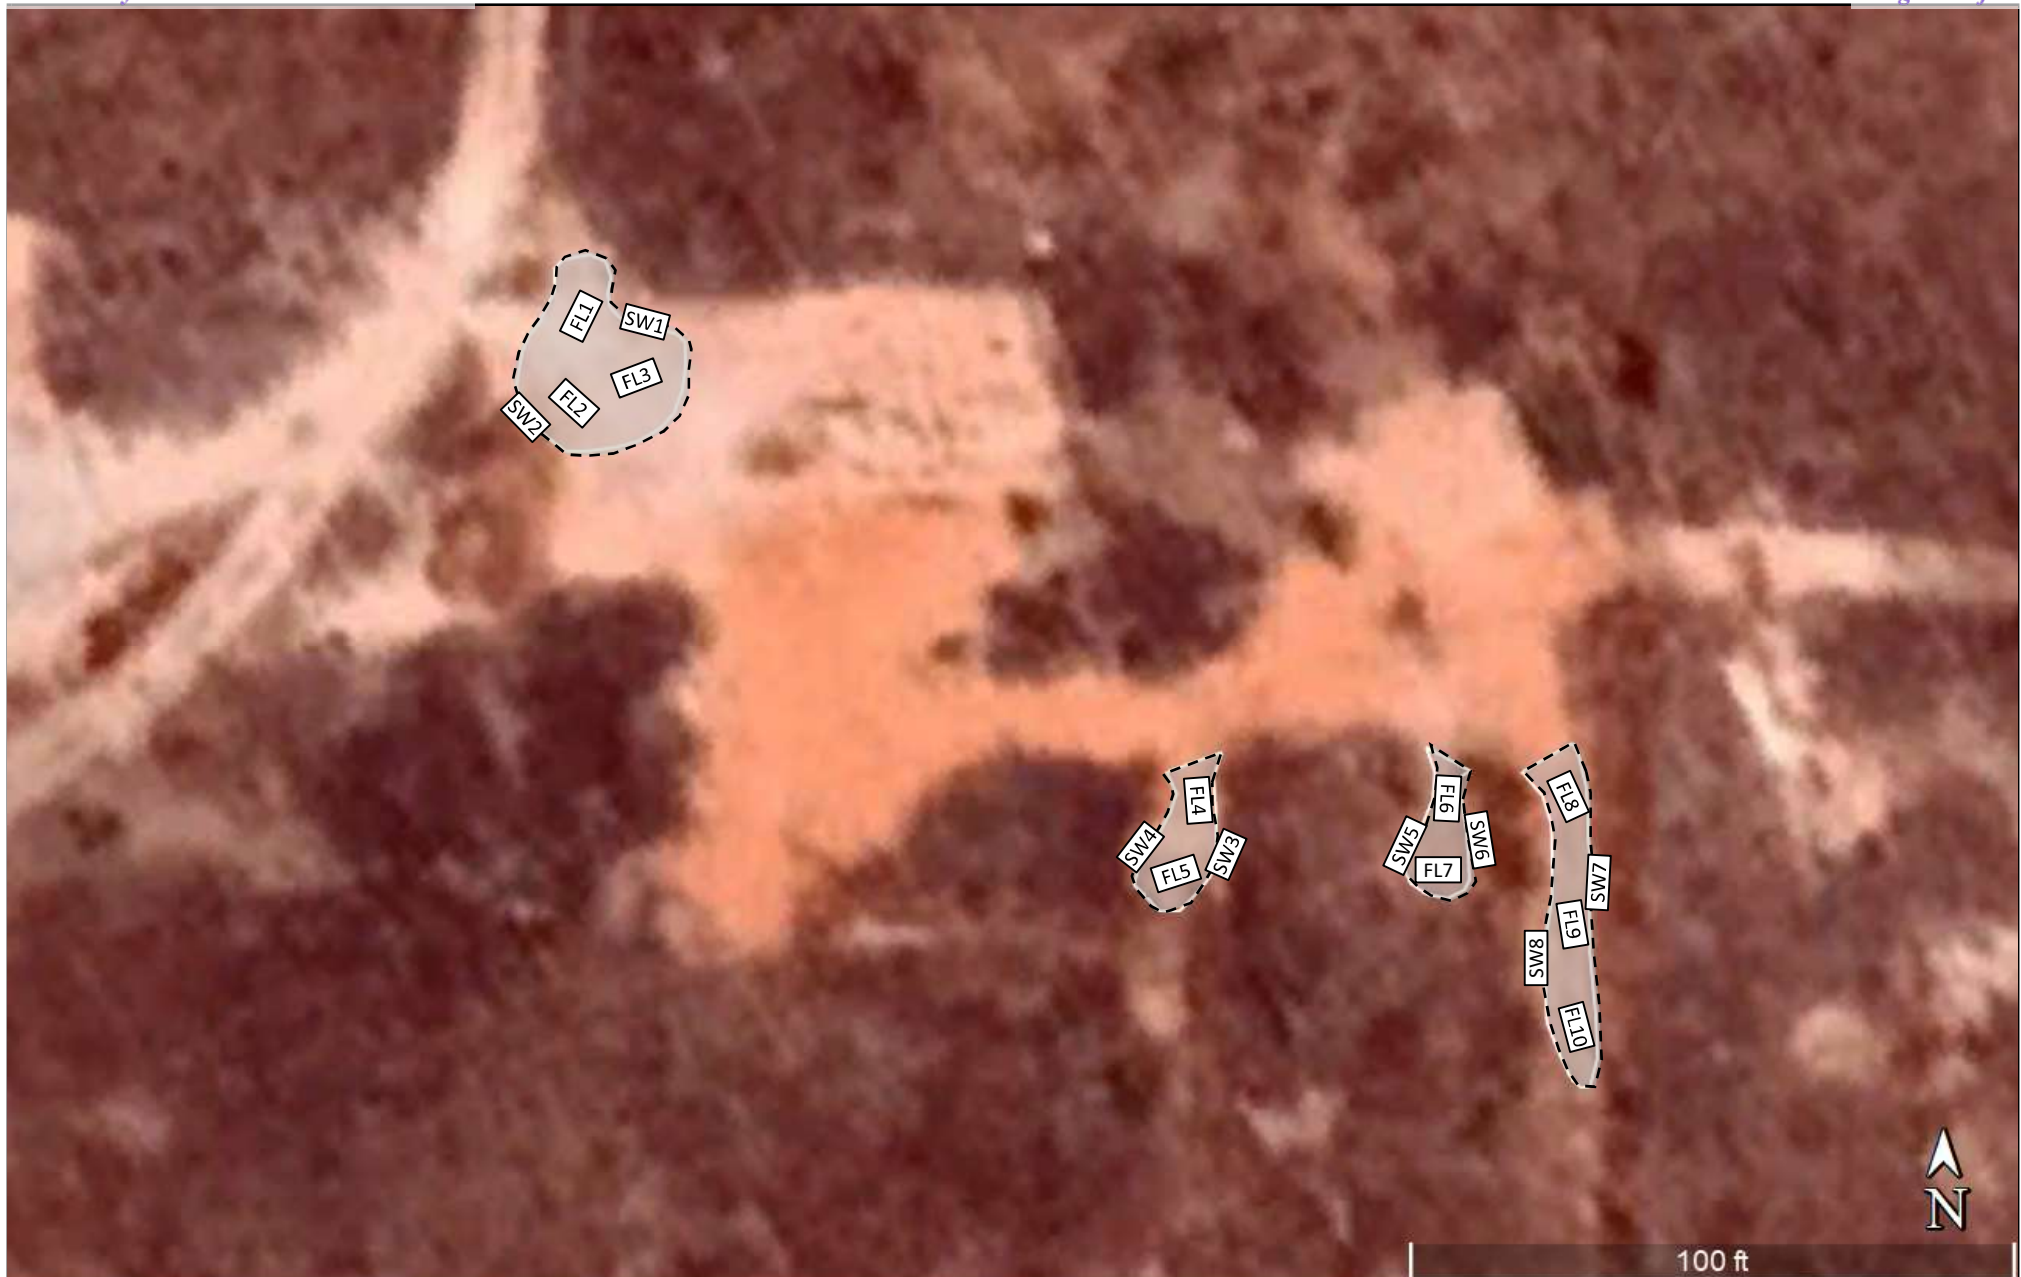
**Figure 5**

Excavation Sample Map  
Great Western Drilling  
South Carter SA Unit #501  
GPS: 32.768517, -103.076546  
Lea County
