Re: Dayton FX #1 Blowdown Tank
30-015-21761
K-21-18S-26E
Eddy County, NM
2RP-117
Incident # nKMW0801154059

Dayton FX #1 Blowdown Tank
Closure Report
#nKMW0801154059

Dayton FX #1 Blowdown Tank

Closure Report

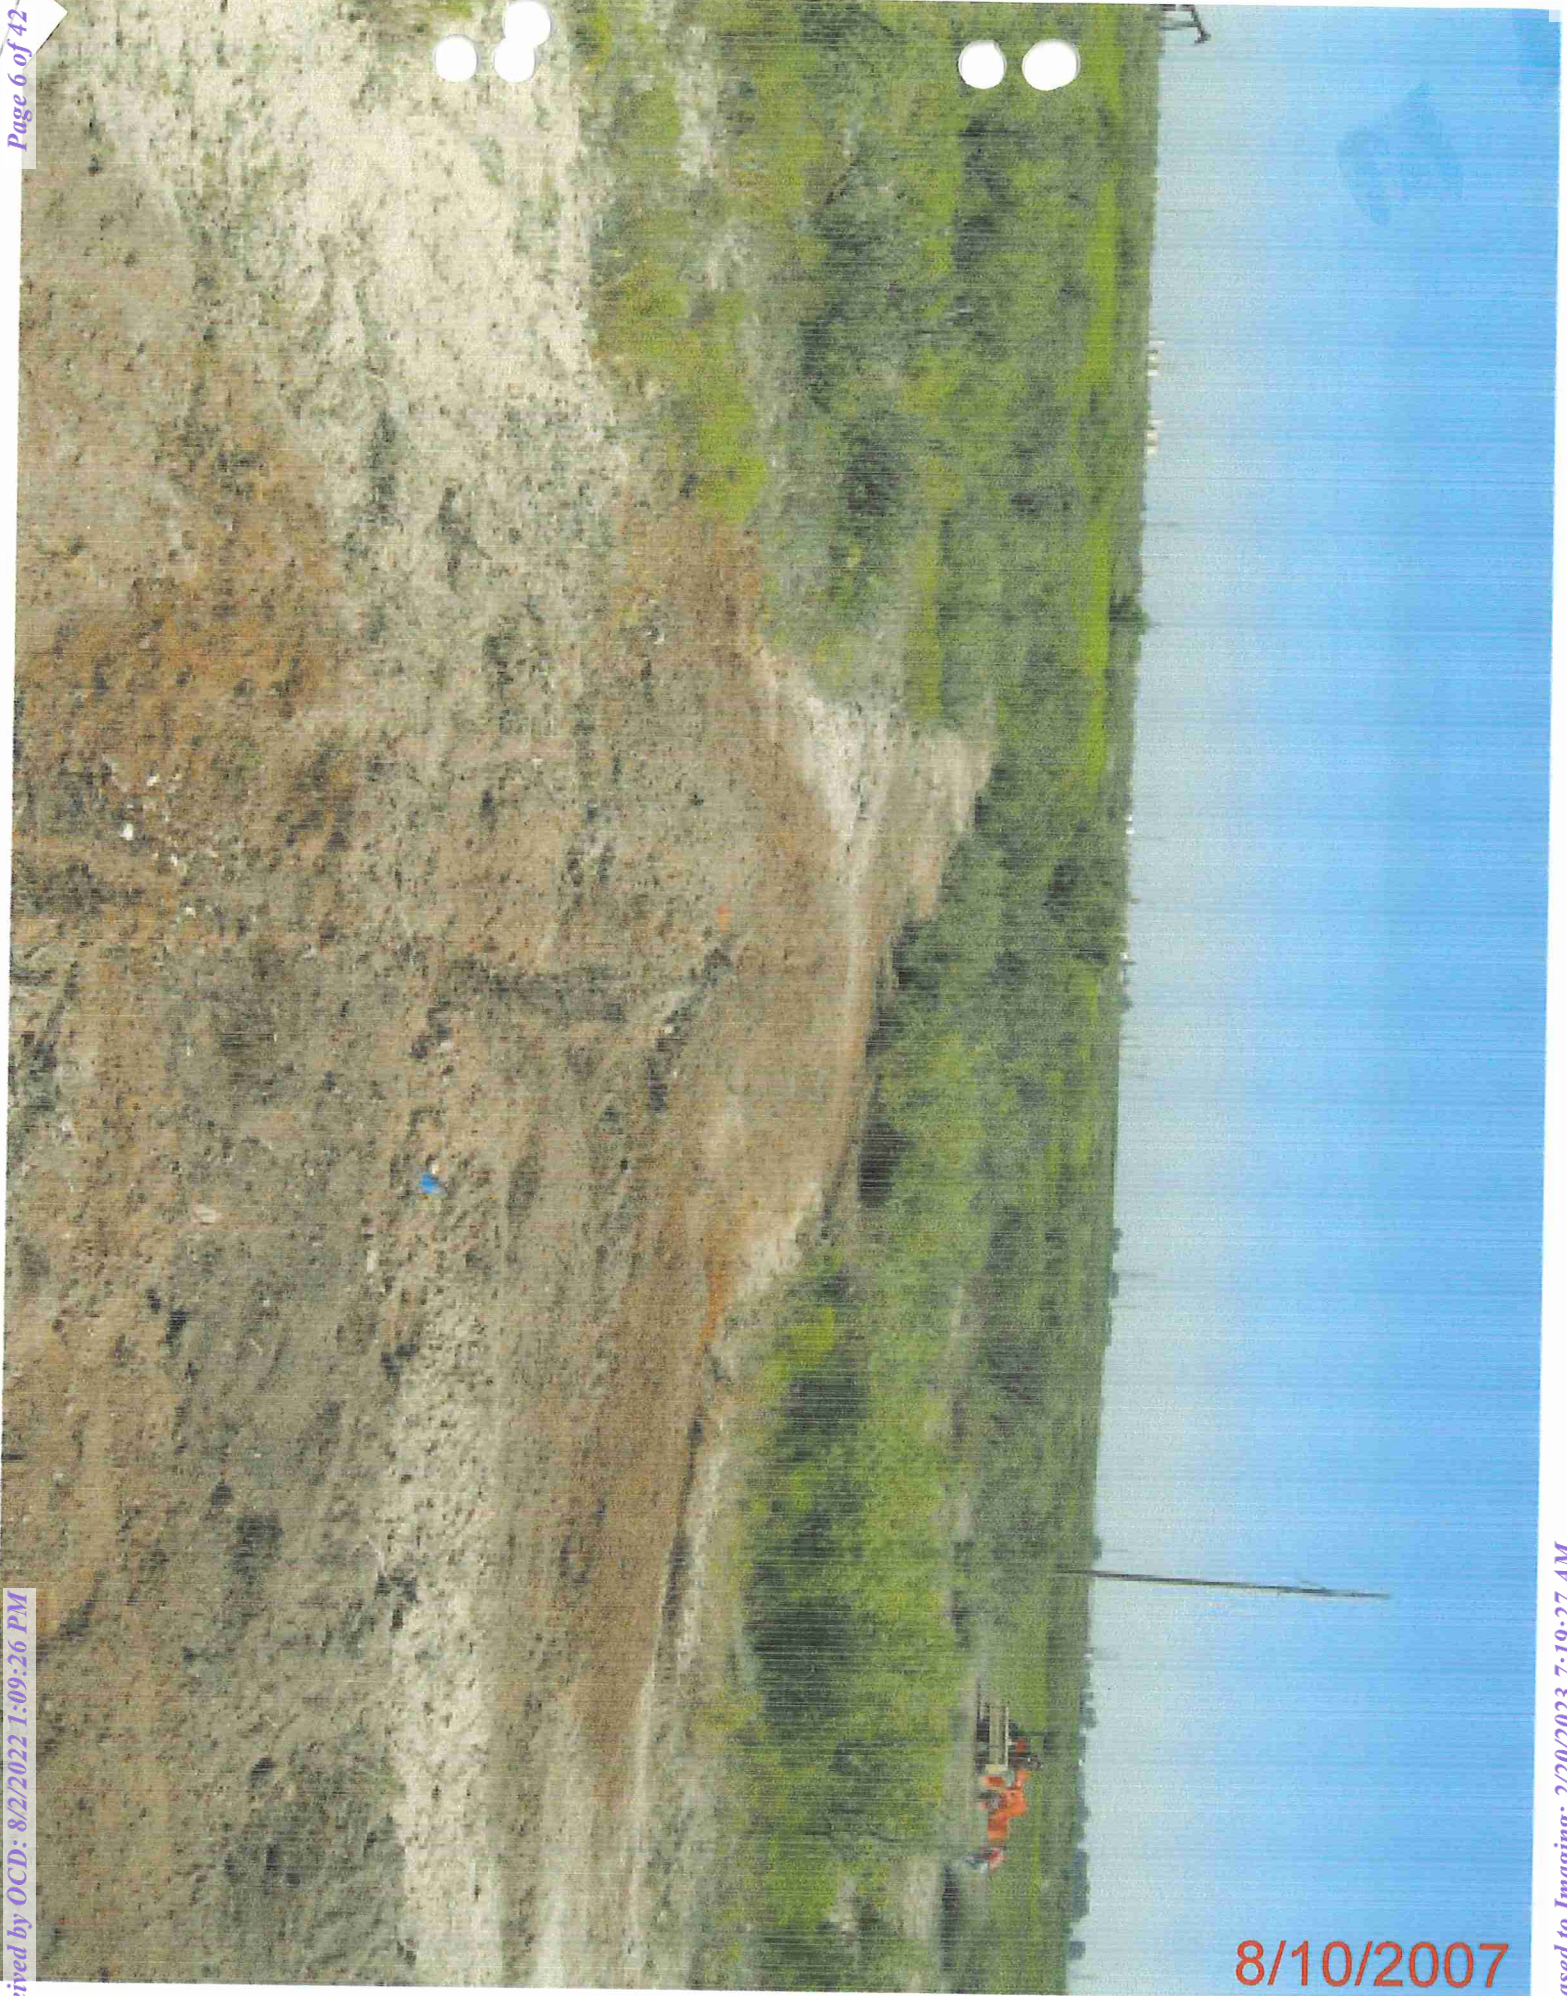
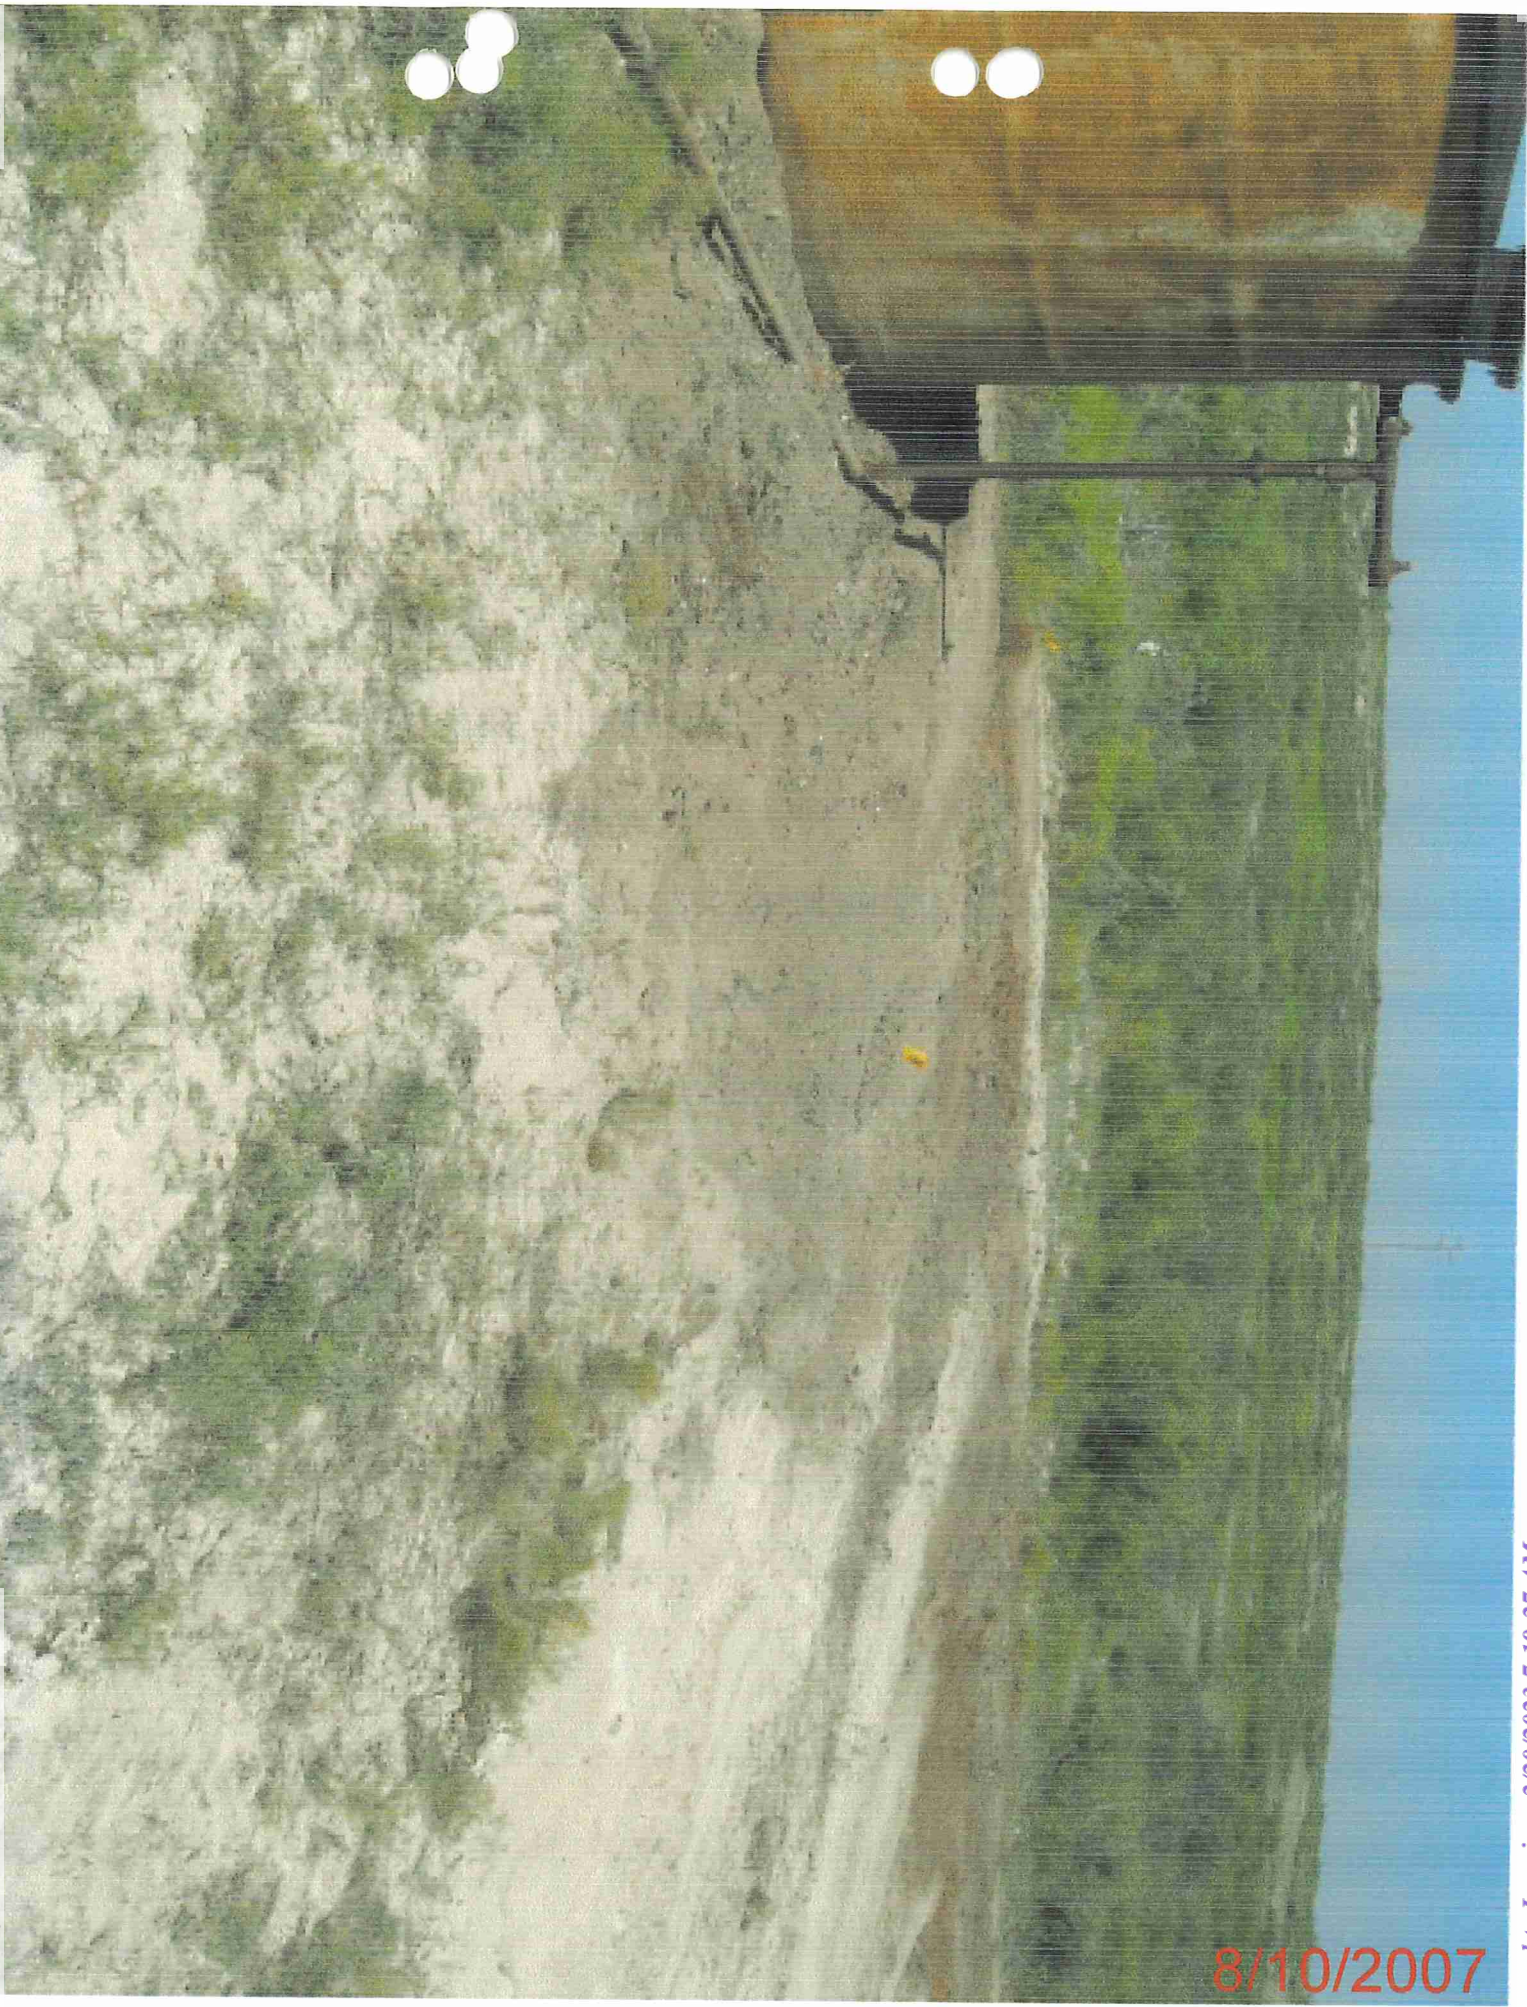
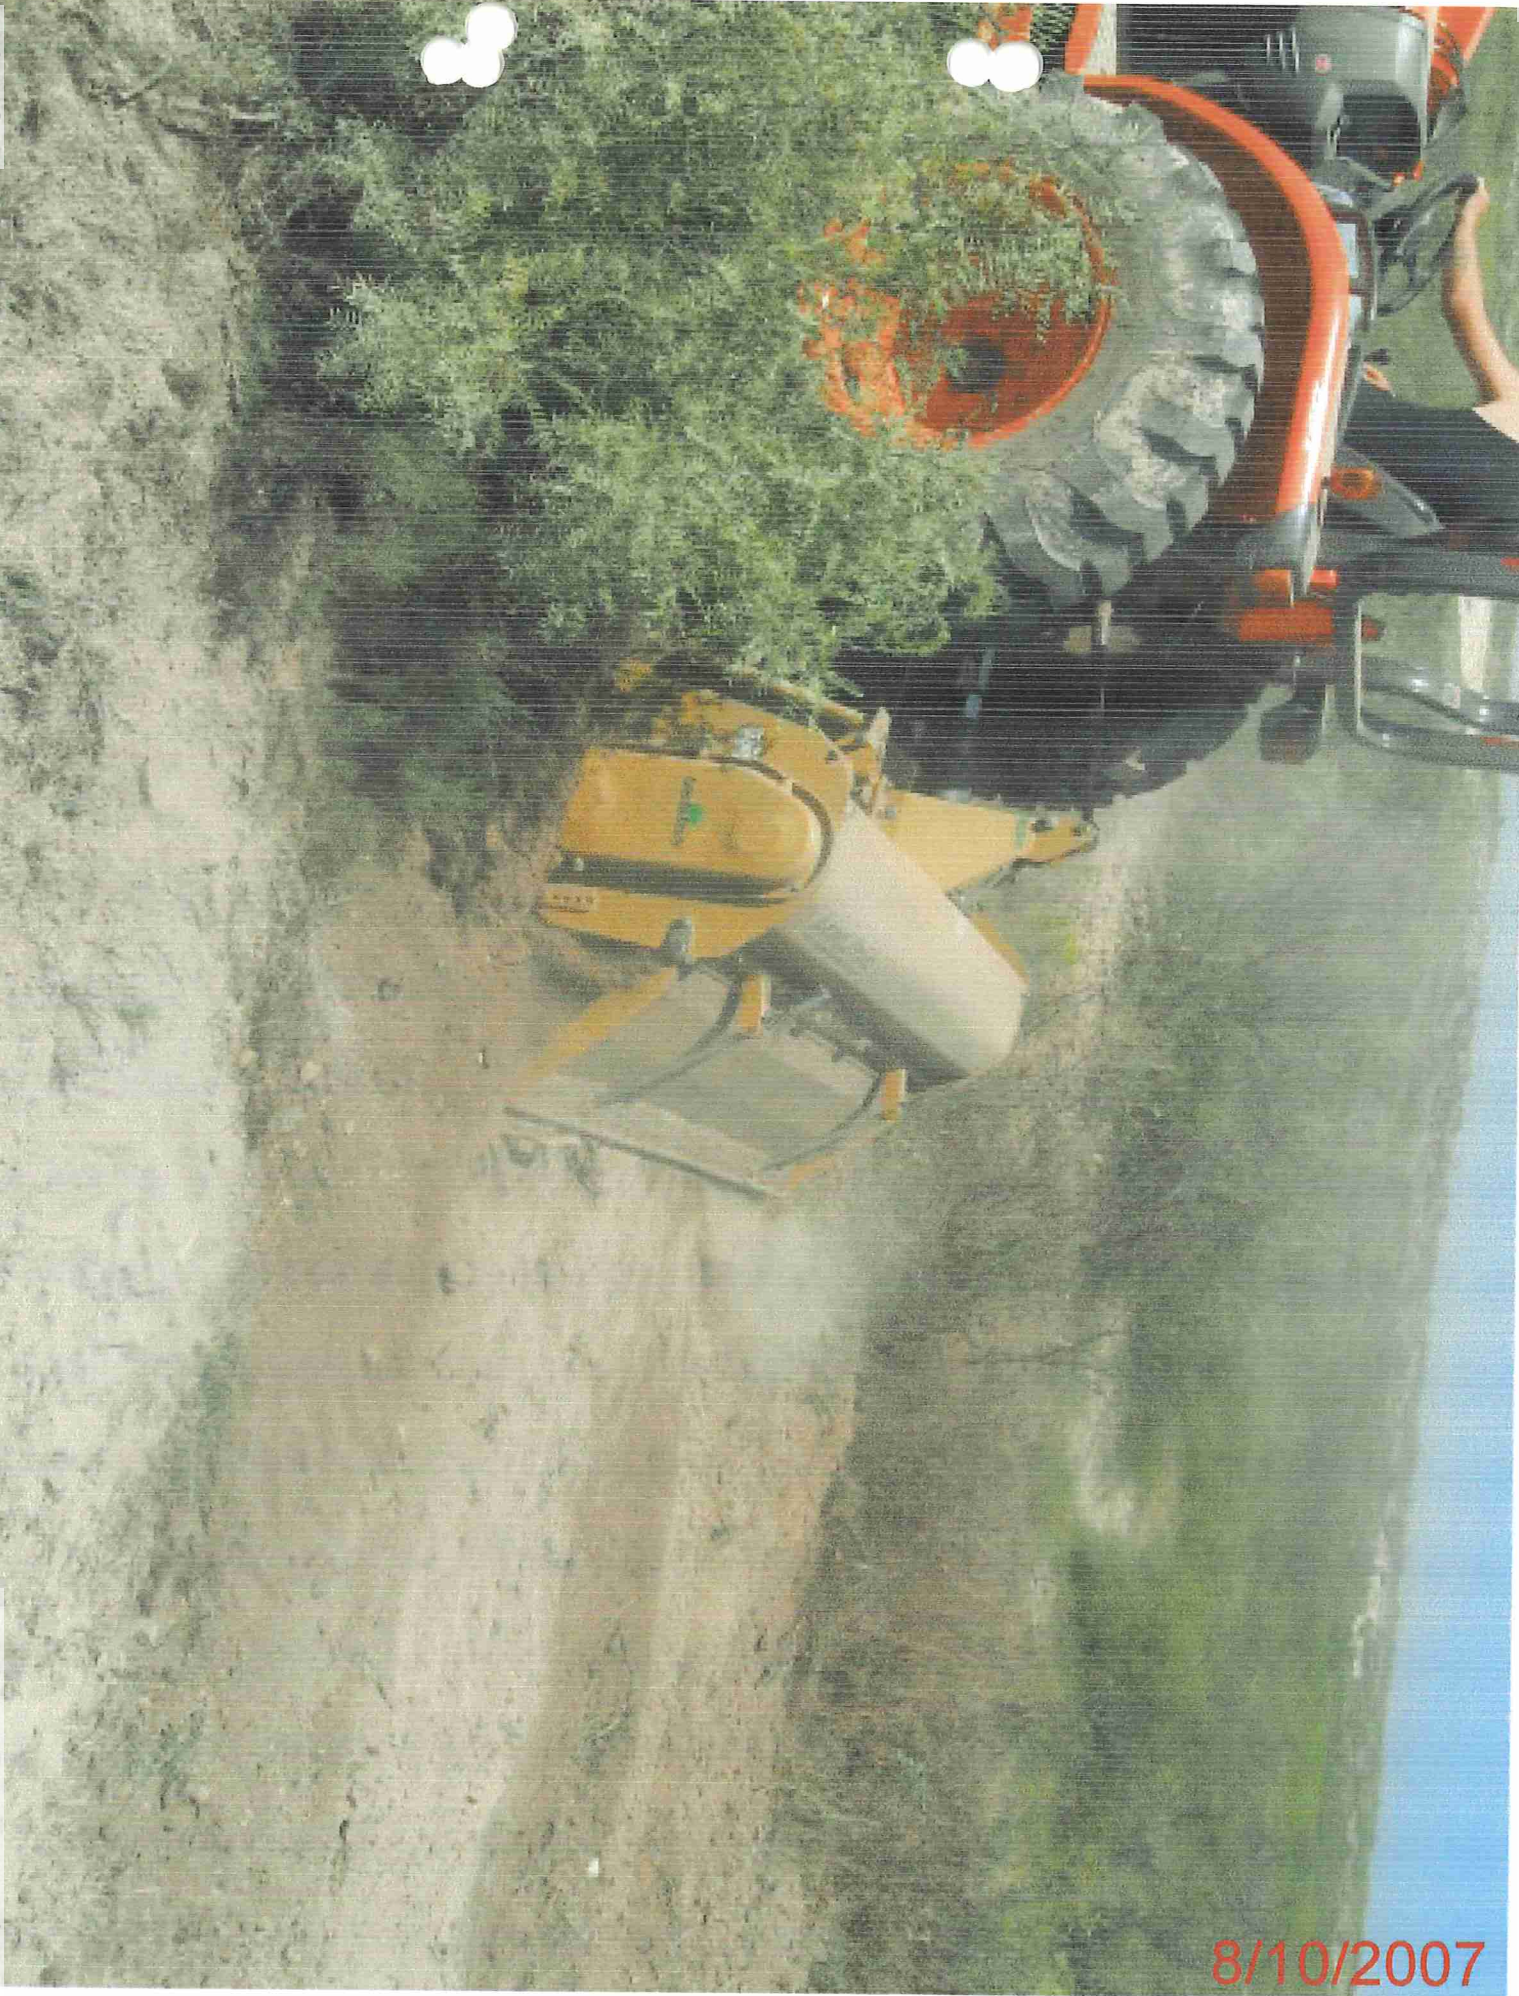
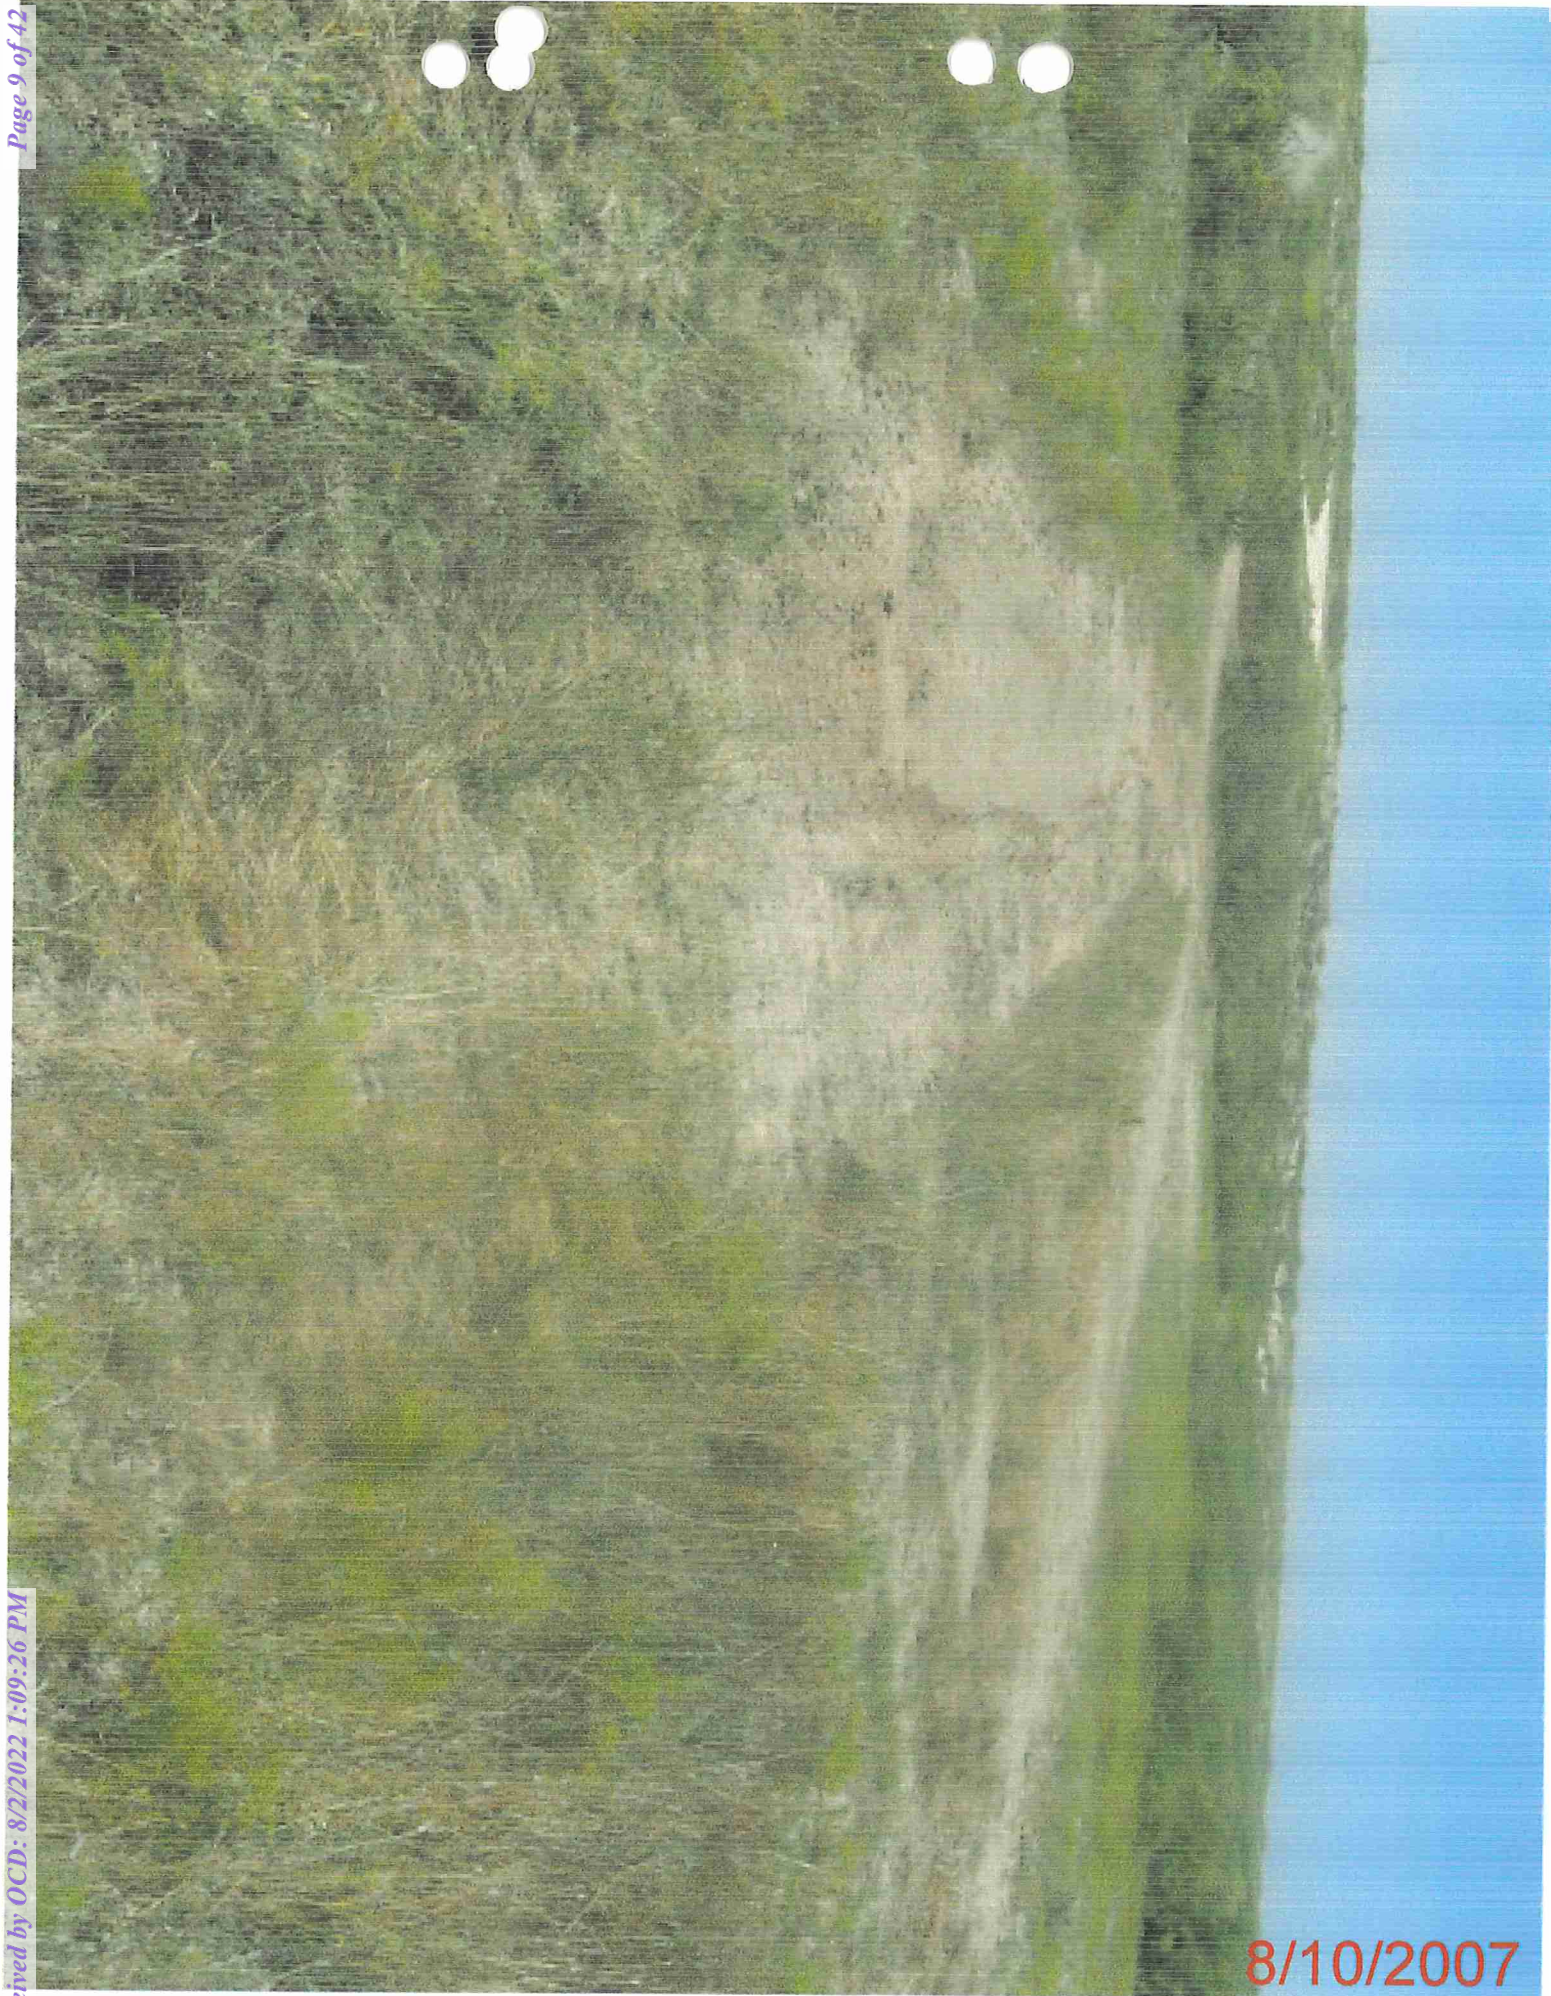
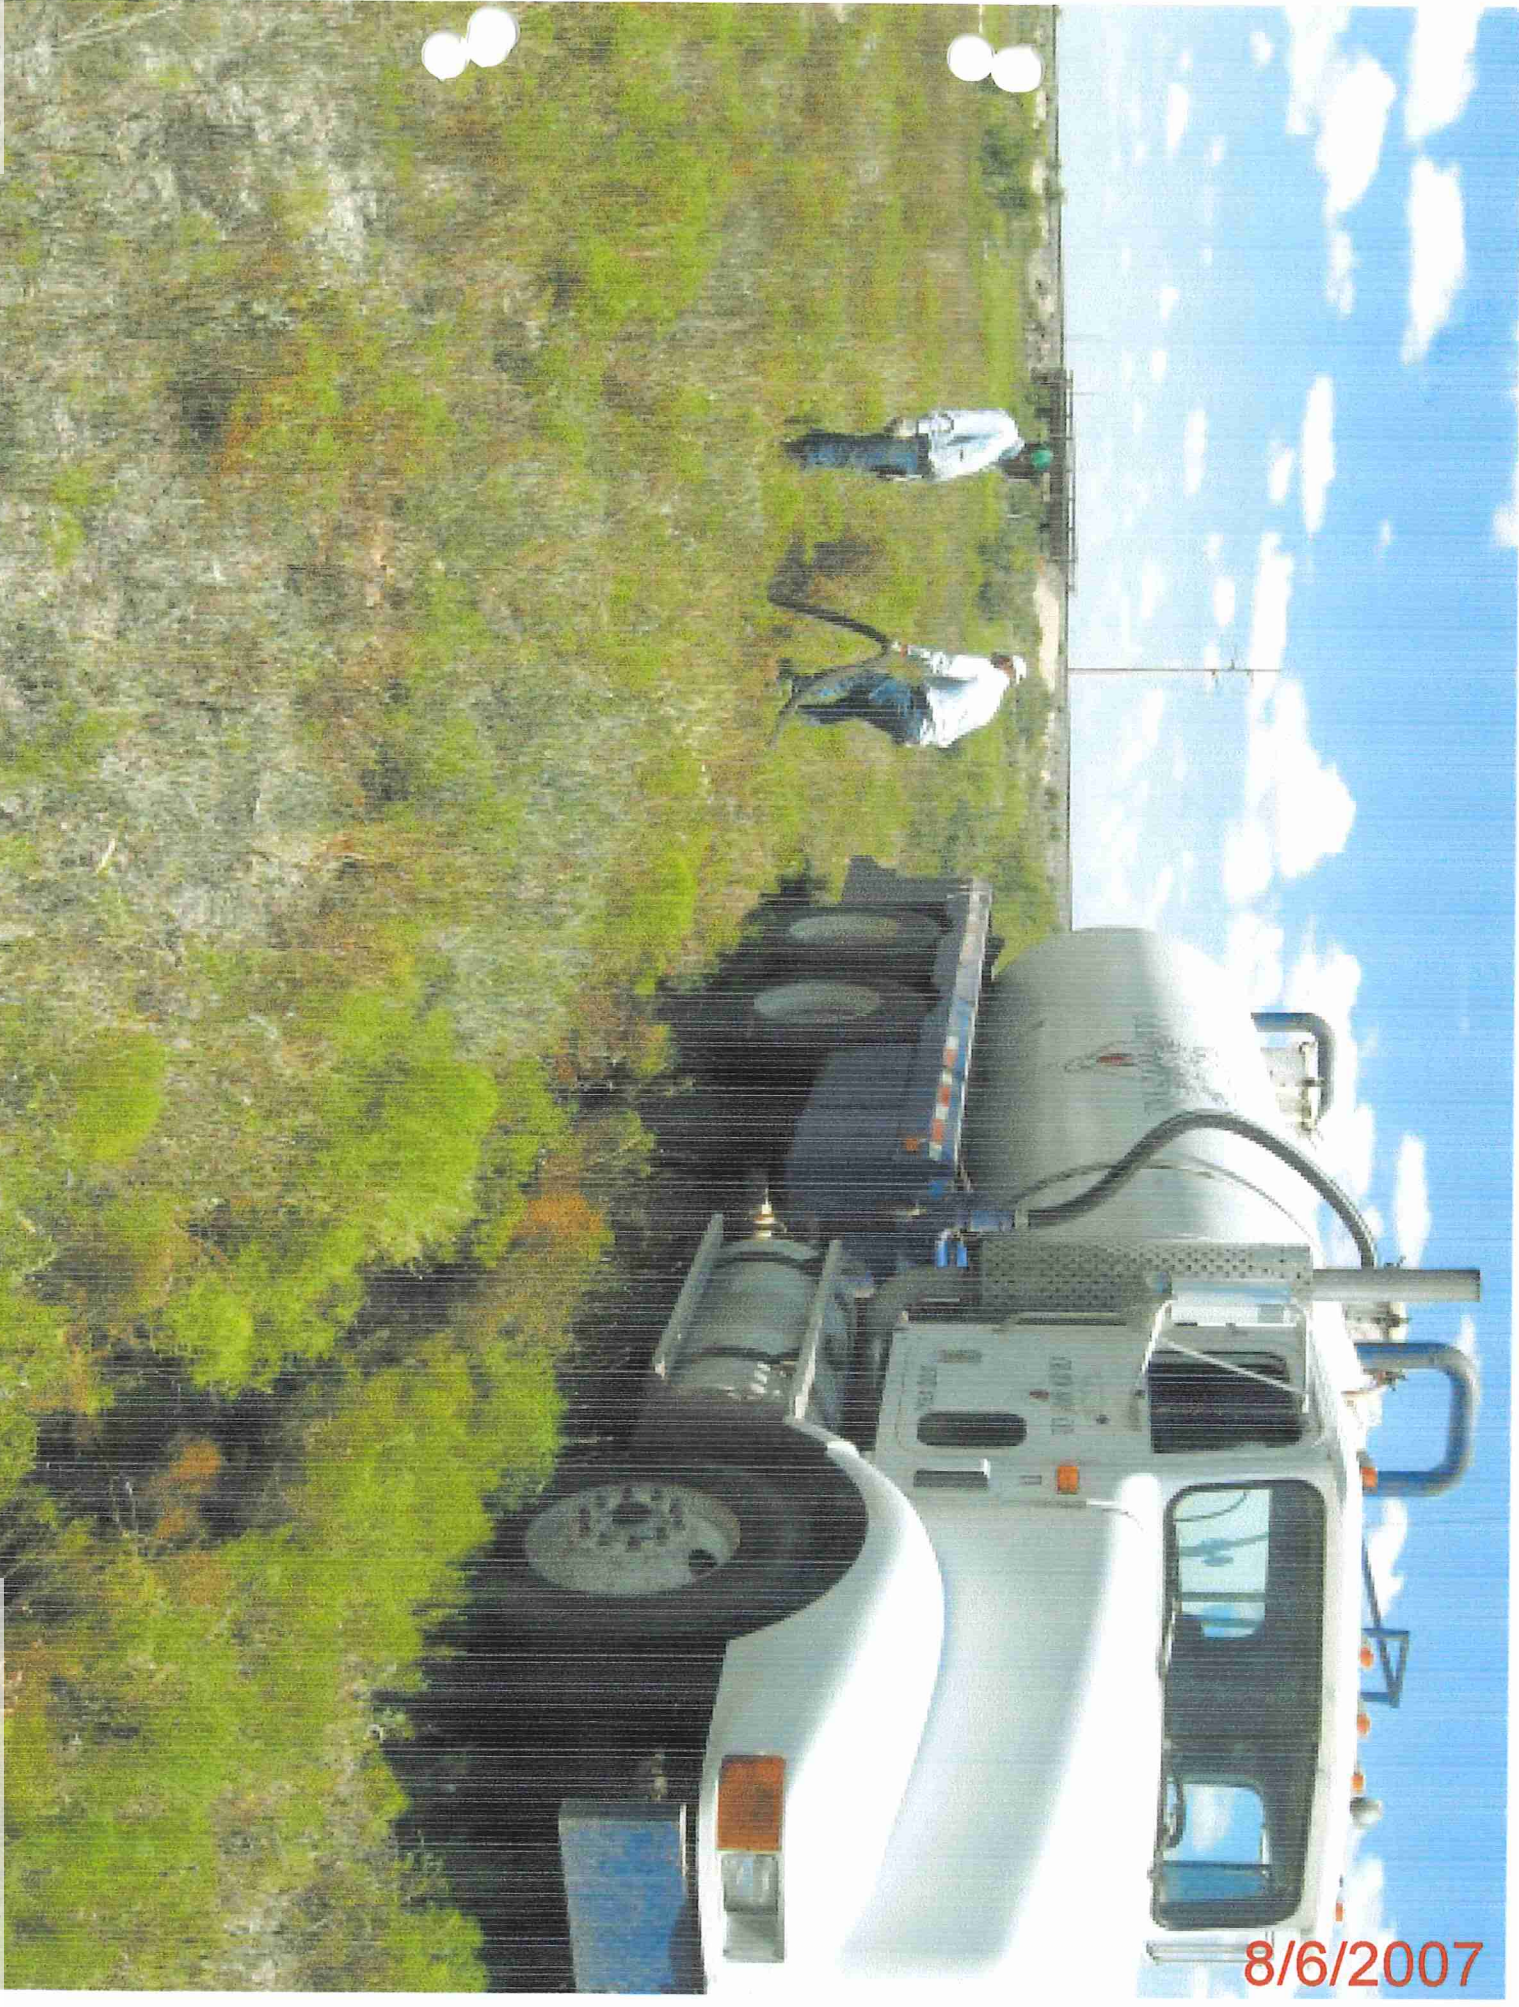
2007 Site Pictures

On August 6, 2007, Yates Petroleum Corporation (YPC) had a release at the Dayton FX #1 Blowdown Tank when during the gas gathering system blowdown activities, the tank became full and overflowed. This caused the release of ten (10) barrels of crude oil that was able to migrate down gradient along cattle trails before pooling at the lowest points.

A vacuum truck was dispatched, recovering five (5) barrels of fluid. A dirt contractor was also contracted to excavate the impacted soils, these soils were then hauled to a NMOCD approved disposal facility. To prevent cattle in the area from possibly being impacted by drinking pooled rainwater that may have residual traces of hydrocarbon, Compost Soil was brought to the site and blended with a Rototiller. After the Composted Soil and native soils had been blended, soil samples were collected with hand auger sent to a third-party laboratory for analysis. Analytical results indicated that all soils were below the Recommended Remediation Action Levels (RRAL) for Benzene, BTEX, and TPH, and chloride concentration was collected for documentation. This work and the analytical results were included with the original C-141 Final Documents that are included as Appendix C.

Nonetheless, reviewing the photographs from the release date (Appendix A) and the current date, July 22, 2022 (Appendix B), and comparing the vegetation in those images, it is obvious that the remediation was successful with the site having recovered. Forage has thrived in the area with a large variety of native grasses and shrubs, and very little visibly bare ground even with the current drought situation that the area is experiencing.
