Re: Dayton FX #1 Blowdown Tank
30-015-21761
K-21-18S-26E
Eddy County, NM
2RP-117
Incident # nKMW0801154059

Dayton FX #1 Blowdown Tank
Closure Report
#nKMW0801154059

Dayton FX #1 Blowdown Tank

Closure Report

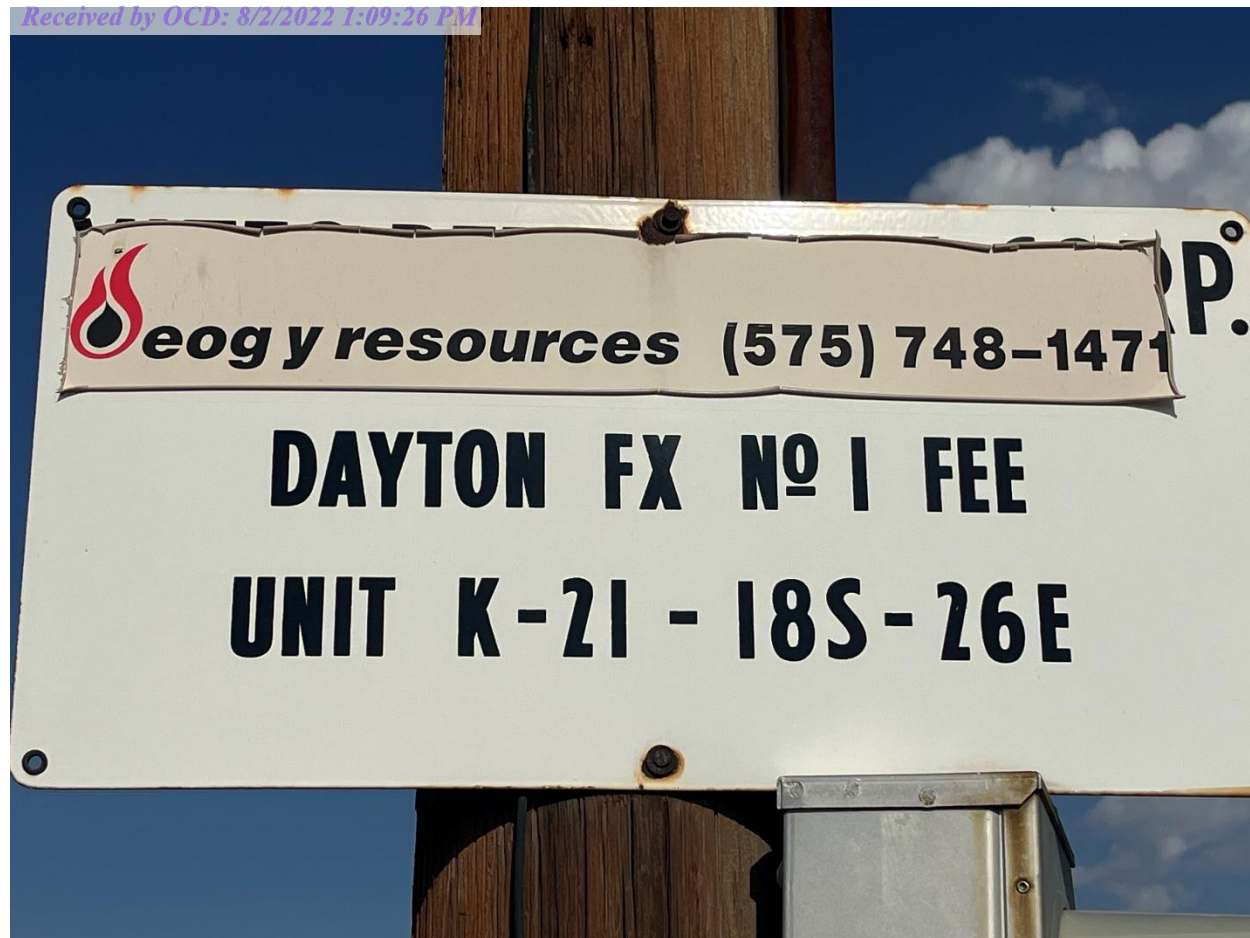
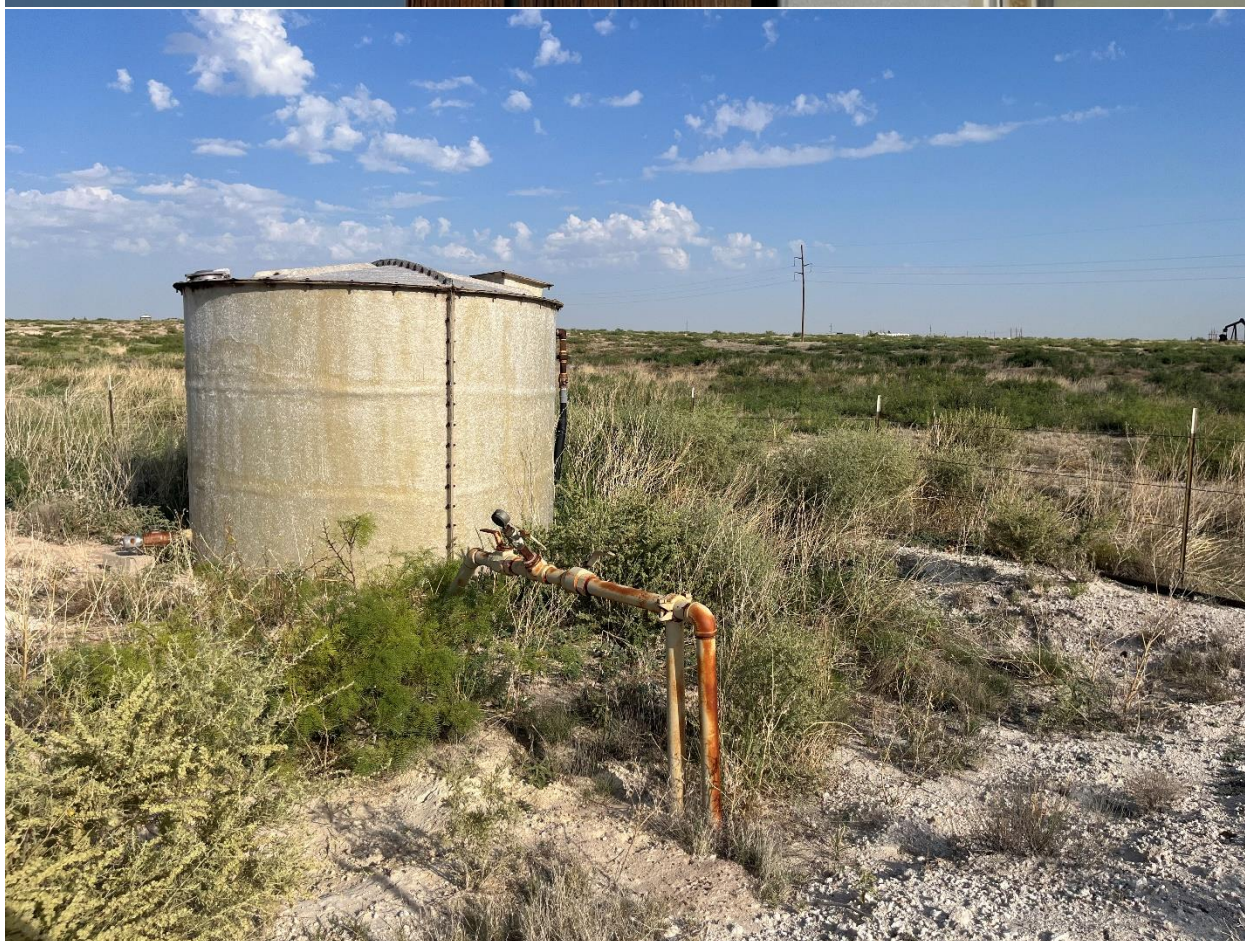
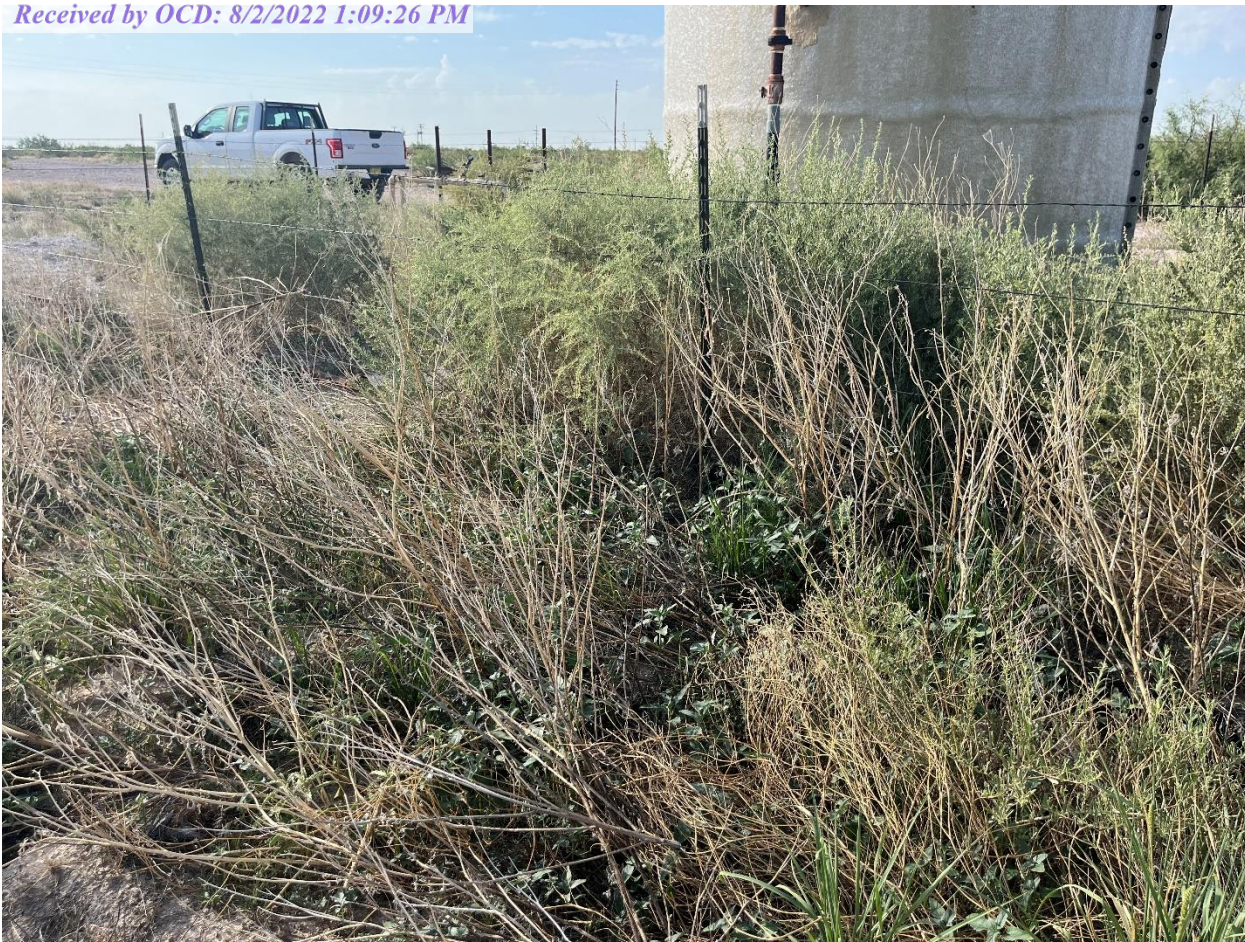
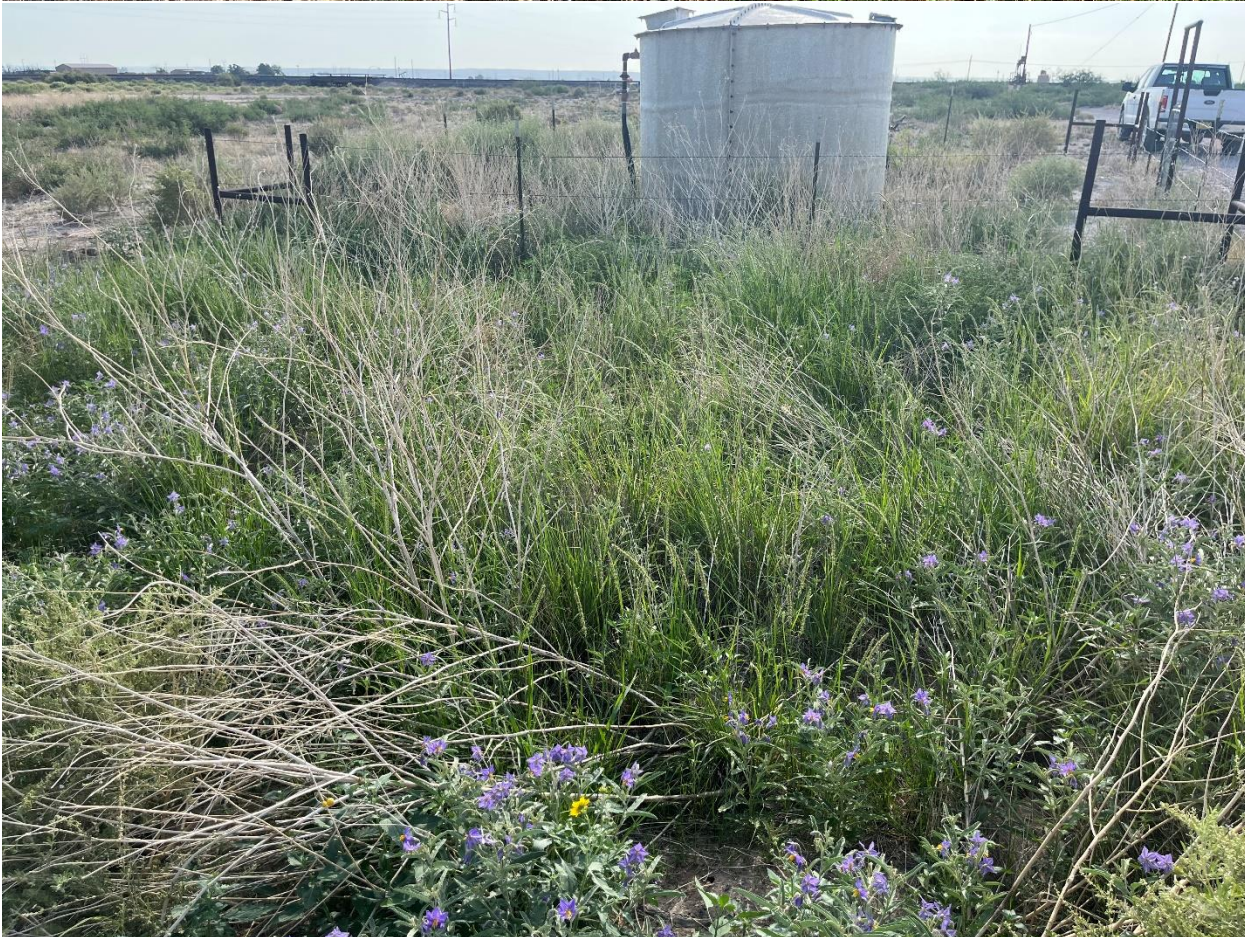
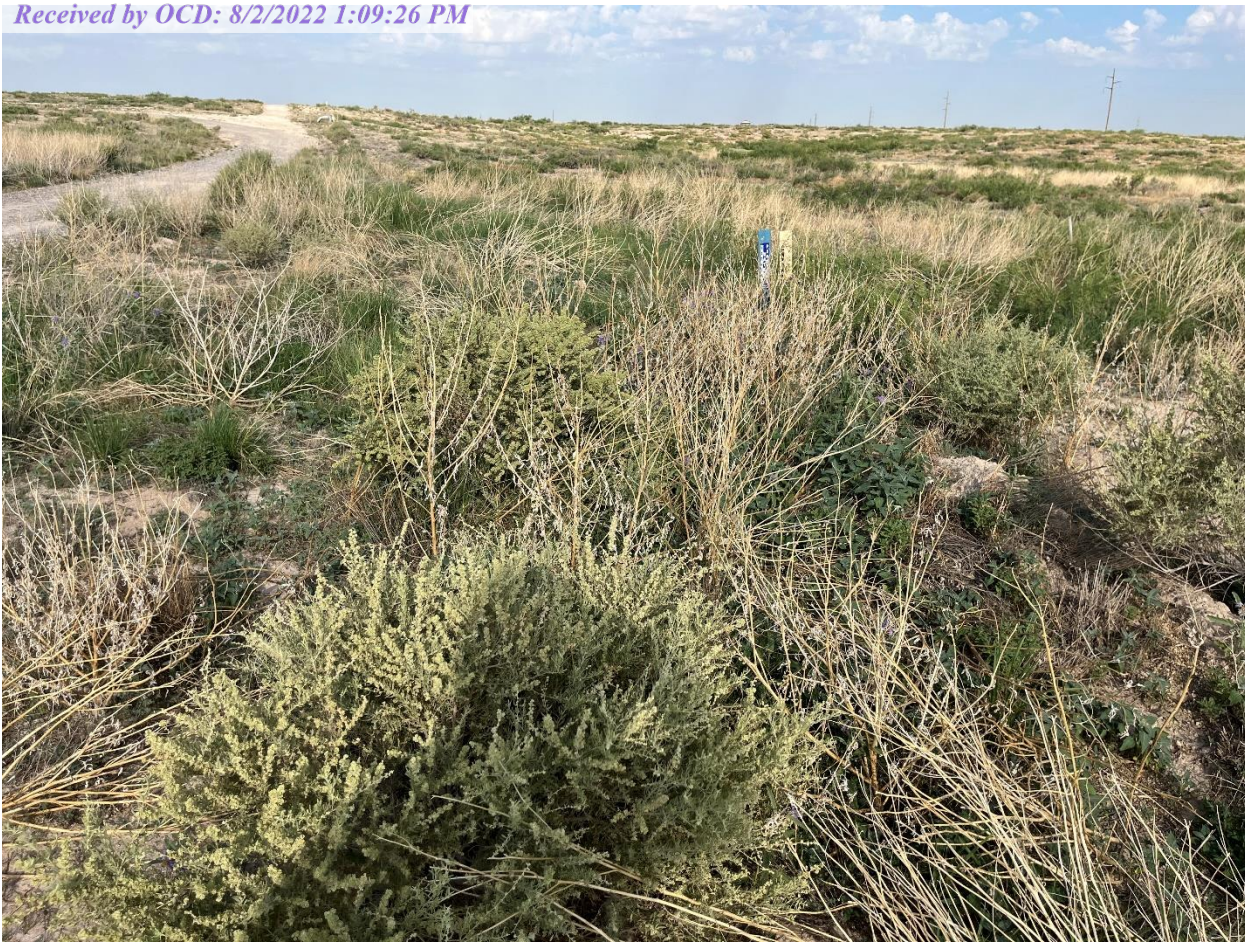
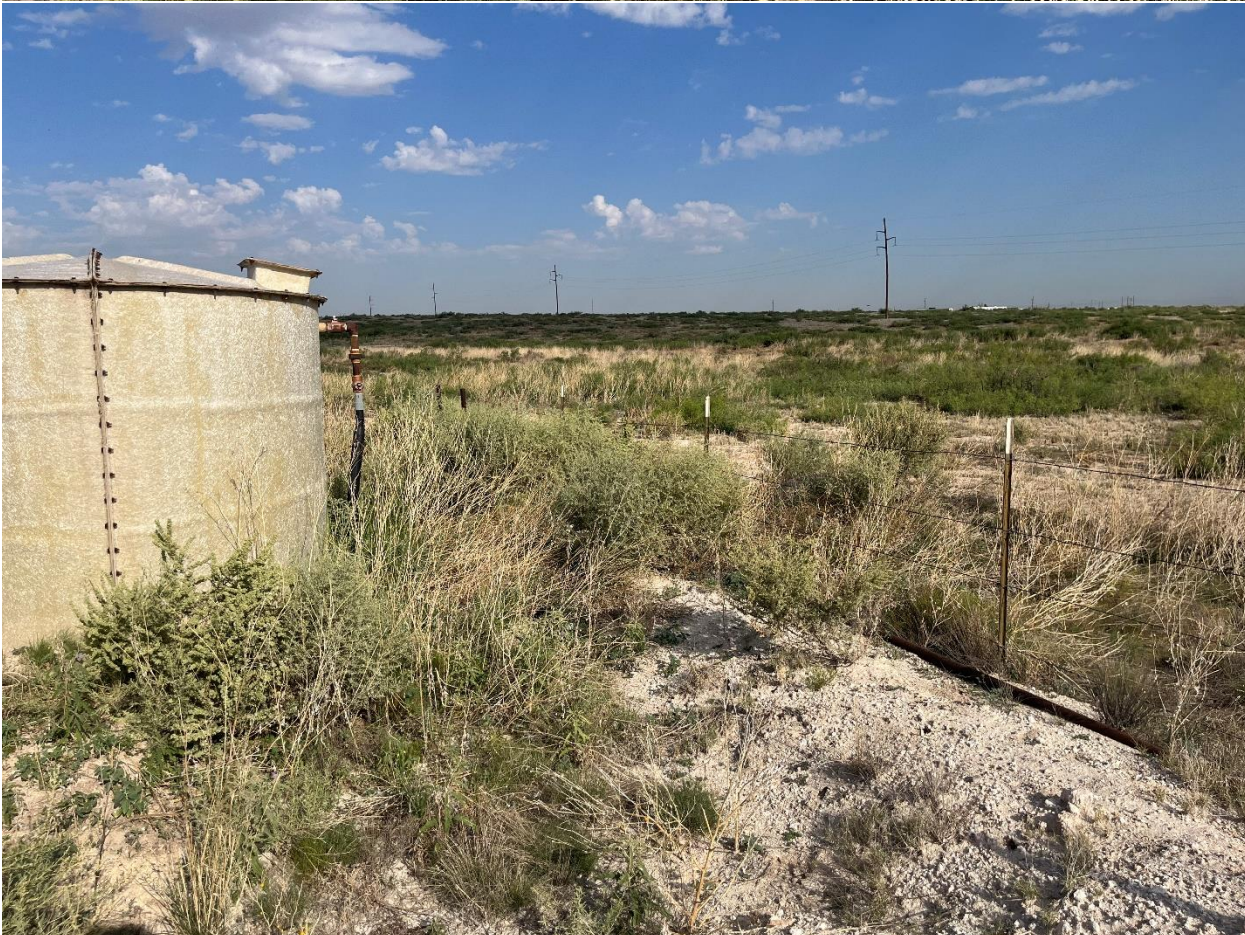
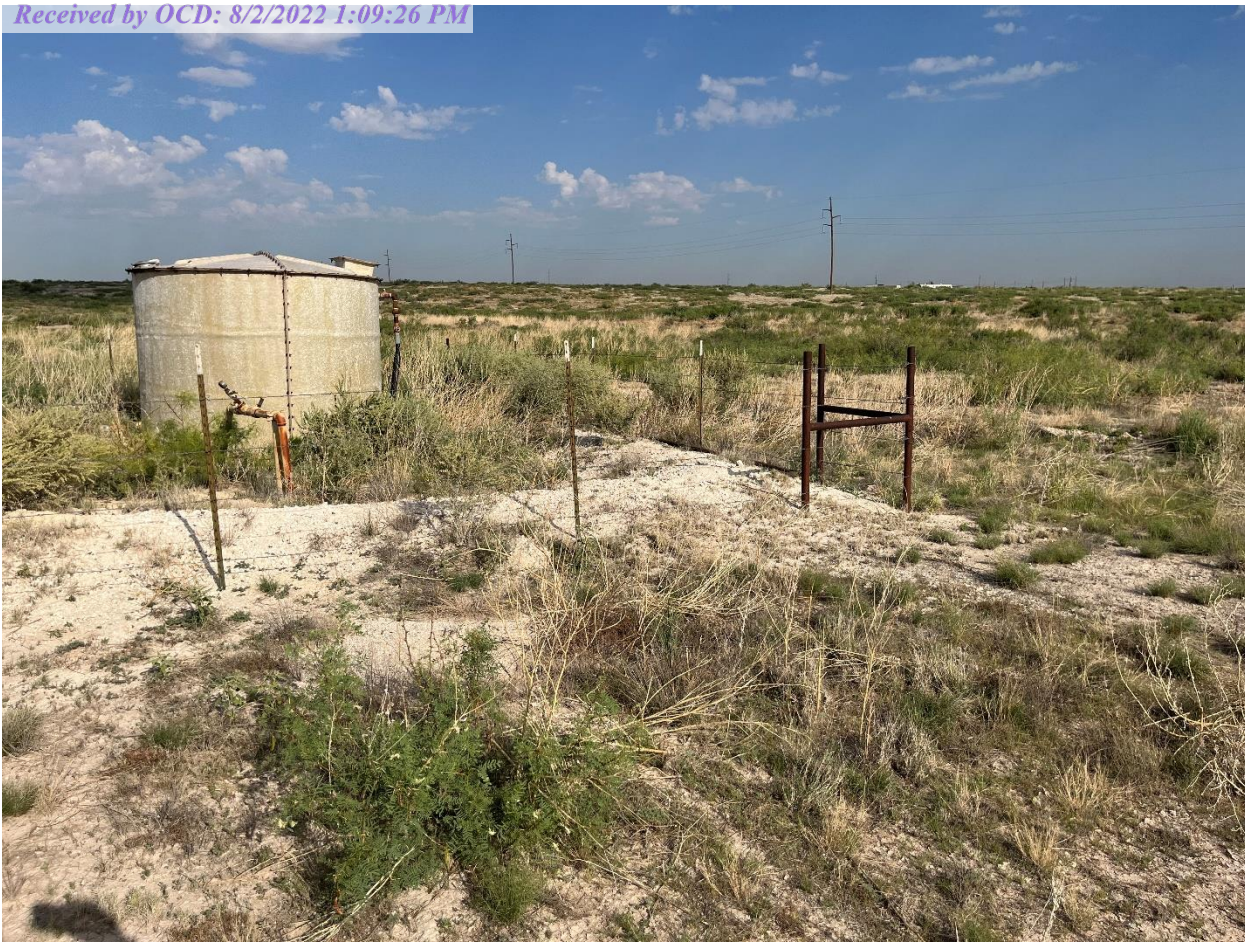
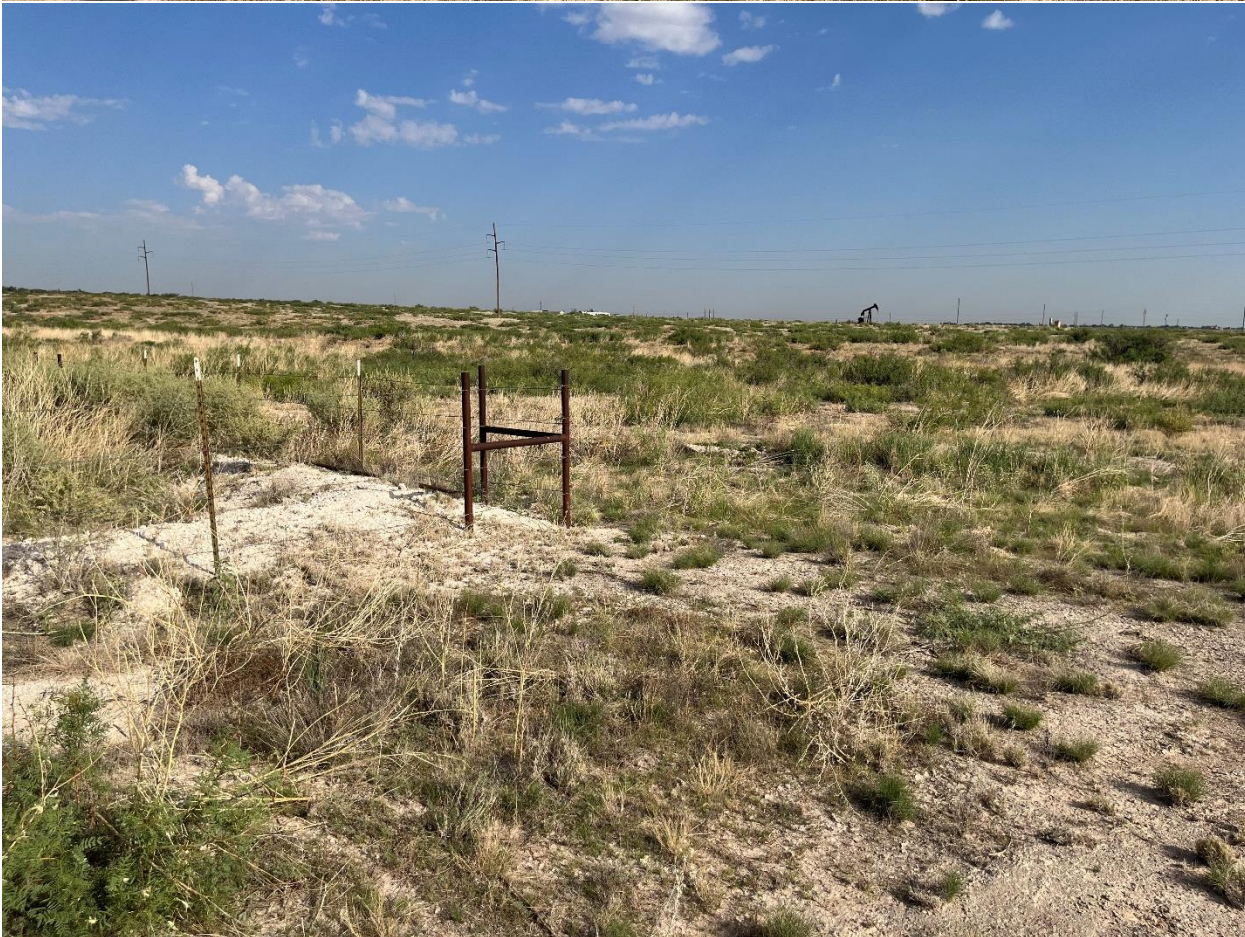
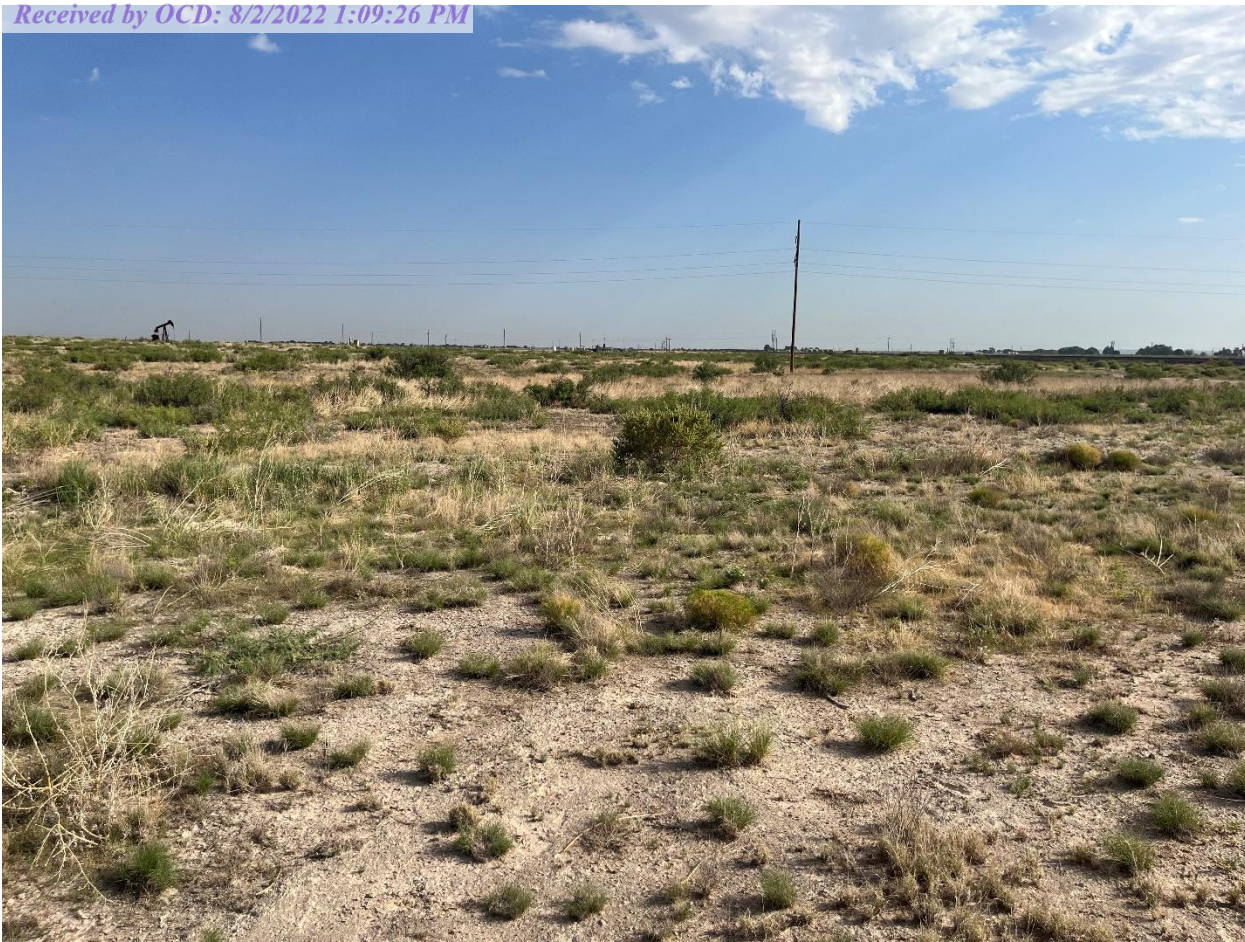
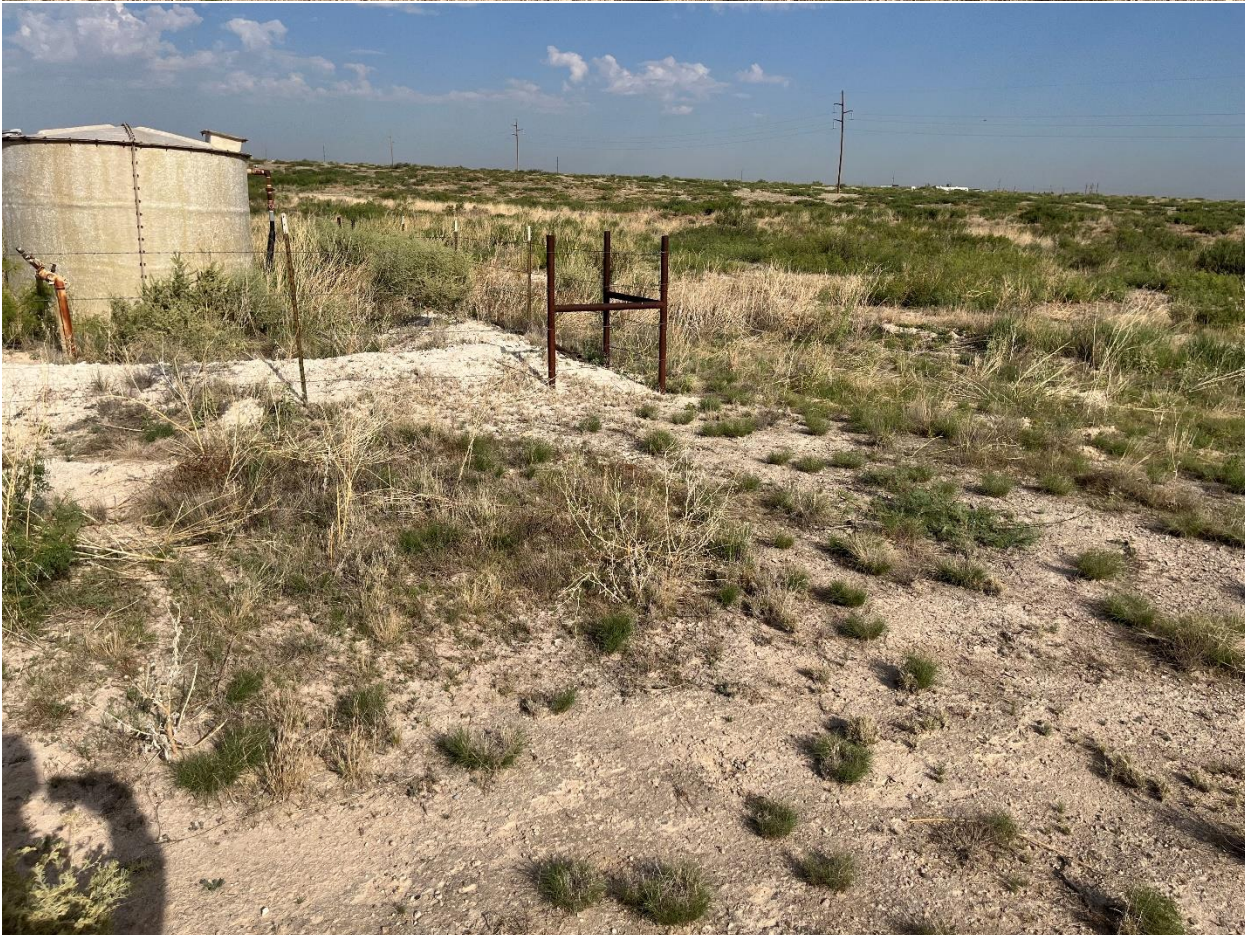
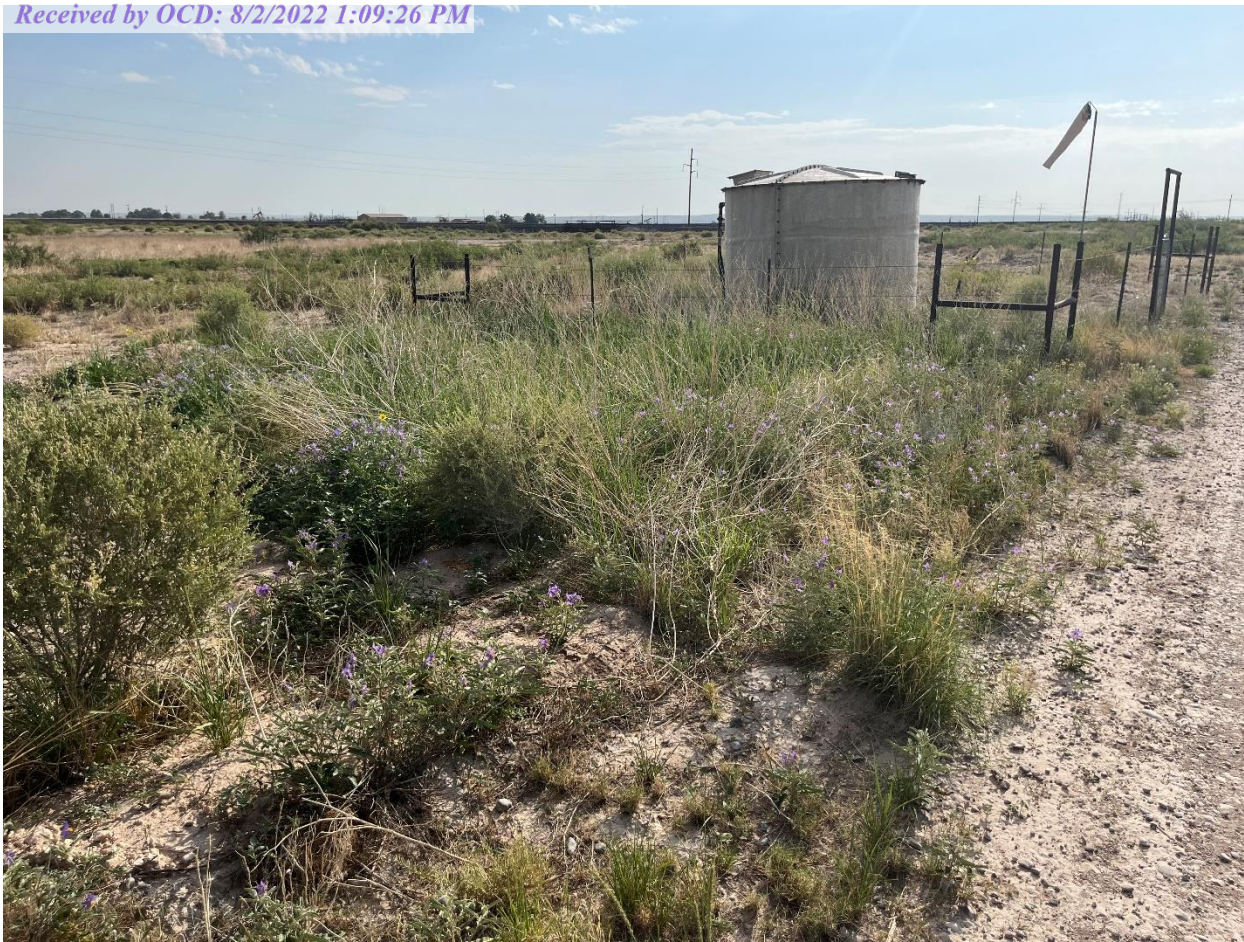
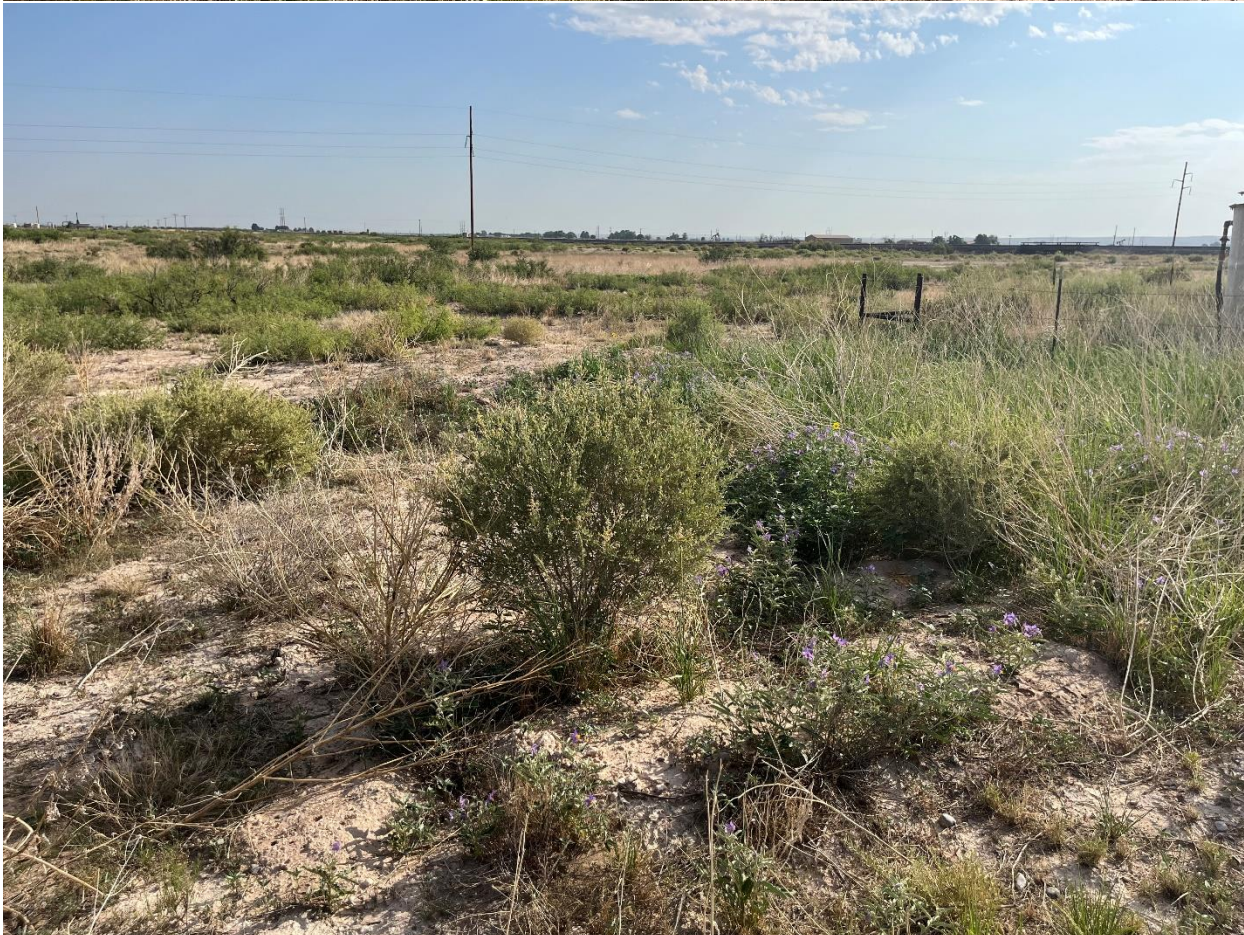
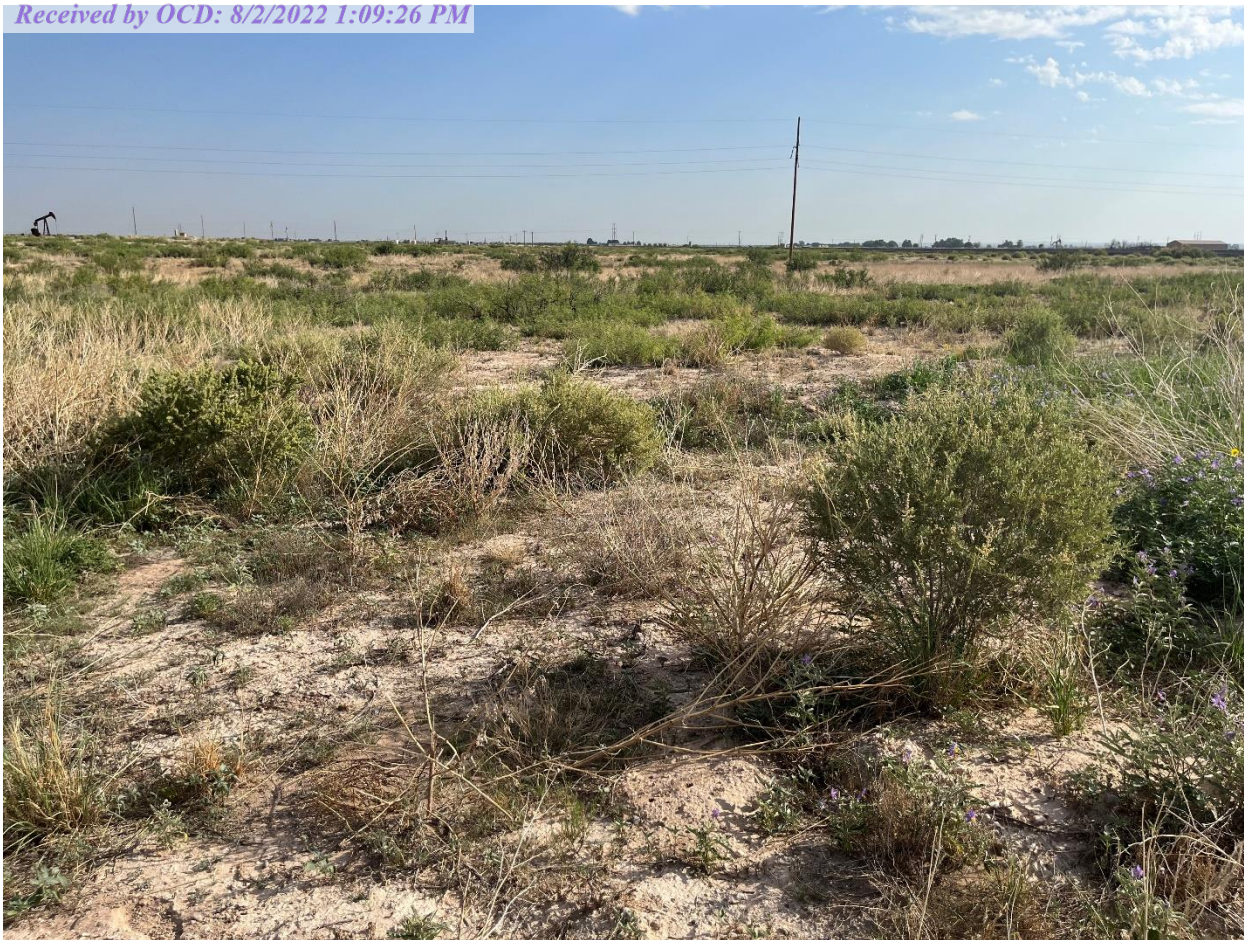
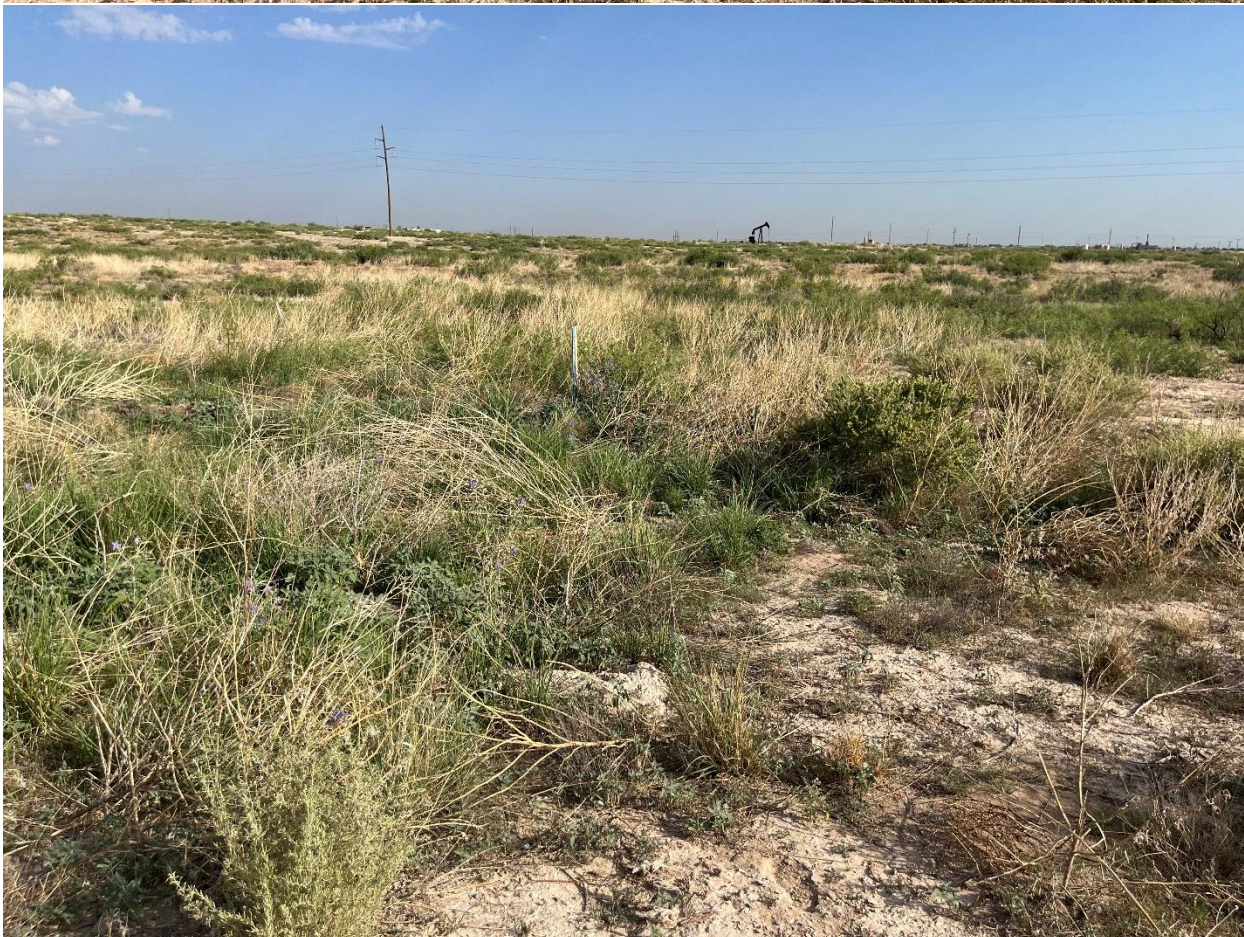
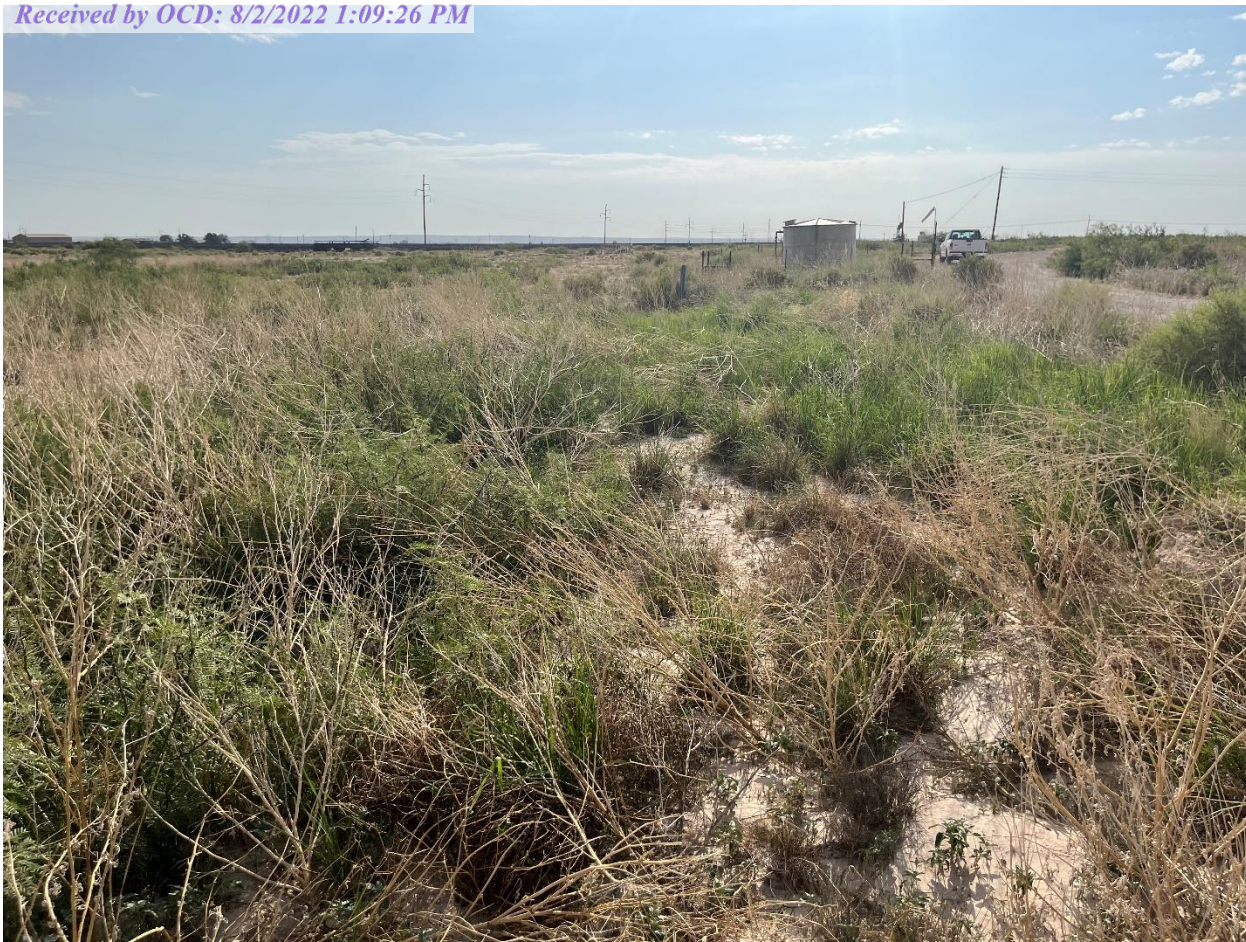
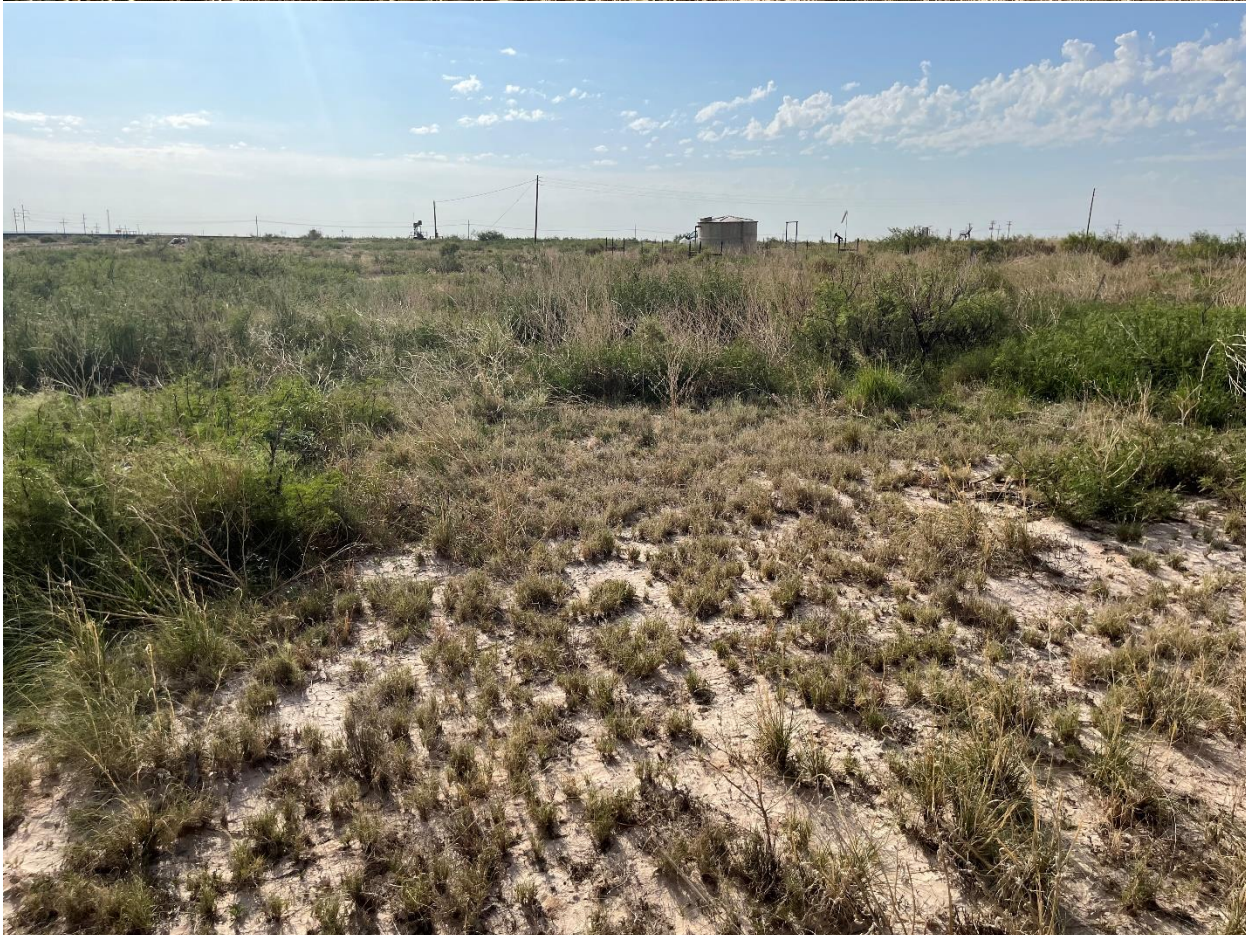
2022 Site Pictures

Nonetheless, reviewing the photographs from the release date (Appendix A) and the current date, July 22, 2022 (Appendix B), and comparing the vegetation in those images, it is obvious that the remediation was successful with the site having recovered. Forage has thrived in the area with a large variety of native grasses and shrubs, and very little visibly bare ground even with the current drought situation that the area is experiencing.

EOG Resources, Inc. believes that the original analytical results and current vegetation are evidence that the remediation was correctly completed at the time of the release, and hereby requests Closure of nKMW0801154059, the current C-141 Closure Form is included with this Closure Report as Appendix D.
