Re: Site Assessment, Remediation, and Closure Report
Mobile Lea State #8 Injection Pump
API No. N/A
GPS: Latitude 32.59976 Longitude -103.53254
UL "K", Sec. 02, T20S, R34E
Lea County, NM
NMOCD Ref. No. NPAC0619942318

Pima Environmental Services, LLC (Pima) has been contracted by Armstrong Energy Corporation to perform a spill assessment, remediation activities, and submit this closure report for a crude oil release that occurred at the Mobile Lea State #8 Injection Pump. The initial C-141 was submitted on July 14th, 2006 (Appendix C). This incident was assigned Incident ID NPAC0619942318, by the New Mexico Oil Conservation Division (NMOCD).

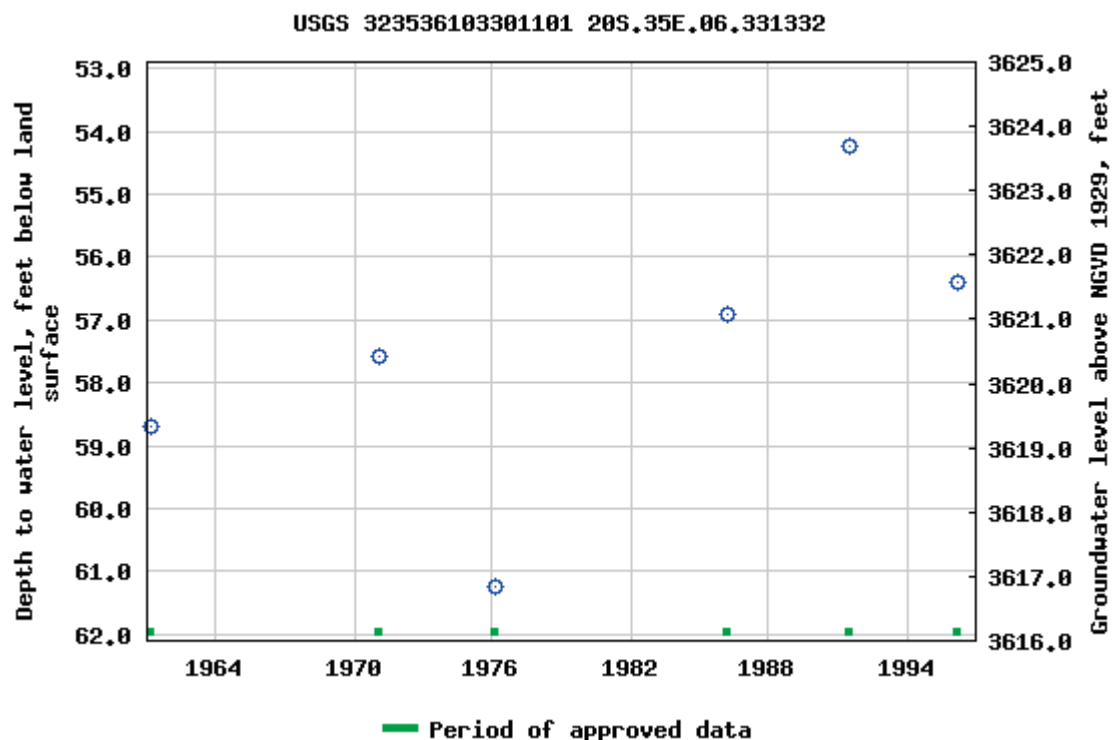
USGS 323536103301101 20S.35E.06.331332

The depth of the well is 70 feet below land surface.

Breaks in the plot represent a gap of at least one year between field measurements.
[Download a presentation-quality graph](#)
