Site Assessment/Characterization

Closure

Re: Site Assessment, Remediation, and Closure Report
Fighting Okra 18 CTB 4
API No. N/A
GPS: Latitude 32.048152 Longitude -103.509695
UL -- C, 18, T23S, R34E
Lea County, NM
NMOCD Ref. No. NAPP2222724957

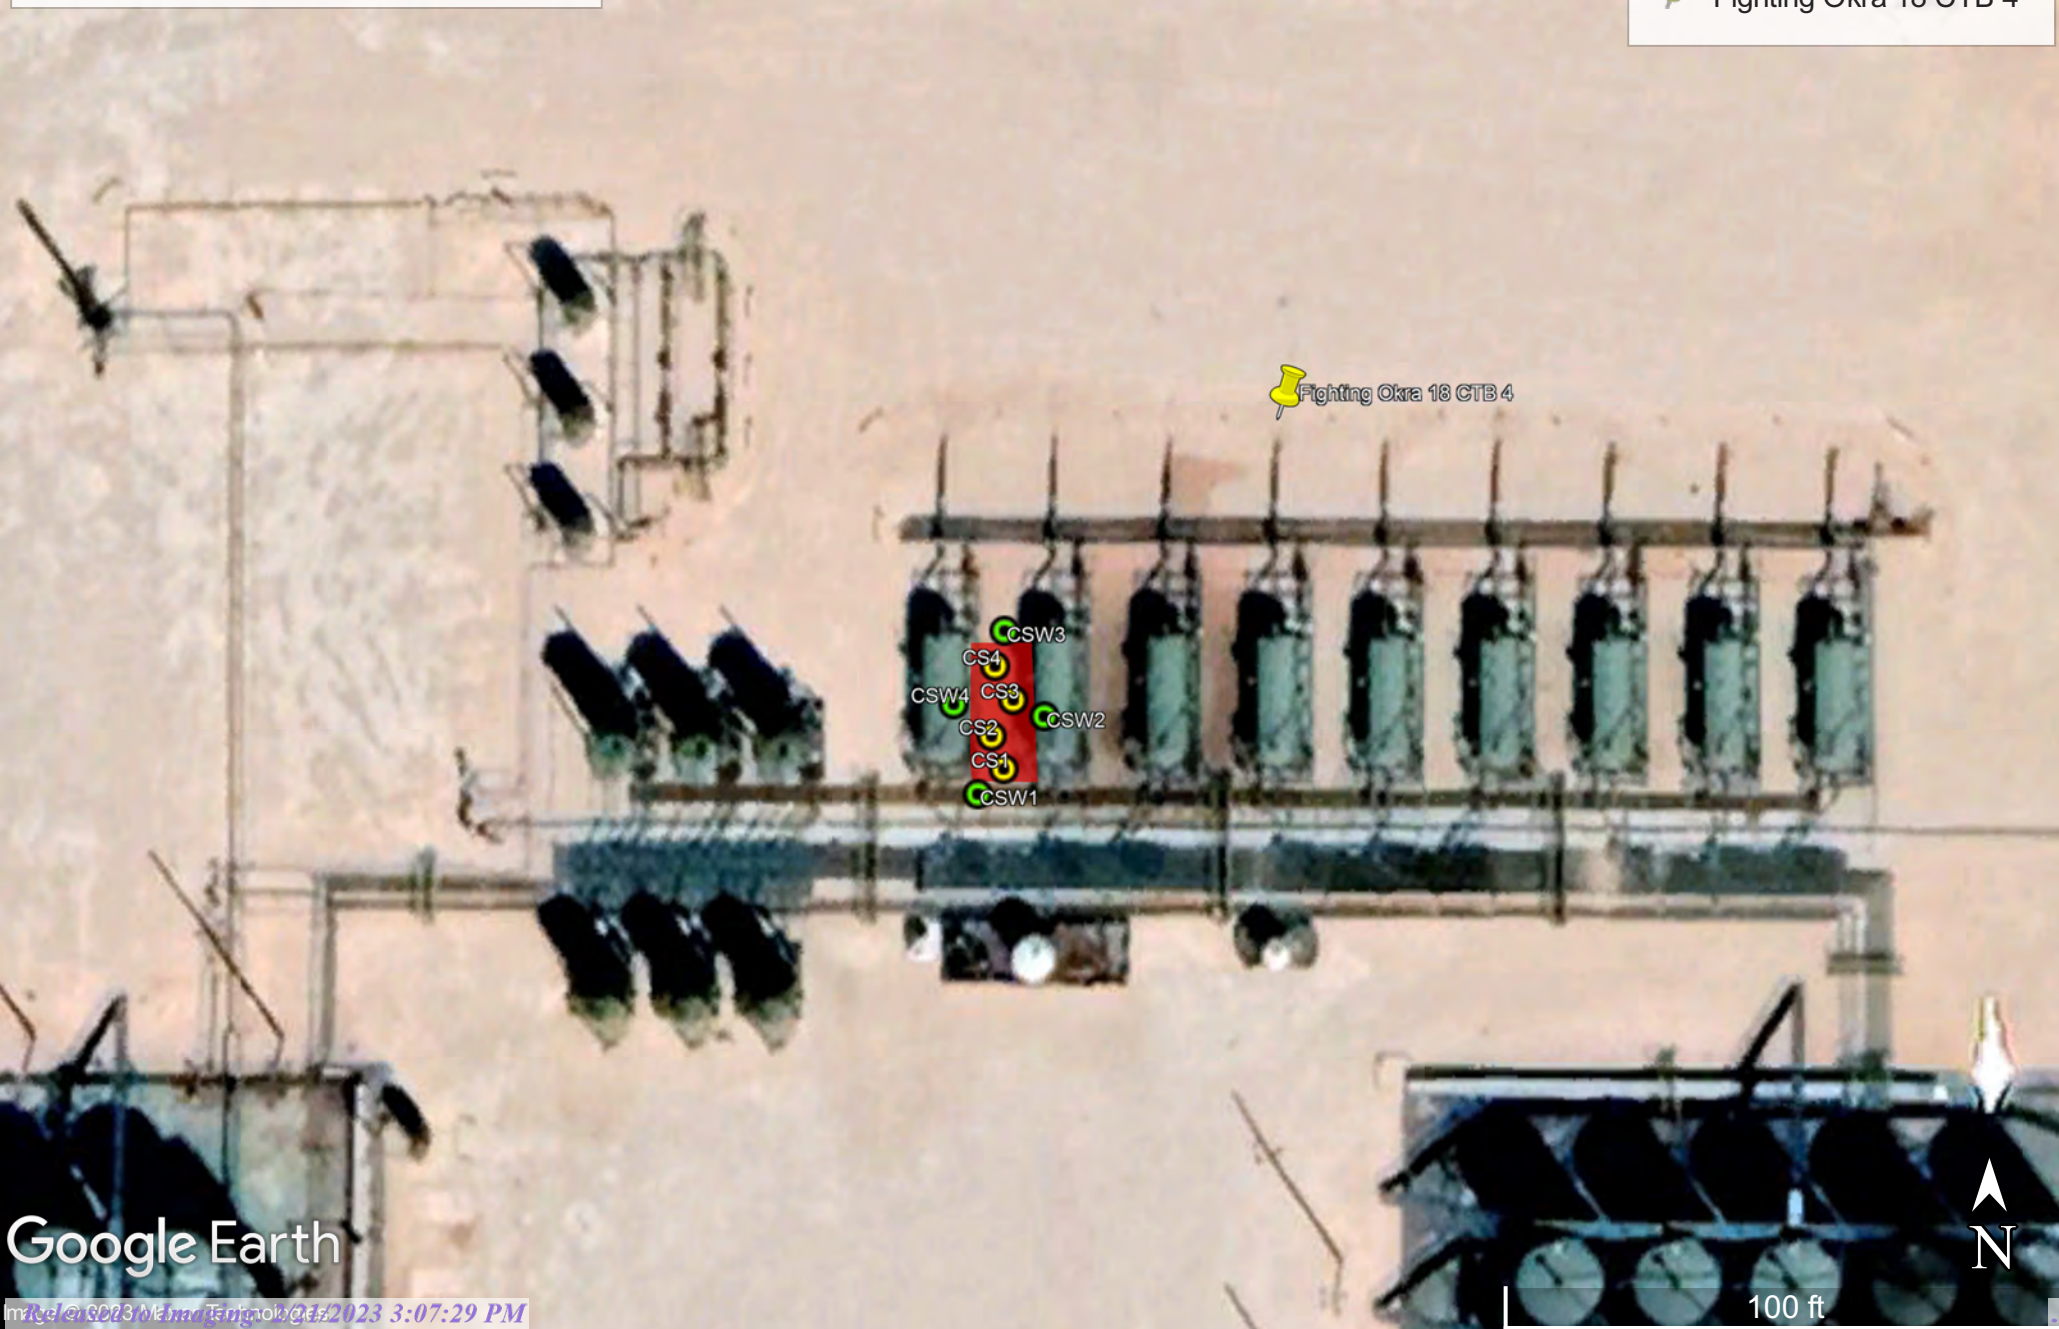
Devon Energy
API# N/A
Lea County, NM
Confirmation Sample Map

On January 19, 2023, after sending a 48-hour notification (Appendix C), Pima returned to the site to collect confirmation samples of the excavation. The results of this sampling event can be found in the following table. A Confirmation Sample Map can be found in Figure 5

- Confirmation Samples
- Excavation Area
- Confirmation Sidewalls
- Fighting Okra 18 CTB 4

Based on the sample results, the bottoms and sidewalls were below NMOCD Closure Criteria 19.15.29 NMAC. The contaminated material was sufficiently removed then transported to an NMOCD approved disposal site. The excavation was then backfilled with clean like material, machine compacted and returned to its previous state. See Appendix D for Photographic Documentation.

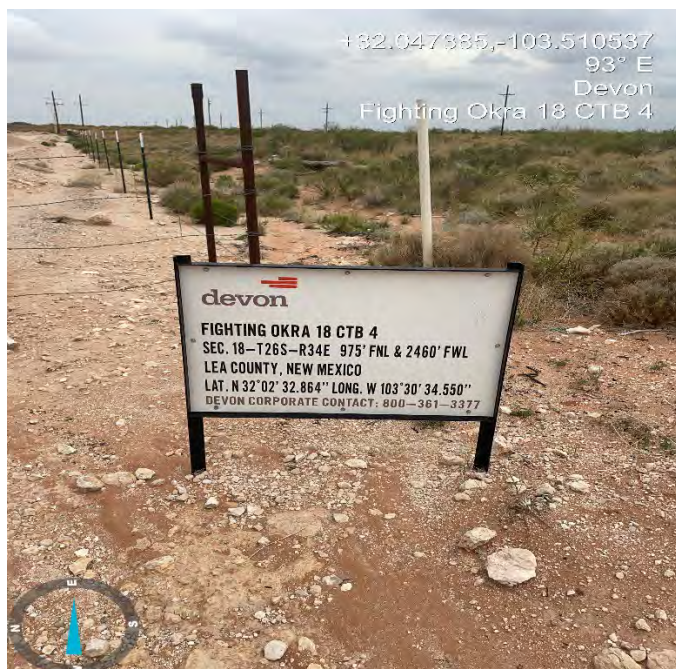
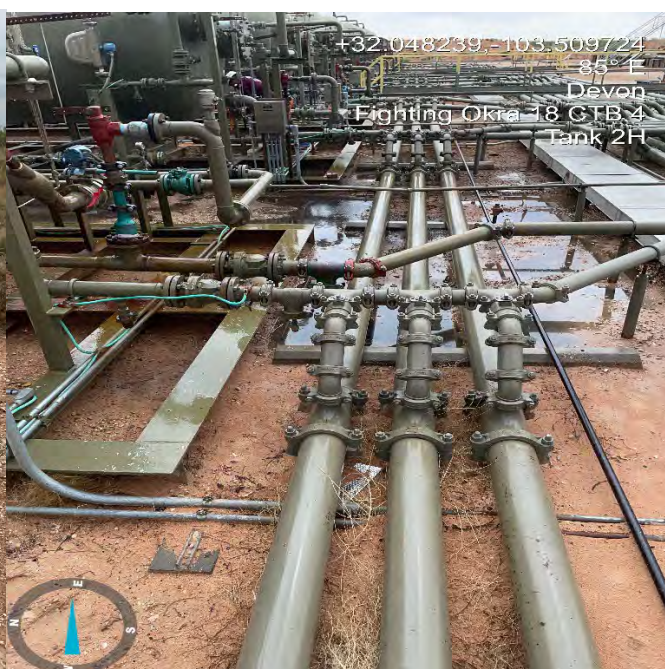
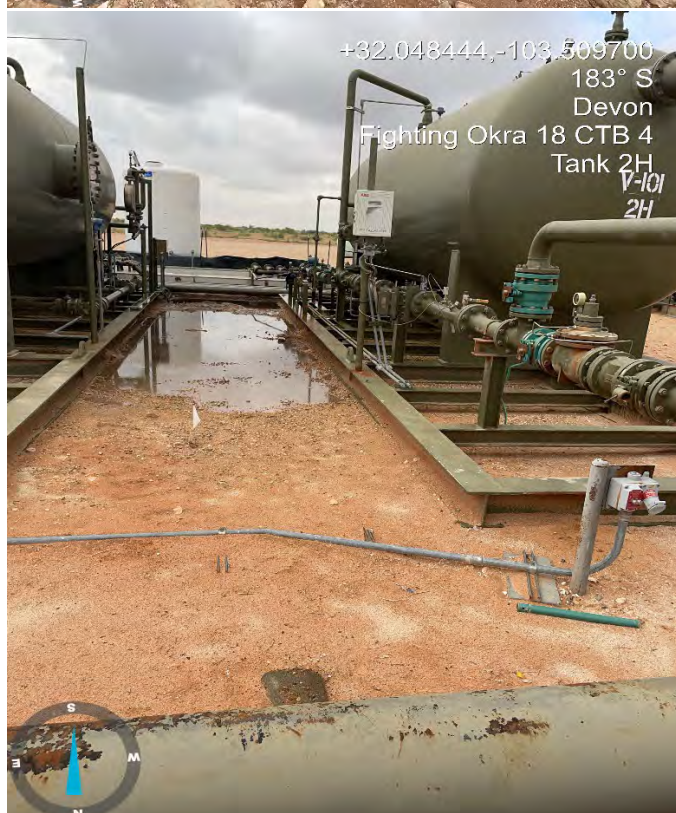
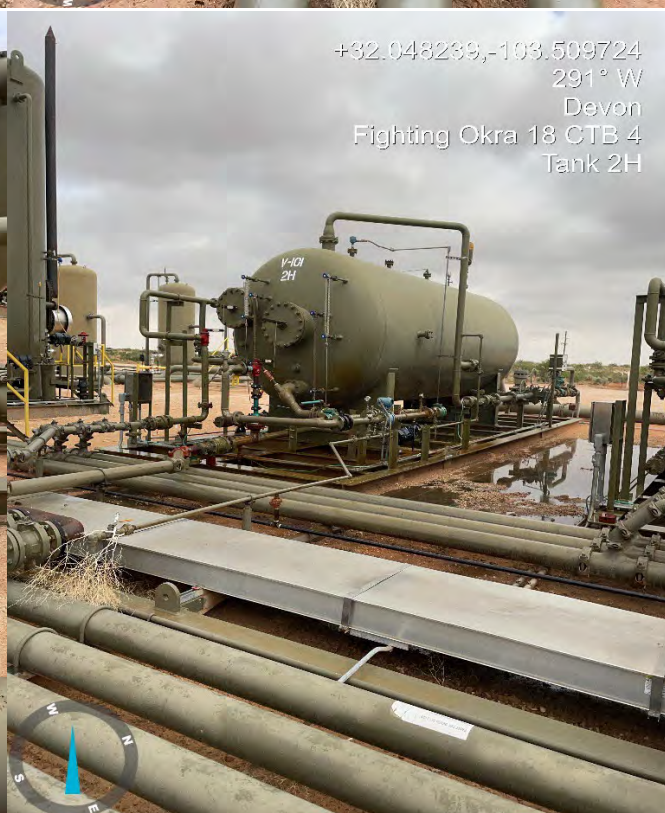
Site Assessment

NAPP2222724957: On August 12, 2022, 3 phase separator developed leak. The released fluids were calculated to be approximately 6.1 barrels (bbls) of produced water. Vacuum truck was able to recover approximately 4 bbls of standing fluid.

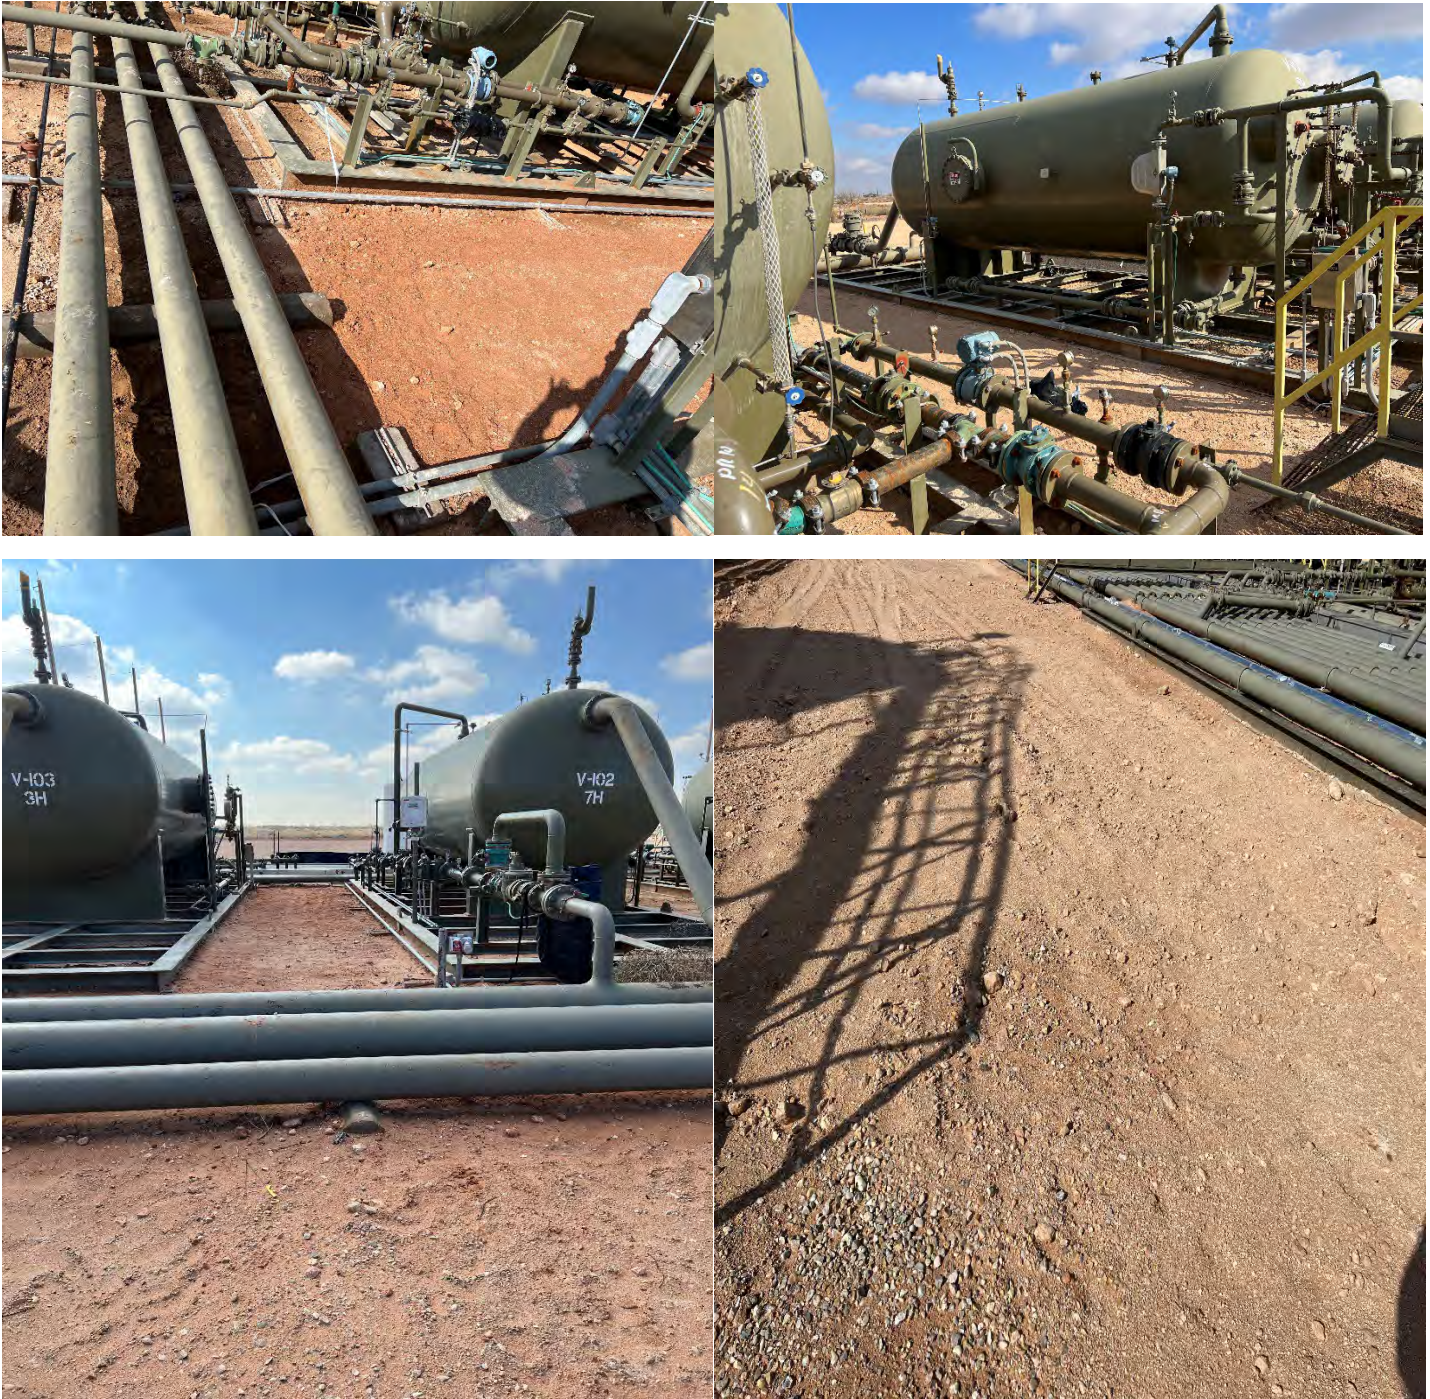
Post scrape

On January 5, 2023, the Devon Construction Department mobilized personnel and equipment to begin immediate remediation activities. They began excavating the area to a depth of 2' BGS. The contaminated soil was hauled to an approved, lined disposal facility and clean backfill material was brought in.
