April 8, 2019

Re: Closure Report  
North Dagger Draw Water Station  
2RP-3651 & 2RP-4649  
Section 20, T19S-R25E  
Eddy County, New Mexico

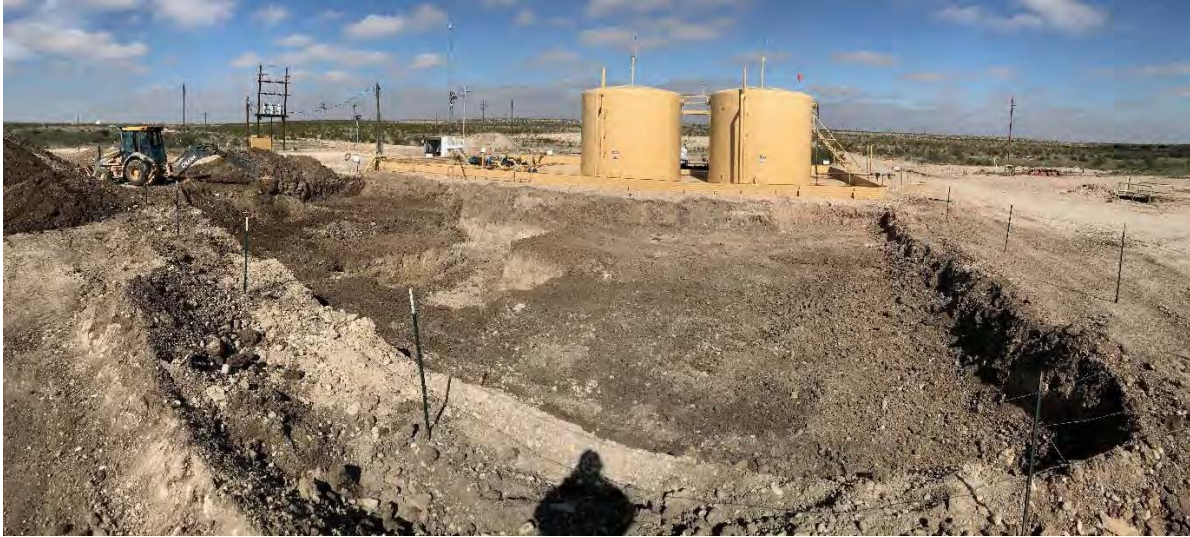
Photograph documenting initiation of site excavation activities in November 2018. View toward the northwest.

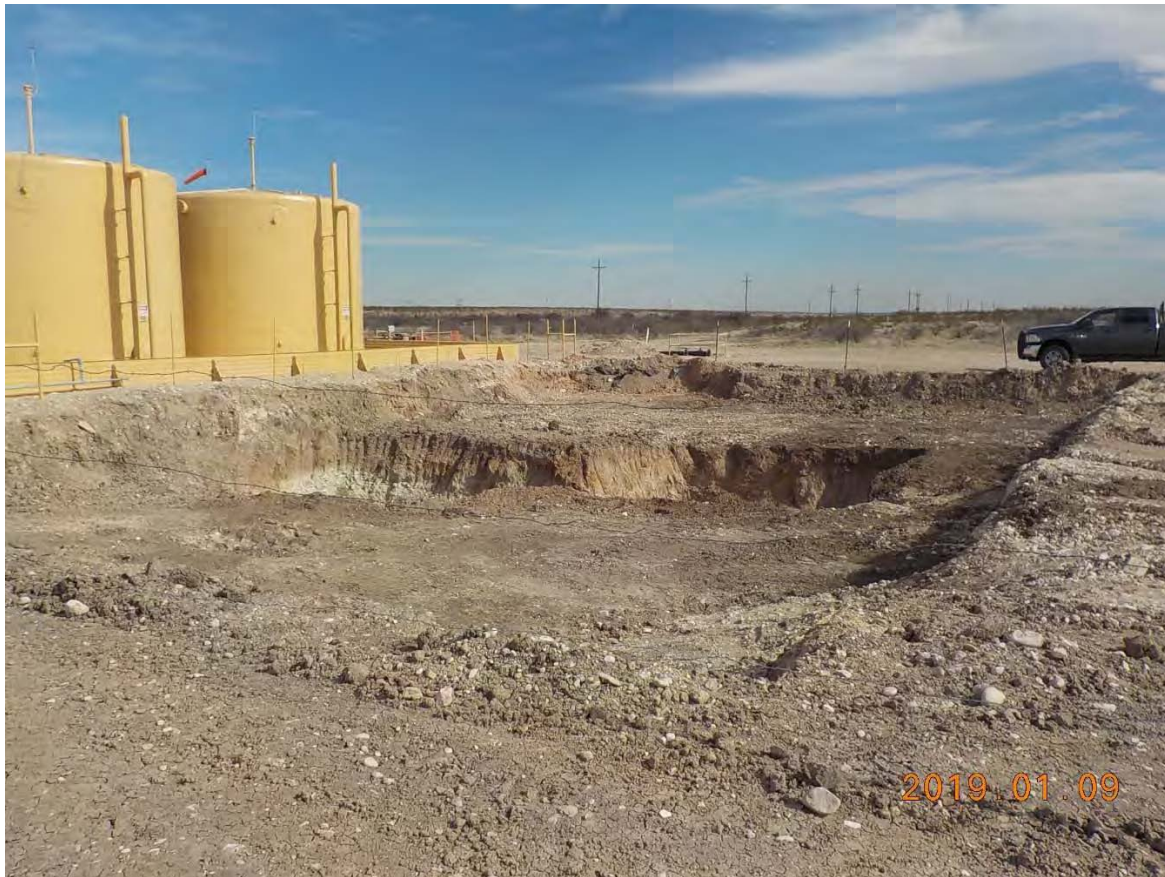
A view of the main excavation area during the initial January 9, 2019 sampling event. View toward the northeast.

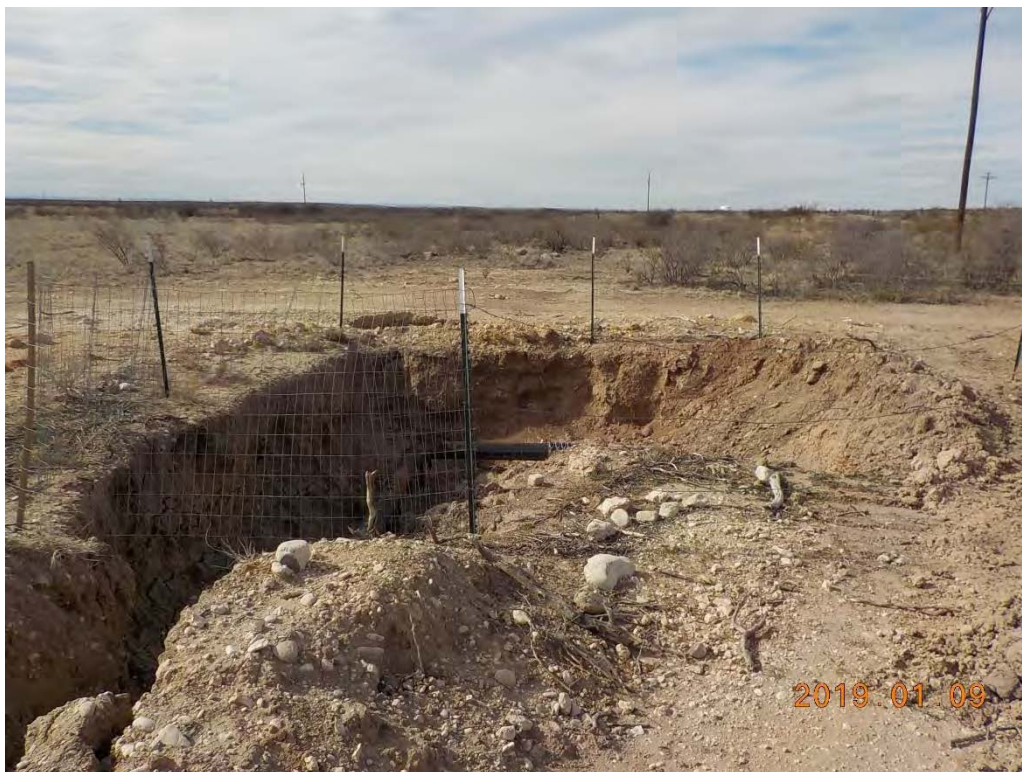
A view of the western excavation area during the initial January 9, 2019 sampling event. View toward the west.

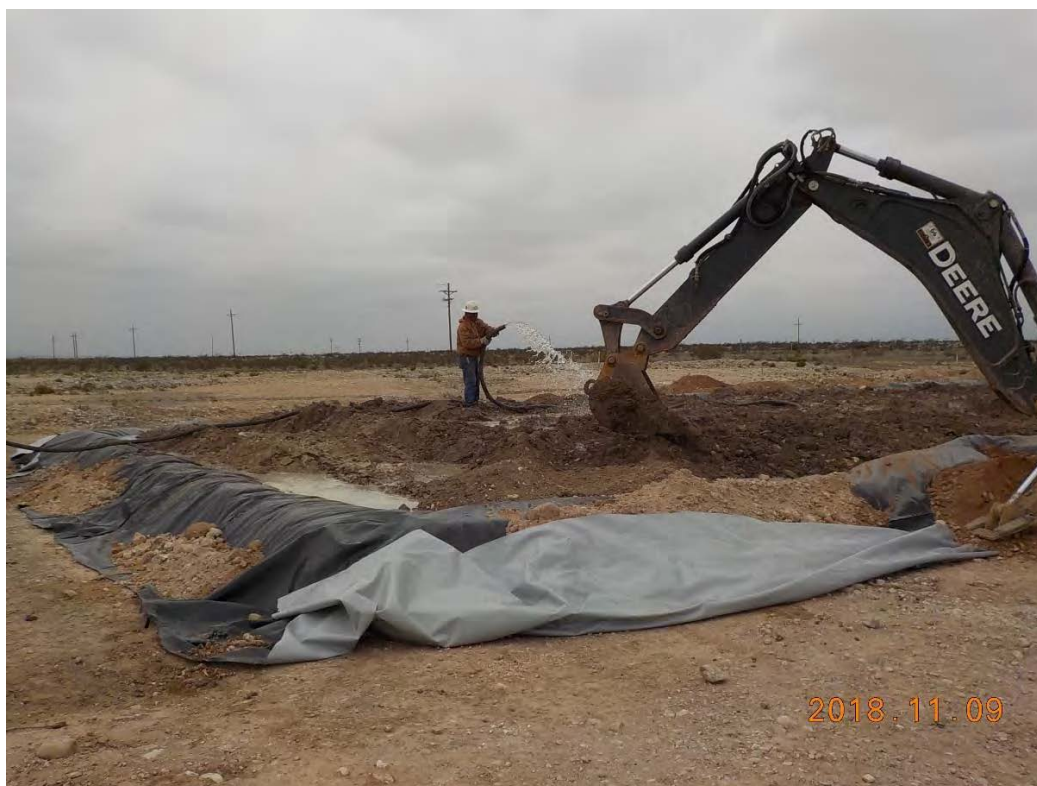
View of the Liquid Remediate™ application process on November 11, 2018.

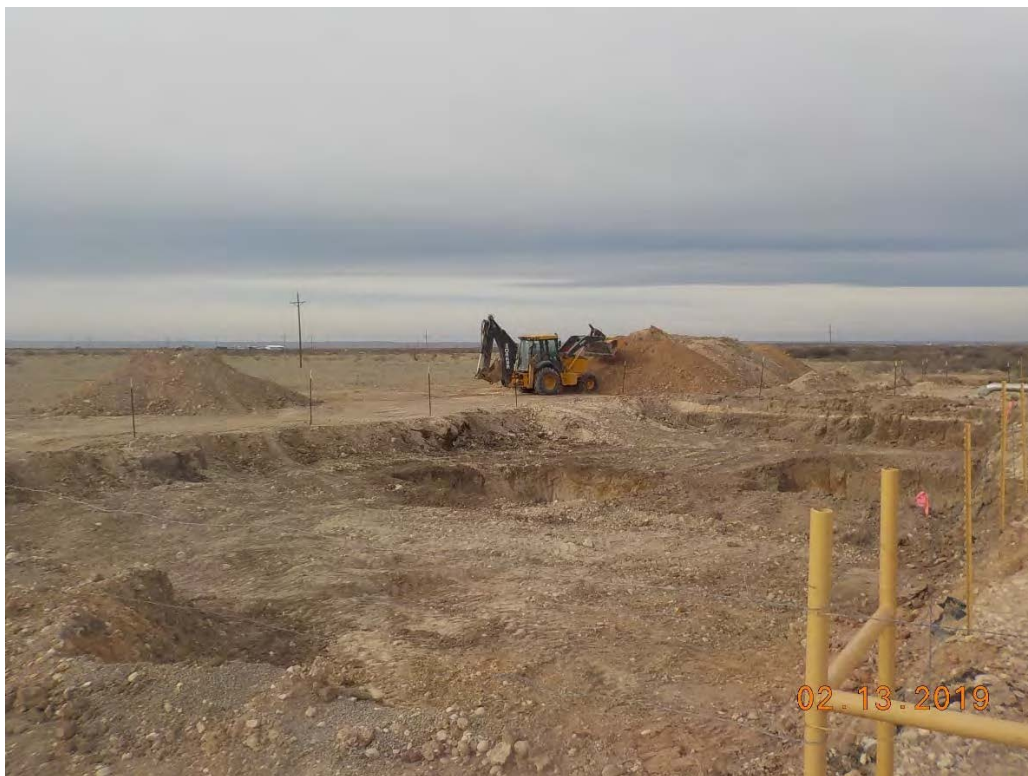
A view of the final main excavation area prior to backfilling. The view is towards the southwest.

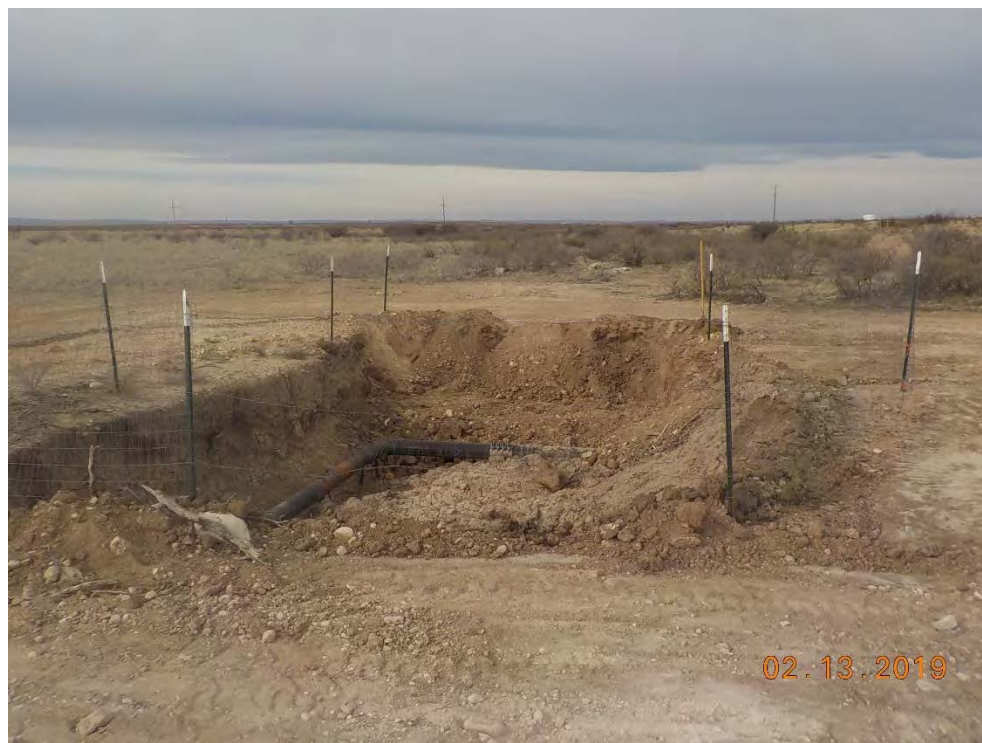
A view of the final western excavation area prior to backfilling. The view is towards the west.
