Re: **Closure Request**
Antelope Ridge Unit #003
Tracking #: NGRL0822027262

Site Information	
Incident ID	NGRL0822027262
Site Name	Antelope Ridge Unit #003
Company	OXY USA, Inc.
County	Lea
ULSTR	K-34-23S-34E
GPS Coordinates (NAD 83)	32.25791, -103.46393
Landowner	Private

Liner Inspection Form

Site Location Map
OXY USA, Inc.
Antelope Ridge Unit #003
32.25791, -103.46393
Lea County, New Mexico
NMOCD Reference # NGRL0822027262

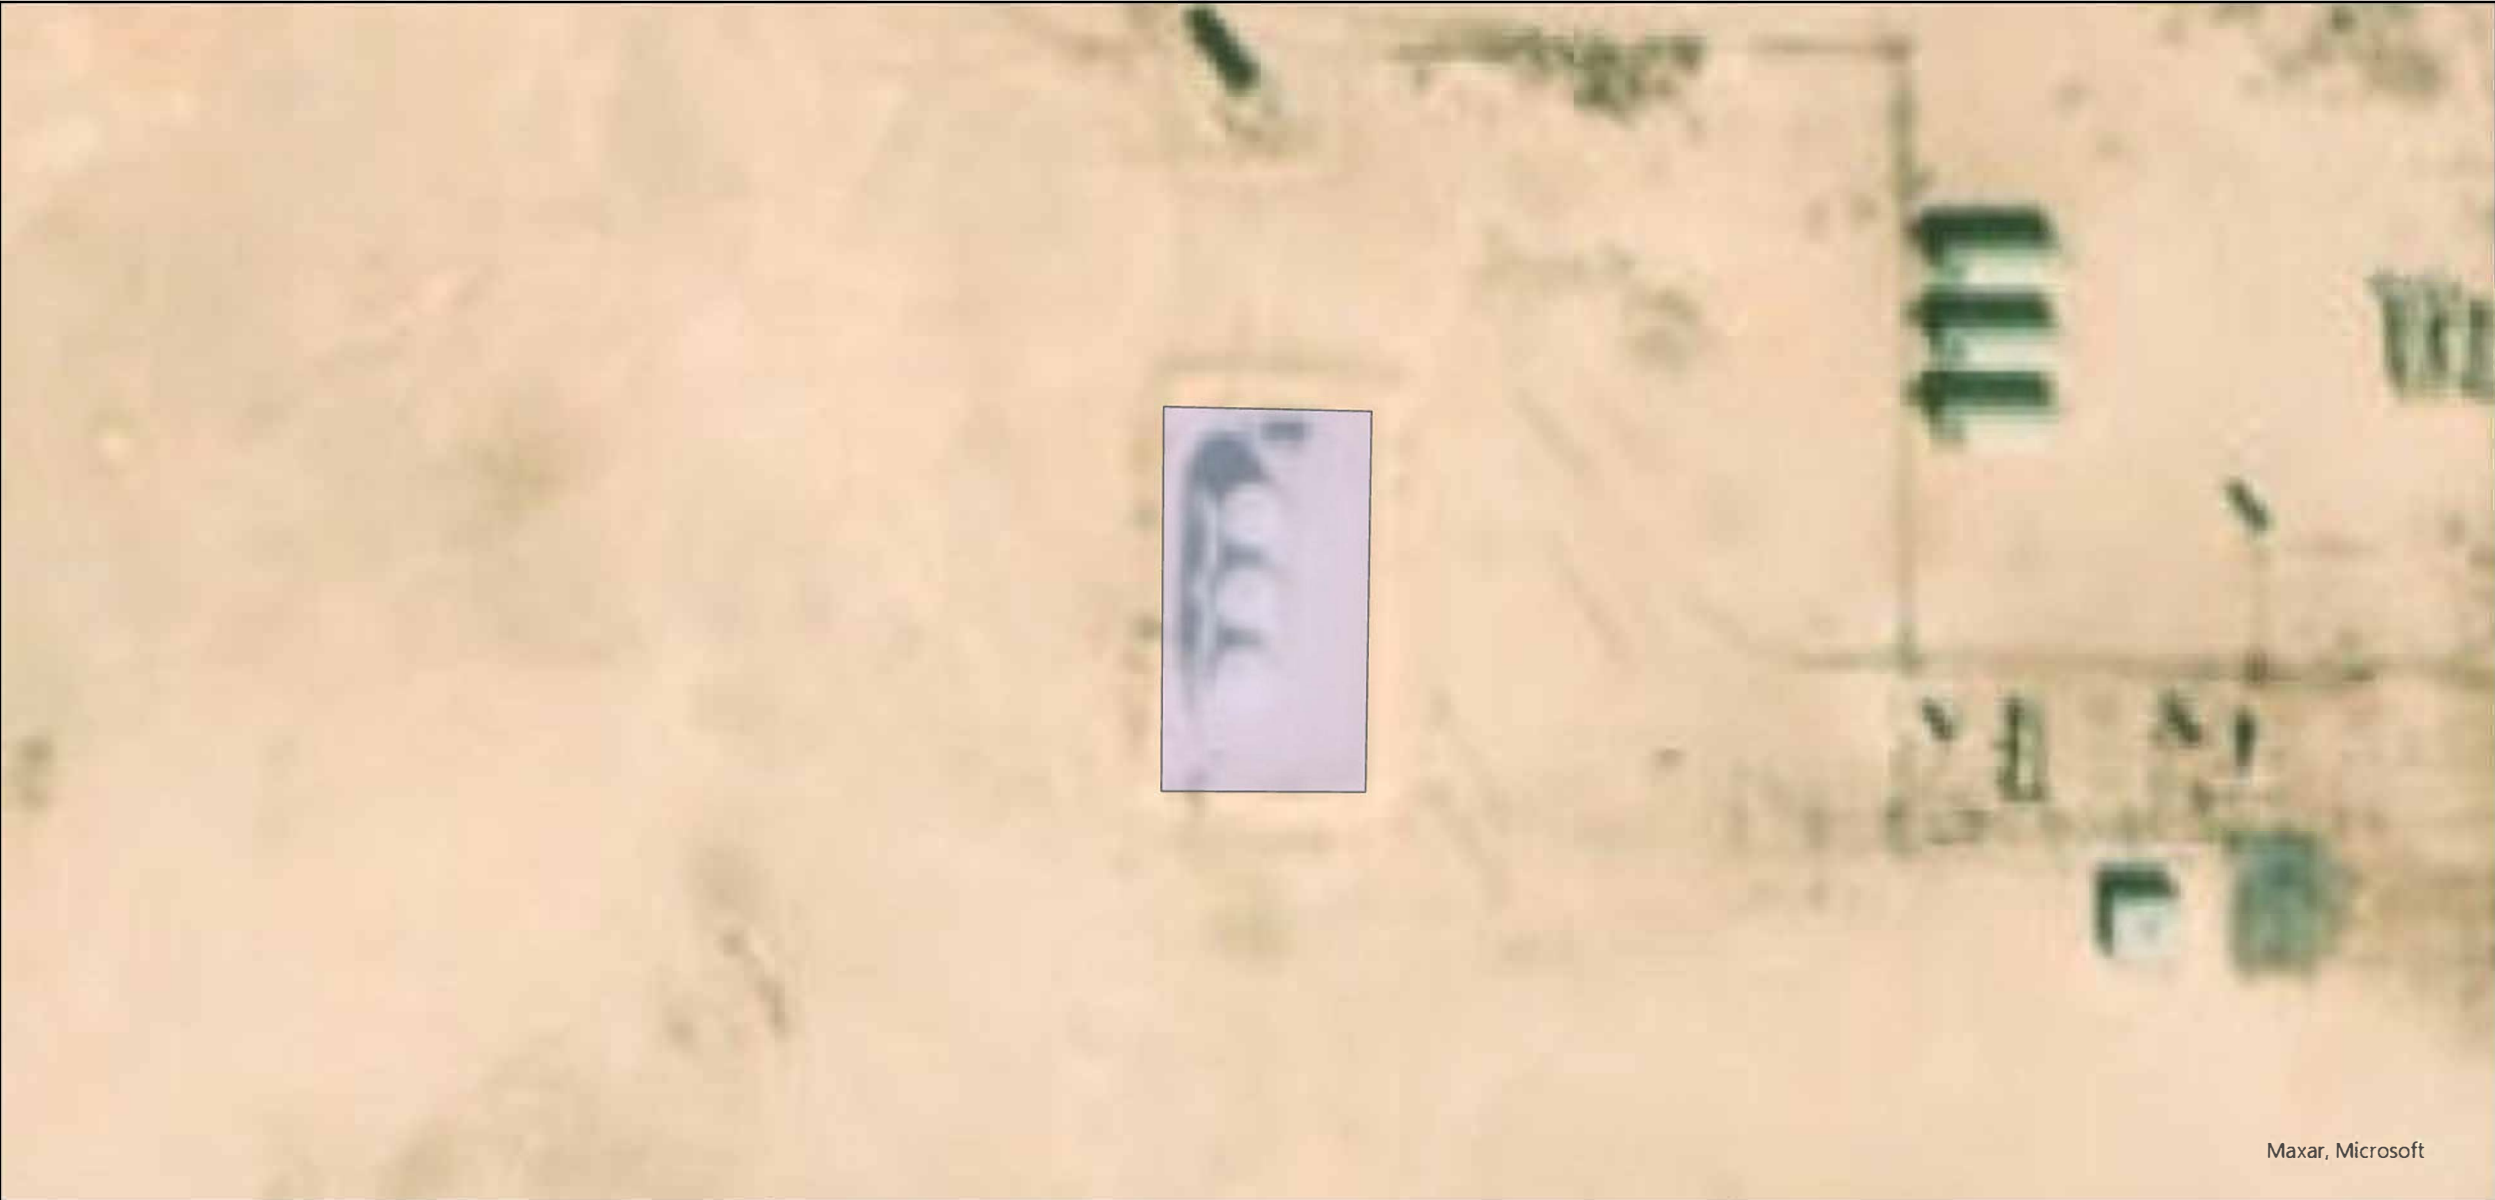
Remediation Map
OXY USA, Inc.
Antelope Ridge Unit #003
32.25791, -103.46393
Lea County, New Mexico
NMOCD Reference # NGRL0822027262

Contained Release

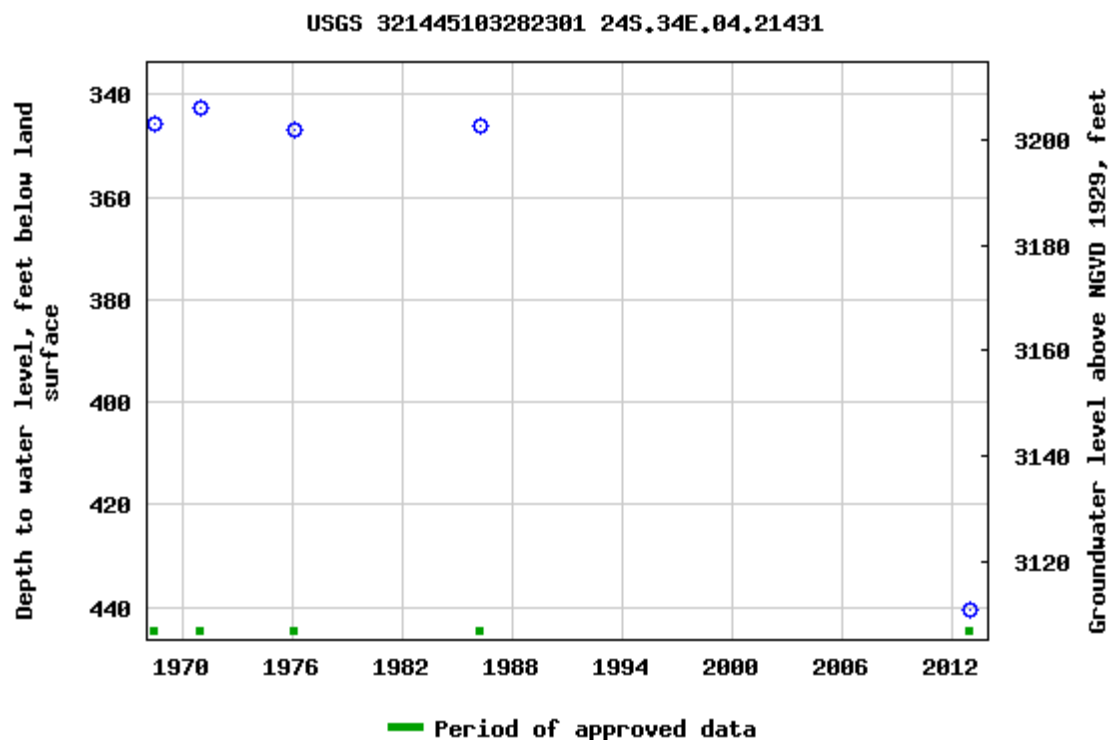
USGS 321445103282301 24S.34E.04.21431

The depth of the well is 630 feet below land surface.

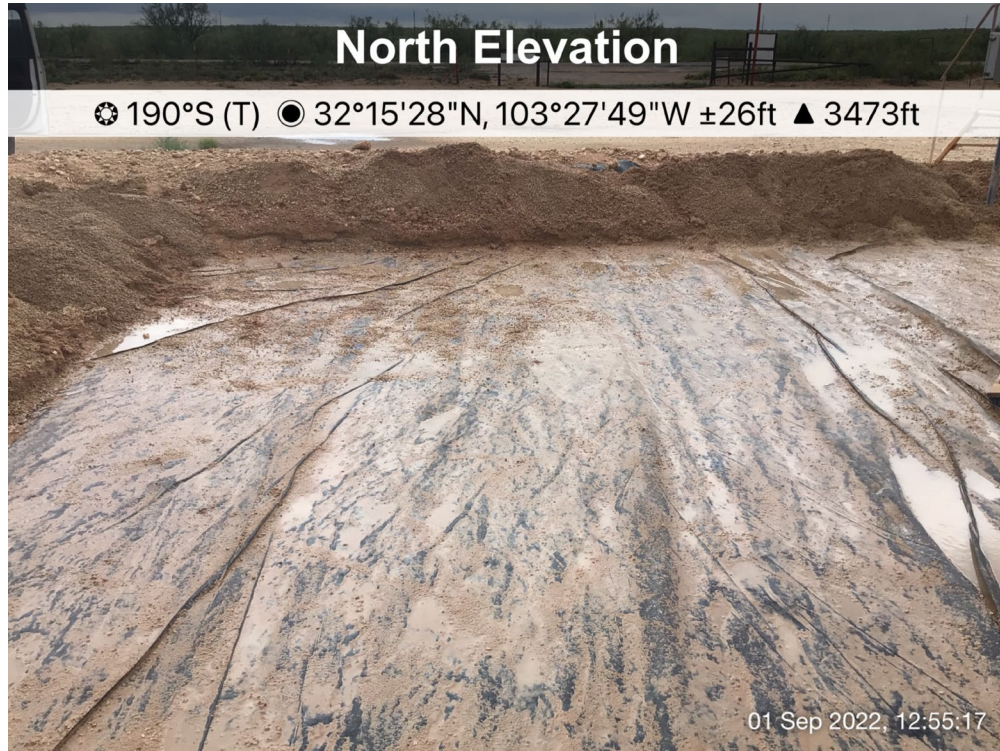
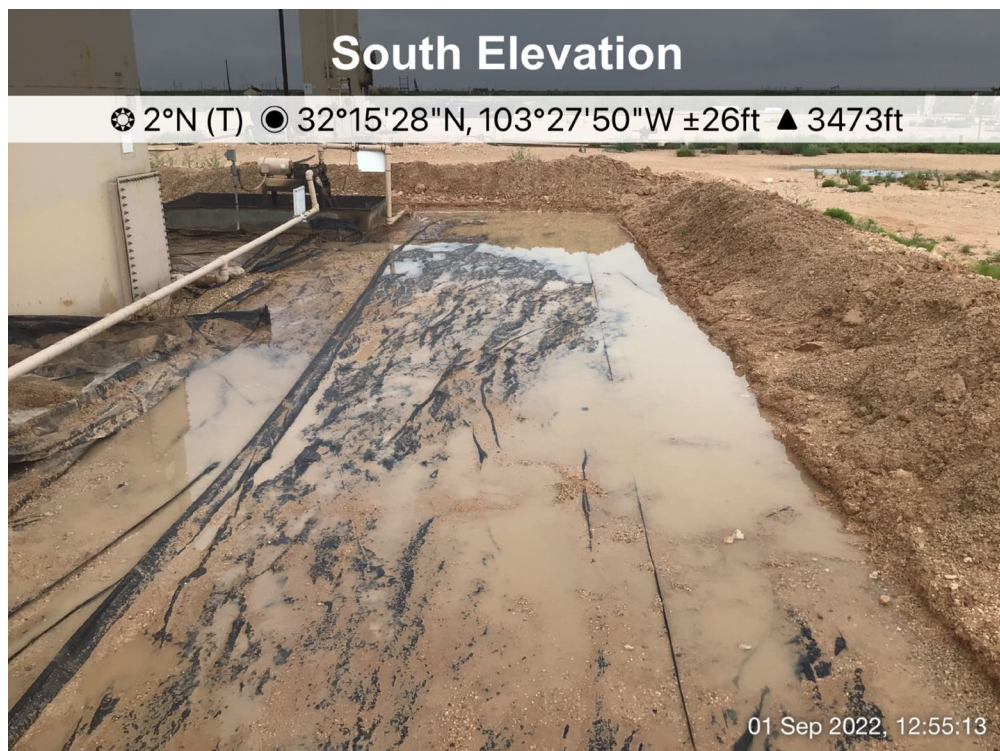
Liner Inspection

Release contained within a lined and contained facility, the liner was cleaned with a pressure washer. Upon inspection the liner is found to be in satisfactory condition.

At the time of inspection, it was noted that the liner material used at the Antelope Ridge Unit #003 containment is typical 20-mil reinforced liner, typical of the material used in oilfield containment structures. The overall condition of the liner was good, and no defects or holes were observed. No significant debris was observed in the containment area.

Repairs Required: No repairs to the liner are required.
