**Re: Closure Request
Rojo 34-27 Facility
Incident Number nAPP2130938365
Lea County, New Mexico**

Ensolum, LLC (Ensolum), on behalf of BTA Oil Producers, LLC (BTA), has prepared this *Closure Request* to document assessment, delineation, and soil sampling activities performed at the Rojo 34-27 Facility (Site). The purpose of the Site assessment, delineation, and soil sampling activities was to assess for the presence or absence of impacts to soil following a release of crude oil onto the well pad at the Site. Based on field observations, field screening activities, and soil sample laboratory analytical results, BTA is submitting this *Closure Request*, describing site assessment and delineation activities that have occurred and requesting closure for Incident Number nAPP2130938365.

BTA Oil Producers, LLC
Closure Request
Rojo 34-27 Facility

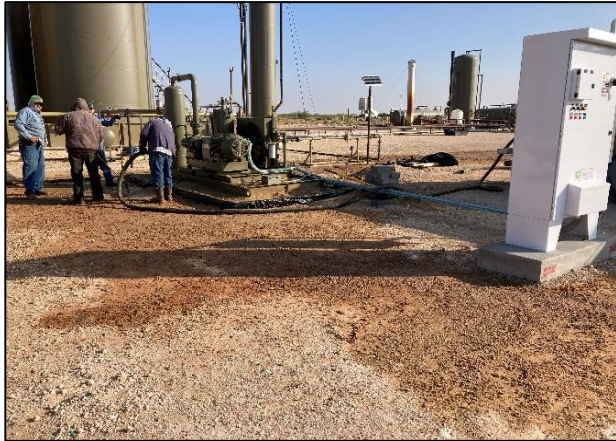
On November 4, 2021, a broken fitting on a scrubber resulted in the release of approximately 5 barrels (bbls) of crude oil onto the surface of the well pad. A vacuum truck was dispatched to the Site to recover free-standing fluids; approximately 3 bbls of crude oil were recovered. BTA reported the release to the New Mexico Oil Conservation Division (NMOCD) on November 5, 2021 and submitted a Release Notification Form C-141 (Form C-141). The release was assigned Incident Number nAPP2130938365.

Photograph: 1 Date: 11/4/2021
Description: Soil staining in release footprint
View: Southeast

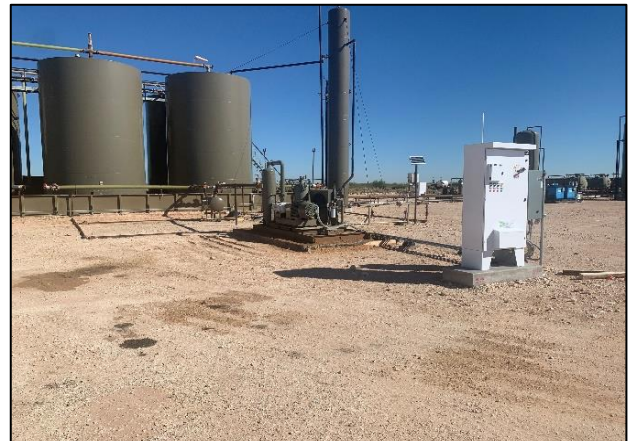
Photograph: 2 Date: 10/20/2022
Description: Initial Assessment activities
View: Southeast

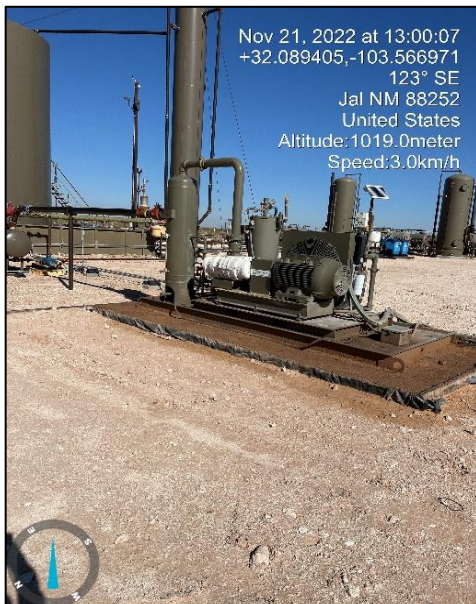
Photograph: 3 Date: 11/21/2022
Description: Delineation activities
View: Southeast

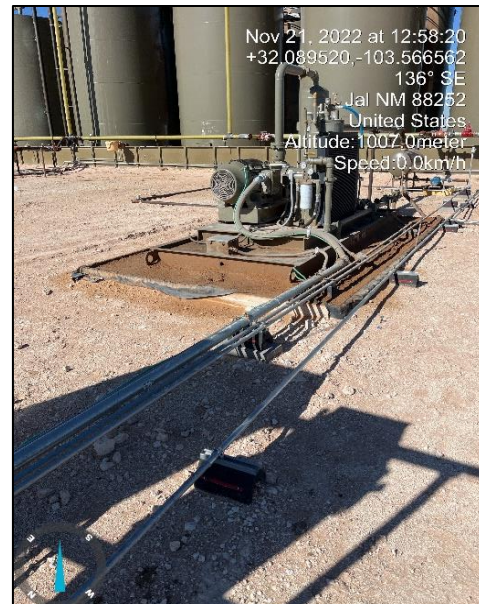
Photograph: 4 Date: 11/21/2022
Description: Delineation activities
View: Southeast
