Remediation Summary and Closure Request

**Frontier Field Services, LLC
12" Caprock Low Pressure Line
Lea County, New Mexico
Unit Letter "O", Section 14, Township 17 South, Range 32 East
Latitude 32.828804 North, Longitude 103.736813 West
NMOCD Incident # nAPP2222037147**

February 2023

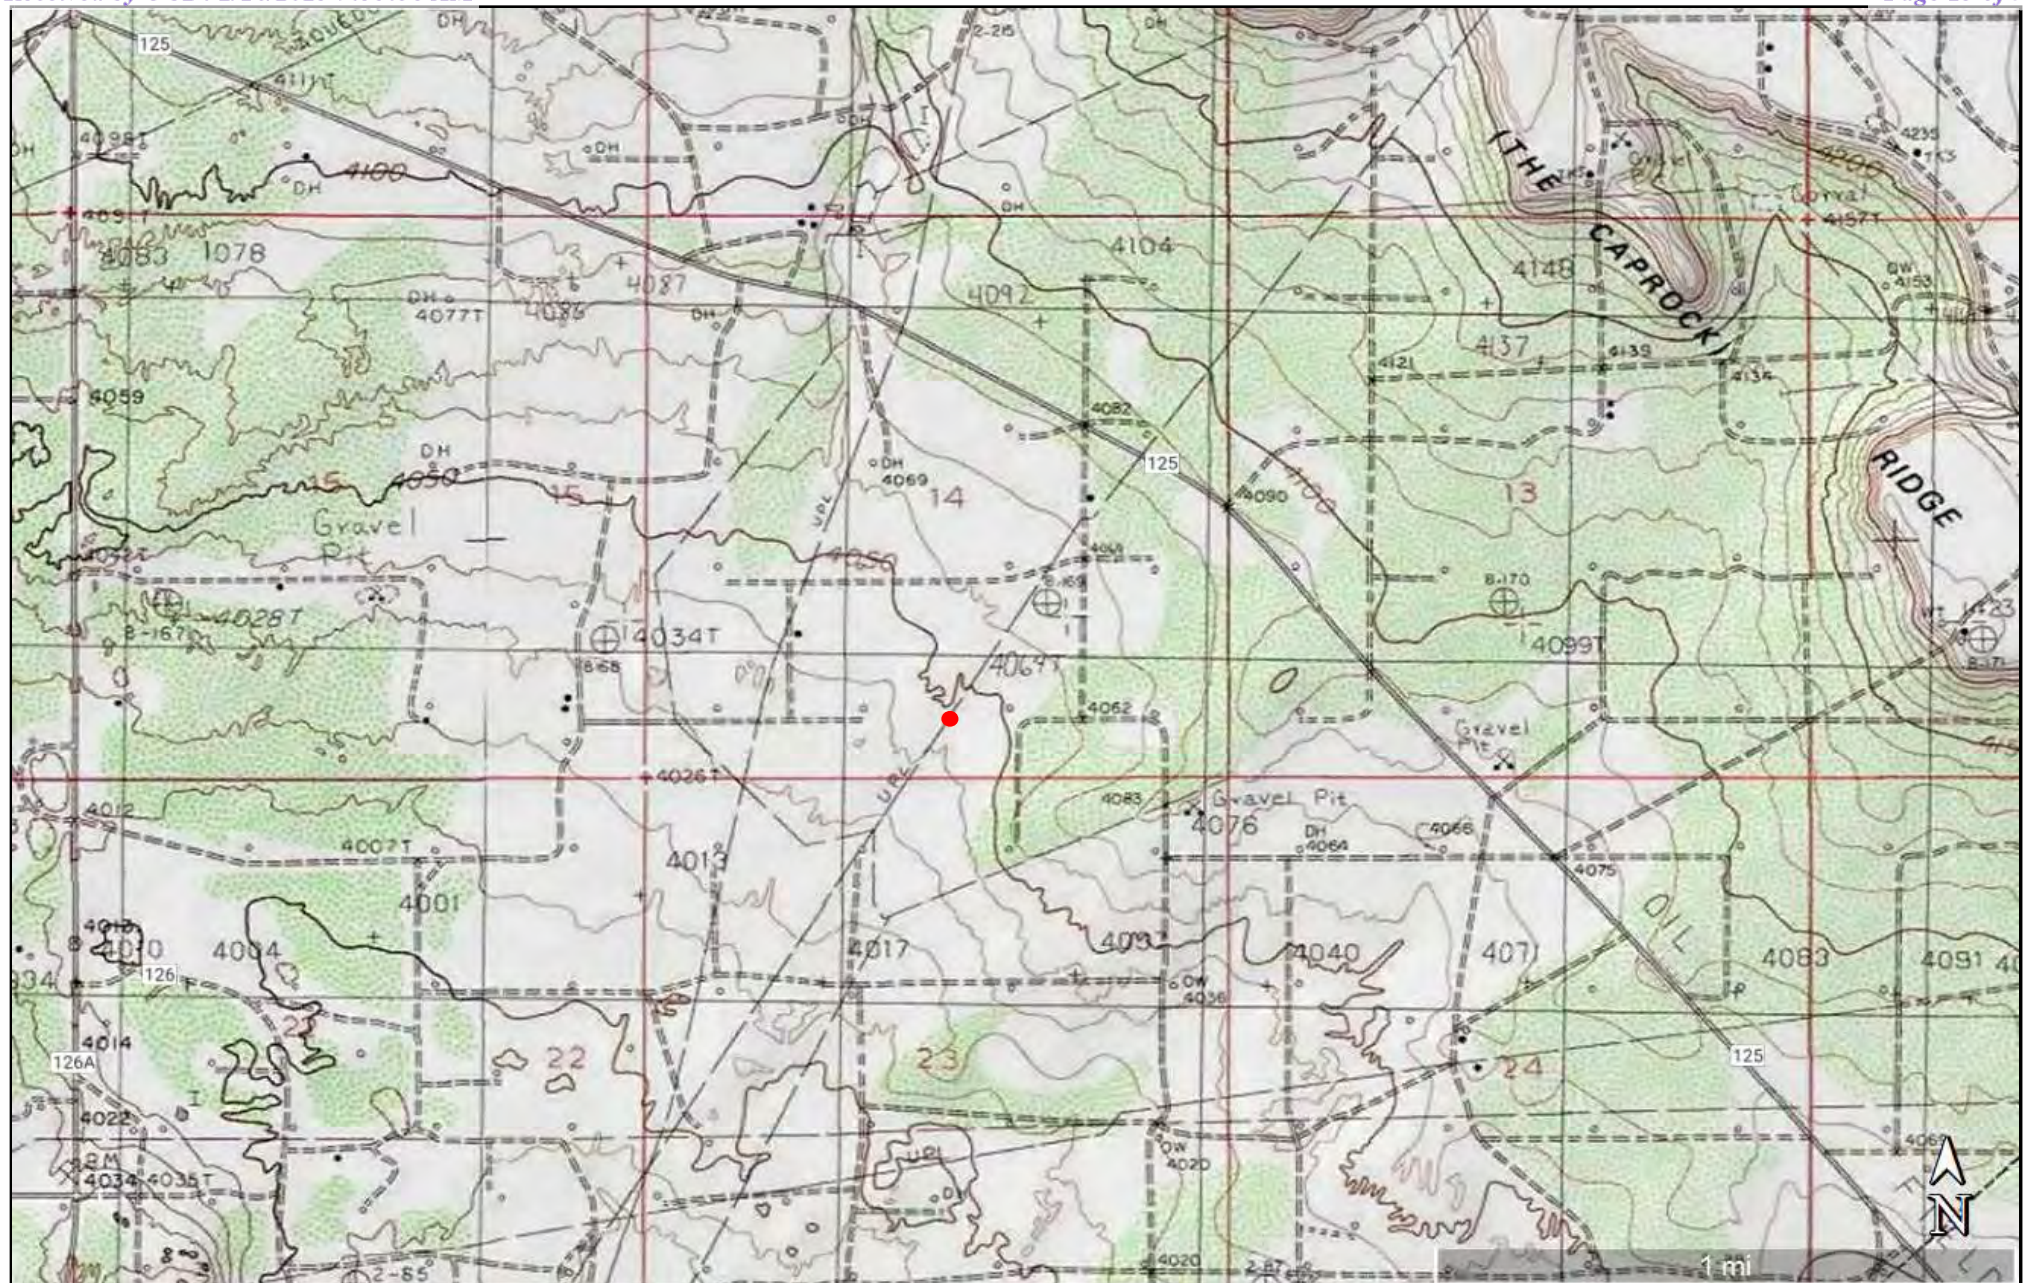
**Figure 1**

Topographic Map
 Frontier Field Services, LLC
 12" Caprock Low Pressure Line
 GPS: 32.82881, -103.73685
 Lea County

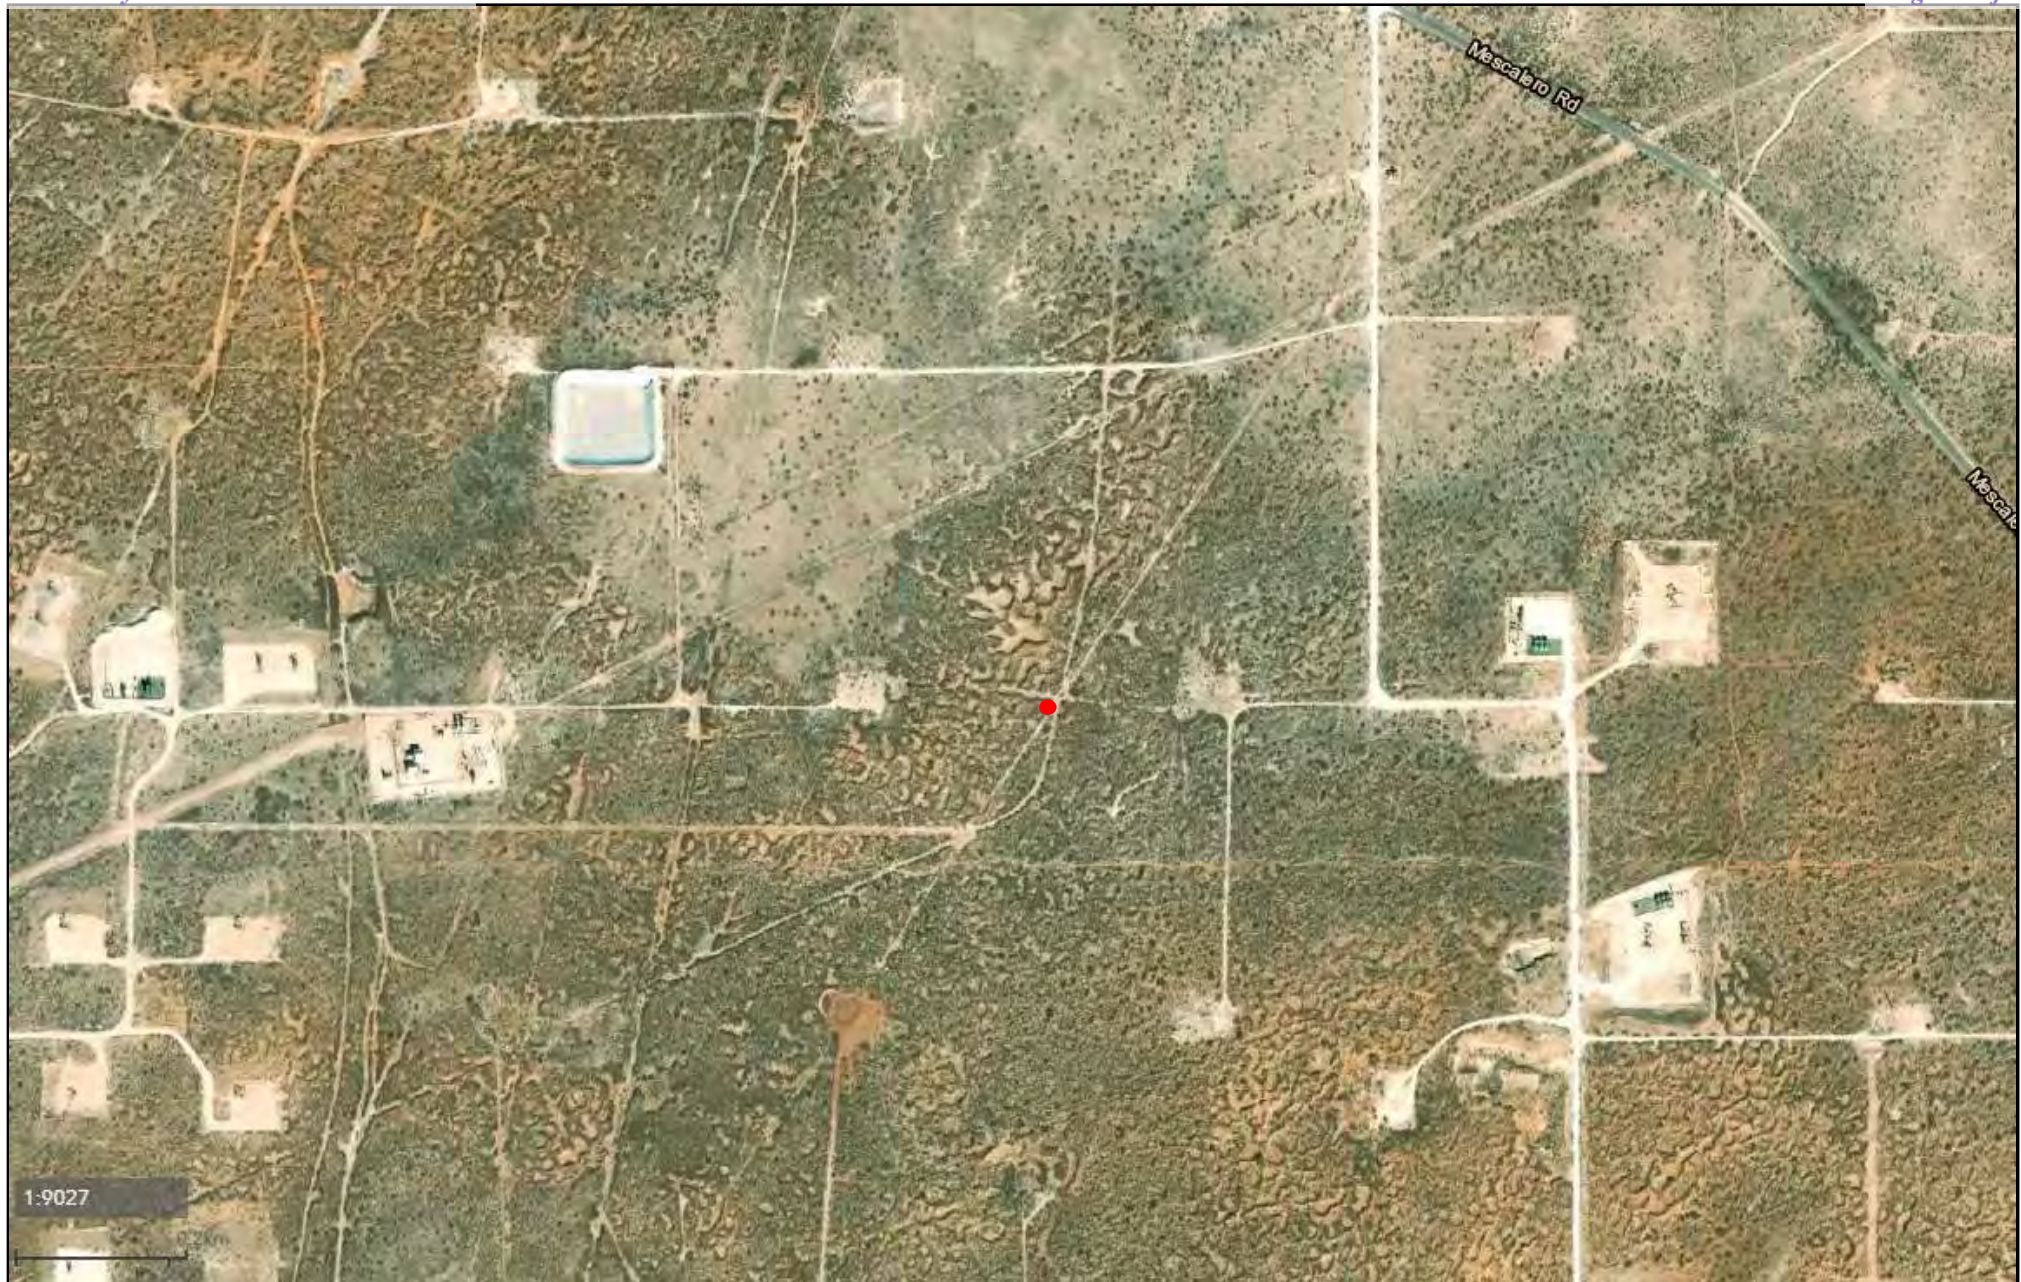
**Figure 2**

OSE POD Locations Map
Frontier Field Services, LLC
12" Caprock Low Pressure Line
GPS: 32.82881, -103.73685
Lea County

A search of the New Mexico Office of the State Engineer (NMOSE) and United States Geological Survey (USGS) groundwater databases was completed in an effort to determine the horizontal distance to known water sources within a half mile radius of the Release Site. Approximate depth to groundwater was determined using maintained and published water well data. Karst mapping indicates the site is not located in a Karst designated area. Karst and Wetland Maps are provided as Attachment I. Depth to groundwater information is provided as Attachment IV and the results are depicted on Figures 2 & 3.

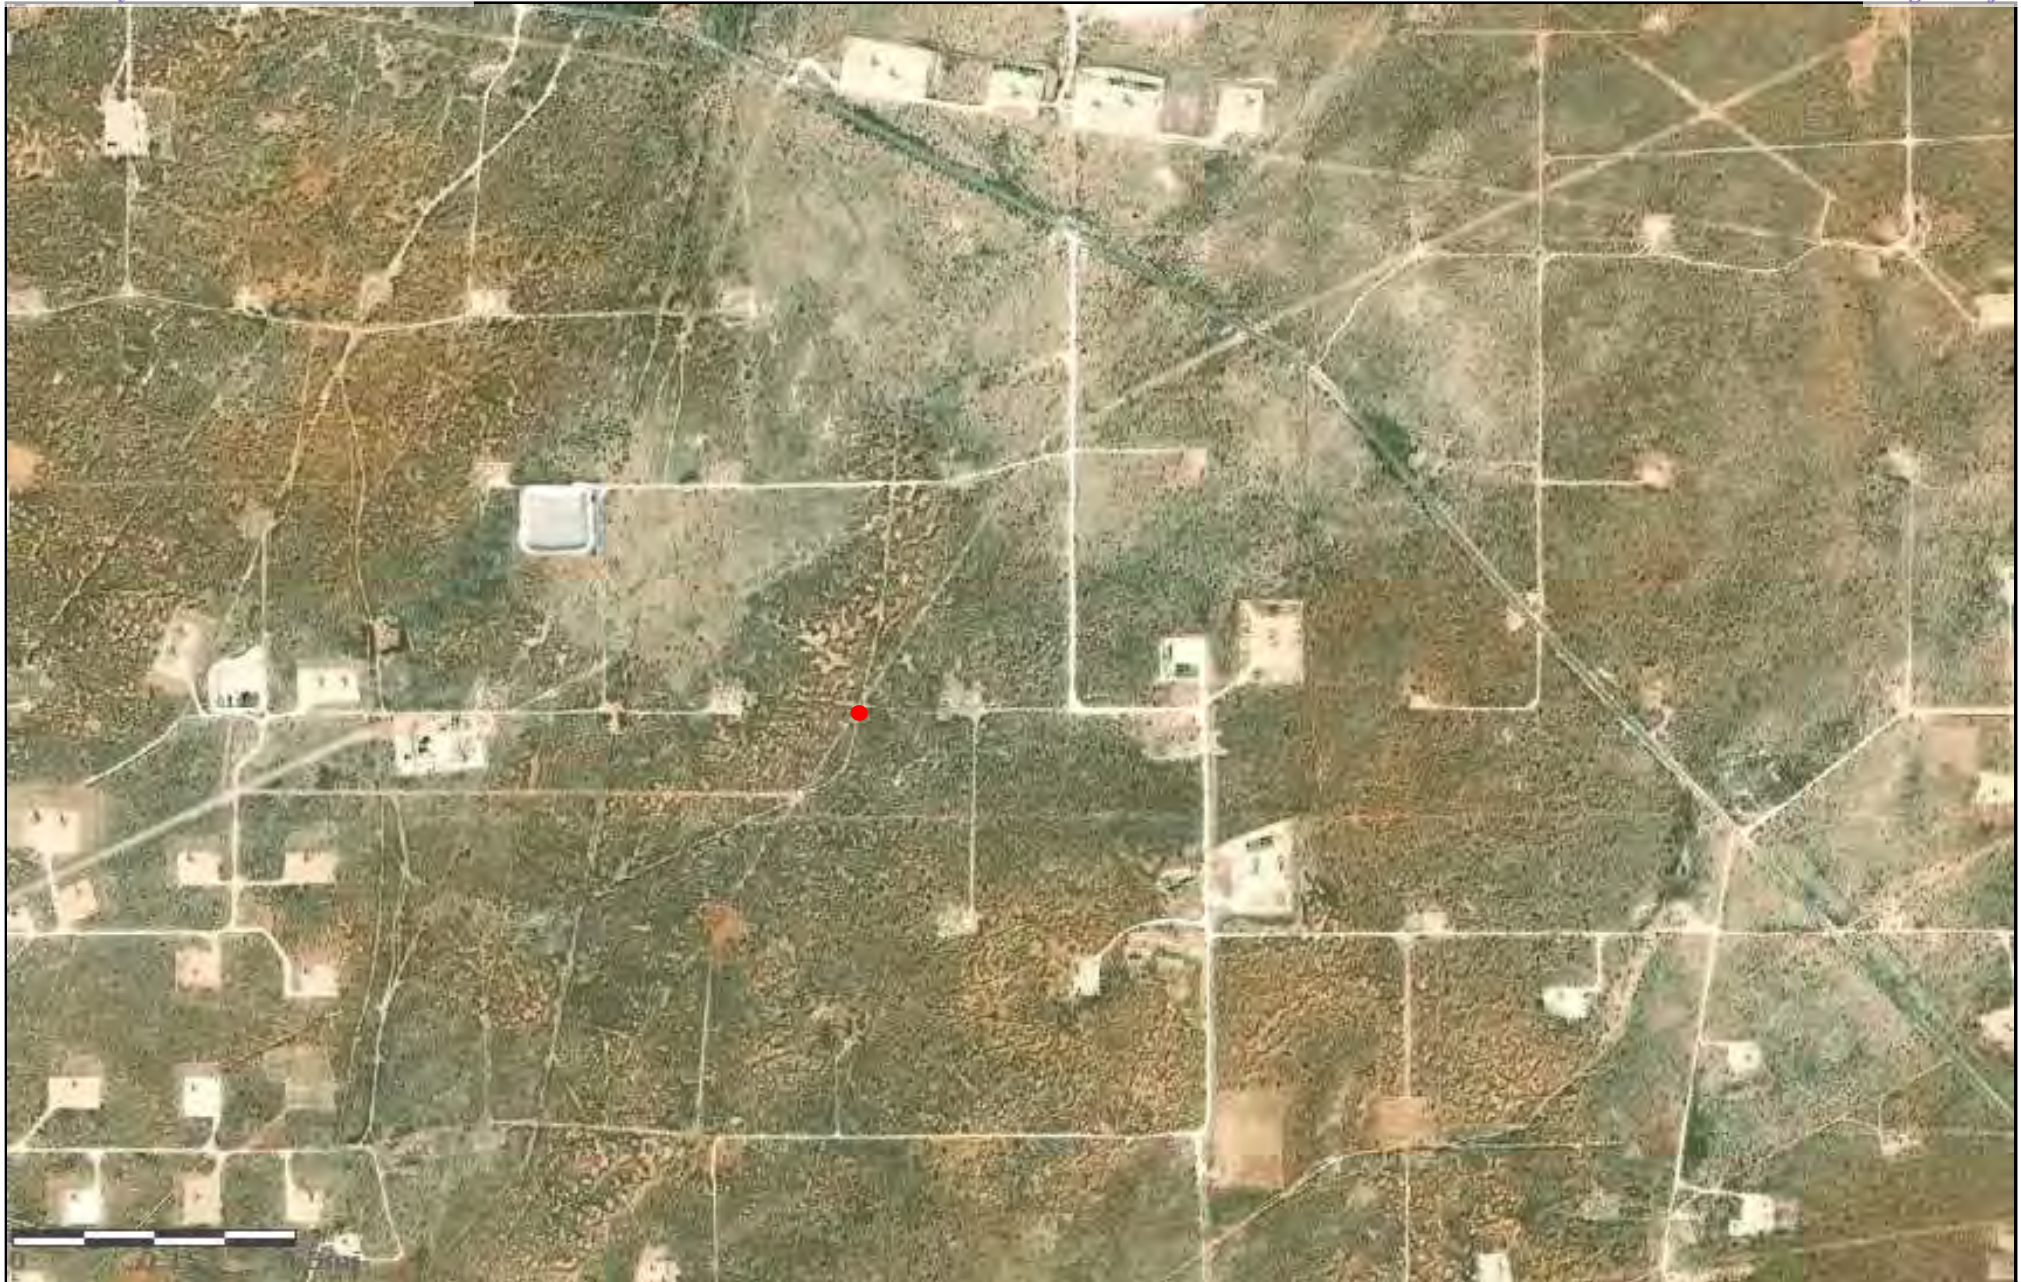
**Figure 3**

USGS Well Locations Map
Frontier Field Services, LLC
12" Caprock Low Pressure Line
GPS: 32.82881, -103.73685
Lea County

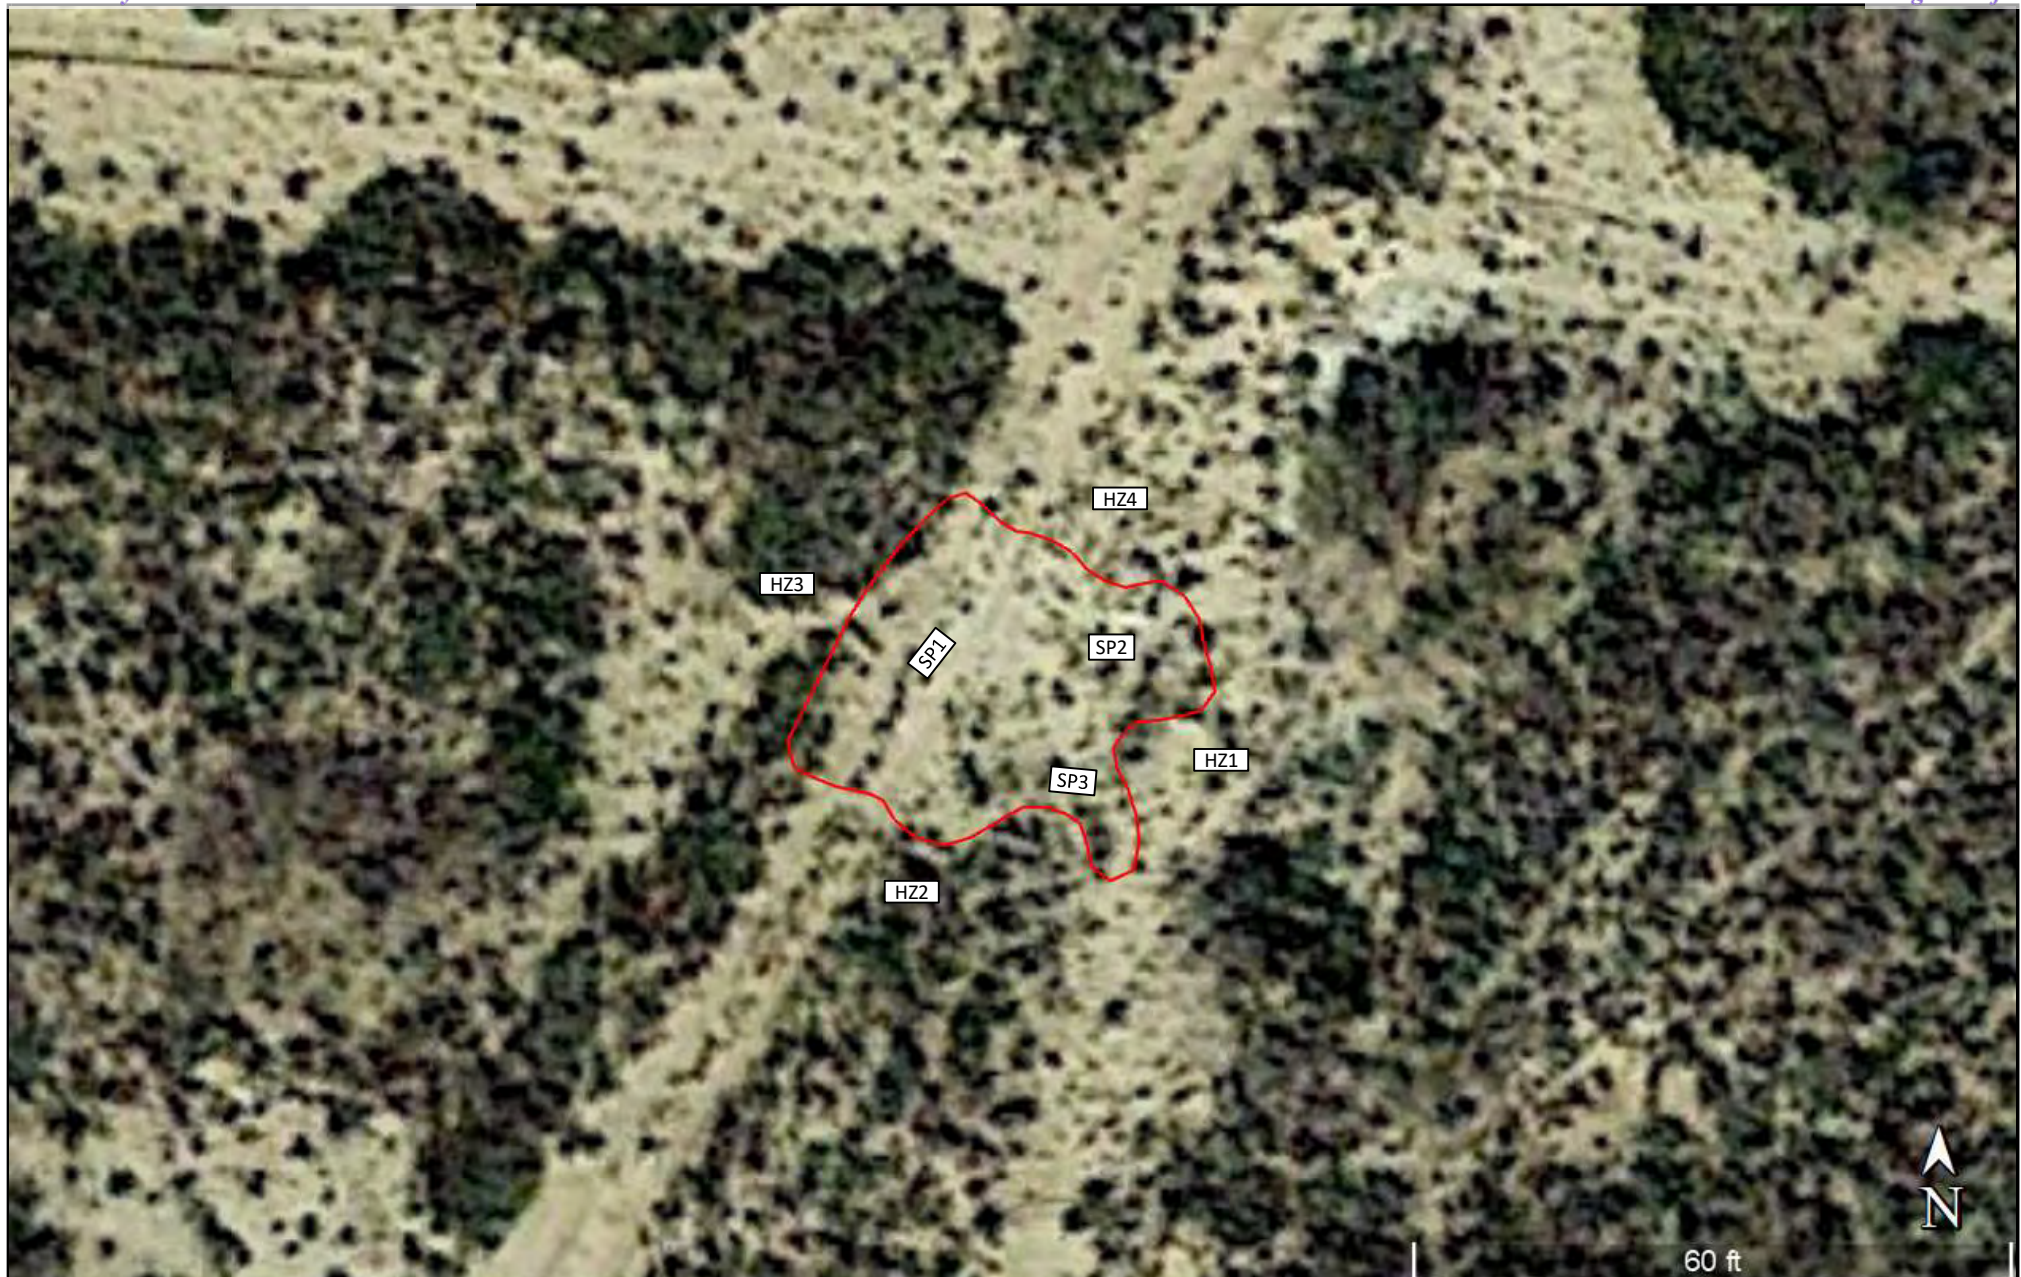
**Figure 4**

Delineation Sample Map
Frontier Field Services, LLC
12" Caprock Low Pressure Line
GPS: 32.82881, -103.73685
Lea County

Based on field observations and field test data noted above and provided in Attachment V, fourteen representative soil samples were selected for laboratory analysis. Delineation soil samples SP1 through SP3, HZ1 through HZ4, were submitted to the laboratory for analysis of BTEX, TPH, and chloride. Laboratory analytical results indicated contaminant concentrations were below the NMOCD Closure Criteria in each of the submitted samples, with the exception of SP1 at Surface, SP2 at Surface, and SP3 at Surface, which exhibited TPH concentrations in excess of the NMOCD Closure Criteria.

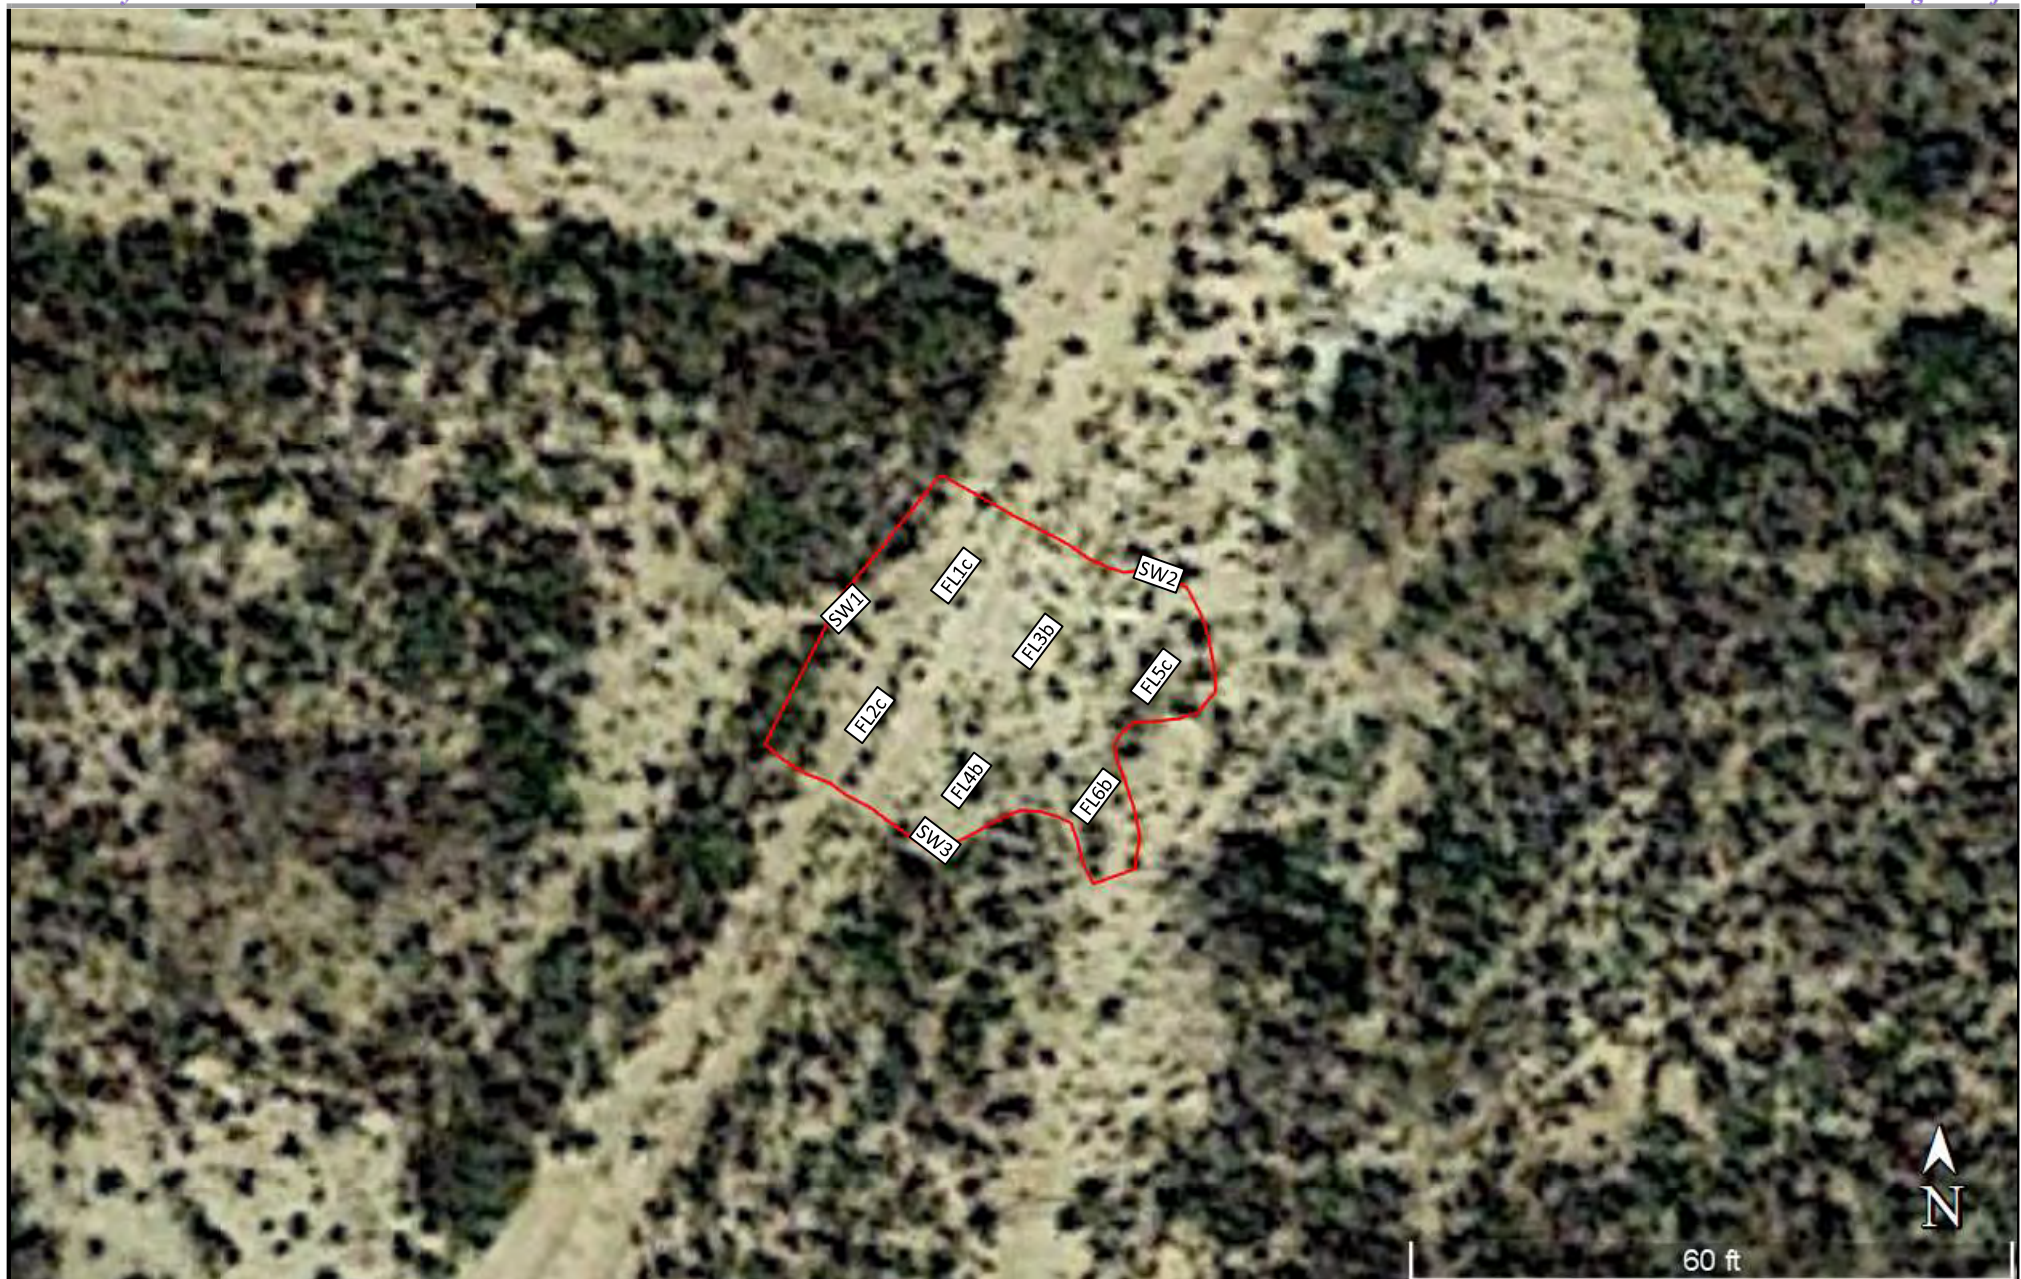
**Figure 5**

Excavation Sample Map
Frontier Field Services, LLC
12" Caprock Low Pressure Line
GPS: 32.82881, -103.73685
Lea County

On January 10, 2023, Frontier Field Services personnel, at the request of the landowner, replaced the section of pipeline that had leaked. From January 31 to February 1, 2023, the excavated area was then backfilled with locally sourced, clean, non-impacted topsoil. Approximately 396 cubic yards of clean soil was utilized to complete backfill activities.
