**Re: Closure Request
Rojo B Poly Line Rupture
Incident Number nAPP2216138632
Lea County, New Mexico**

Ensolum, LLC (Ensolum), on behalf of BTA Oil Producers, LLC (BTA), has prepared this *Closure Request* to document assessment, excavation, and soil sampling activities performed at the Rojo B Poly Line Rupture (Site). The purpose of the Site assessment, excavation, and soil sampling activities was to address impacts to soil resulting from a produced water release at the Site. Based on the excavation activities and laboratory analytical results from the soil sampling events, BTA is submitting this *Closure Request*, describing remediation that has occurred and requesting closure for Incident Number nAPP2216138632.

BTA Oil Producers
Closure Request
Rojo B Poly Line Rupture

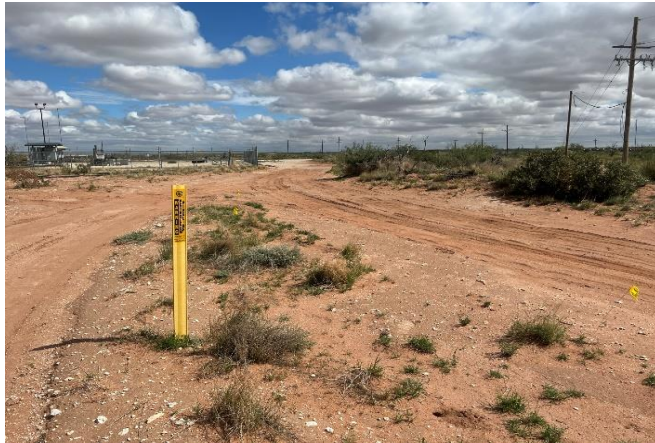
Photograph: 1 Date: 8/22/2022
Description: Soil staining in release footprint
View: Northwest

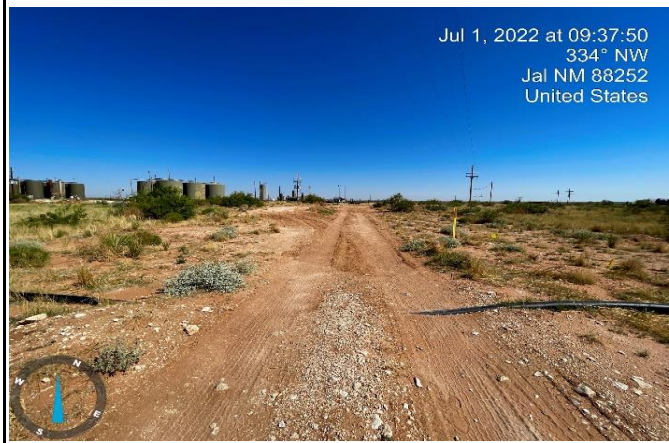
Photograph: 2 Date: 7/1/2022
Description: Delineation activities
View: Northwest

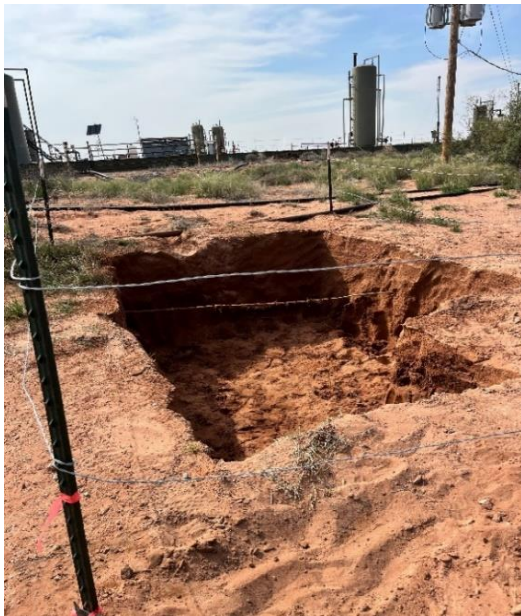
Photograph: 3 Date: 9/7/2022
Description: Excavation activities
View: Northwest

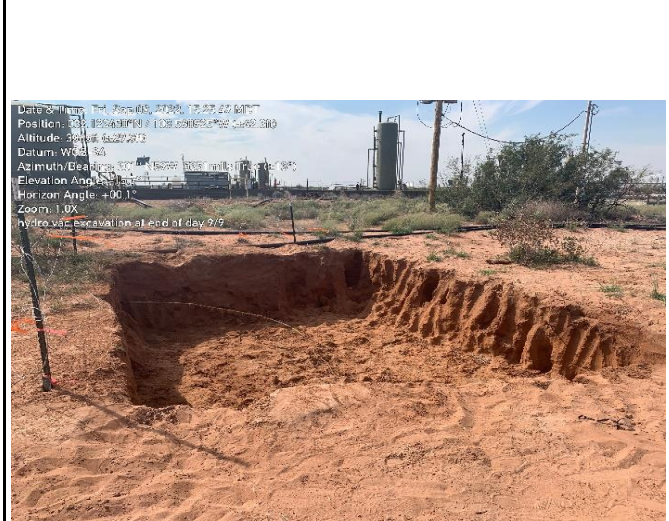
Photograph: 4 Date: 9/9/2022
Description: Excavation activities
View: Northwest
