**Re: Remediation Work Plan
Rojo 18 ELL and Rojo 18/19 & 38/39 Tank Battery
Incident Numbers nAPP2222753156 and nAPP2123047003
Lea County, New Mexico**

Ensolum, LLC (Ensolum), on behalf of BTA Oil Producers, LLC (BTA), has prepared this *Remediation Work Plan (Work Plan)* to document assessment and soil sampling activities performed at the Rojo 18 ELL and Rojo 18/19 & 38/39 Tank Battery (collectively referred to as the Site) and to detail remedial actions proposed for the Site. The purpose of the Site assessment and soil sampling activities was to address impacts to soil following two overlapping release events at the Site. Based on laboratory analytical results from the soil sampling events, BTA is submitting this *Work Plan*, describing remediation that has occurred and requesting to complete a soil boring to confirm depth to groundwater data as well as complete necessary excavation and proper disposal of impacted soil.

BTA Oil Producers, LLC
Remediation Work Plan
Rojo 18 ELL and Rojo 18/19 & 38/39 Tank Battery

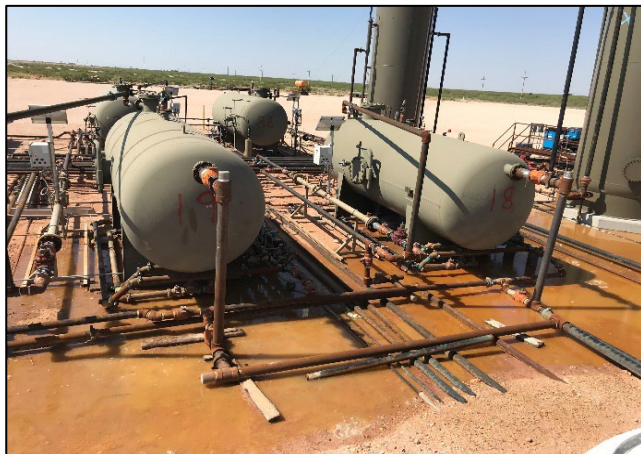
On August 14, 2022, a fitting failed on the separator resulting in the release of approximately 43 barrels (bbls) of produced water onto the well pad. A vacuum truck was immediately dispatched to the Site to recover free-standing fluids; approximately 35 bbls of produced water were recovered. BTA reported the release immediately to the New Mexico Oil Conservation Division (NMOCD) on August 14, 2022 and submitted a Release Notification Form C-141 (Form C-141) on August 15, 2022. The release was assigned Incident Number nAPP2222753156.

Photograph: 1 Date: 8/14/2022
Description: Soil staining in release footprint
View: Northwest

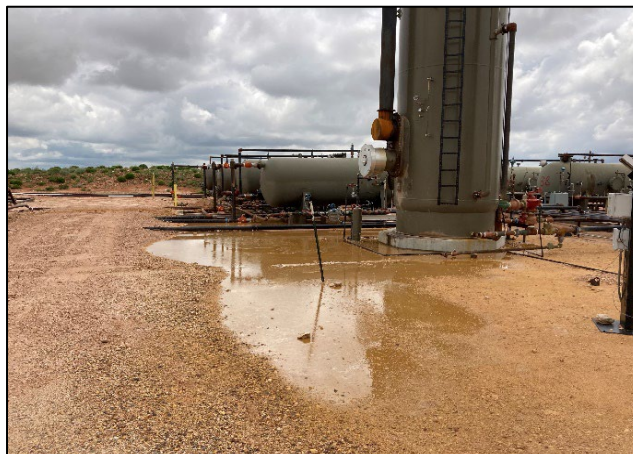
On August 17, 2022, a piping tee, located under the separator, washed out, resulting in the release of approximately 17 bbls of produced water and 8 bbls of crude oil onto the well pad. A vacuum truck was immediately dispatched to the Site to recover free-standing fluids; approximately 14 bbls of produced water and 6 bbls of crude oil were recovered. BTA reported the release immediately to the NMOCD on August 17, 2022 and submitted a Form C-141 on August 18, 2022. The release was assigned Incident Number nAPP2123047003.

Photograph: 2 Date: 8/17/2022
Description: Soil staining in release footprint
View: East

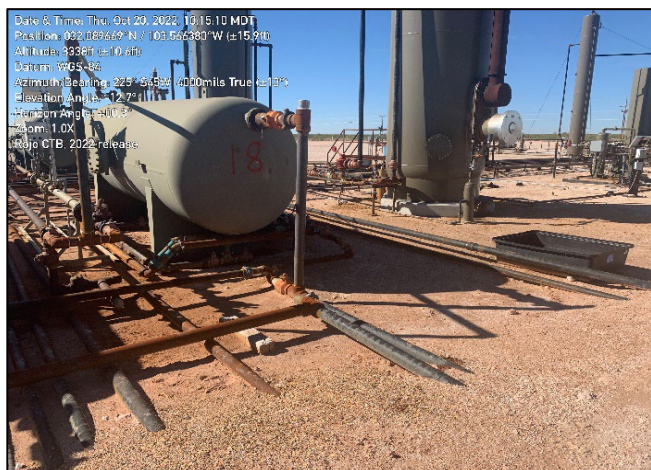
Photograph: 3 Date: 10/20/2022
Description: Initial Assessment Activities
View: Northwest

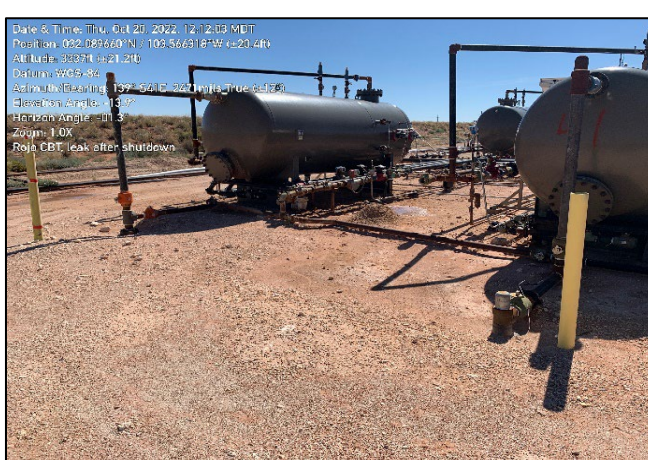
Photograph: 4 Date: 10/20/2022
Description: Initial Assessment Activities
View: Southeast

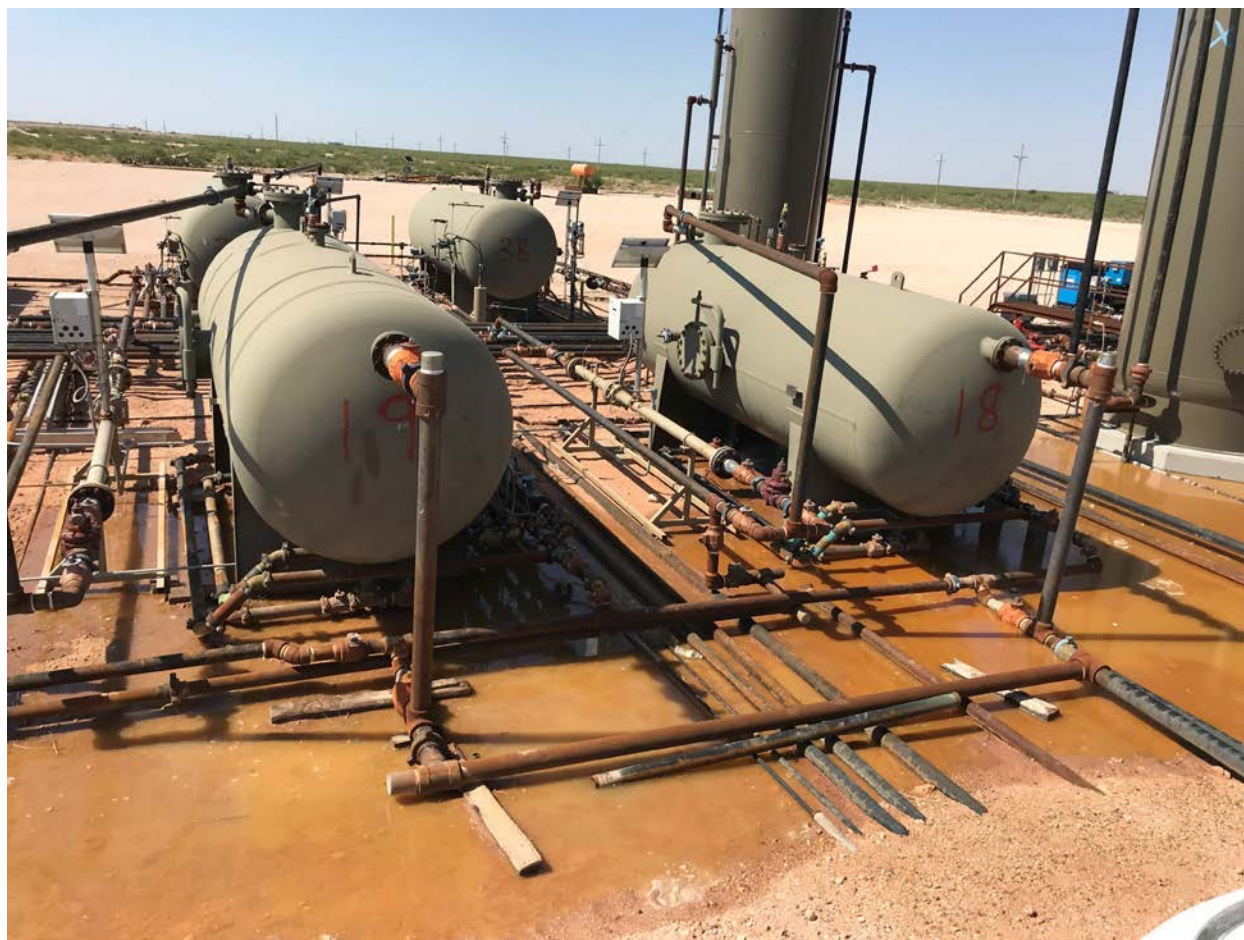
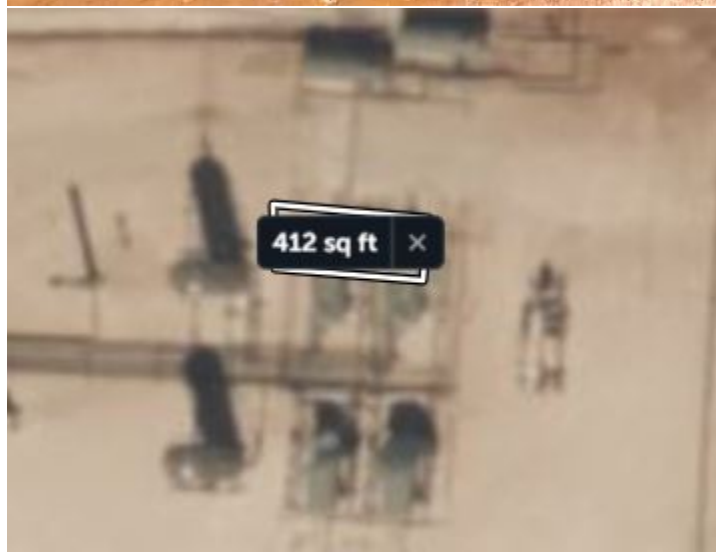
Rojo 18 ELL
8/14/2022

Incident #nAPP2222753156

Fitting Failure. An ell on the bottom of the separator washed out. Produced water released under the vessel into unlined containment area. Recovered 35 BW with vacuum truck. Spill volume calculation is included.
