# Hudson 1 Federal Well #007

## CLOSURE REQUEST

API No. 30-015-31513

RE: **XTO – Hudson 1 Federal Well #007**  
**Closure Request**  
UL/F, Section 1, T23S, R30E  
API No. 30-015-31513  
NMOCD Case #: 2R-3955  
NMOCD Score: 0

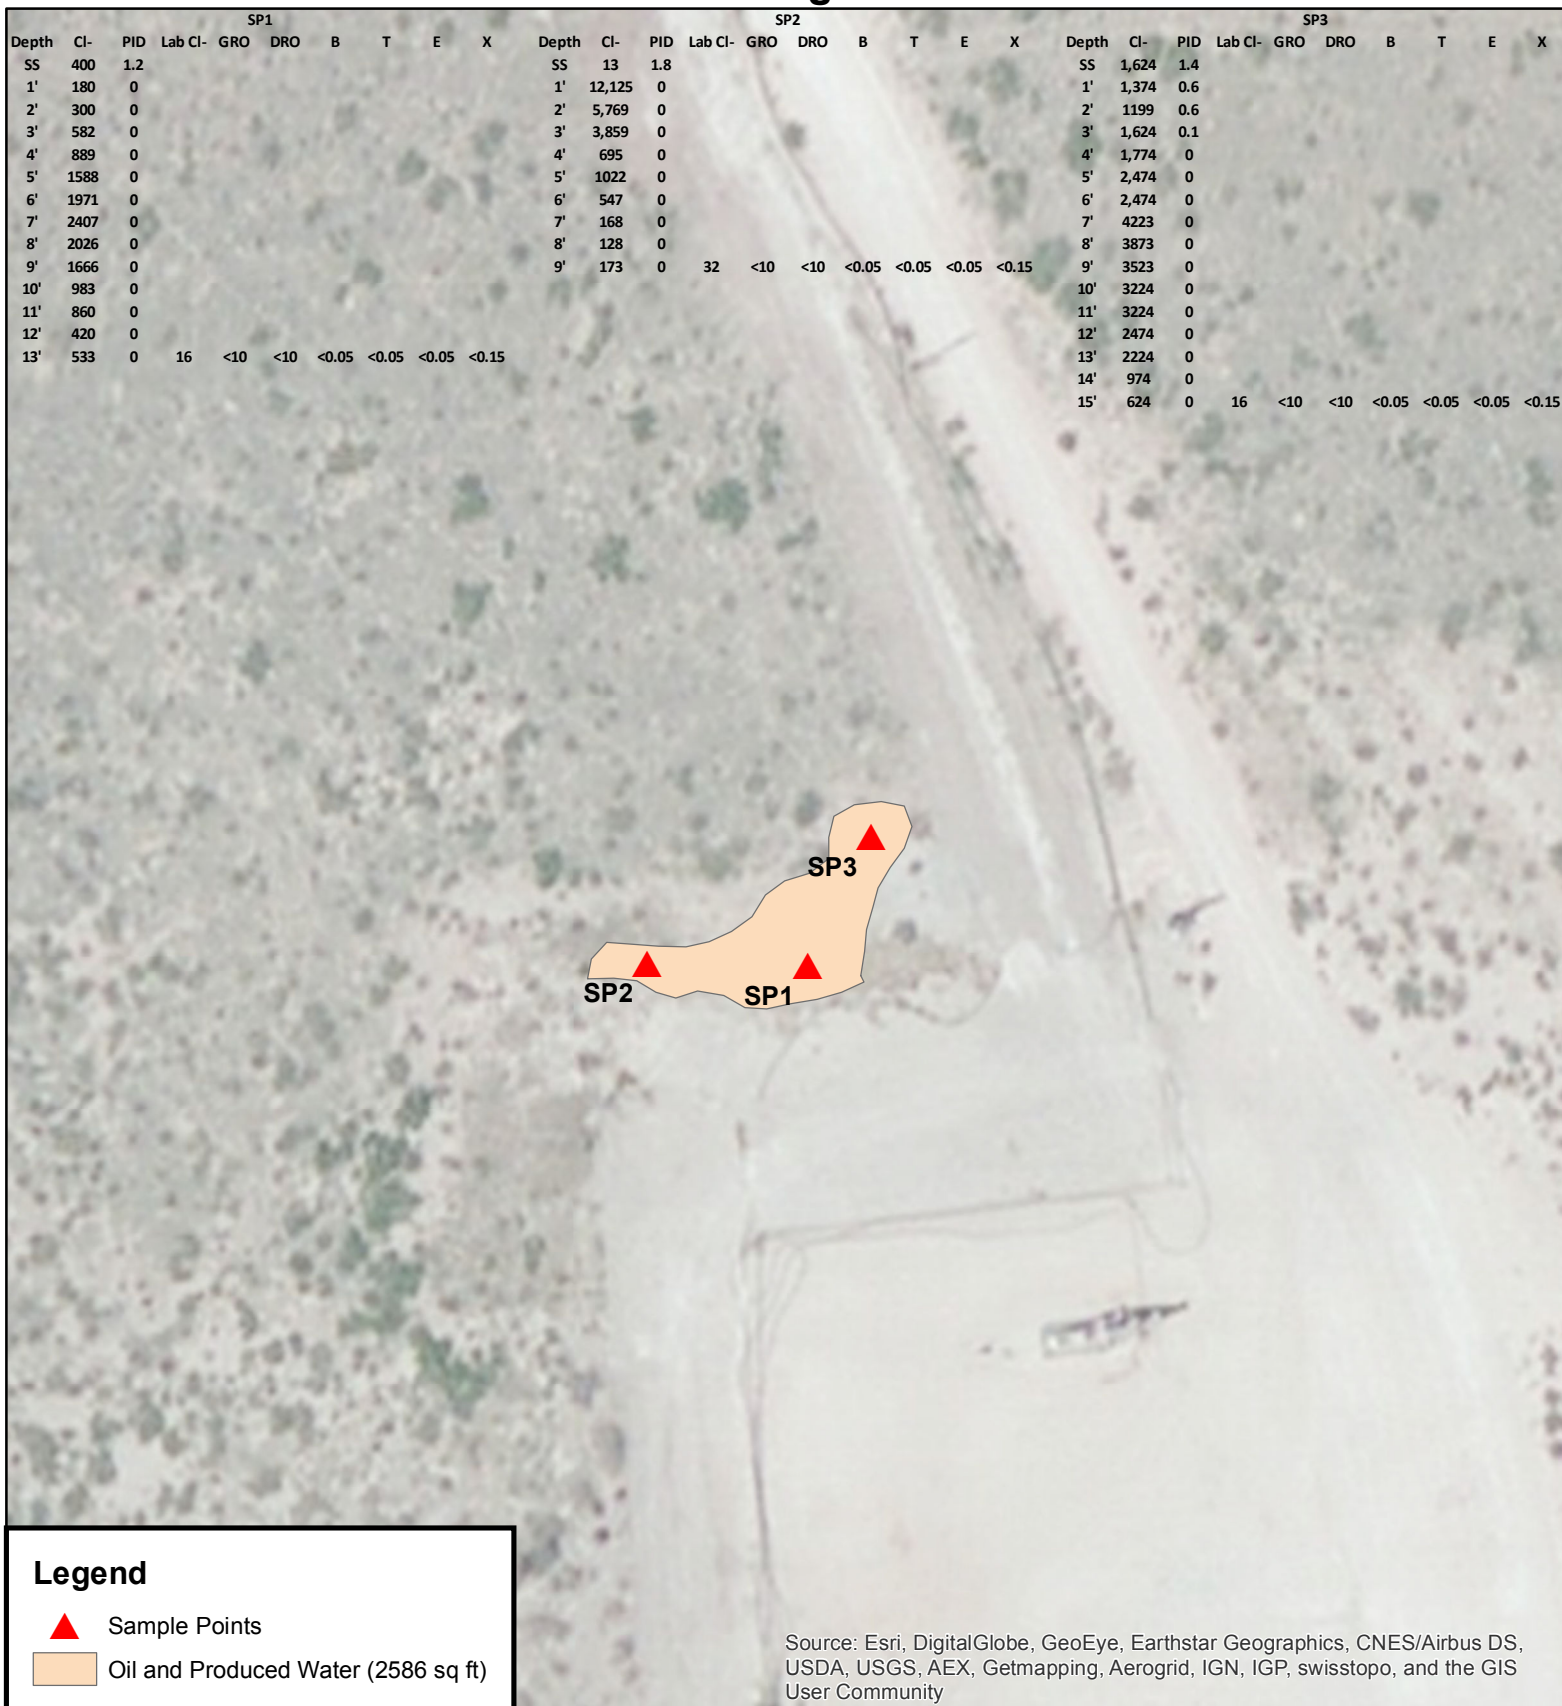
Figure 1

June 16, 2017 DFSI personnel were on site to obtain samples at regular intervals within the release area (Figure 1). Three samples were obtained and field tested for chloride levels, as well as BTEX. The samples were screened using a Mini Rae Photoionization Detector (PID). Clean field samples were submitted for laboratory analysis at Cardinal Laboratories of Hobbs, NM to obtain confirmation (Appendix III).

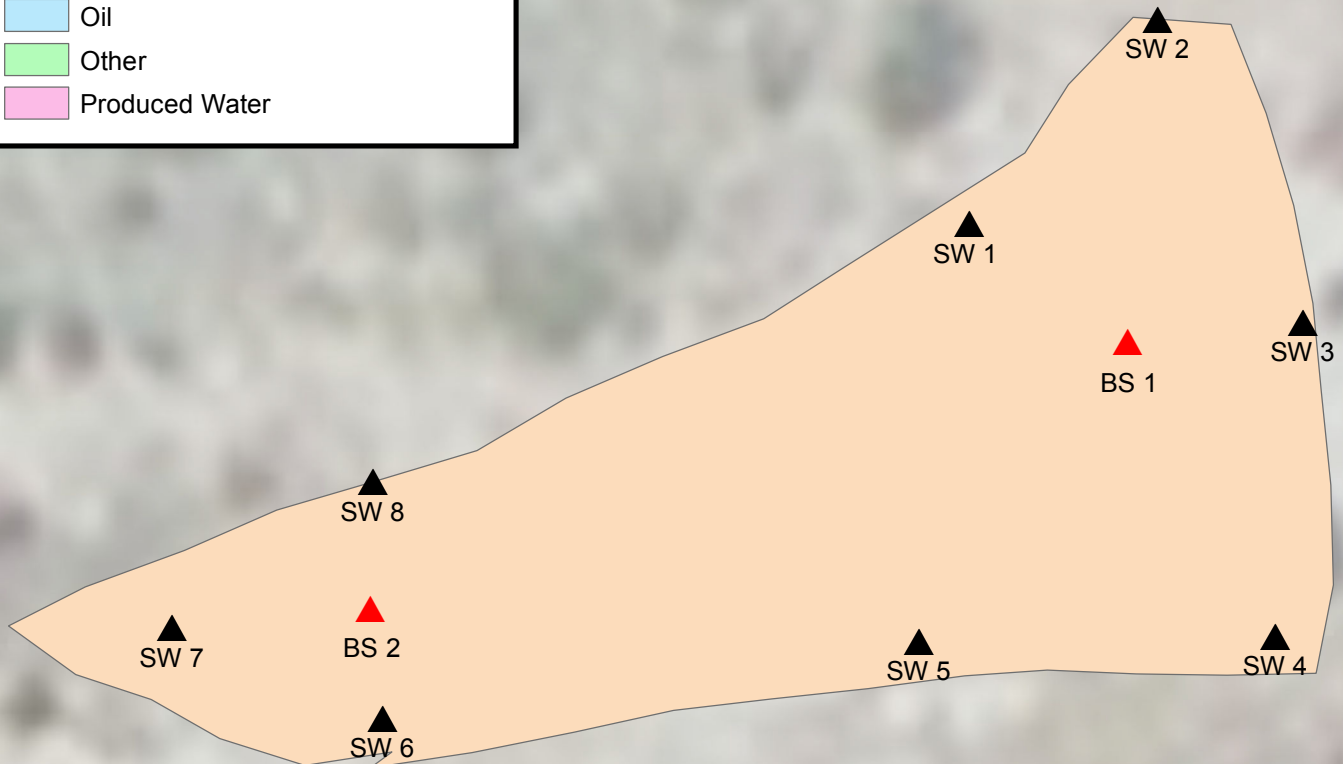
Beginning September 29, 2017, the release area was excavated to a depth of 4' bgs (Appendix IV) with excavated soil being properly disposed of at an approved NMOCD facility. Eight side wall samples were obtained and taken to Cardinal Laboratories to confirm all contaminants within the release area were removed (Figure 2/Appendix III). At the base of the excavation, a 20-mil, reinforced poly liner was installed and properly seated. Excavation was backfilled with clean, imported top soil to ground surface and contoured to the surrounding area. Due to season and limitation of growth, seeding will commence during the first few weeks of spring.

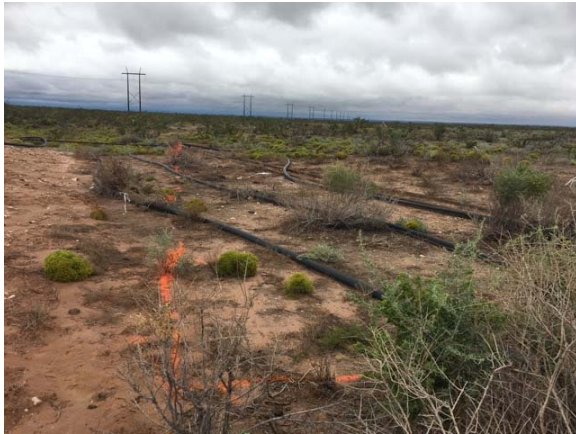
Site Prior

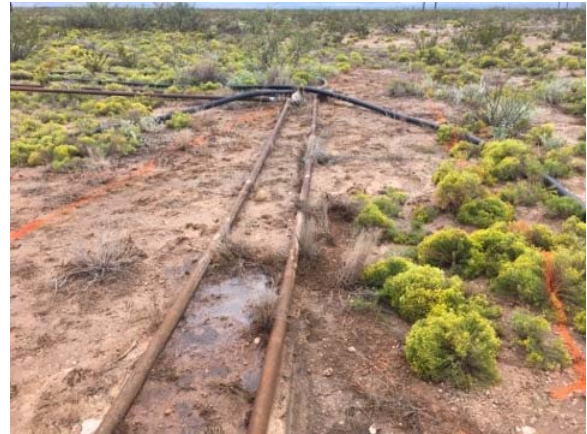
Site Prior

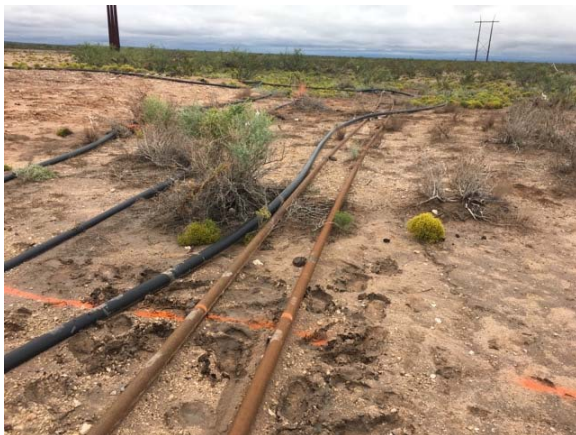
Site Prior

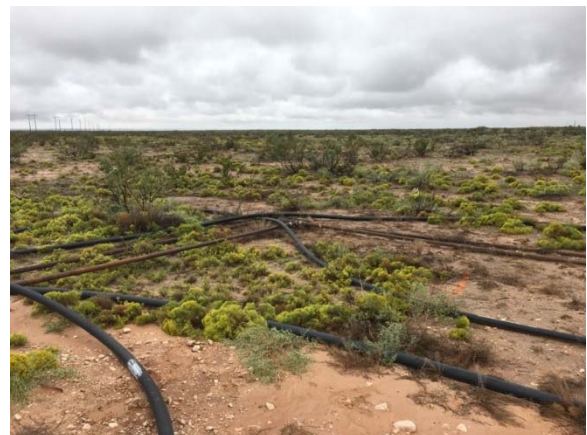
Site Prior
