Re: Site Assessment, Remediation, and Closure Report
Fighting Okra 18 CTB 4
API No. N/A
GPS: Latitude 32.047990 Longitude -103.509606
UL -- C, 18, T26S, R34E
Lea County, NM
NMOCD Ref. No. NAPP2114636364

Pima Environmental Services, LLC. (Pima) has been contracted by Devon Energy Production Company, LP (Devon) to perform a spill assessment, remediation activities, and submit this closure report for a Produced Water release that occurred at the Fighting Okra 18 CTB 4 (Fighting Okra). The initial C-141 was submitted on June 8, 2021 (Appendix C). This incident was assigned Incident ID NAPP2114636364 by the New Mexico Oil Conservation Division (NMOCD).

NAPP2114636364: On May 25, 2021, The Vic clamp on a water heater caused a fluid release. The released fluids were calculated to be approximately 15.7 barrels (bbls) of produced water. No fluids were recovered.

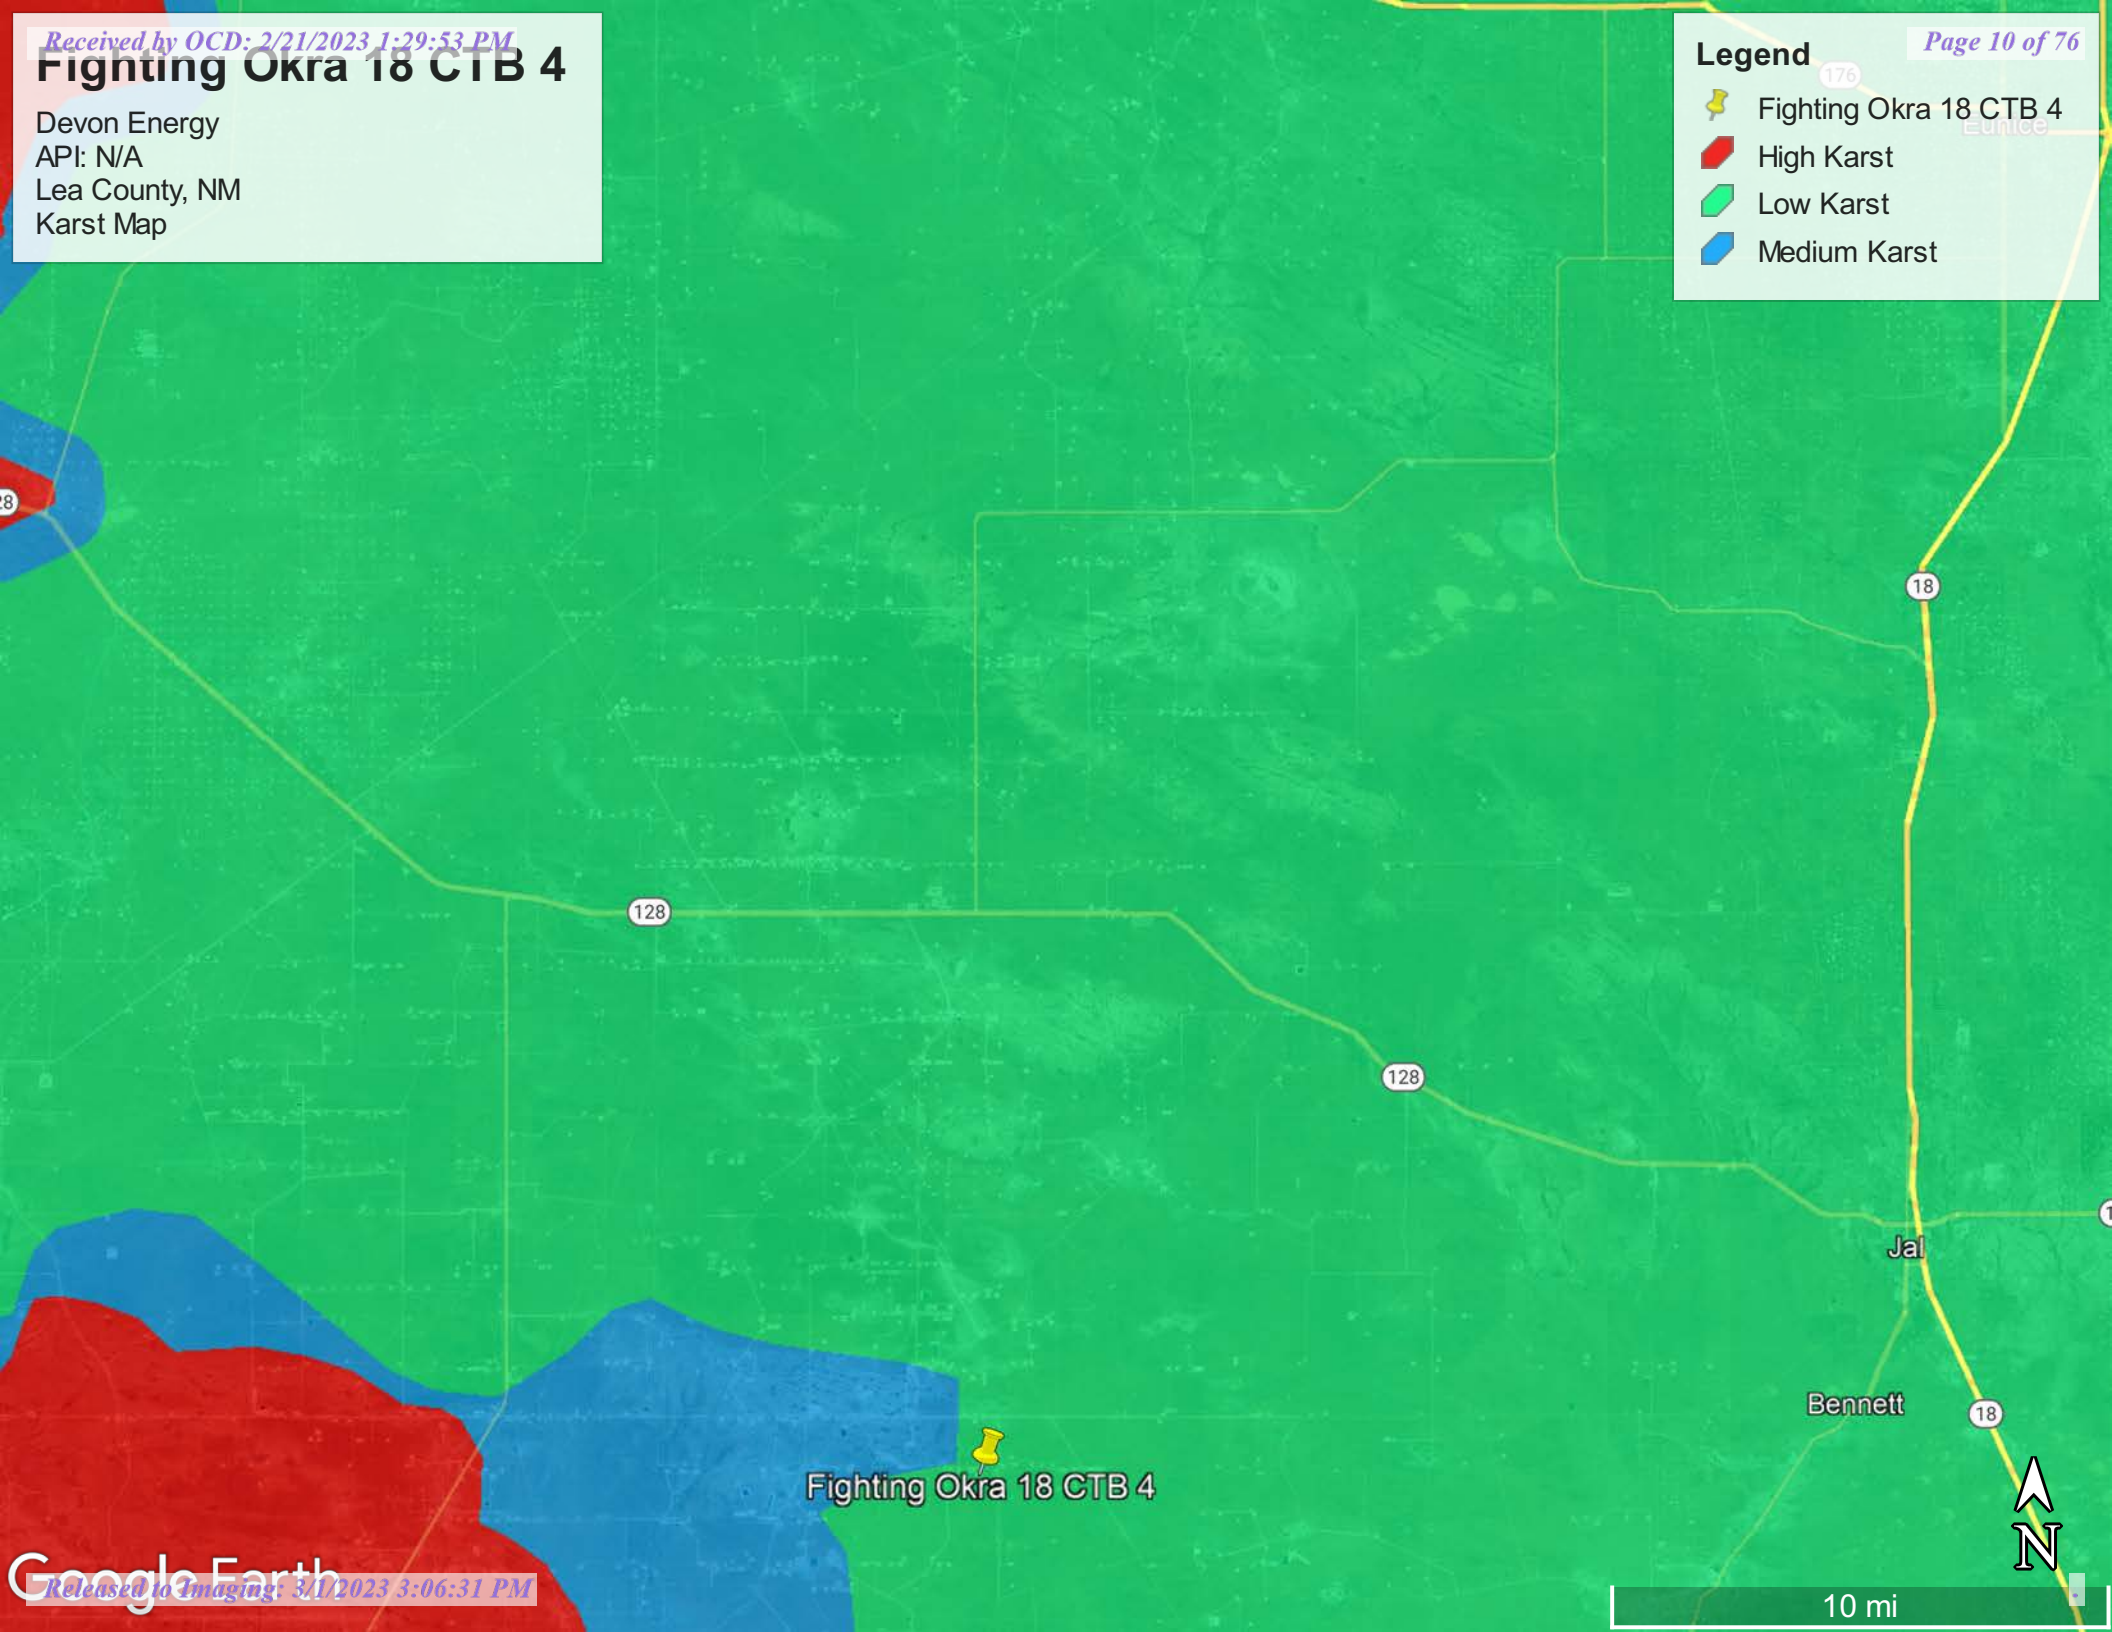
3-Karst Map

Per the New Mexico Bureau of Geology and Mineral Resources, the geology is made up of Interlayered eolian sands and piedmont-slope deposits along the eastern flank of the Pecos River valley, primarily between Roswell and Carlsbad. Typically capped by thin eolian deposits. The soil in this area is made up of Pyote and Maljamar fine sands, 0 to 3 percent slopes according to the United States Department of Agriculture Natural Resources Conservation Service soil survey (Appendix B). The drainage class in this area is well drained. There is a low potential for karst geology to be present around the Fighting Okra (Figure 3).

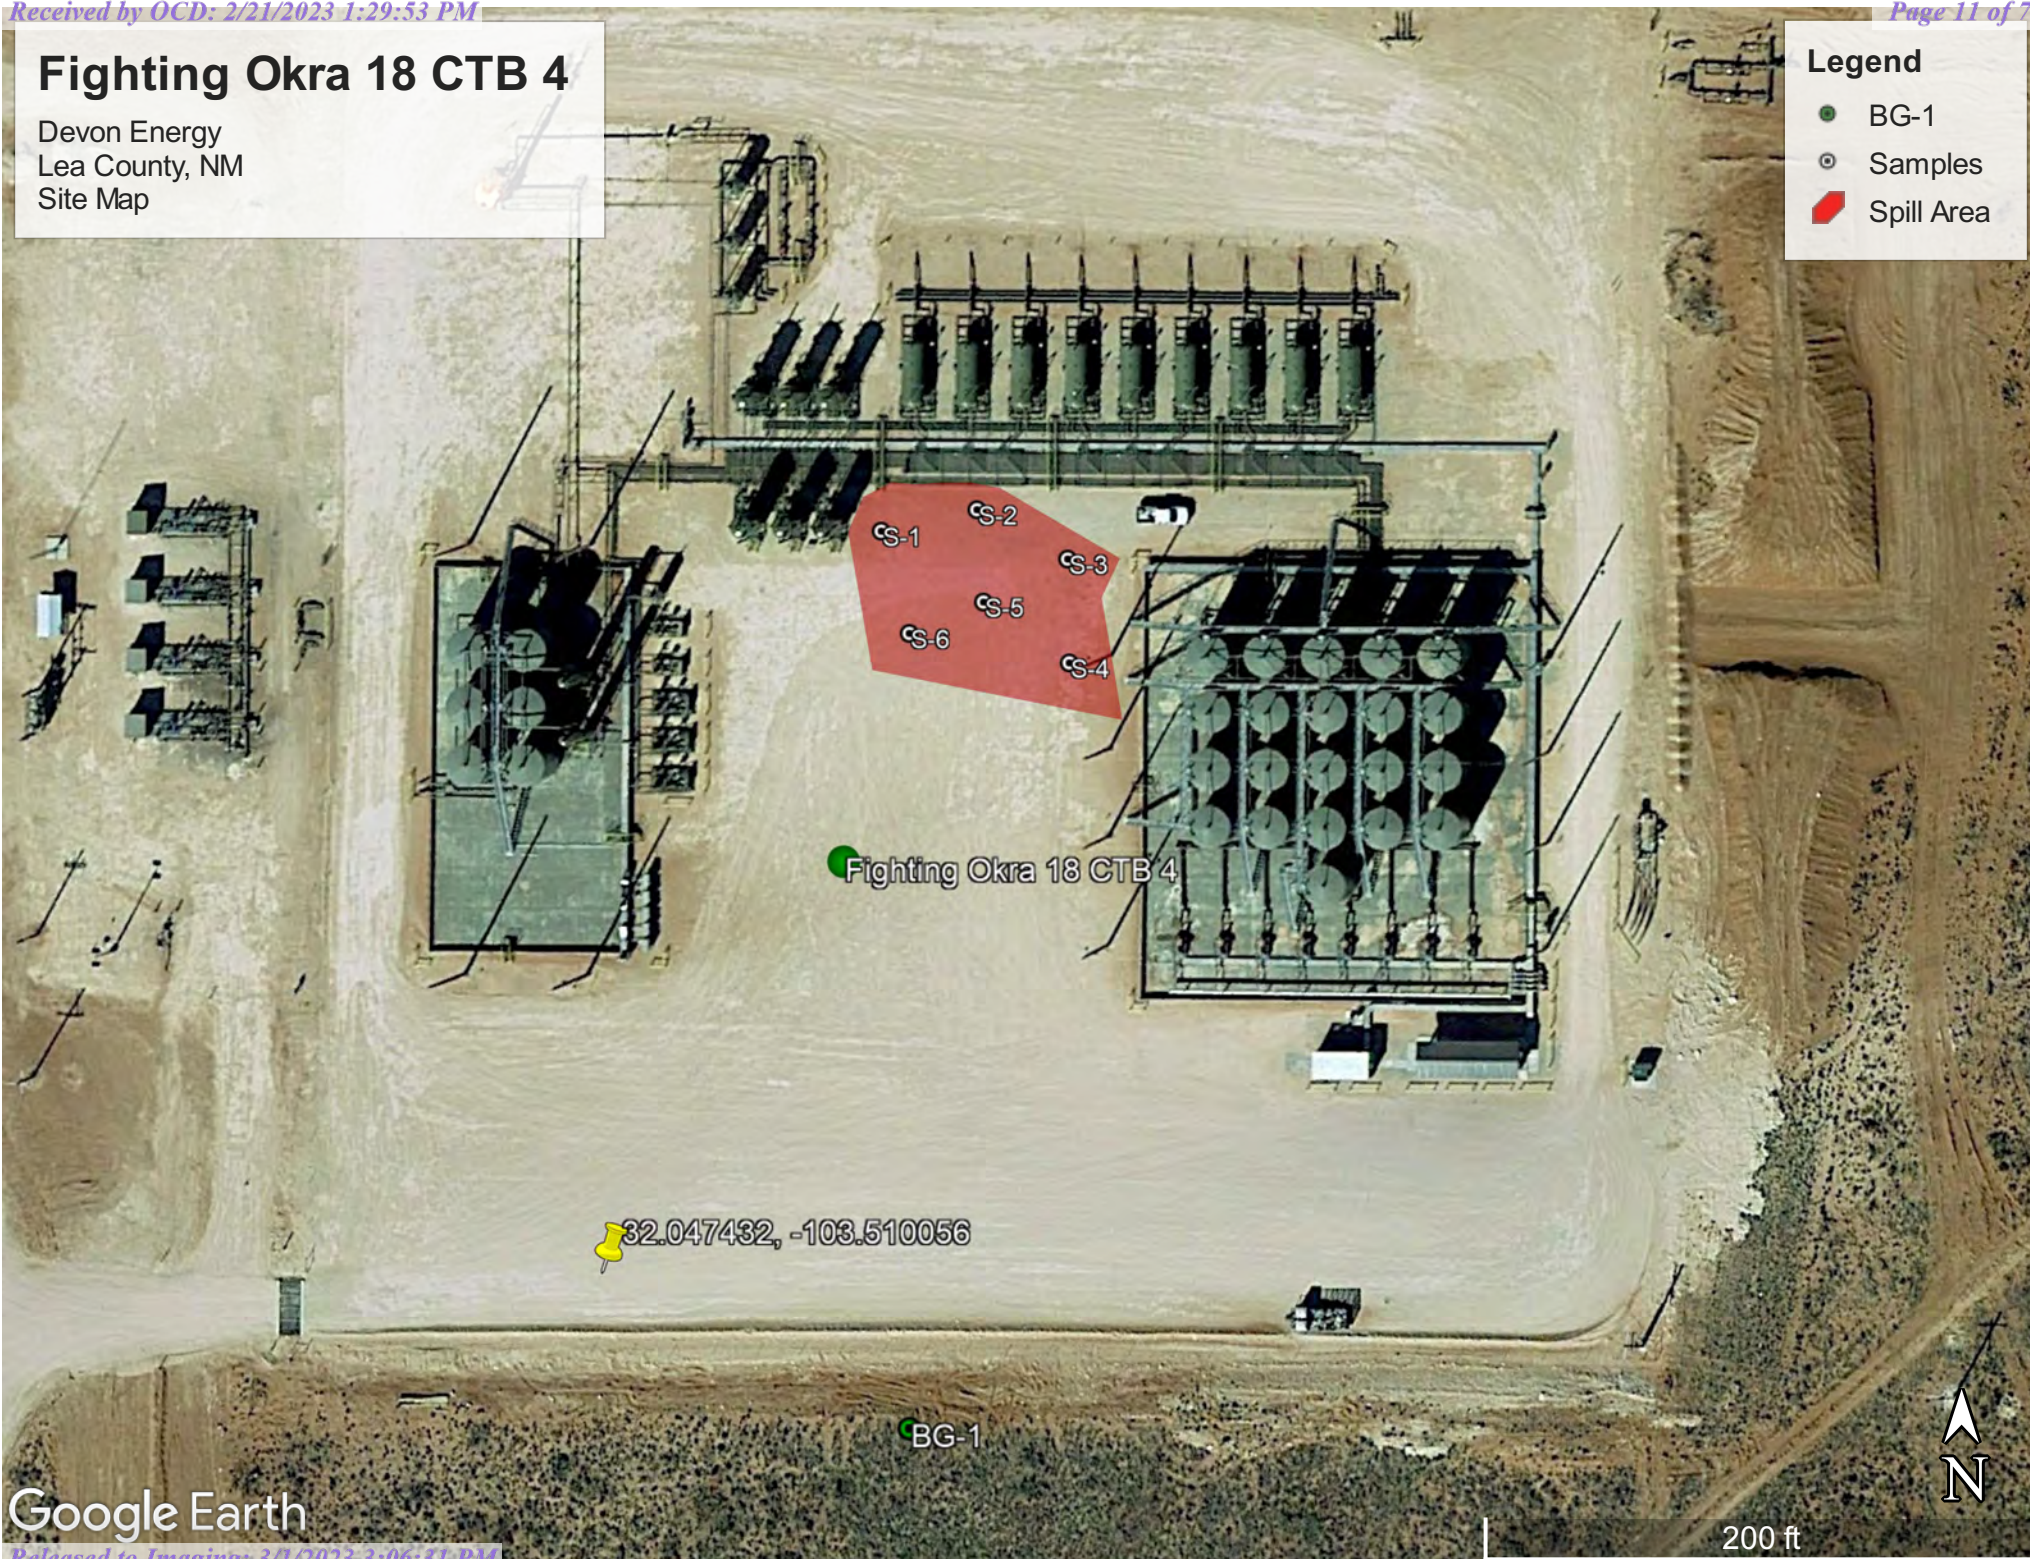
4-Site Map

On February 6, 2023, Pima mobilized personnel to the site to begin collecting soil samples from spill area. The laboratory results of this sampling event can be found in the following data table. A Site Map can be found in Figure 4.

- BG-1
- ⊙ Samples
- Spill Area

Based on the sample results, the bottoms and sidewalls were below NMOCD Closure Criteria 19.15.29 NMAC. See Appendix D for Photographic Documentation.
