# **SUBSEQUENT CLOSURE REPORT**

### **Spur Energy Partners**

JC Federal #27 Battery

Incident ID: NAPP2105332930; NAPP2111658280

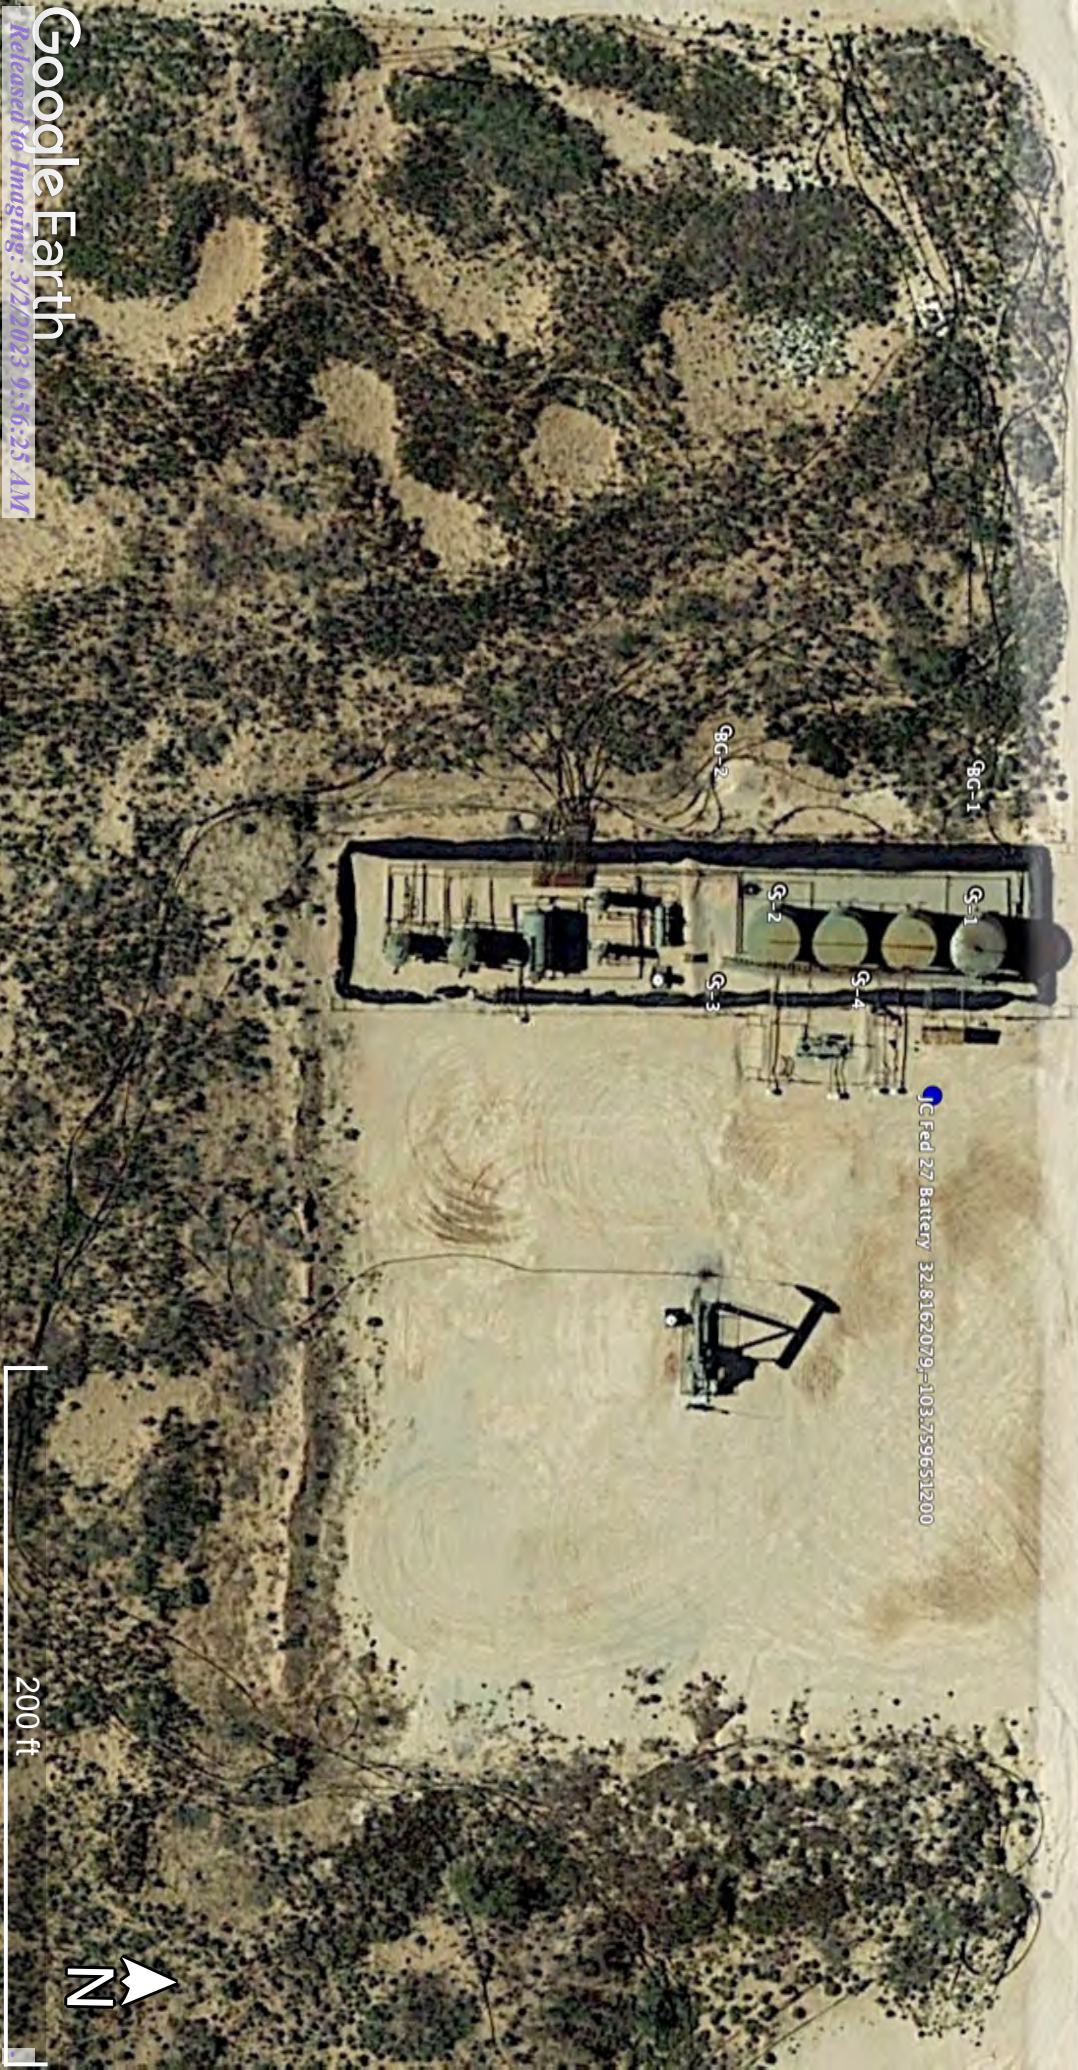
# Spur Energy Partners

JC Federal #27 battery  
AP# 30-025-39247  
Lea County, NM  
Site Map

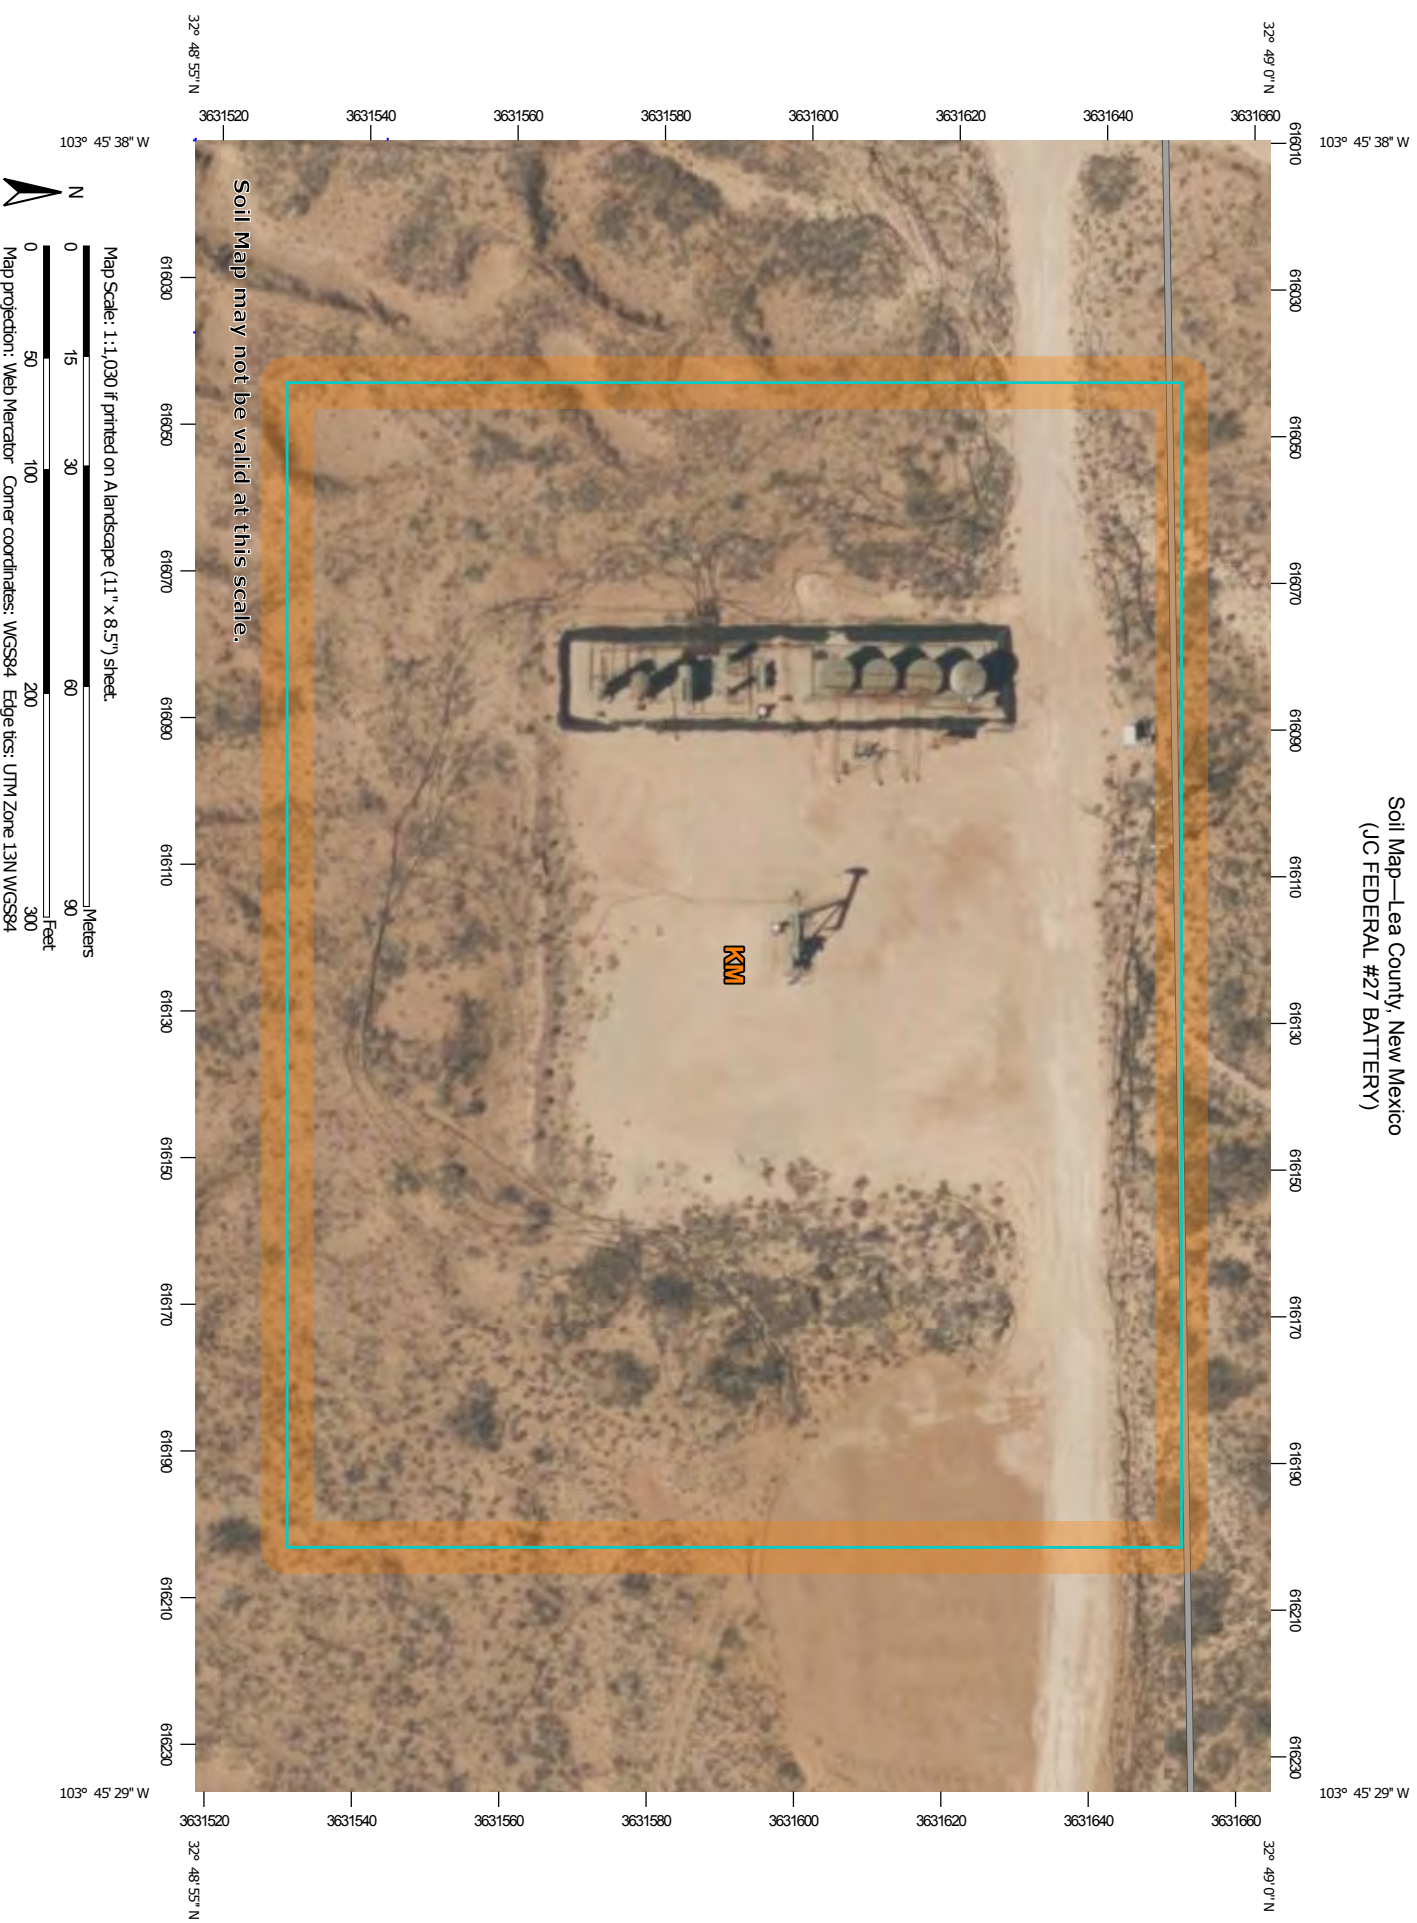
Soil Map—Lea County, New Mexico  
(JC FEDERAL #27 BATTERY)

The *United States Department of Agriculture Natural Resources Conservation Service* indicates that the soil type found at the JC consists of Kermit Soils and Dune Land with 0 to 12 percent slopes. Please see the soil map attached herein.

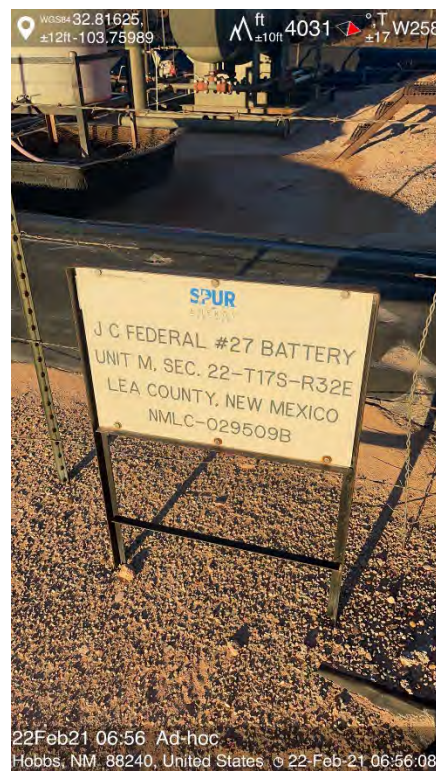
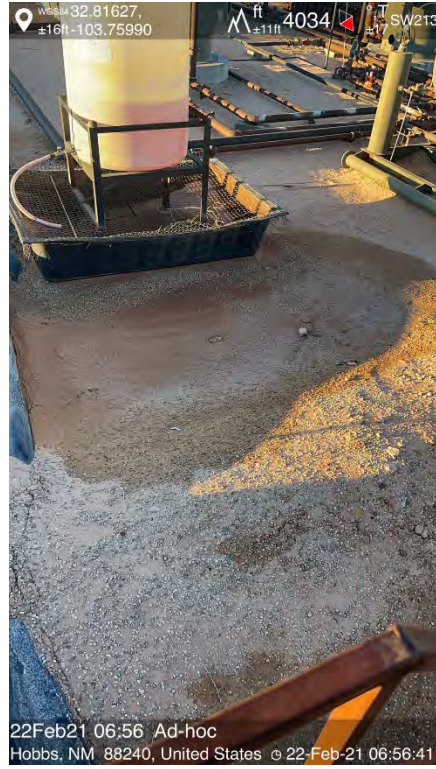
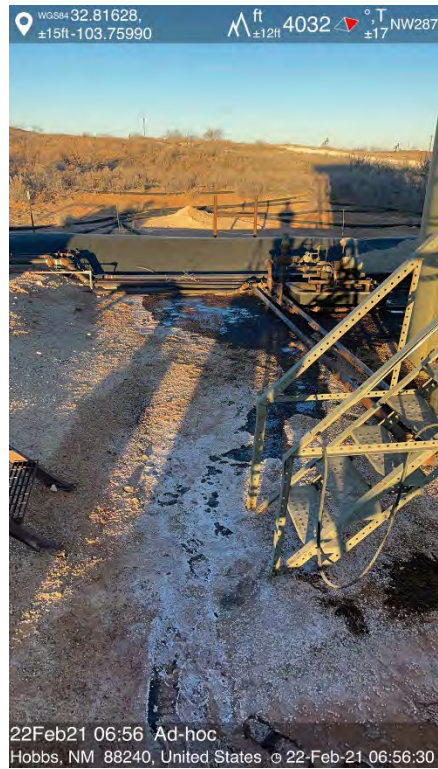
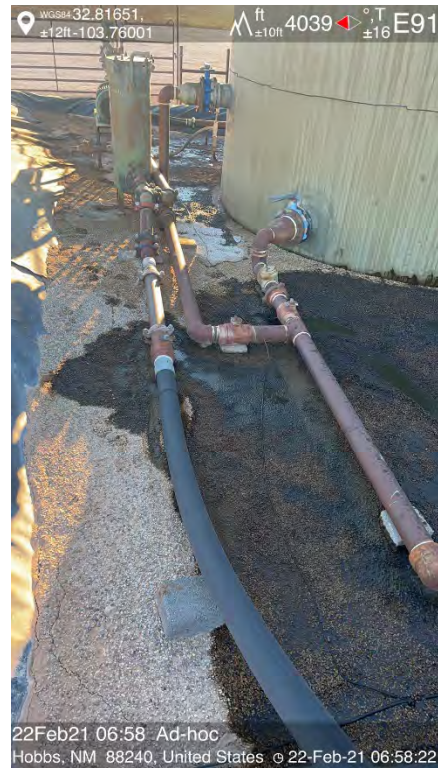
## INITIAL PHOTOS

ESS arrived on site for the initial site assessment on February 21, 2021. The facility was found to be lined with a black polyurethane liner, with pea gravel on-top of the liner. Please see the initial site photos. No fluid breached the liner onto the production pad. Crews arrived back on-site April 20<sup>th</sup>, to begin removing the contaminated soil from on top of the liner (12 cy of contaminated soil hauled to Lealand) and then pressure washed the liner to conduct the liner inspection. On April 21<sup>st</sup>, an email was sent to the OCD and BLM to conduct a liner inspection and sampling protocol on the JC site and that work would begin on April 26<sup>th</sup>. Crews left the site for the liner to dry and were called backout on April 24<sup>th</sup> to conduct another site assessment due to the second release at the JC. It was found that the liner was full of oil and water, no breaching of the liner had occurred. Vac trucks were called out to recover the standing fluids. At this time the crews again, pressure washed the containment to free it from any standing fluids and to clear it for the liner inspection. On April 28<sup>th</sup>, the liner inspection was conducted and a few small punctures in the liner were found. Four vertical sample points were placed and GPS'd. The liner was cut, samples were obtained, field analyzed and submitted to Envirotech Laboratory for confirmation. A background sample was also obtained and submitted to the lab. Below you will find the field data along with lab analysis results. Please find the sample data and lab reports attached herein.

**DOR: 02/19/2021**

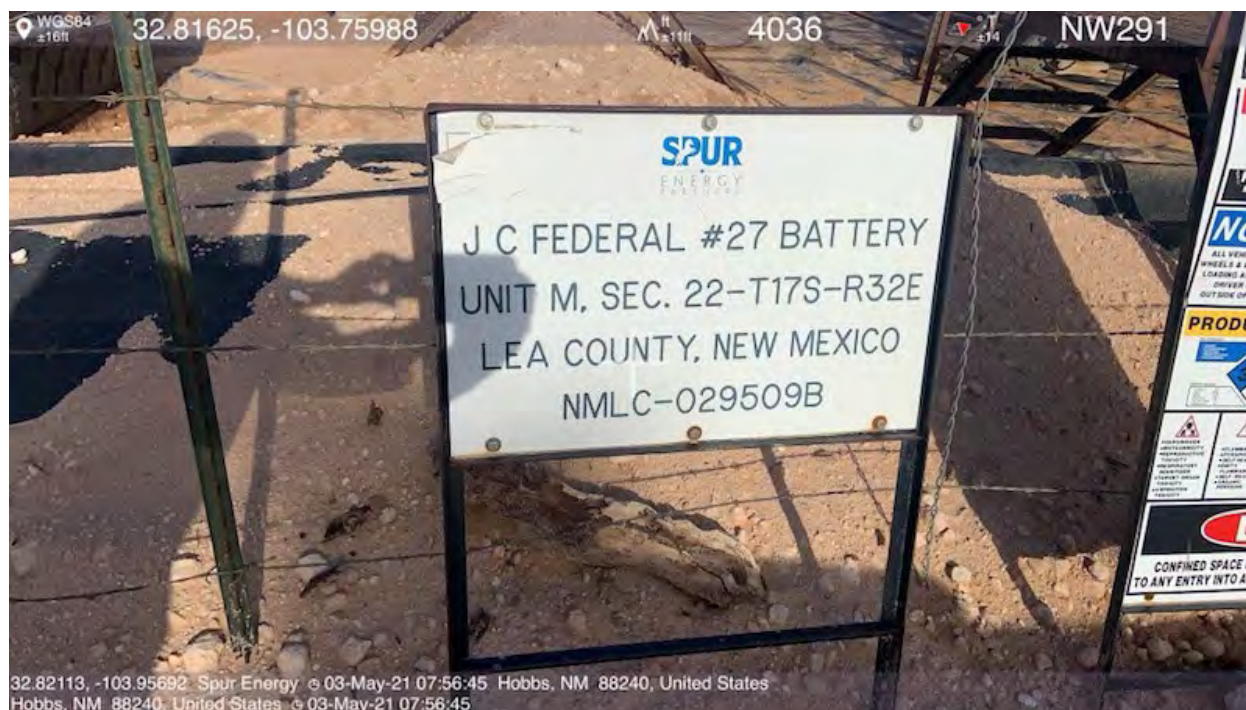
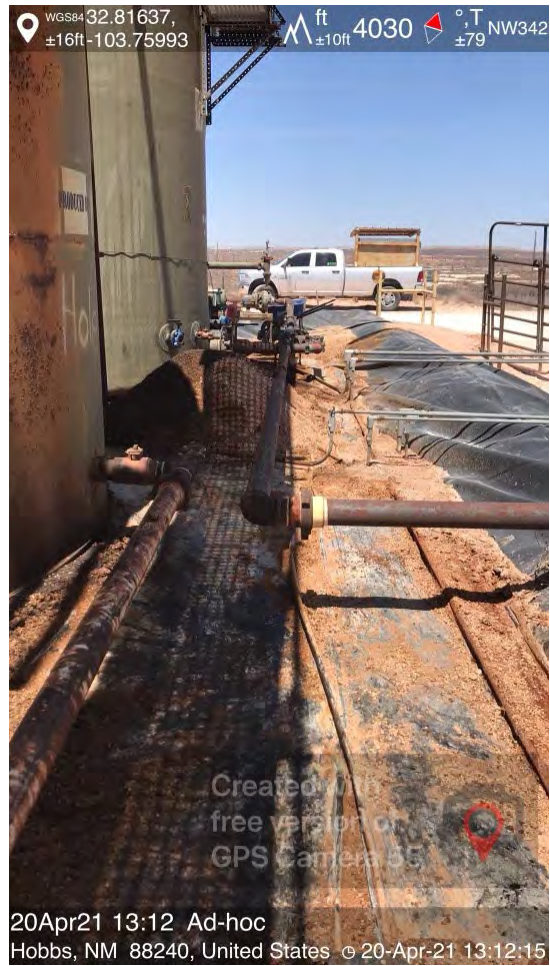
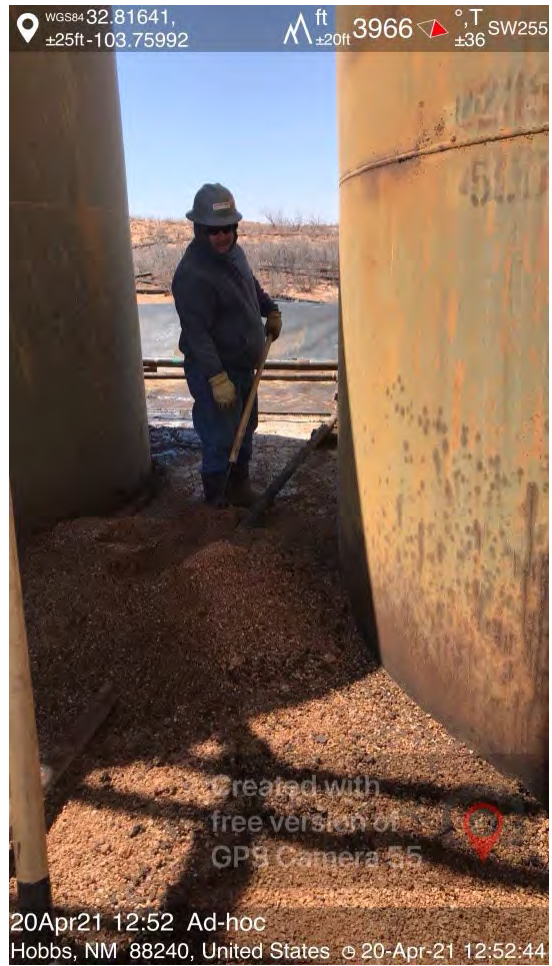
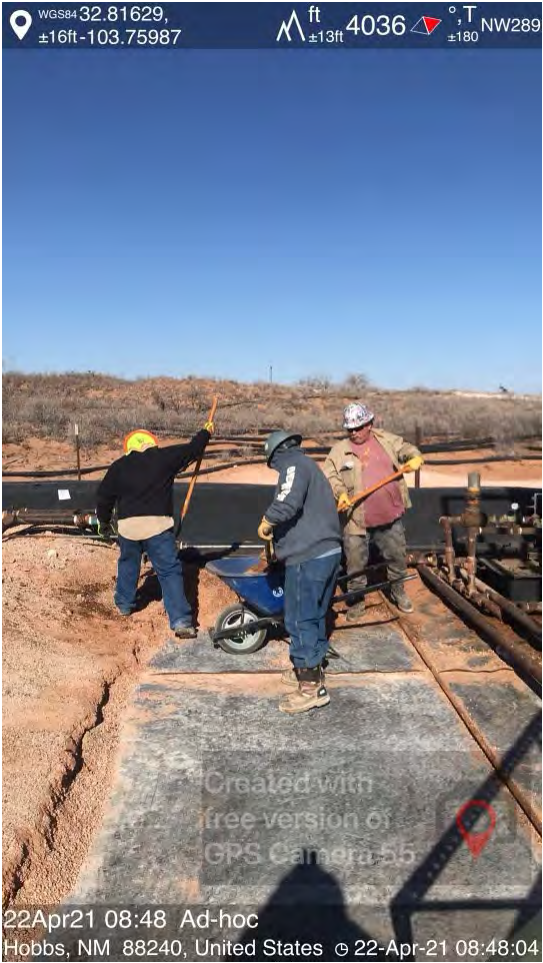
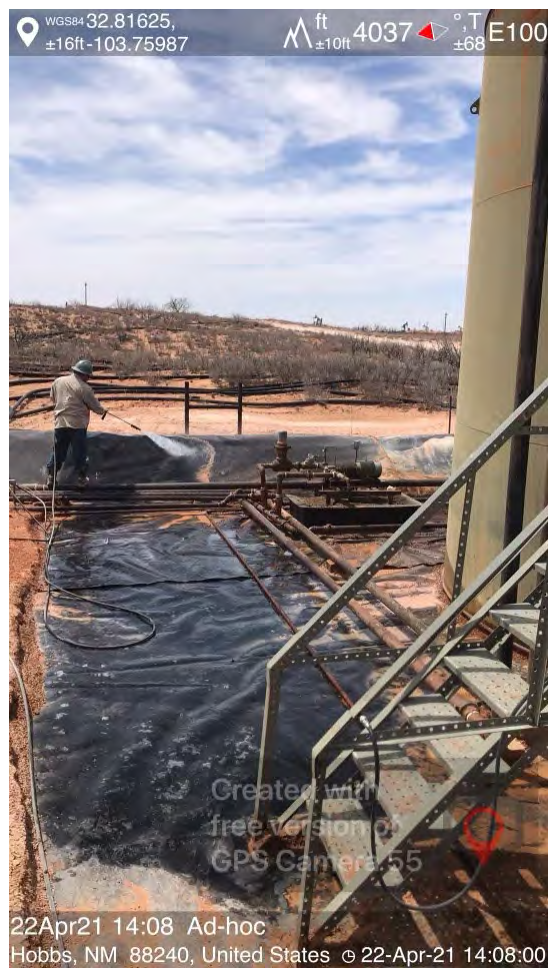
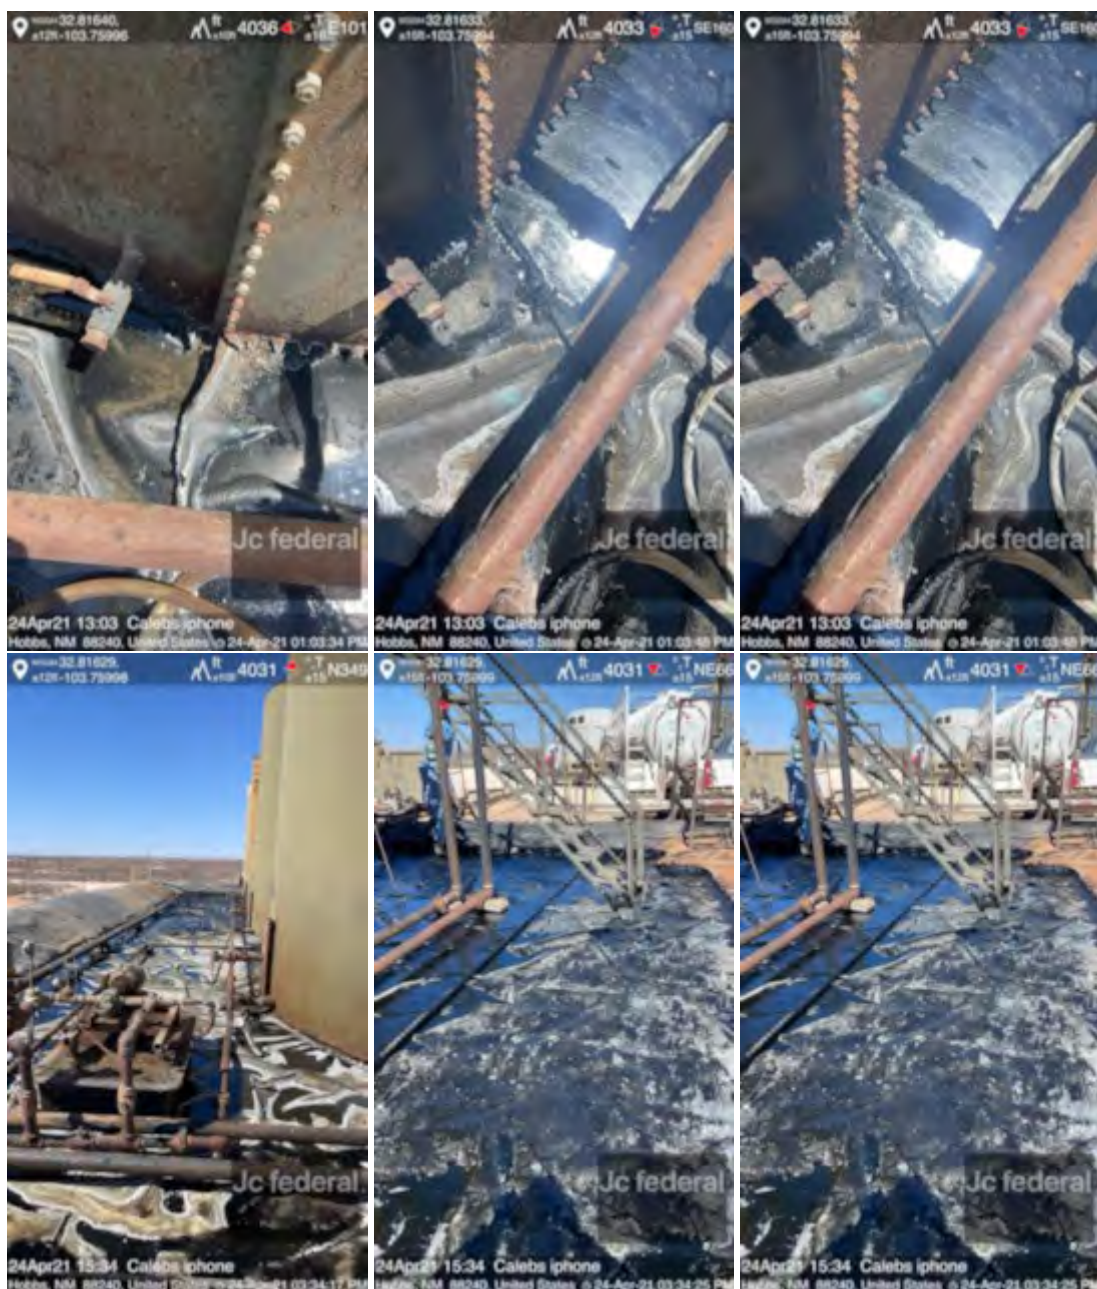
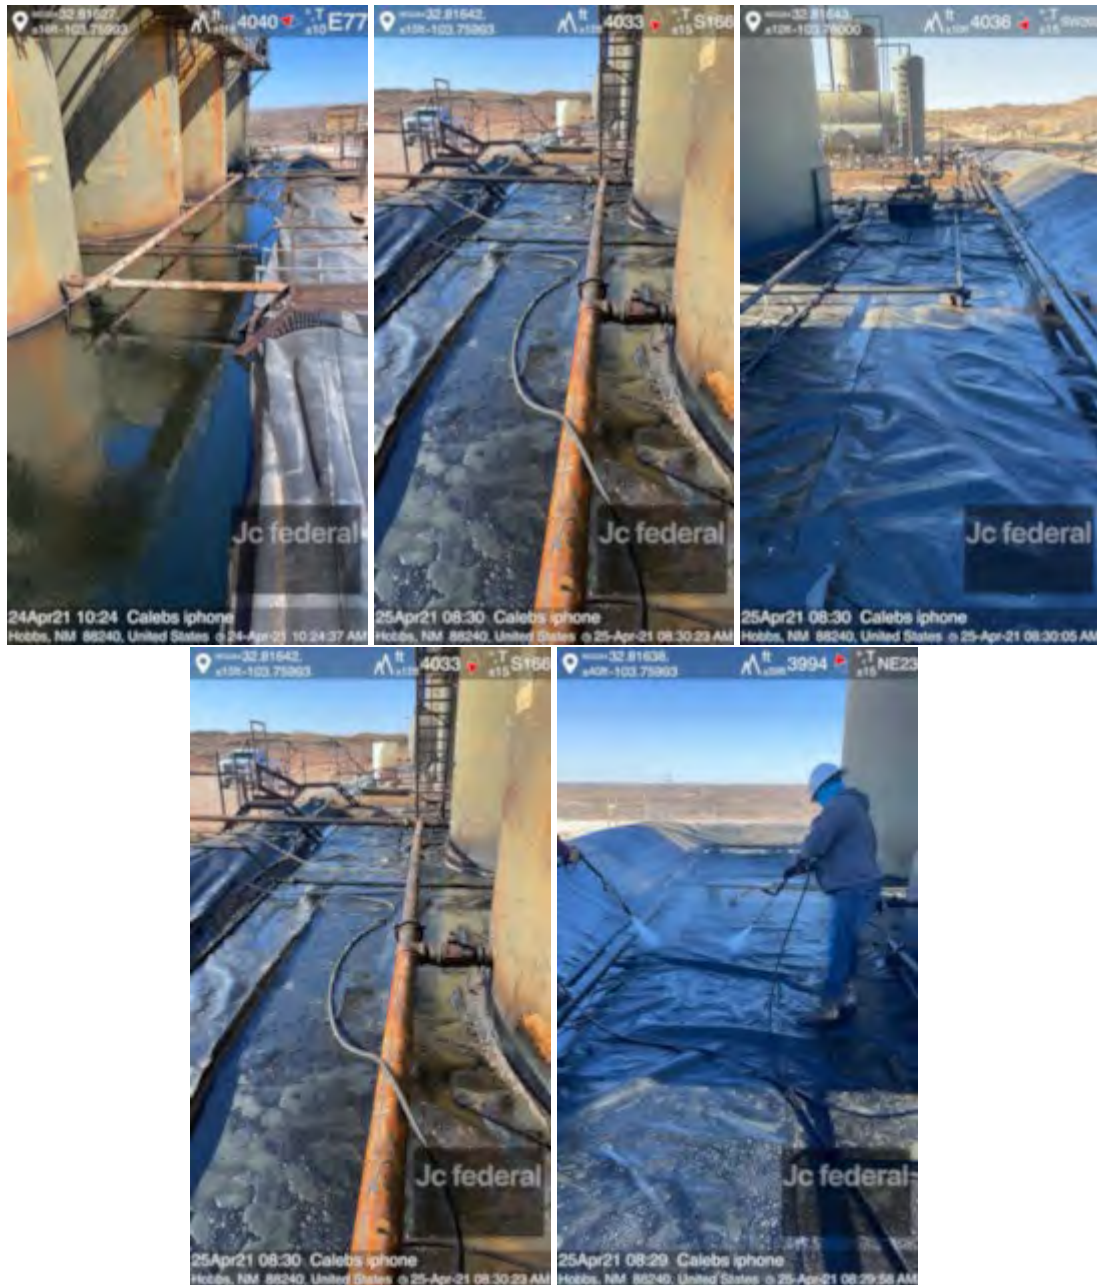
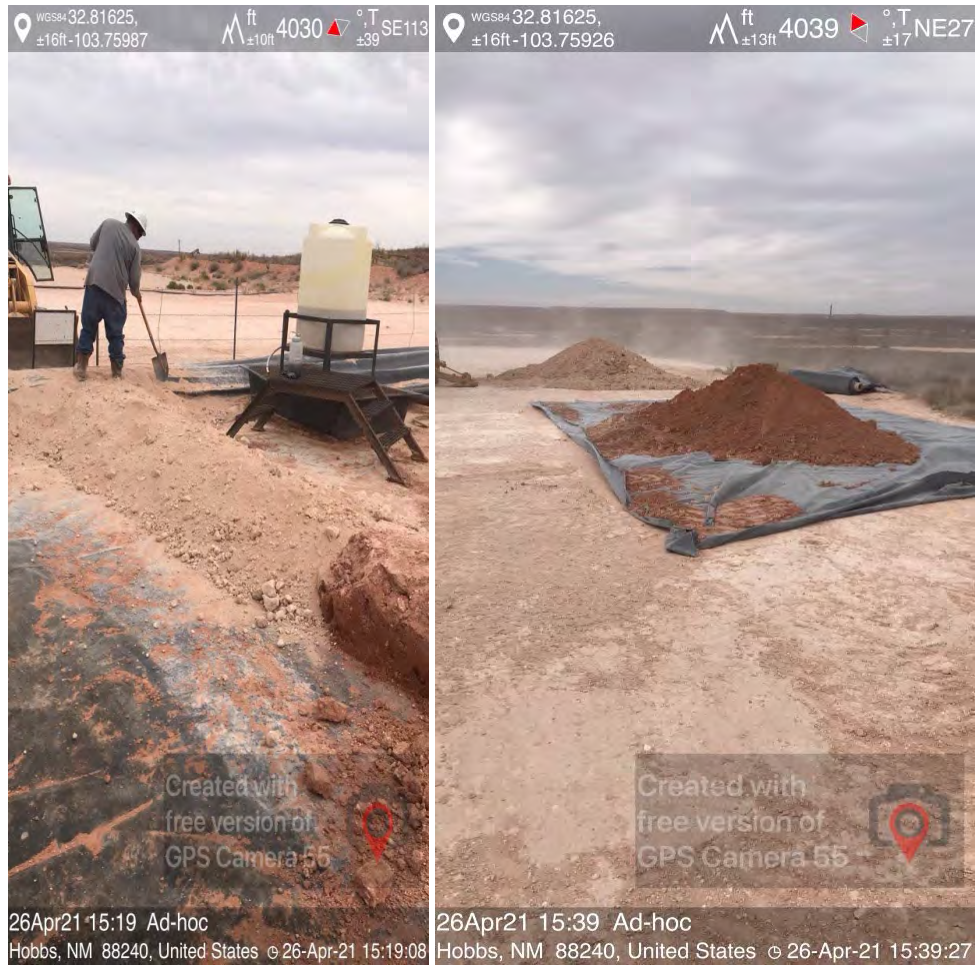
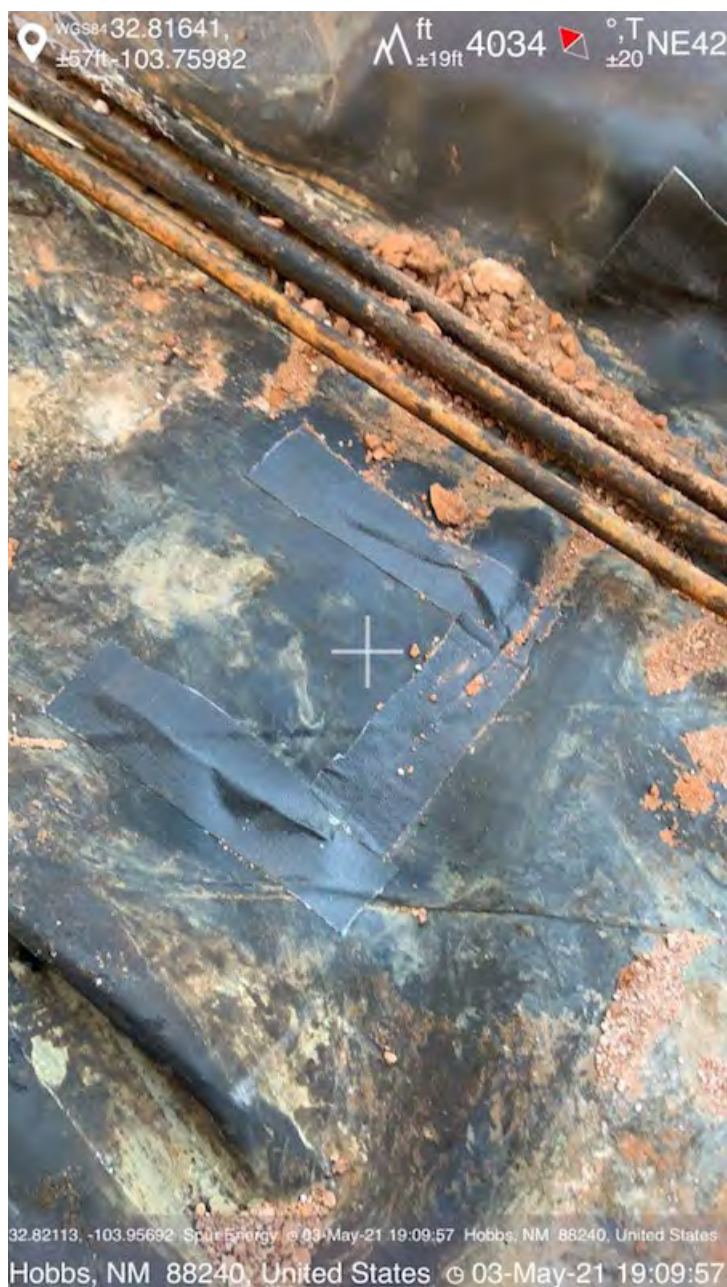
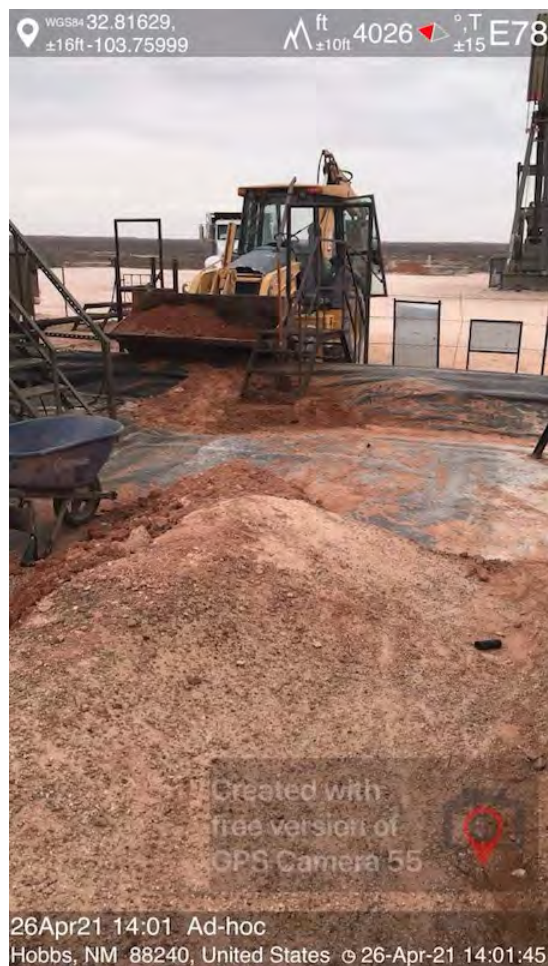
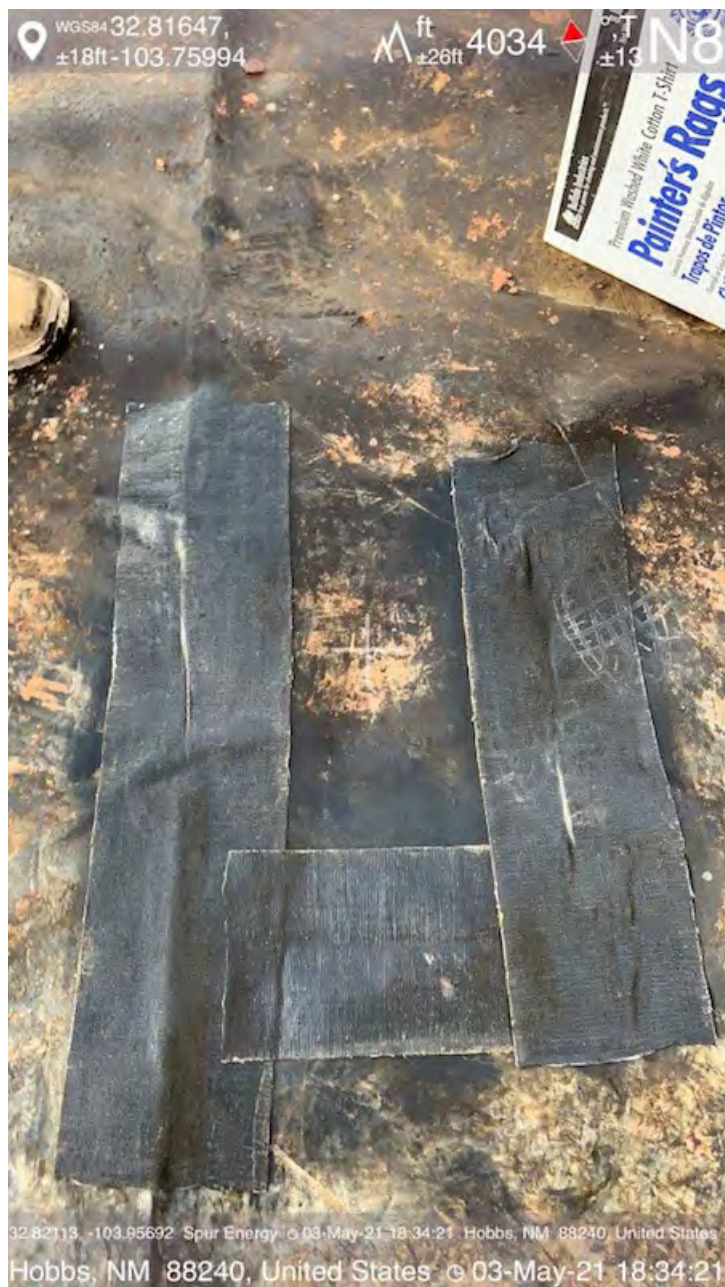
## REMEDIATION PHOTOS AND FINAL PHOTOS

**DOR: 02/19/2021 AND 04/24/21**

With the sampling that was conducted it was found that a minor concentration of chlorides was located under the liner with no detection of TPH or BTEX. At this time, the areas that were compromised were patched and sealed, which was conducted on May 3<sup>rd</sup> of 2021.. Please find site photos attached.
