**RE: Closure Request
Poker Lake Unit Ross Ranch 33-25-30 USA Battery
Remediation Permit Number 2RP-4669
Eddy County, New Mexico**

LT Environmental, Inc. (LTE), on behalf of XTO Energy, Inc. (XTO), presents the following report detailing excavation of impacted soil and confirmation soil sampling activities at the Poker Lake Unit Ross Ranch 33-25-30 USA Battery (Site) in Unit D, Section 33, Township 25 South, Range 30 East in Eddy County, New Mexico (Figure 1). The purpose of the excavation and soil sampling activities was to address impacts to soil after a produced water release at the Site.

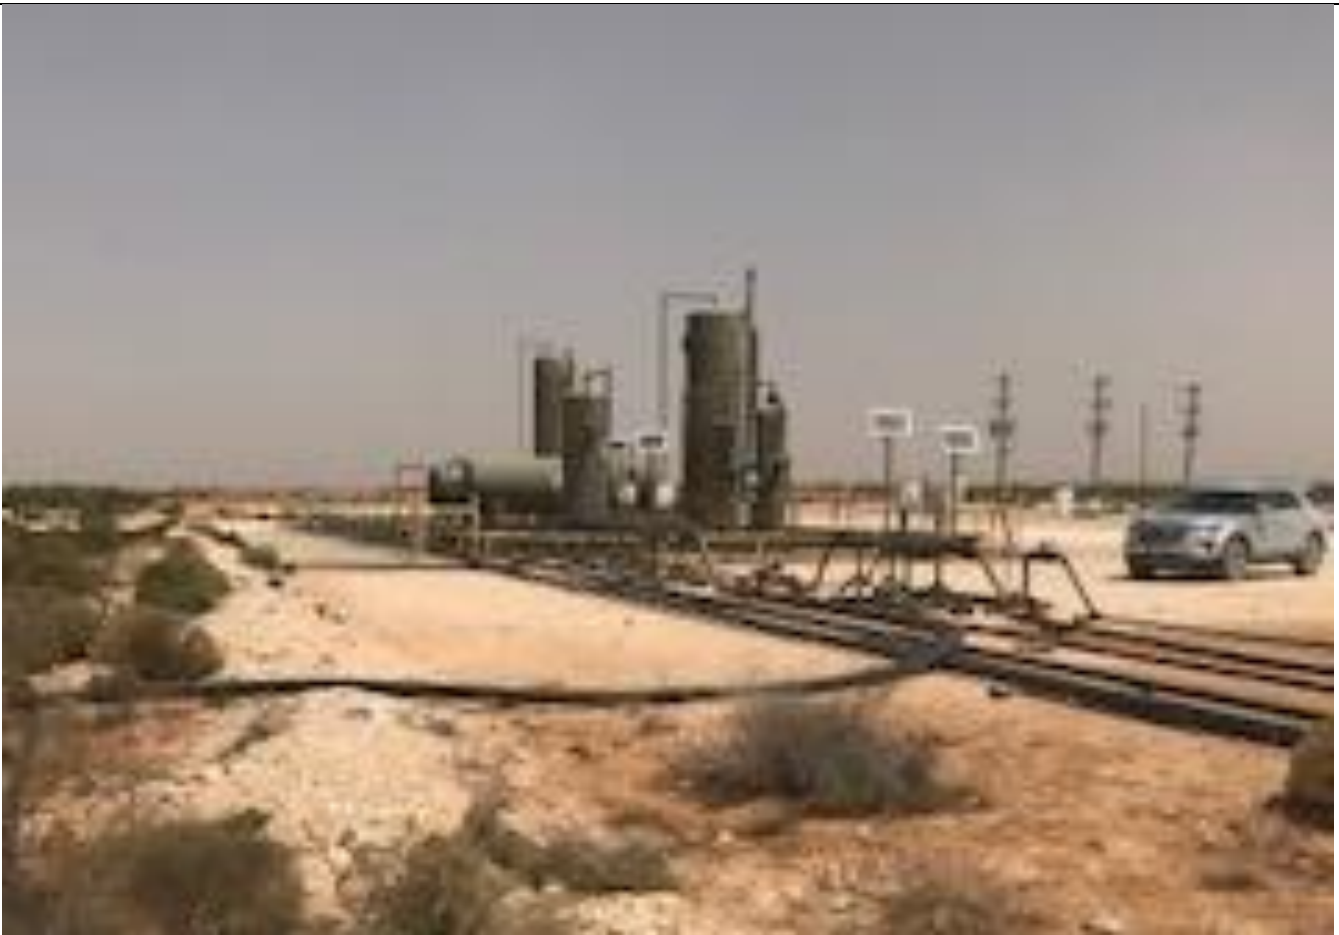
North facing view of release area and processing equipment prior to excavation activities.

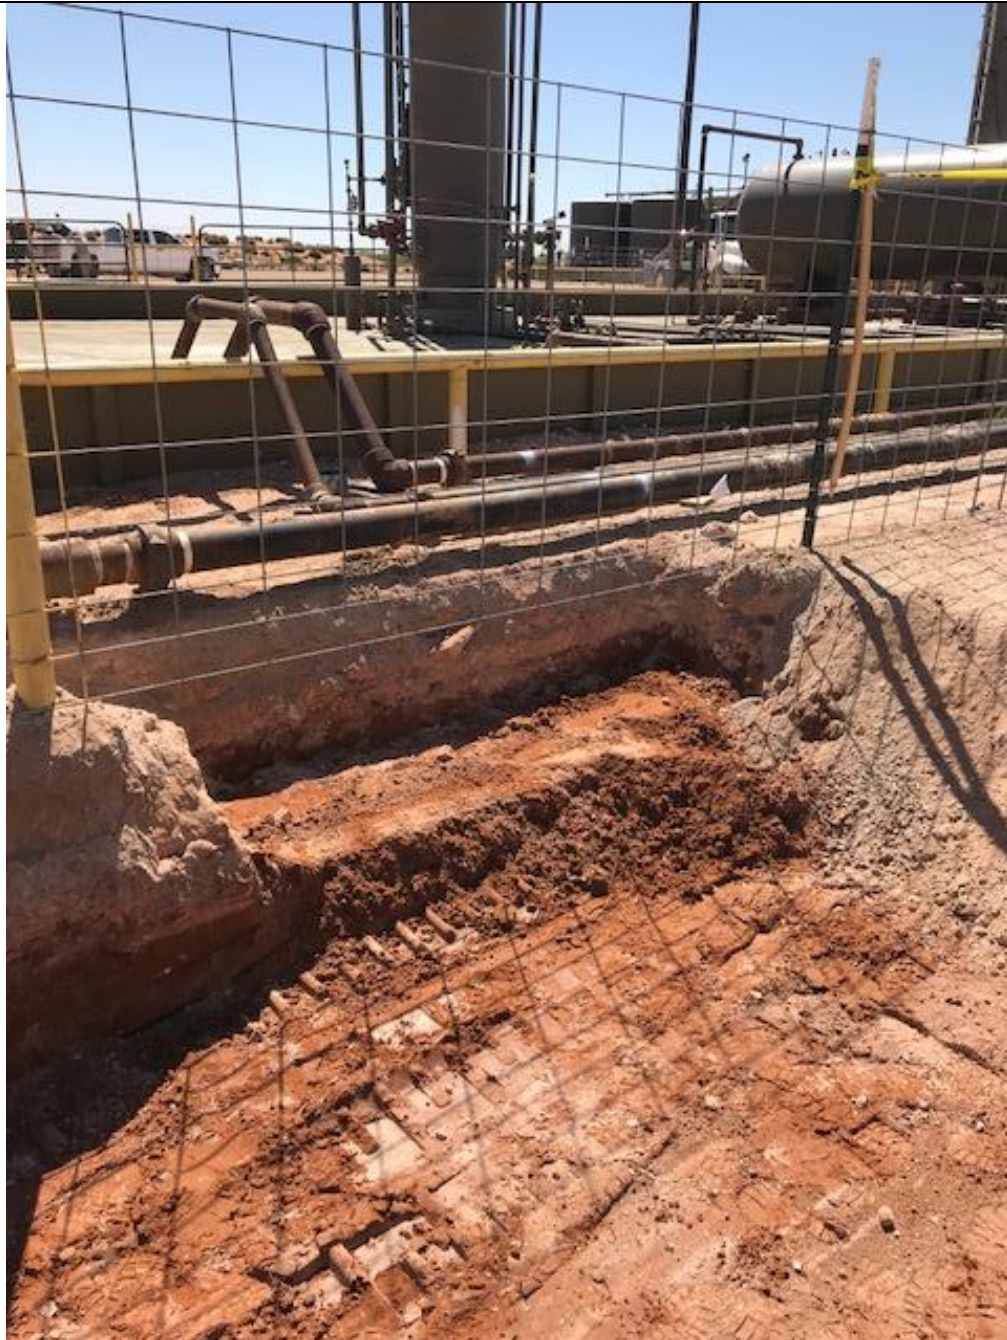
East facing view of the open excavation.

The excavation measured approximately 240 square feet in area and was completed to a depth of 1.5 feet bgs. Composite soil sample FS01 was collected from the floor of the excavation from a depth of 1.5 feet bgs. Composite soil samples SW01 and SW02 were collected from the sidewalls of the excavation from depths ranging from 0 feet to 1.5 feet bgs. The excavation soil sample locations and the horizontal extent of the excavation is presented on Figure 2. A total of approximately 15 cubic yards of impacted soil were removed from the excavation. The impacted soil will be transported and properly disposed of at Lea Land landfill facility in Hobbs, New Mexico.

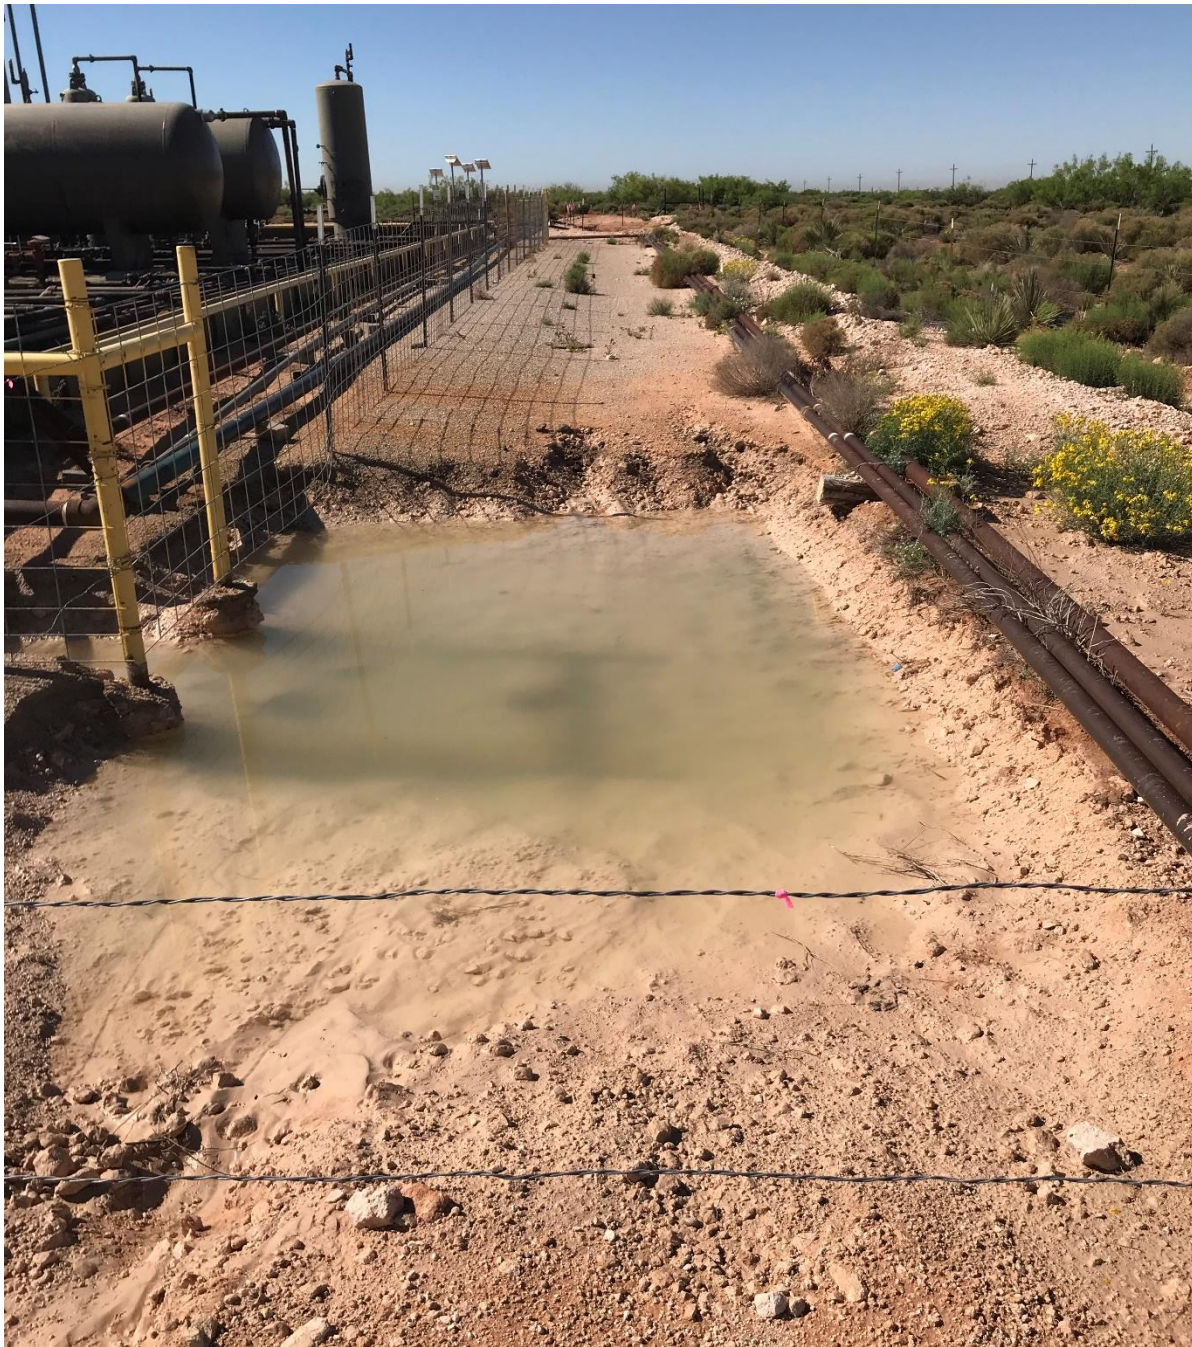
South facing view of the final excavation extent after a rain event.
