DELINEATION WORKPLAN

OXY – STERLING SILVER 34 FEDERAL 2 CTB (Leak Date: 6/12/18)

RP # 2RP-4824

This delineation workplan and remediation proposal addresses the releases associated with RP # 2RP-4824.

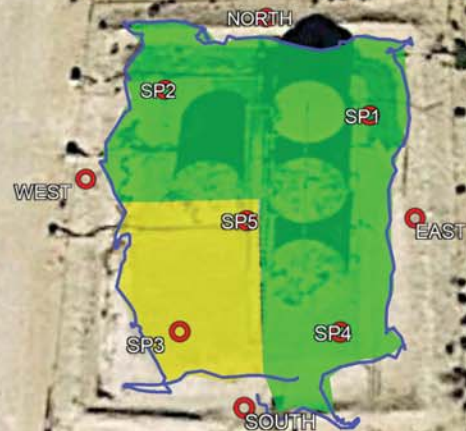
Oxy, Sterling Silver 34 Federal 2 CTB

Leak date: 6/12/18
Eddy County, NM
AP# 30-015-27936
2RP-4824

- Legend**
- 1 ft Excavation
 - 6 in Excavation
 - Sample points
 - Leak Area

OXY will excavate the spill area as depicted on the following site diagram. The leak areas near SP1, SP2, and SP4 (GREEN shade on diagram) will be excavated to a depth of 6 inches. The leak area near SP3 and SP5 (YELLOW shade on diagram) will be excavated to a depth of 1 foot.

Bottom confirmation samples will be collected at no greater than 50 ft. intervals. Estimated volume of material to be removed is 105 cubic yards. The remediation will be completed within 90 days of plan approval.
