Re: Site Assessment, Remediation, and Closure Report
Aquila 22 Fed Com 4H
API No. 30-015-41159
GPS: Latitude 32.6442938 Longitude -103.8492756
UL -- I, Sec. 22, T19S, R31E
Eddy County, NM
NMOCD Ref. No. NJMW1325447866

Pima Environmental Services, LLC. (Pima) has been contracted by Devon Energy Production Company, LP (Devon) to perform a spill assessment, remediation activities, and submit this closure report for a 15% HCL Acid release that occurred at the Aquila 22 Fed Com 4H (Aquila). The initial C-141 was submitted on September 10th, 2013 (Appendix C). This incident was assigned Incident ID NJMW1325447866 by the New Mexico Oil Conservation Division (NMOCD).

Remediation Activities, Site Assessment, and Soil Sampling Results

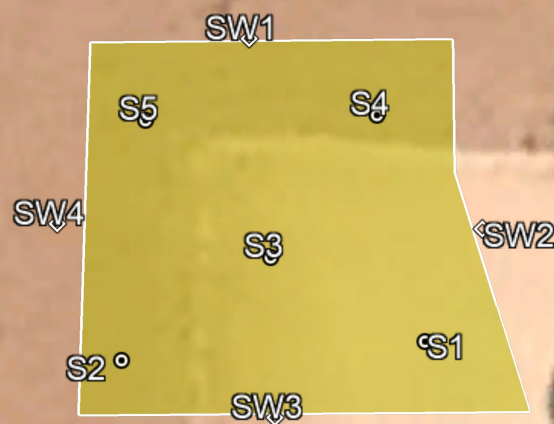
4-Site Map

On February 17th, 2023, Pima Environmental mobilized personnel to the Aquila to assess the impacted area. Pima sampled the areas surrounding the area underlying the frac tank manifold release and collected a total of fifteen soil samples for laboratory analysis. Five bottom samples (S1-S5) were collected at depths of 1 and 4 feet to determine vertical delineation. Additionally, side wall samples (SW1-SW4) were collected at a depth of 6 inches to determine horizontal delineation. One background sample (BG-1) was collected to assess naturally occurring Chloride levels. An initial site map can be found in Figure 4.

Devon Energy
API:30-015-41159
Eddy County, NM
NJMW1325447866
Site Map

Based on the sample results, the bottoms and sidewalls are below NMOCD Closure Criteria 19.15.29 NMAC. We believe the impacted area has been adequately remediated. See Appendix D for Photographic Documentation.

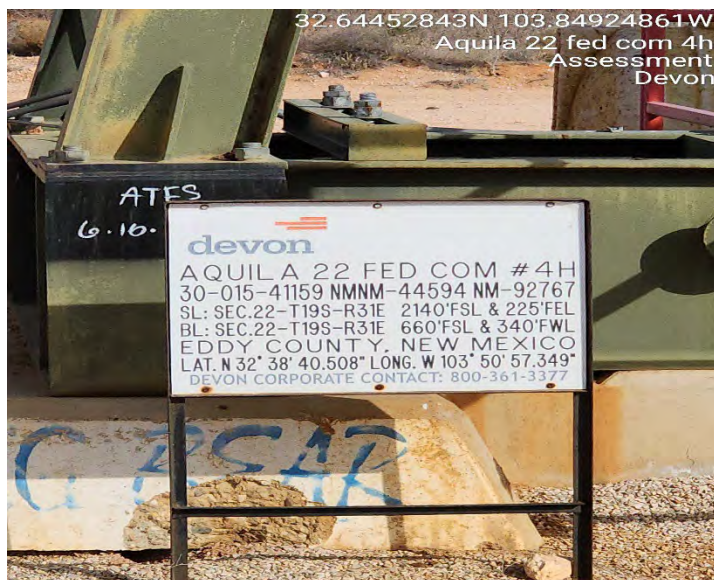
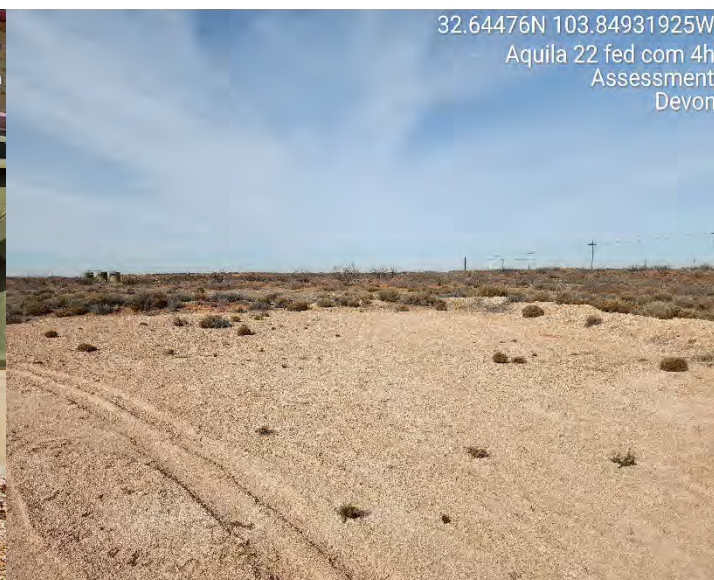
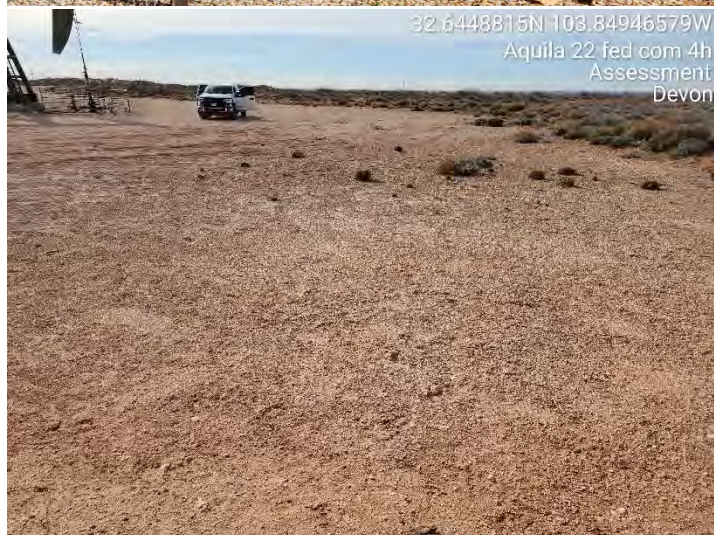
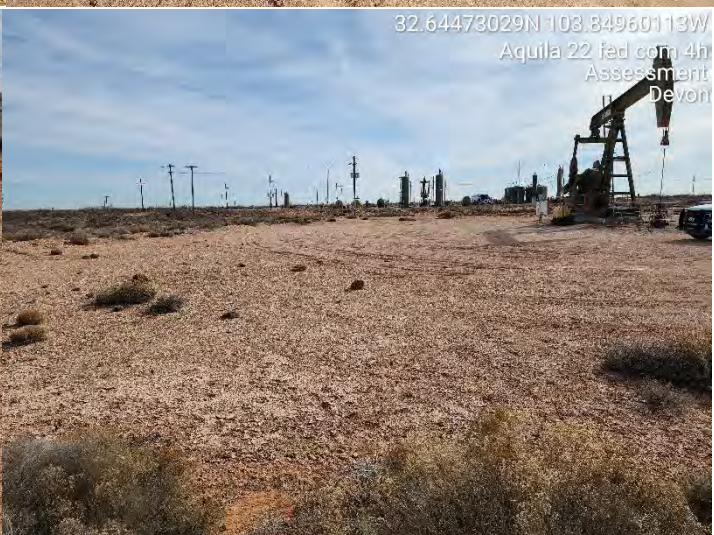
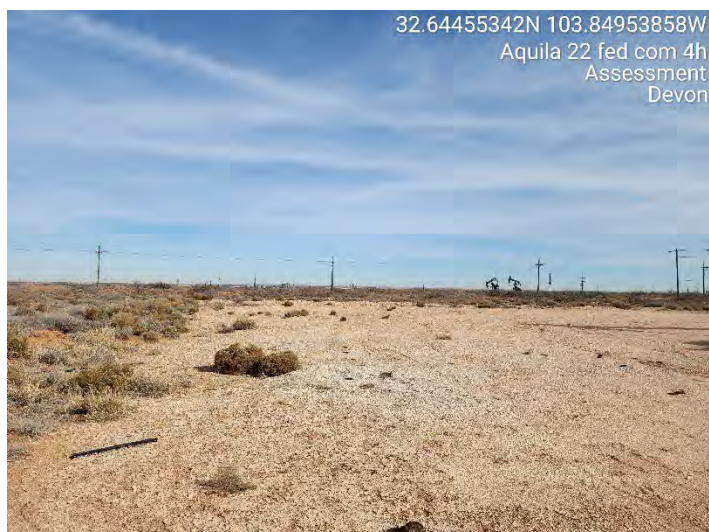
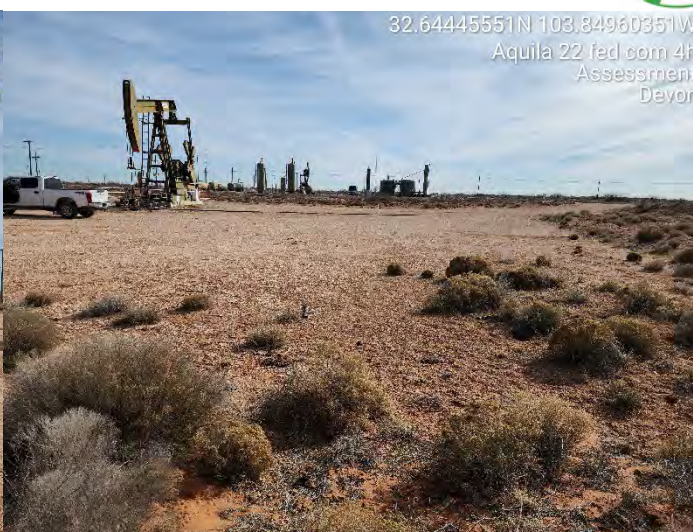
**SITE PHOTOGRAPHS
DEVON ENERGY
AQUILA 22 FED COM #4H**

Site Assessment
