Re: Anadarko Pardue Farms ANQ Com #1
30-015-22212
F-27-21S-24E
Eddy County, NM
2RP-468
nMLB1031337060

Anadarko Pardue Farms ANQ Com #1
Closure Report
#nMLB1031337060

Closure Report

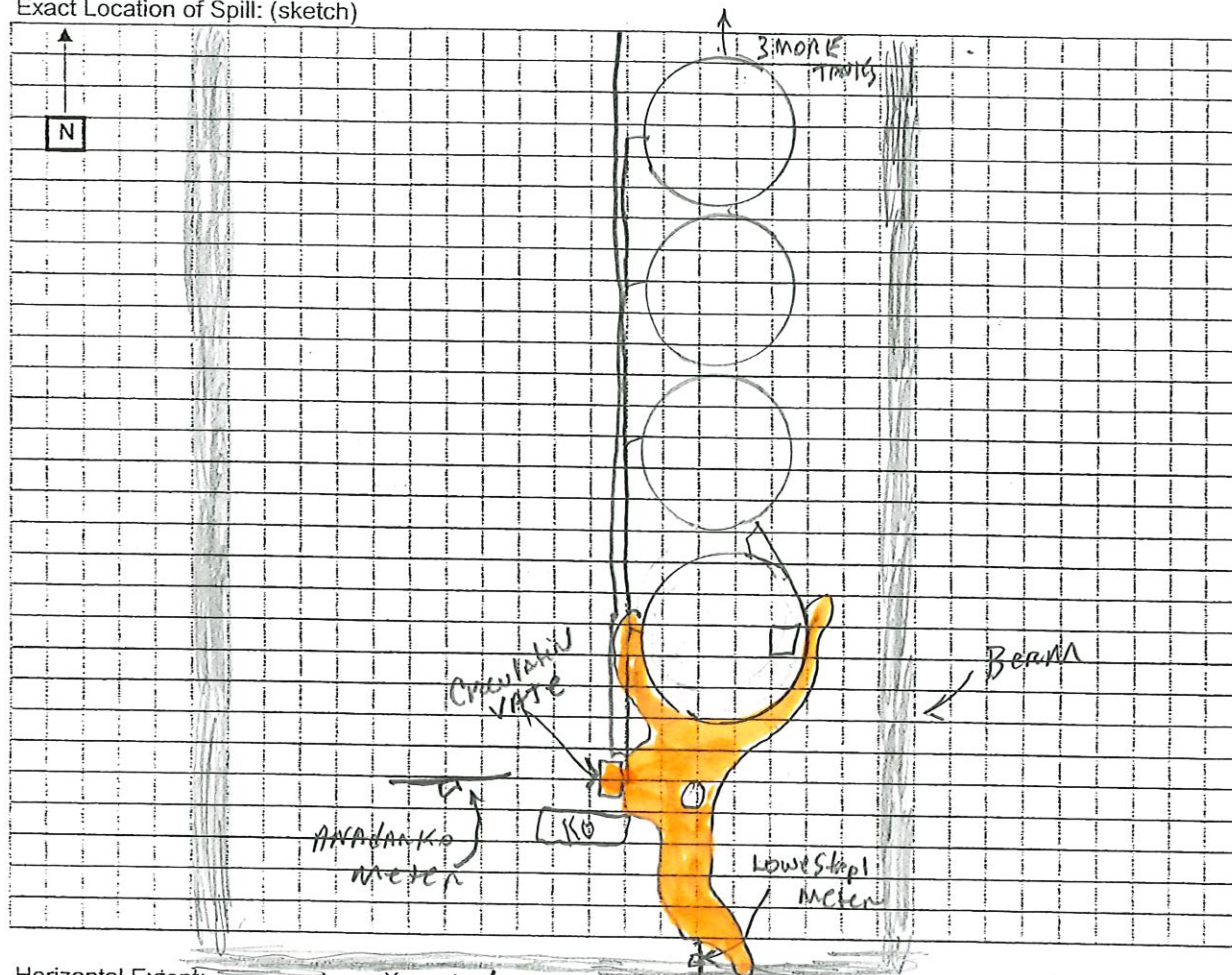
Exact Location of Spill: (sketch)

Horizontal Extent: 21' X 10' Estimated Vertical Extent: SOAKED 1" feet / inches

Degree of Contamination: ☒ Highly Contaminated/Saturated ☐ Unsaturated

☒ Excavate, remove and replace remove soil gravel & replace soil gravel

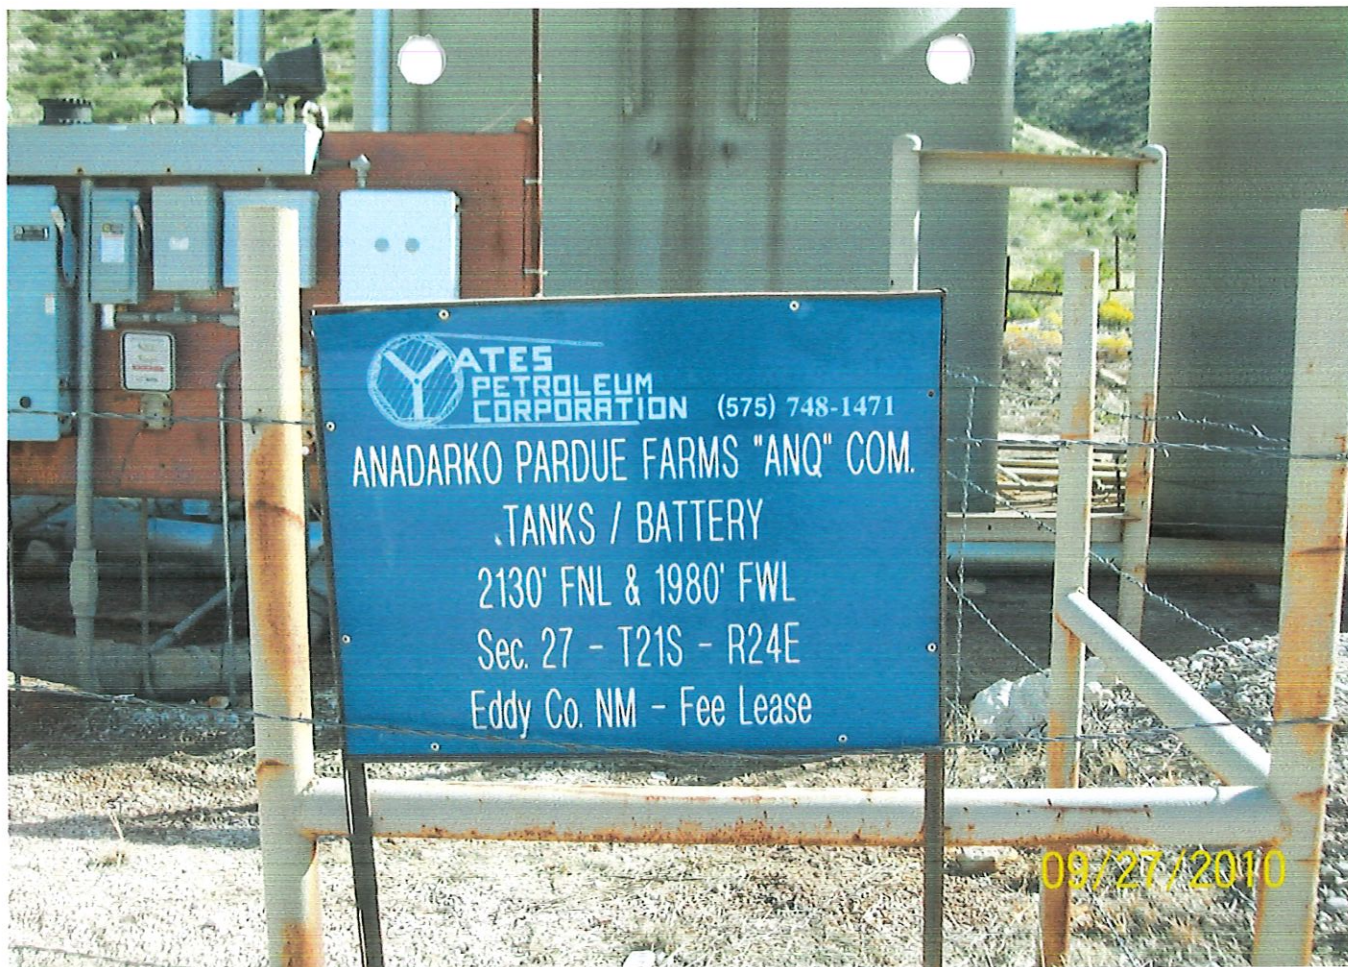
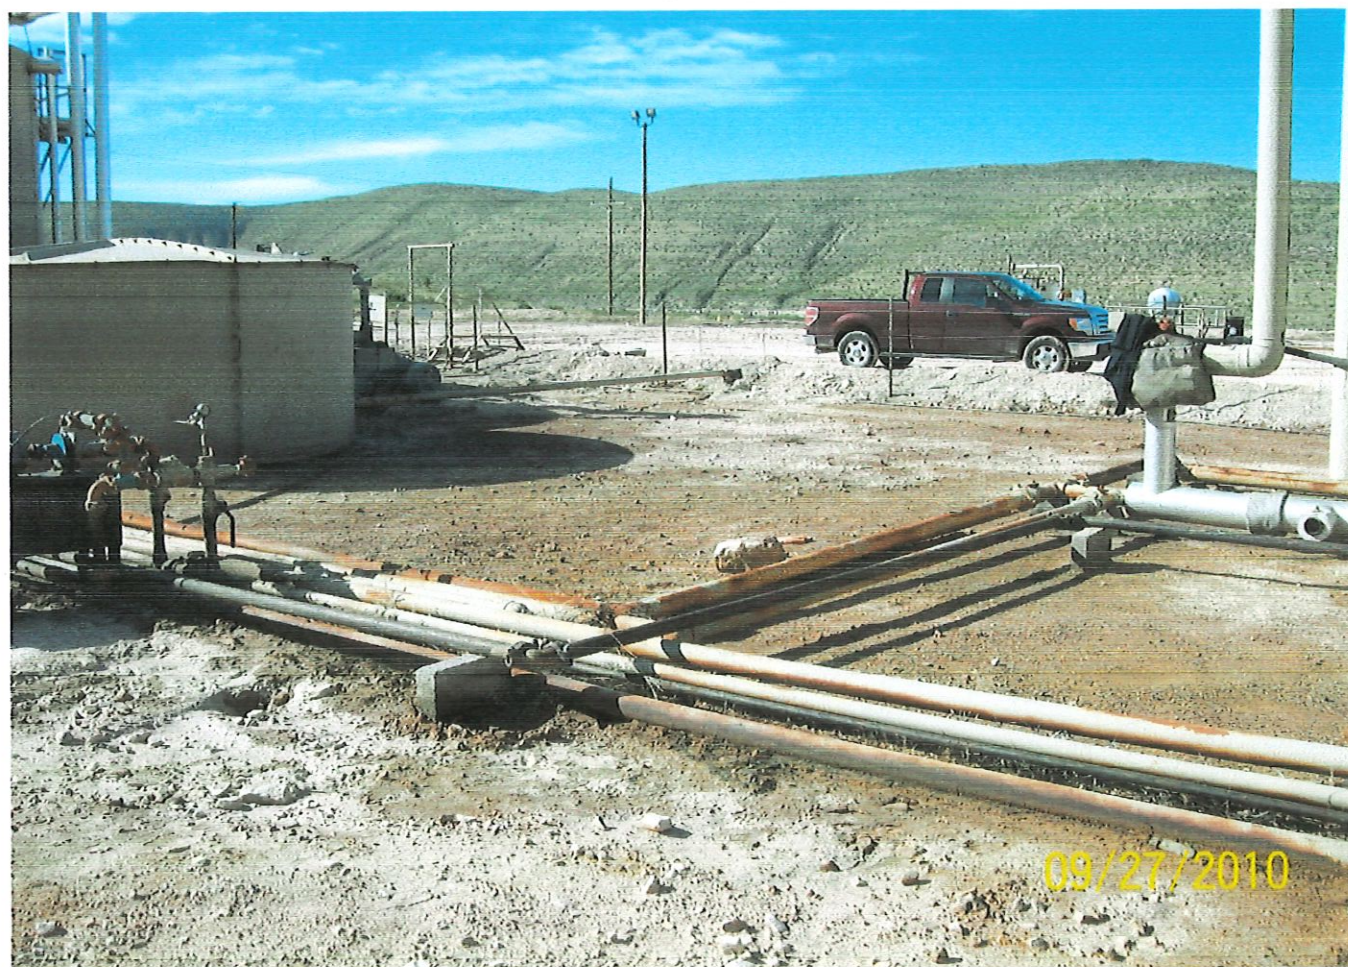
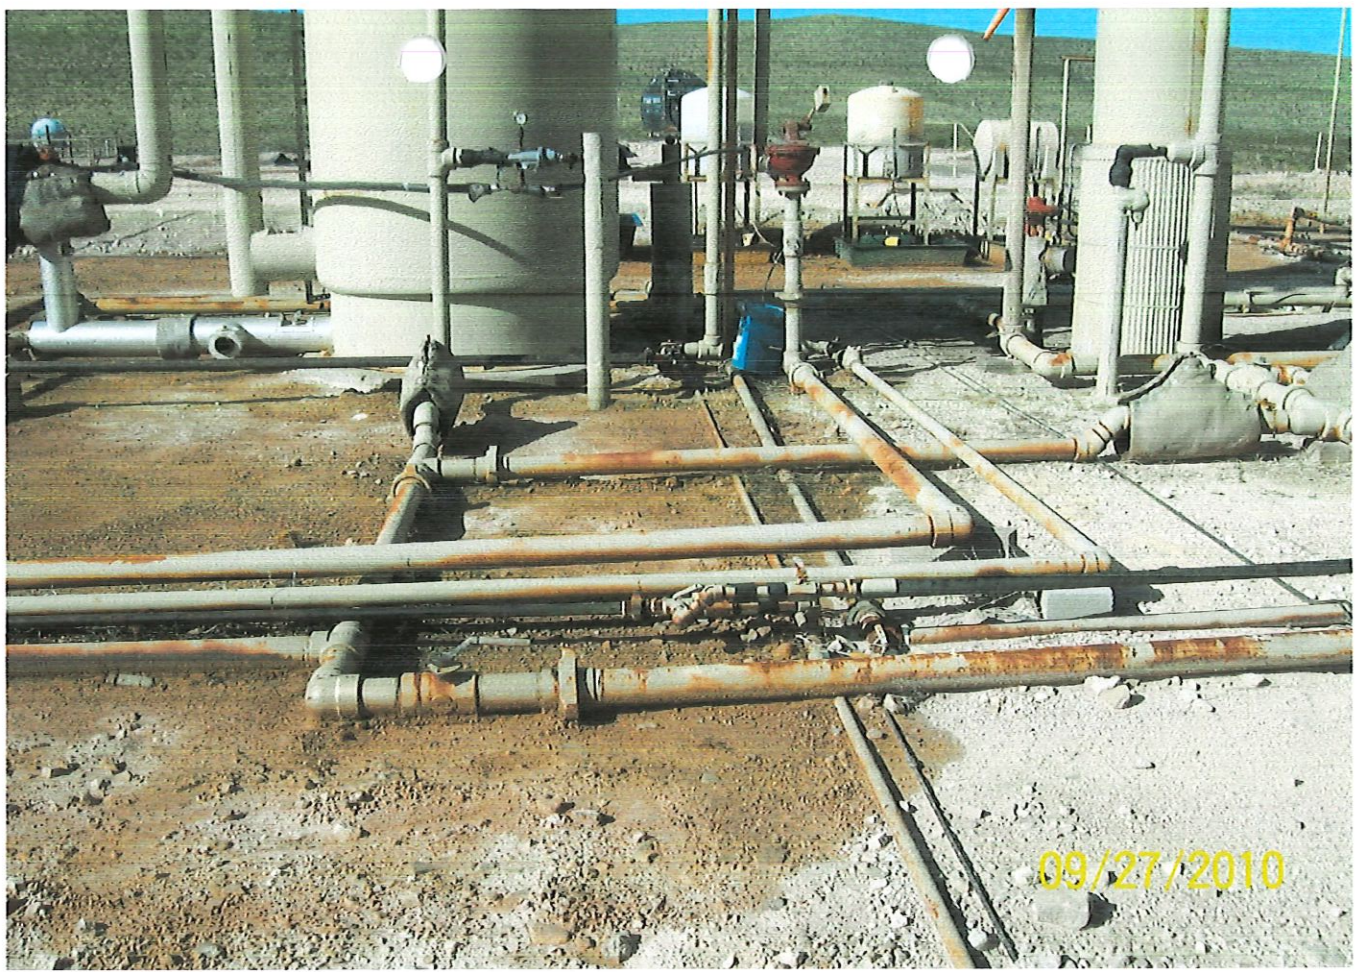
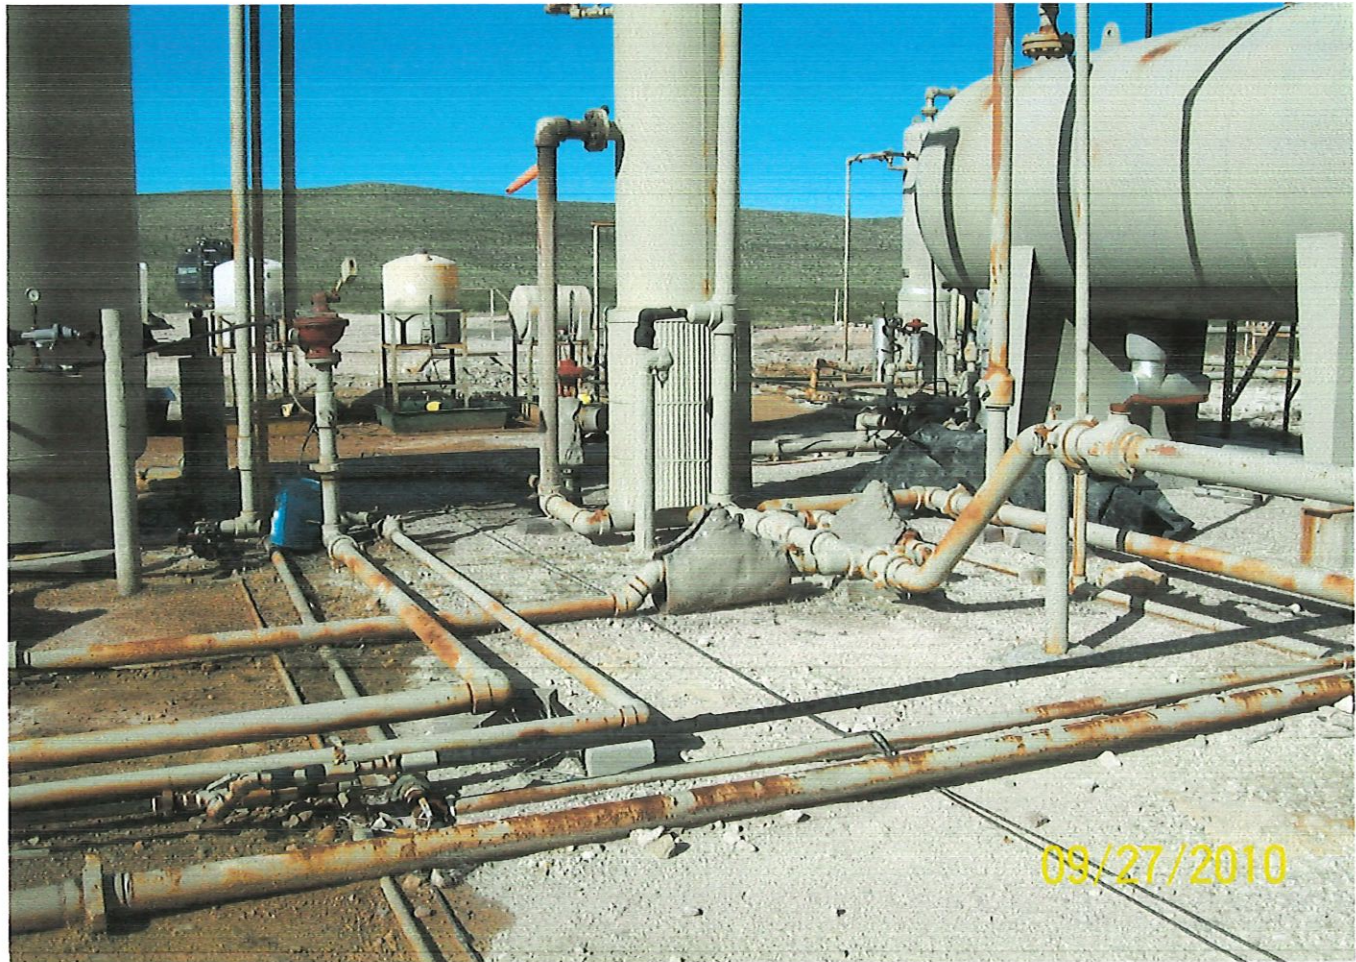
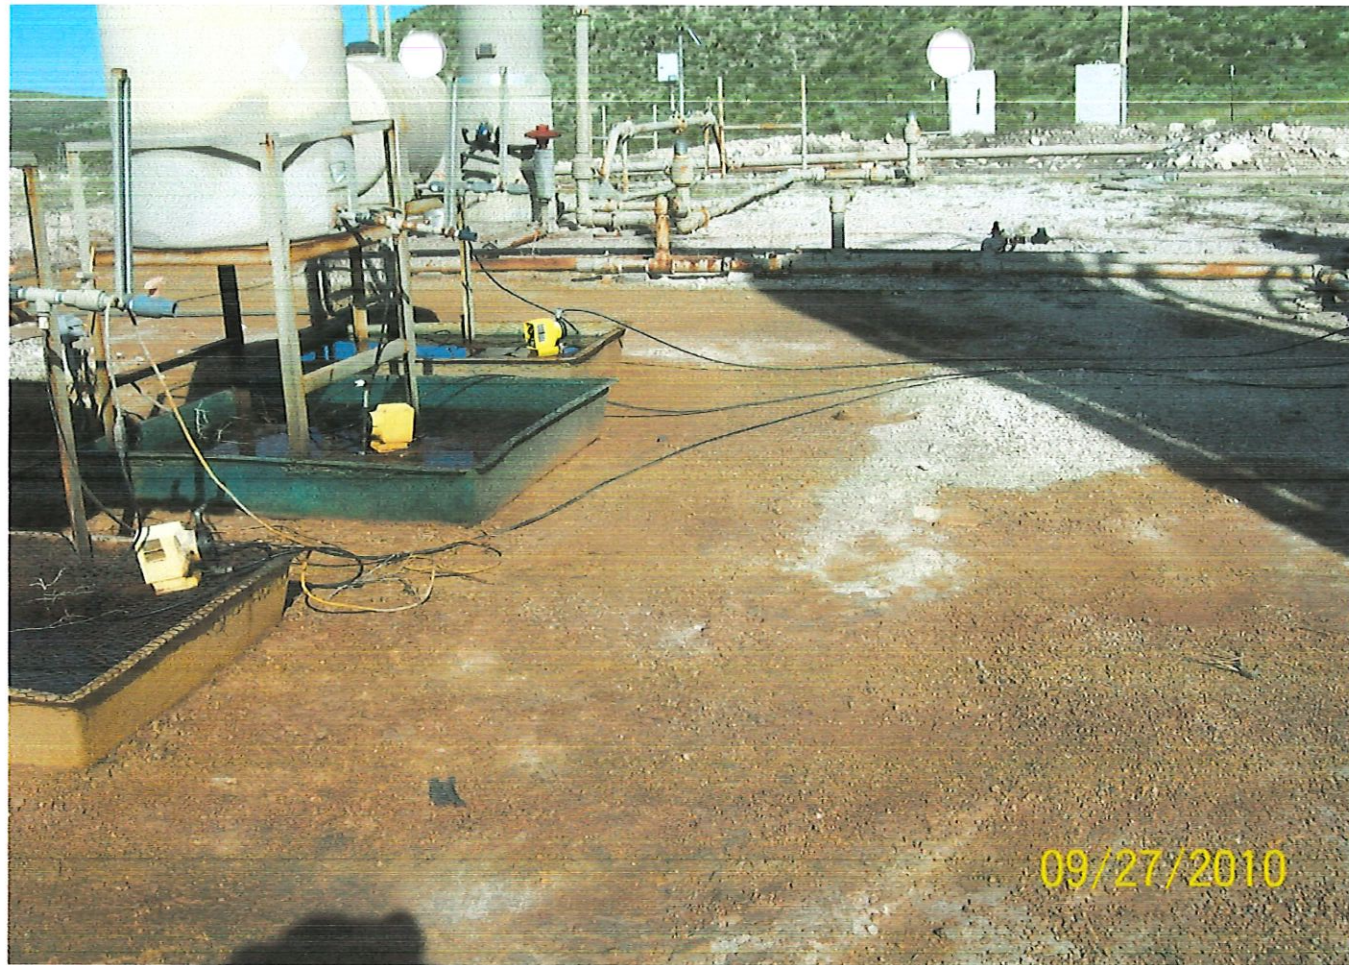
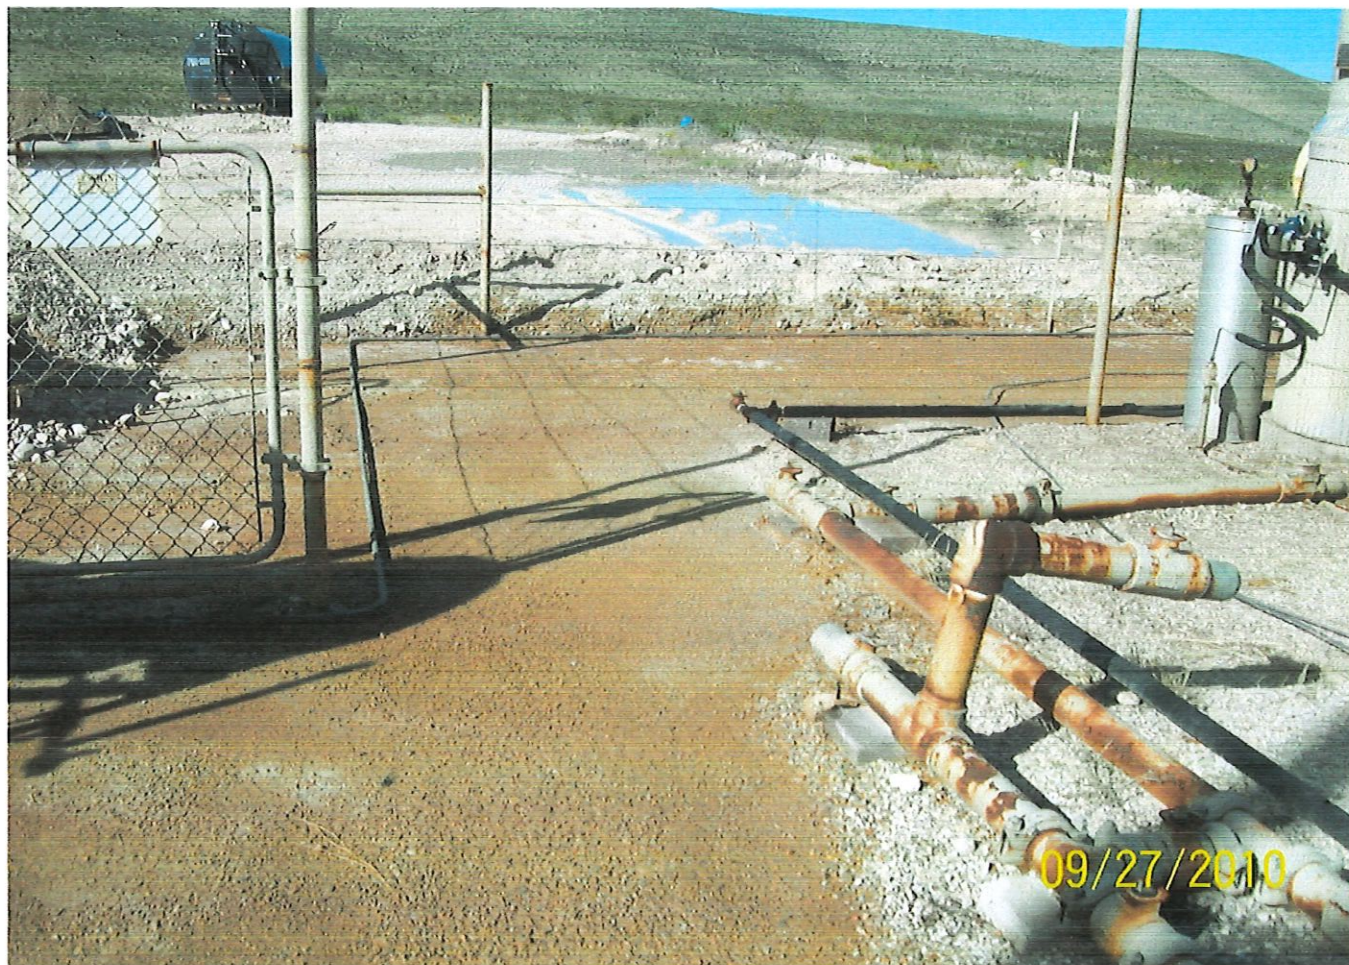
Internal YPC Documents/Photos

3. SOURCE AND CAUSE: Circulating pump failed AND Catch Valve RAN over
Valve Not fully closed. Circulated back through valve

Once the production tanks and equipment were removed from the release area, the excavation was increased to a depth of four (4) feet below grade surface (bgs). Confirmation soil sampling then occurred on January 14, 2011, with these samples submitted to Cardinal Laboratory for analysis. Results (Appendix D) of the confirmation sampling event indicated that the excavation had removed all impacted soils above the RRALs, meeting the closure criteria for the era.

Backfill of the excavation was undertaken beginning in May, along with further reconstruction of the battery. On September 27, 2011, the original C-141 Final was submitted to NMOCD requesting closure of 2RP-468. These documents are included as Appendix D.
