February 1, 2023

**Re: Release Characterization and Remediation Report
Maverick Natural Resources, LLC
MCA 478 Injection Line Release
Unit Letter O, Section 28, Township 17 South, Range 32 East
Lea County, New Mexico
Incident ID# nRM1935448024**

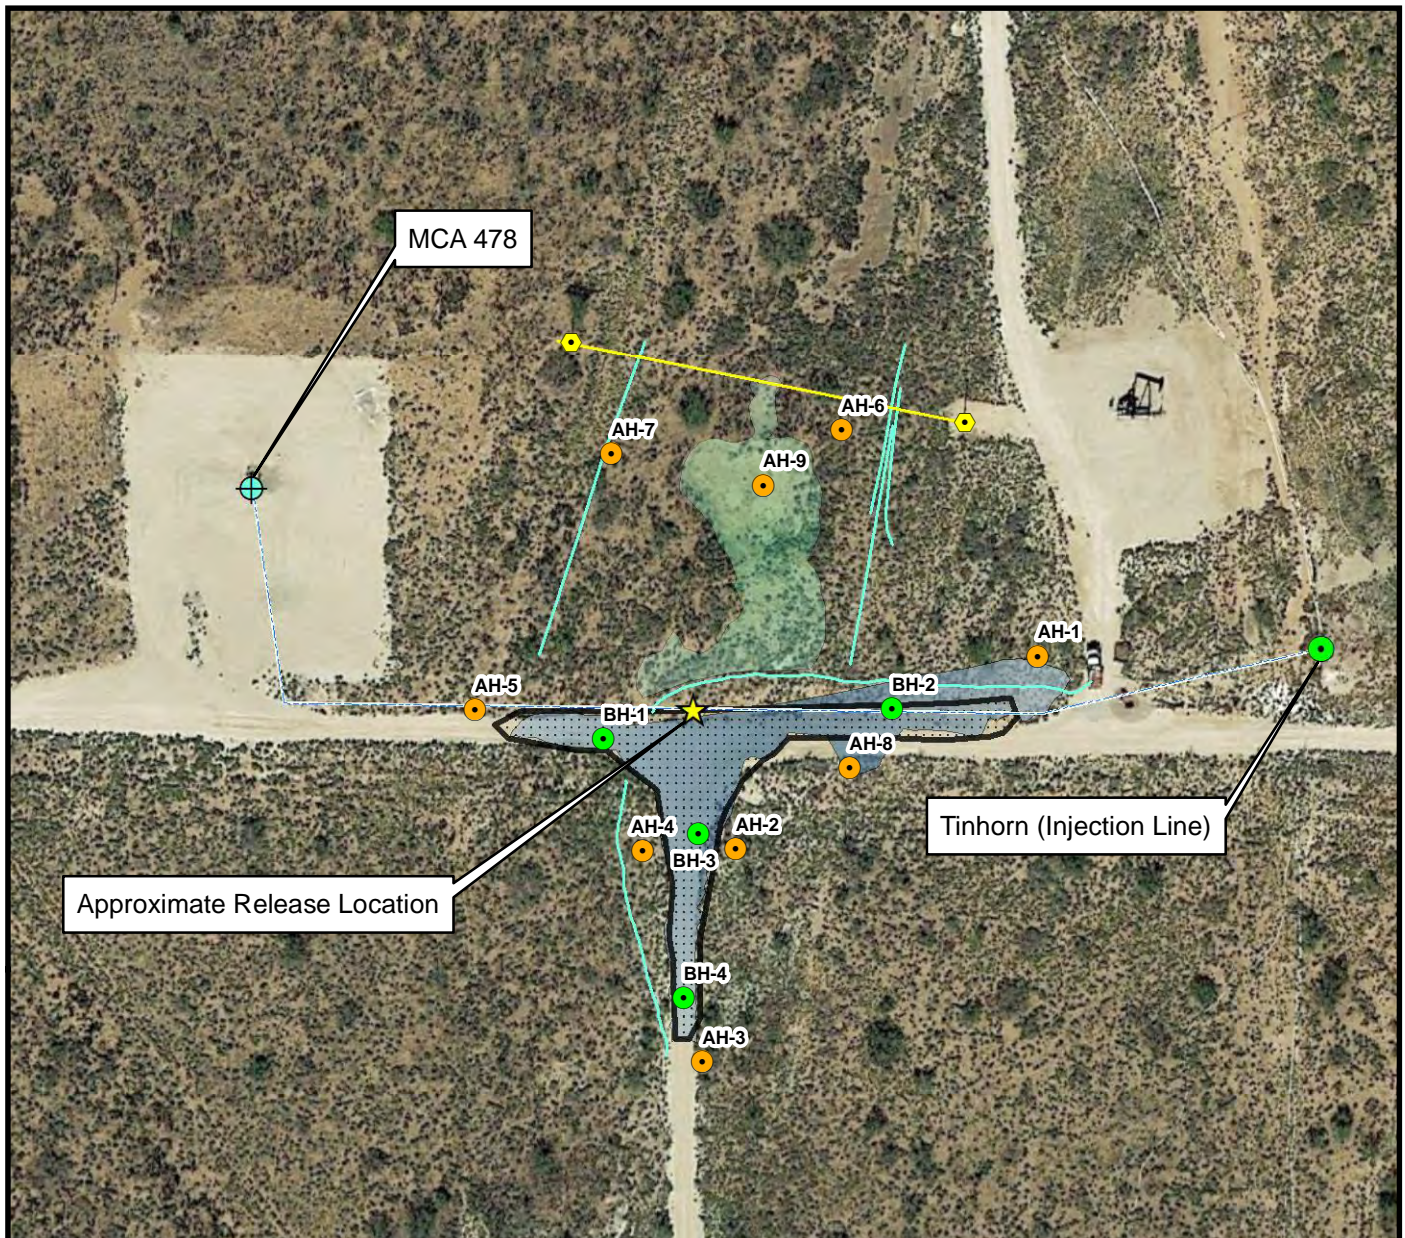
3

Tetra Tech conducted a visual site inspection of the release area on May 18, 2021, to assess current Site conditions and document the release area footprint. The NMOCD online well records indicate that the MCA 478 injection well is active. During the site visit, stressed vegetation was observed in the pasture north of the lease road and the reported release point coordinates. A cursory aerial review of this area revealed evidence of disturbed soils and possible remedial actions conducted in this area prior to the October 2019 injection line release. Based on this review, this area north of the release point is believed unrelated to the MCA 478 Injection Line Release. The nRM1935448024 release extent, area of disturbed soils, and observed site features are presented in **Figure 3**.

- Power Pole
- Boring Location
- Boring Location - Hand Auger
- Flowline
- Power Line
- Approximate Subsurface Water Injection Line
- Reported Initial Response Area
- Area of Previous Remediation
- Approximate Release Extent

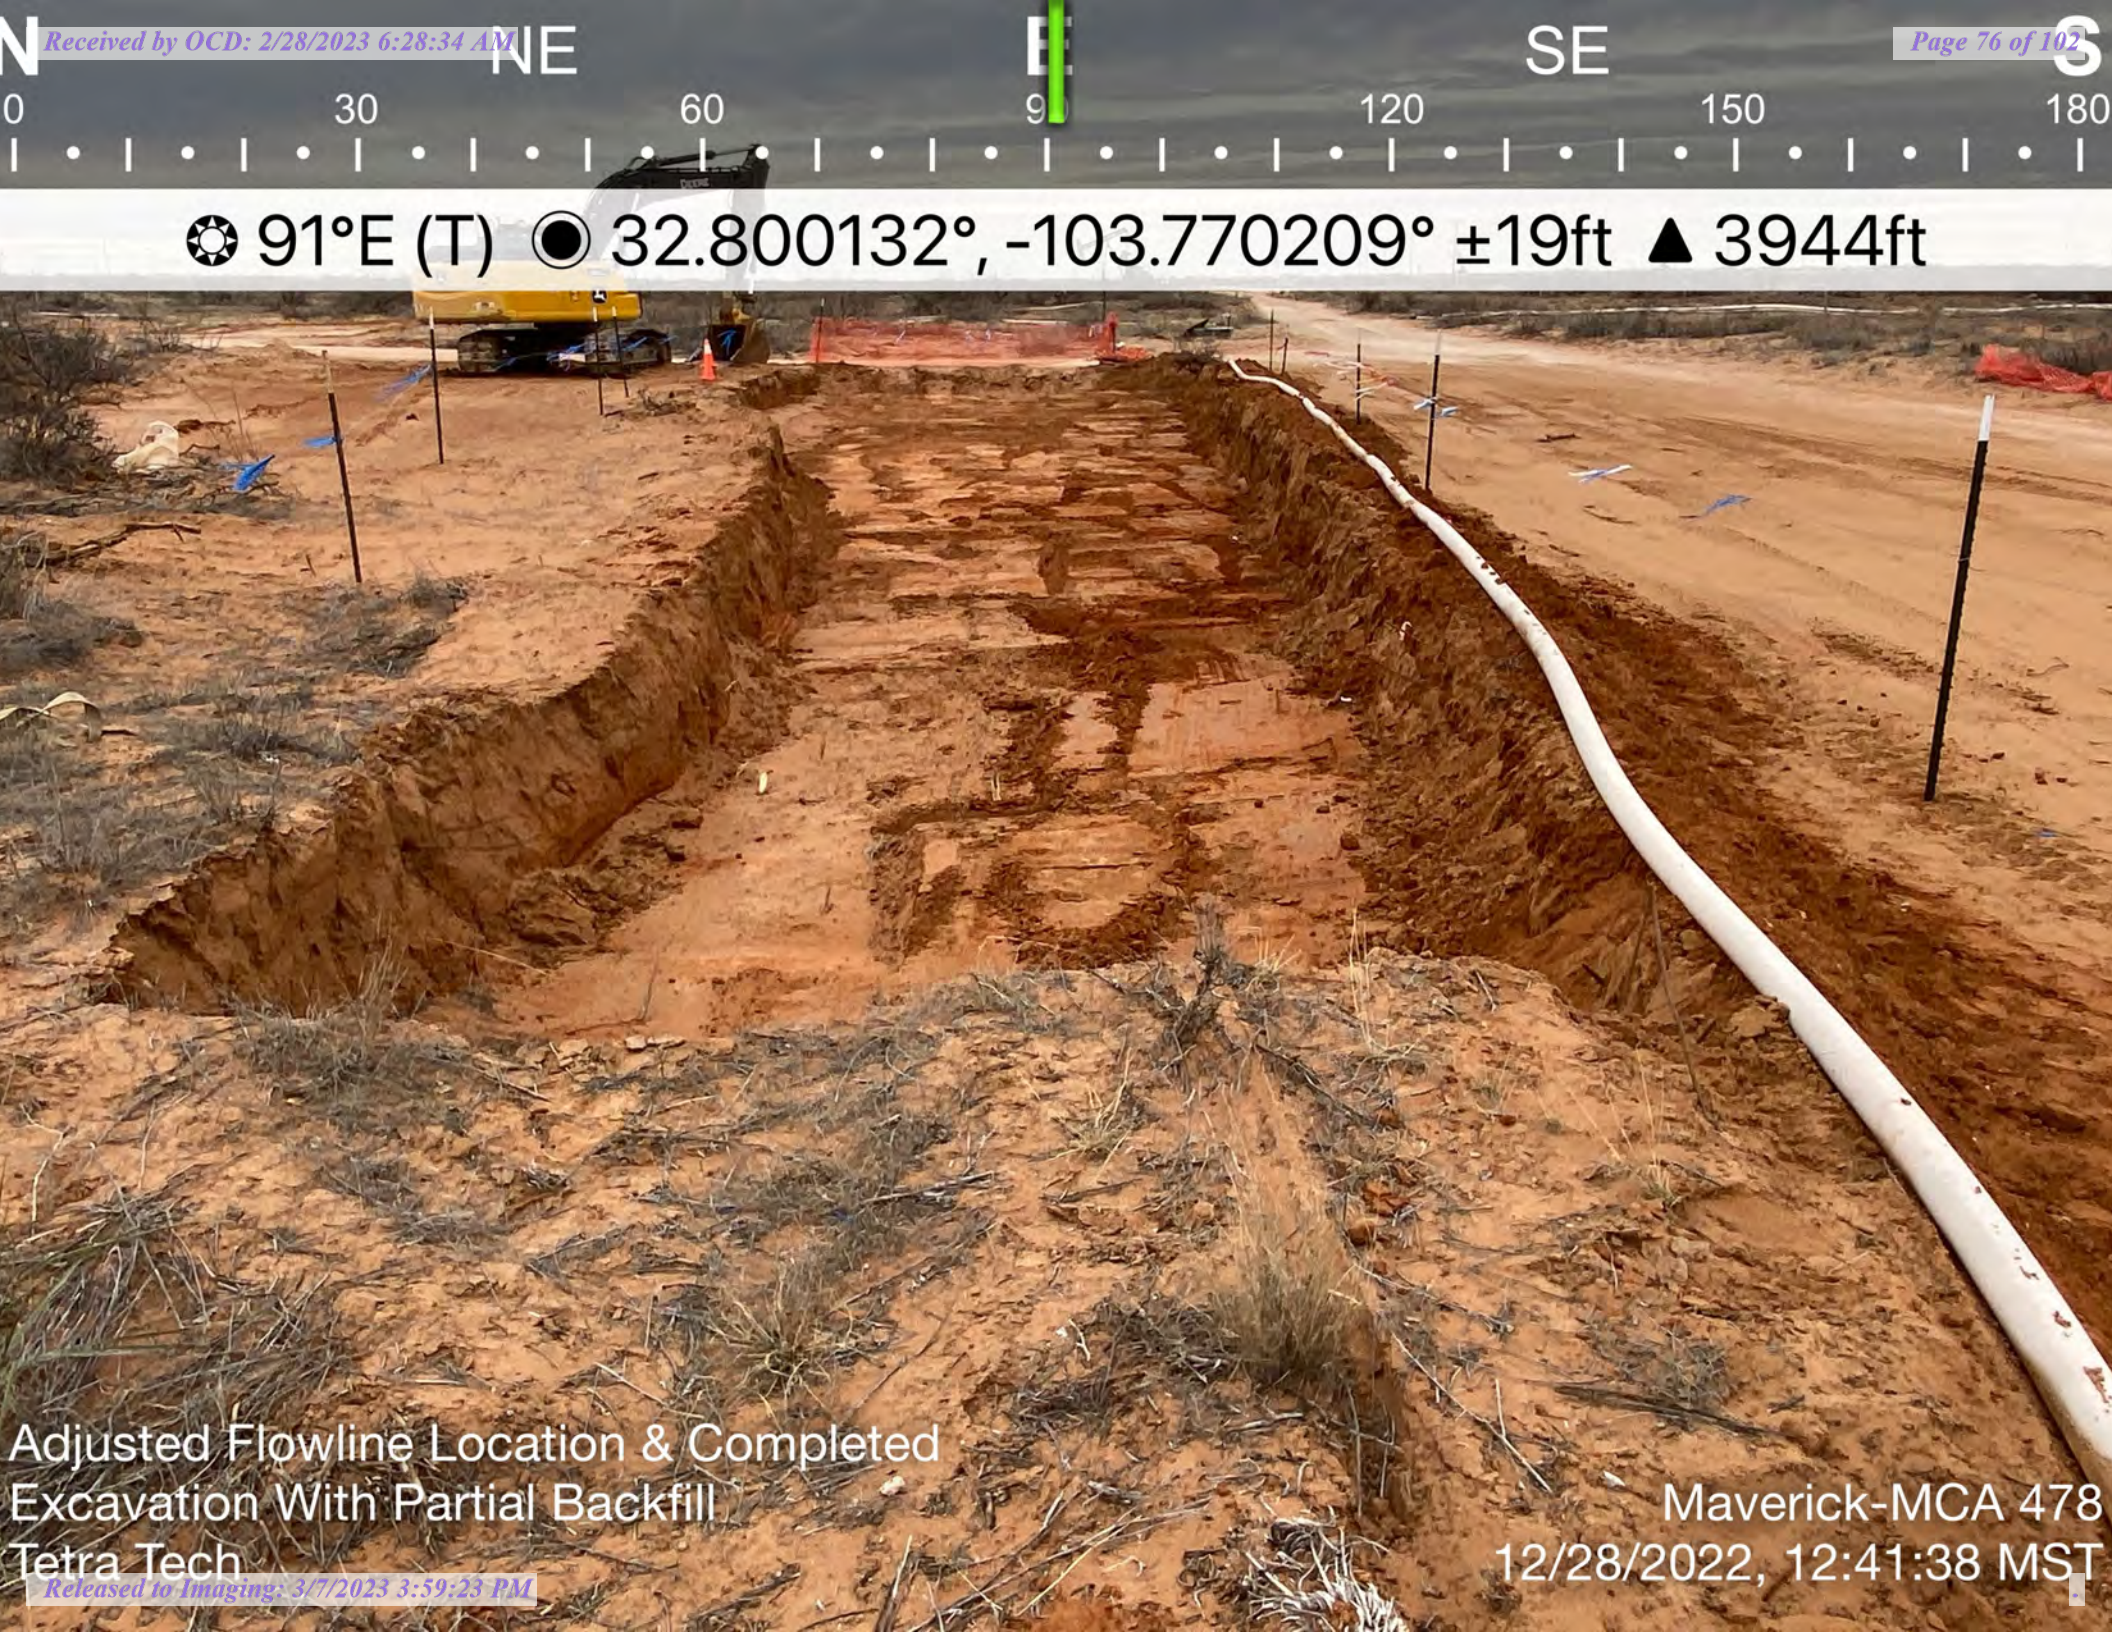
Adjusted Flowline Location & Completed
Excavation With Partial Backfill
Tetra Tech

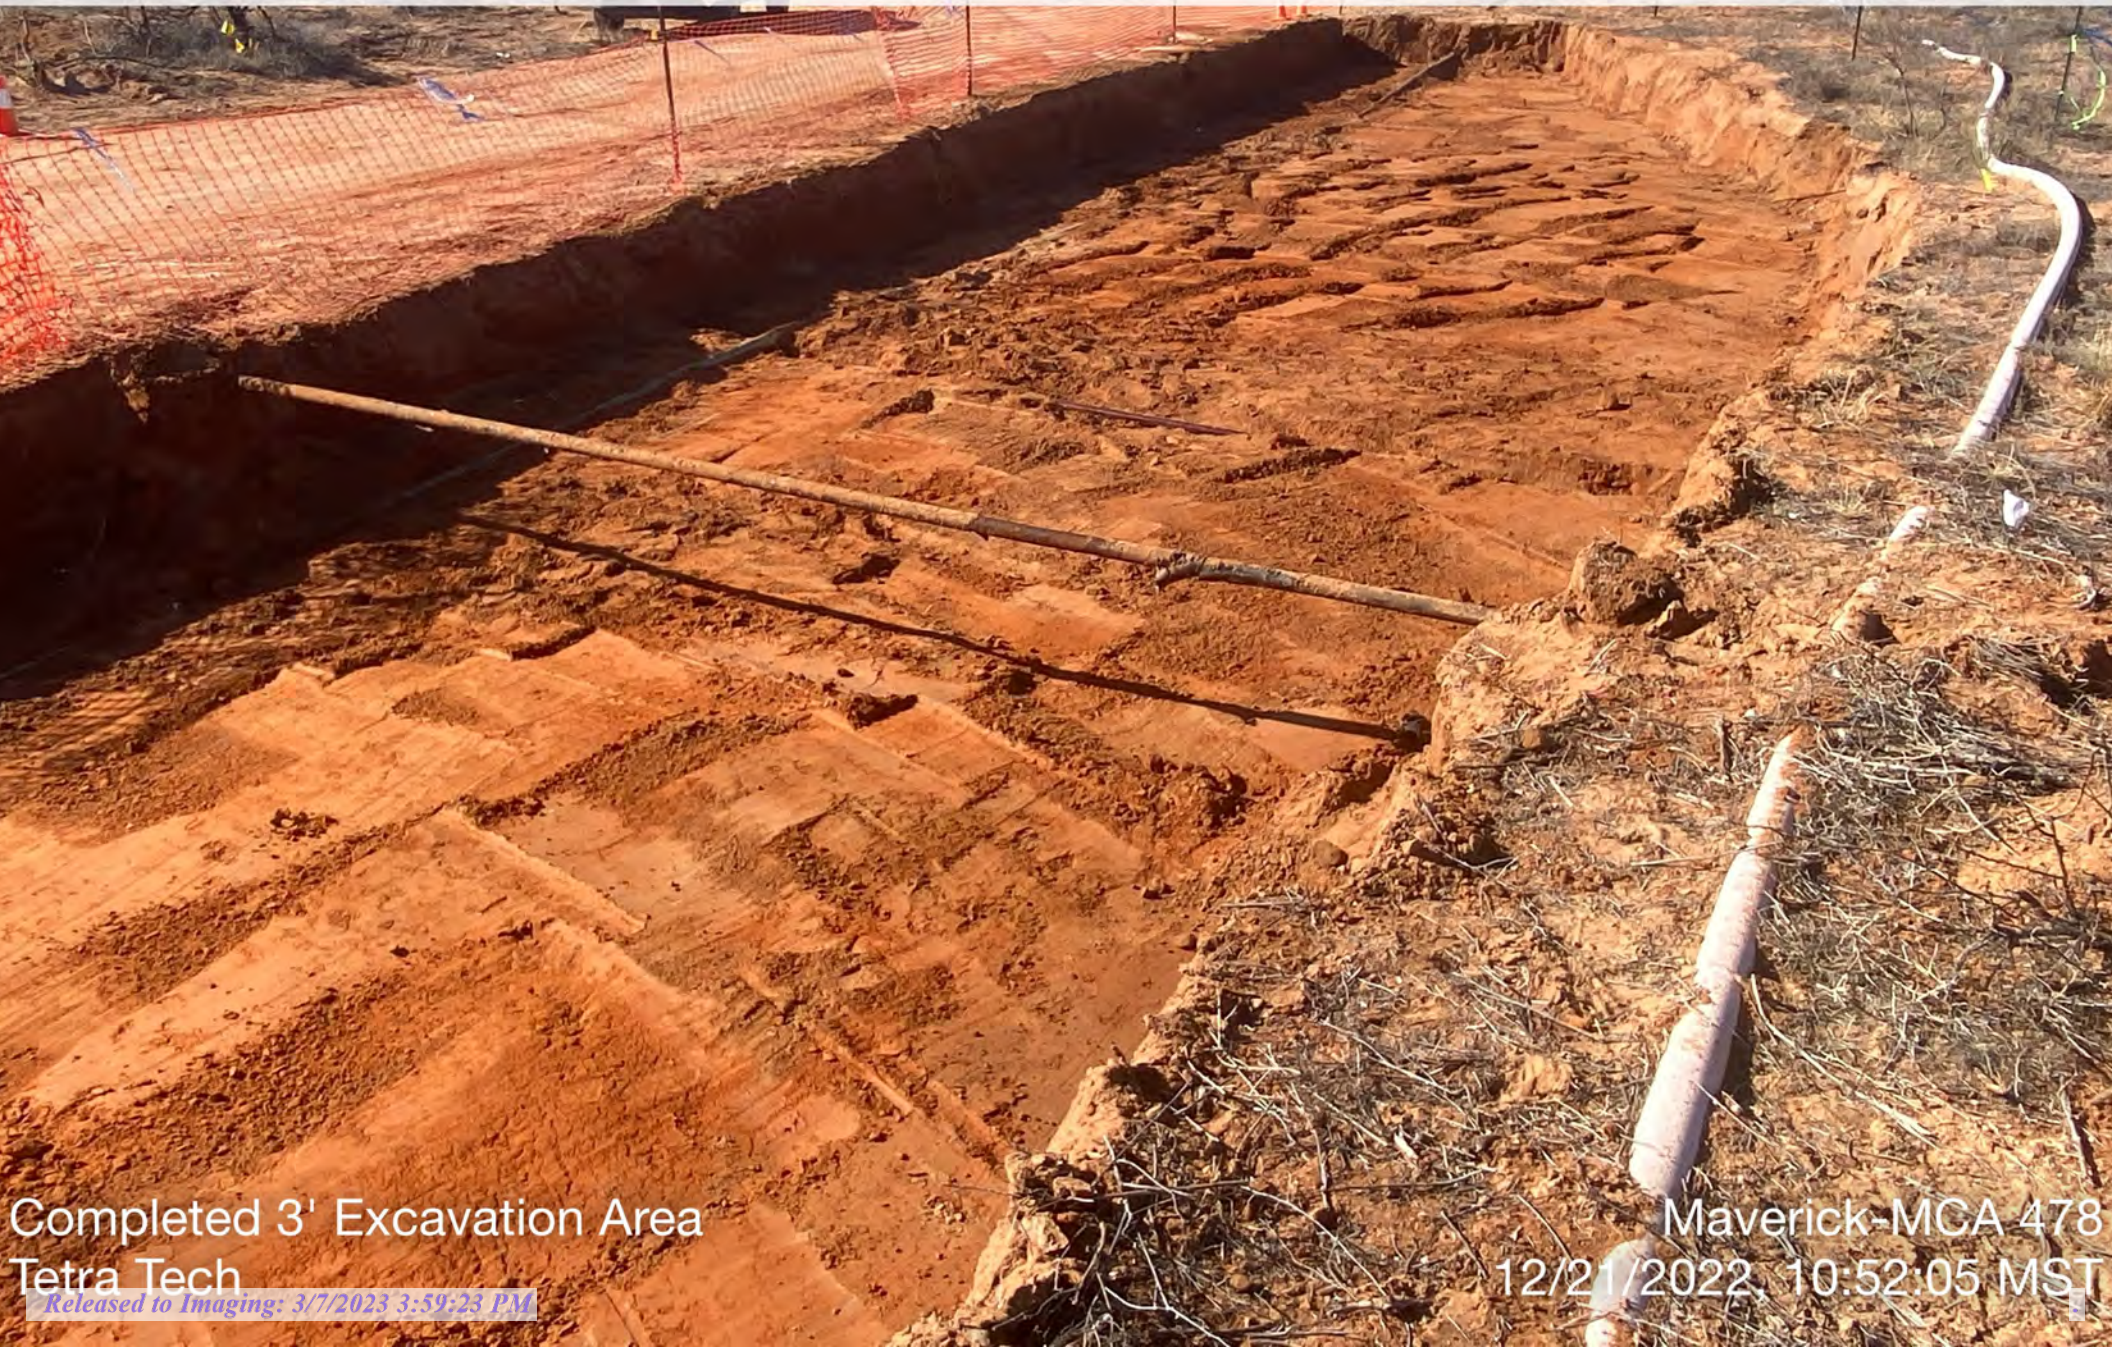
Completed 3' Excavation Area
