RE: CLOSURE REPORT FOR A RELEASE OF PRODUCED WATER LOCATED AT THE JICARILLA APACHE B 15E WELL SITE (API: 30-039-27724), RIO ARriba COUNTY, NEW MEXICO

RELEASE CLOSURE REPORT

LOCATION:
JICARILLA APACHE B 15E WELL SITE
SECTION 30, TOWNSHIP 24N, RANGE 5W
RIO ARRIBA COUNTY, NEW MEXICO

PROJECT #17035-0219
NMOCD INCIDENT #NCS1917731471
JUNE 4, 2020

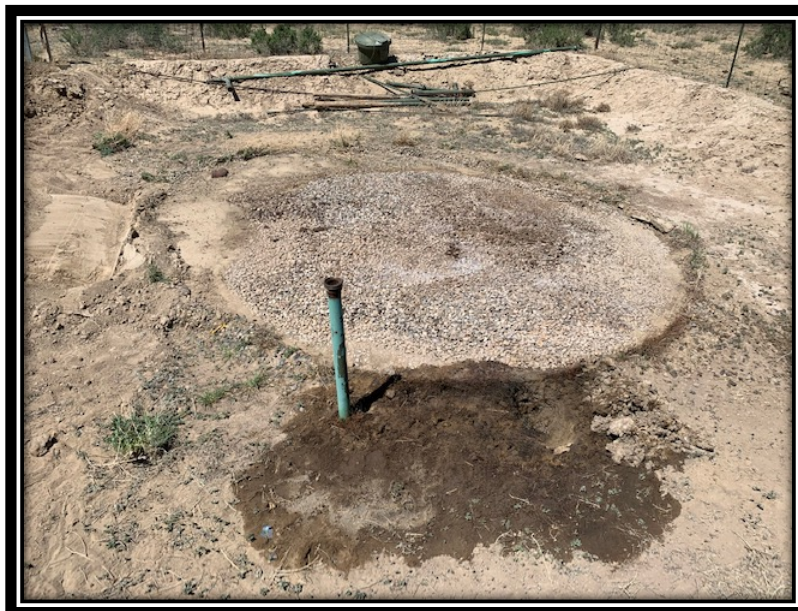
Picture 2: View of Release

Cause of Release: A small hole in tank was discovered 4" above the bottom of the tank.

Prior to Envirotech's arrival, DJR had removed the produced water tank and excavated the contaminated soil. Excavation dimensions were approximately 15 feet by 12 feet by 9 feet total depth. Confirmation soil samples were collected under witness of Orson Sandoval, Jicarilla Apache Nation Oil and Gas (JOGA) representative, on May 22, 2020.

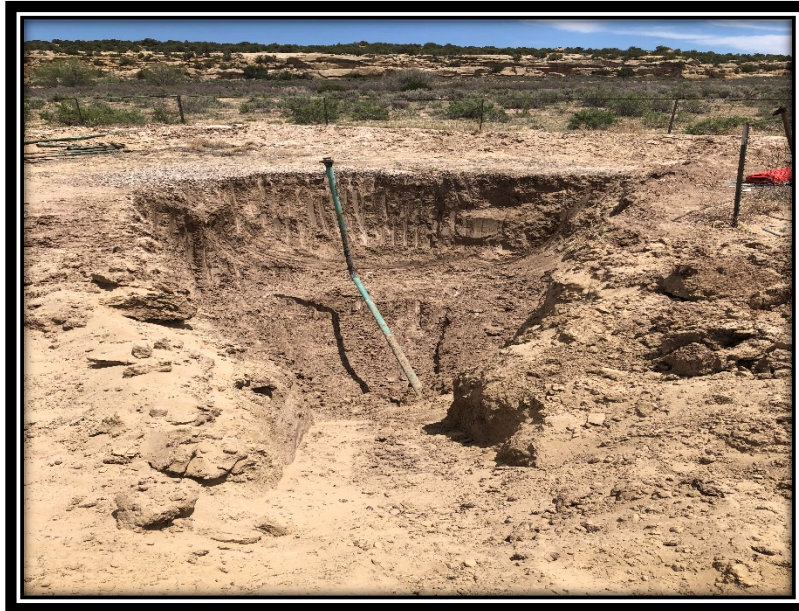
Picture 3: View of Excavation Looking North

One (1) five-point composite sample was collected from the north wall, east wall, west wall, and base for a total of four (4) soil samples. A sample was not collected from the south wall since it consisted of a clean overburden ramp built to access the excavation. Samples were placed into individual laboratory provided 4-ounce jars, capped head space free, and transported on ice to Envirotech Analytical Laboratory. Soil samples were analyzed for total petroleum hydrocarbons (TPH) as gasoline, diesel, and oil range organics (GRO/DRO/ORO) using EPA Method 8015D; benzene, toluene, ethylbenzene, and total xylenes (BTEX) using EPA Method 8021B; and chlorides using EPA Method 300.0. Soil sample locations are illustrated in **Figure 2, Site Map and Appendix A, Site Photography**.

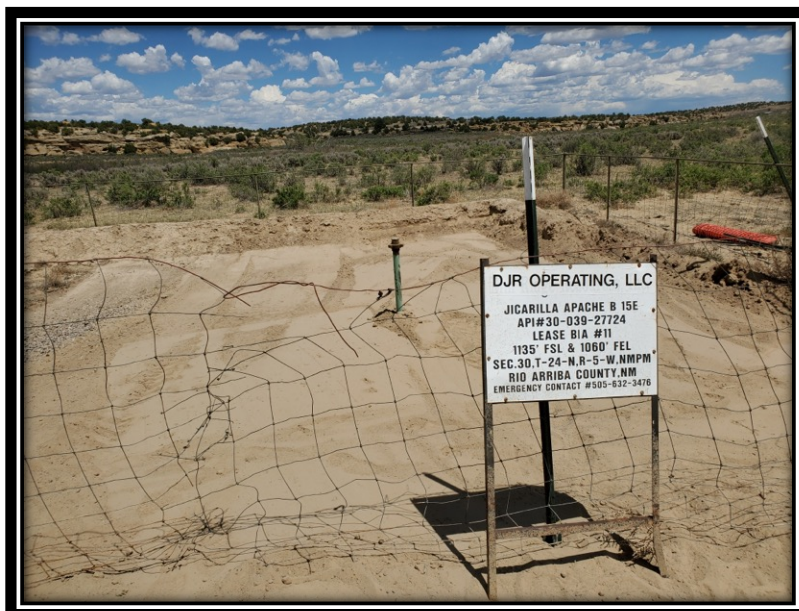
Picture 4: Subsequent Backfill of Release Site

Based on the final laboratory analytical results of the excavation at the location, GRO, DRO, ORO, BTEX, and chlorides were below the applicable NMOCD and (JOGA) Closure Criteria for Soils Impacted by a Release. DJR Operating will place an above ground tank back in operation at the location; therefore, reclamation will not be required at this time. Envirotech recommends **No Further Action** regarding the subject release site.

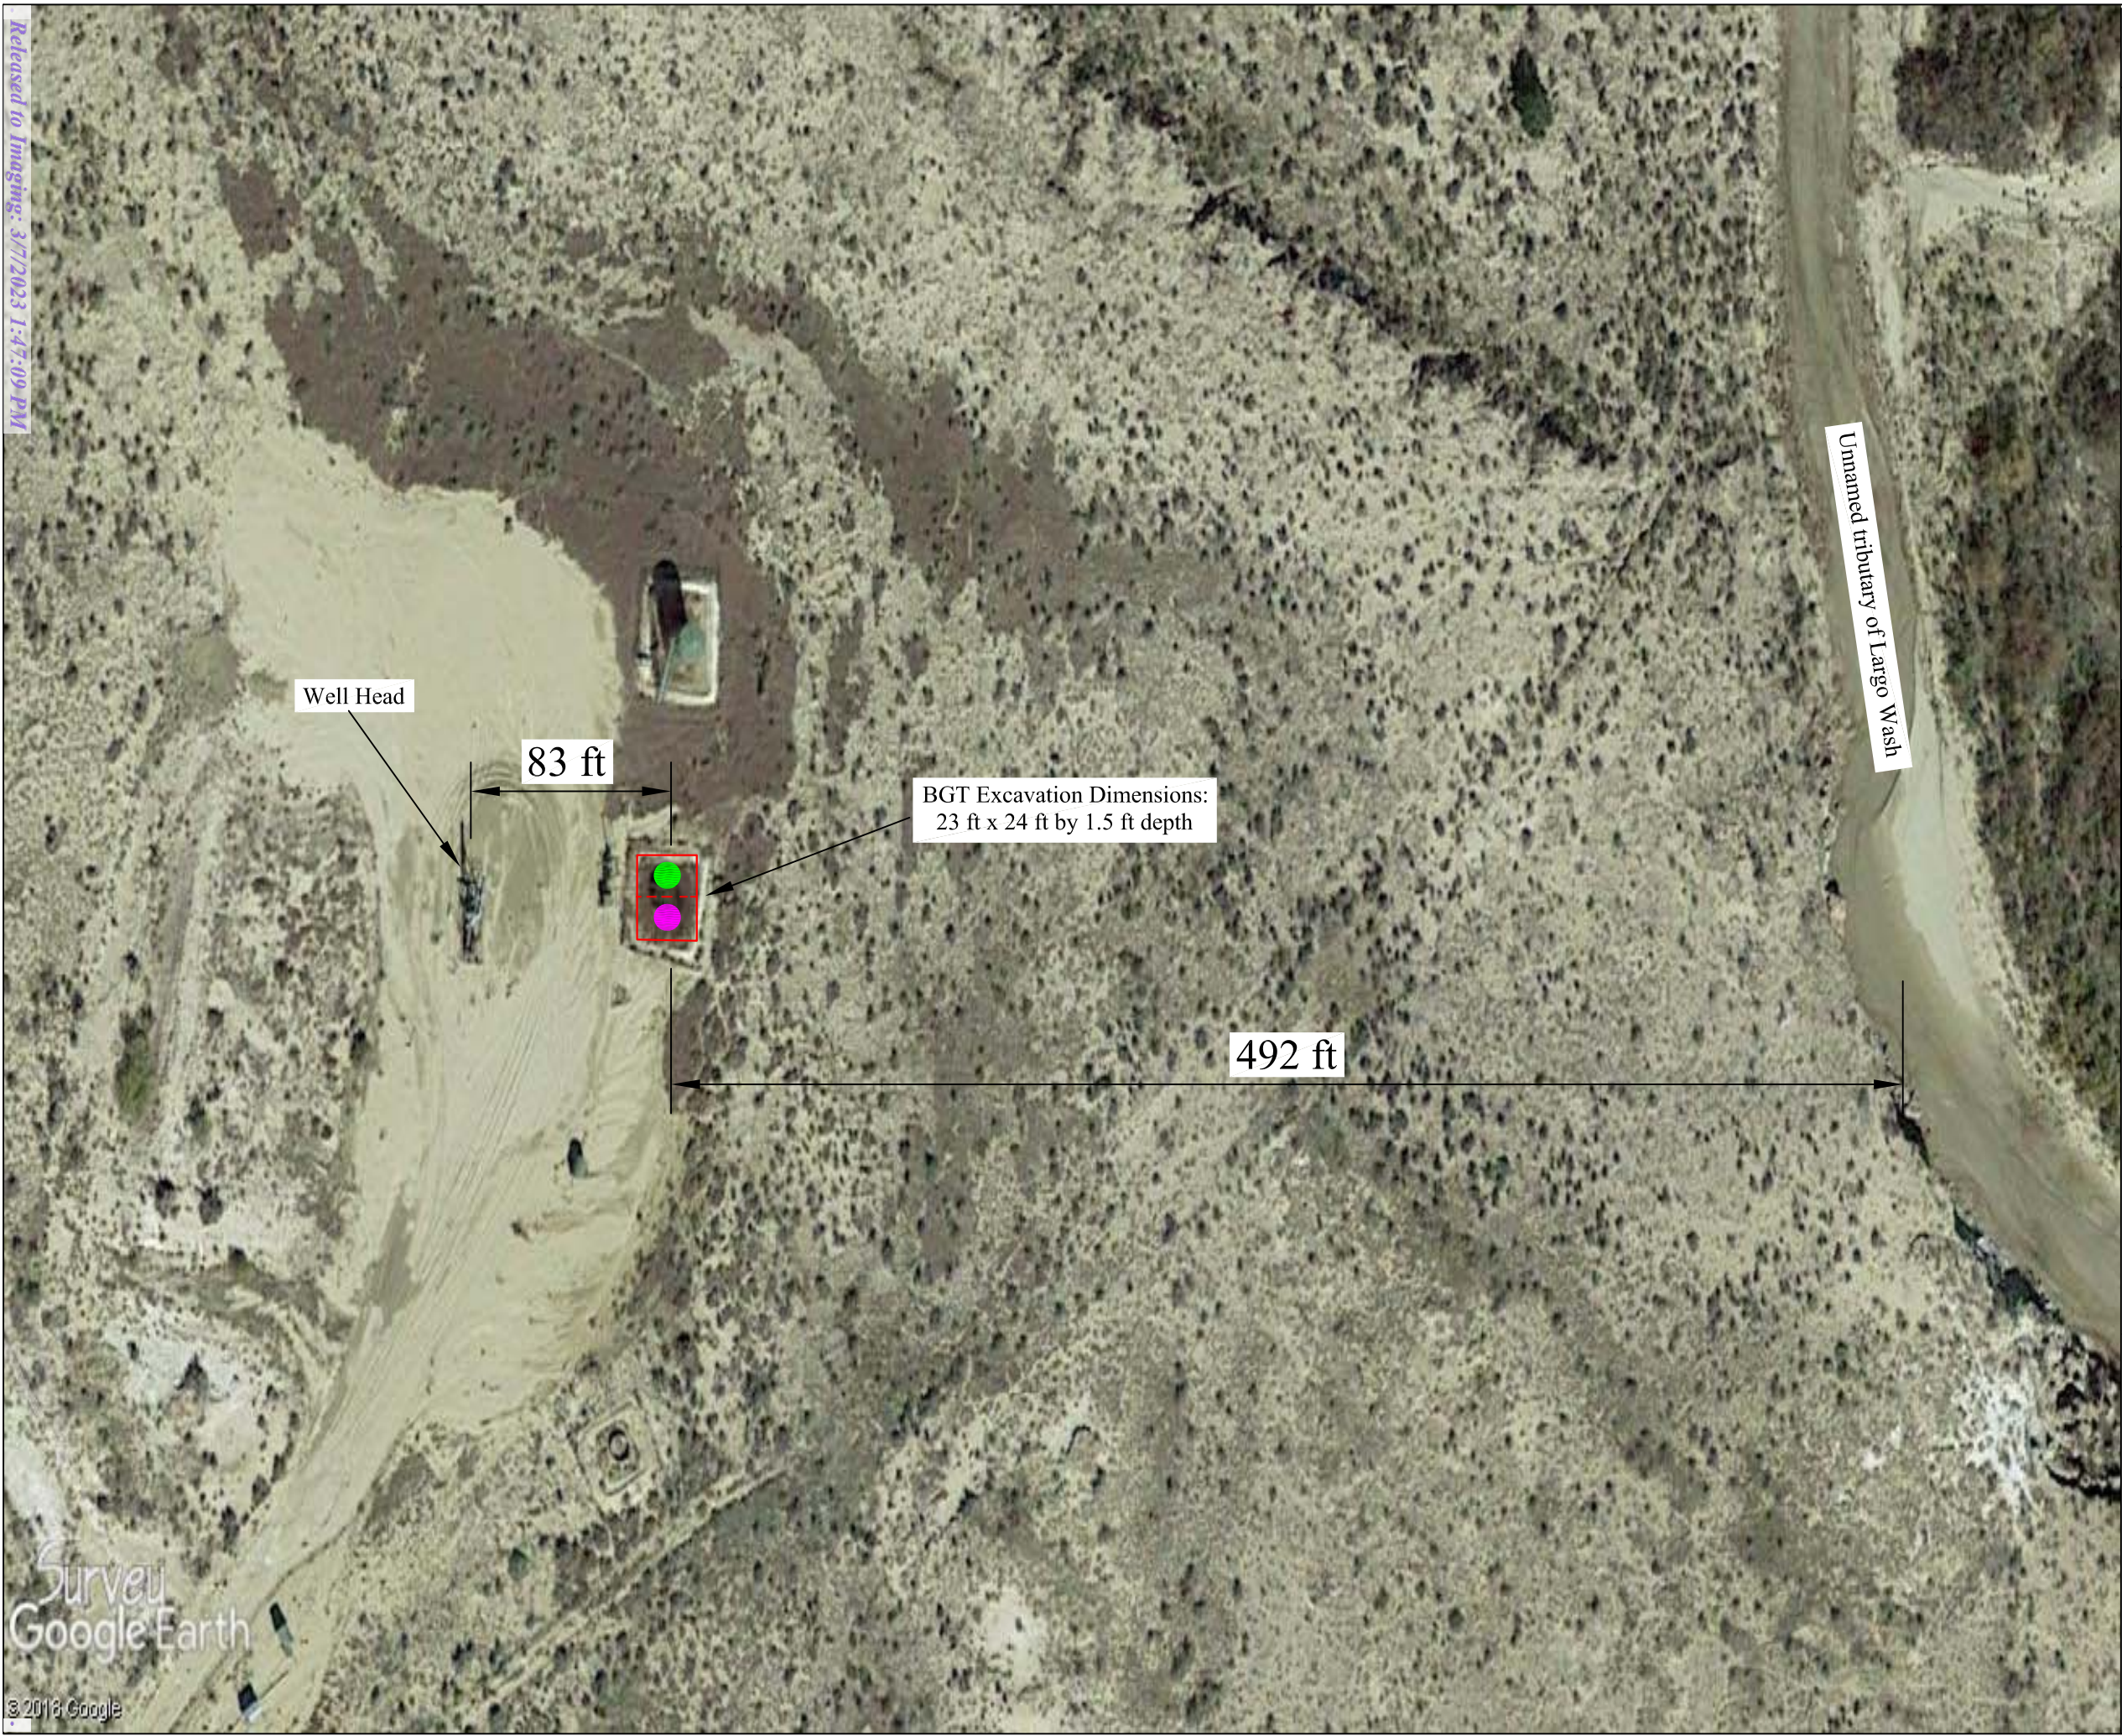
Figure 3, Siting Criteria Map

Sample locations represent 5-point composite samples
caollected along the excavation walls and base

Depth to Groundwater Determination (NMAC 19.15.29.11A.2)				
Cathodic Report/Site Specific Hydrogeology	None Available			
Elevation Differential	46 ft higher elevation than SJ-00074 (similar proximity to unnamed			
Water Wells	SJ-00074 reports depth to water at 216 feet			
Cathodic Report Nearby Wells	None Available			
Sensitive Receptor Determination			Yes	No
