RELEASE CLOSURE REPORT  
XTO ENERGY, INC. — HARDISON (API#: 30-025-06808)

1RP-3045

**Re: Release Closure Report**  
**XTO Energy, Inc.**  
**F F Hardison B No. 005**  
**RP #: 1RP-3045**  
**Approximate Geographic Coordinates: 32.442357°N, -103.144816°W**  
**Unit Letter O, Section 27, Township 21S, Range 37E**  
**Lea County, New Mexico**

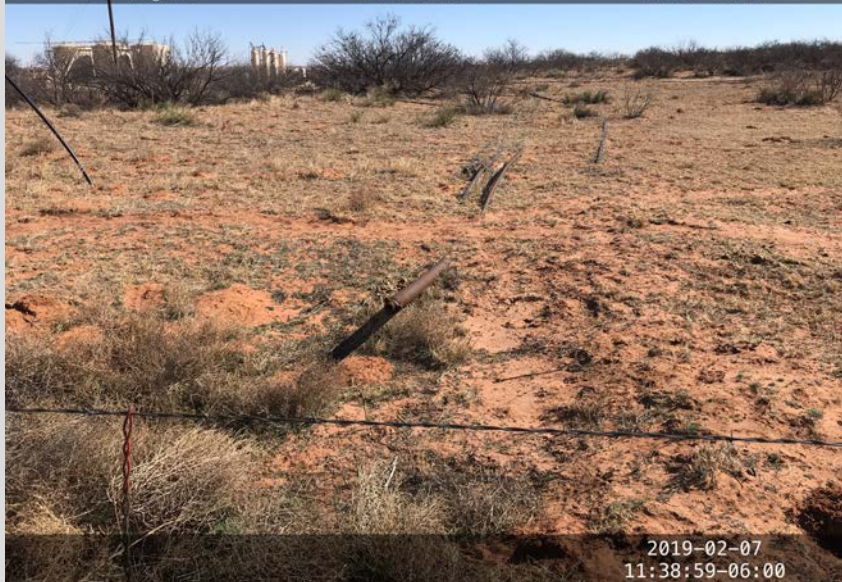
<p>The subject site is visible and vegetation is present. Hand-augering was the only means of sampling possible in this location due to safety concerns including the presence of flowlines and underground piping. The site is also located near a railway line and electrical power lines.</p> <p>This photograph was captured in February 2019 during a pre-sampling site survey to assess the location.</p>
<div data-bbox="289 1098 974 1146"> DIRECTION 32.44226°N ACCURACY 6 m  36 deg(T) 103.14468°W DATUM WGS84 </div>

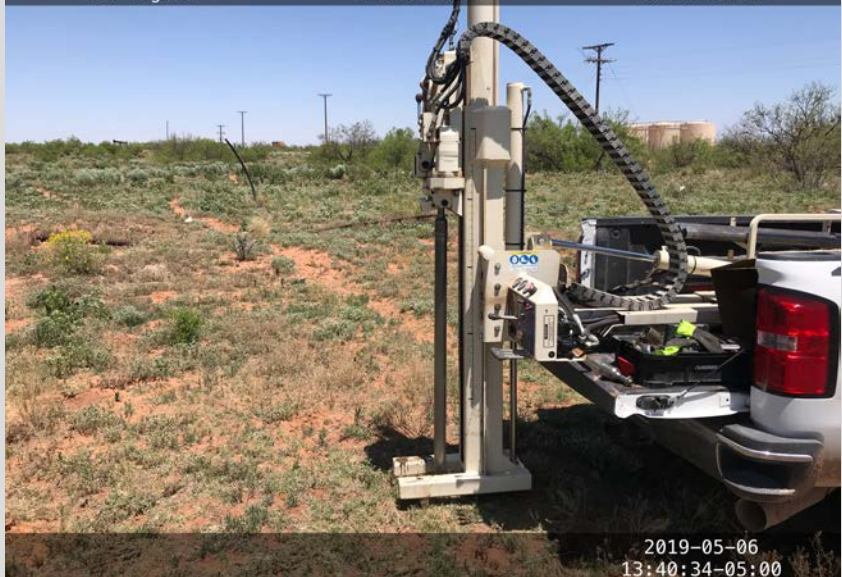
<p>Soil boring 1 (SB1) sample location is pictured here. Photograph shows that vegetation is present at the subject site and that the topography matches the surrounding area.</p>

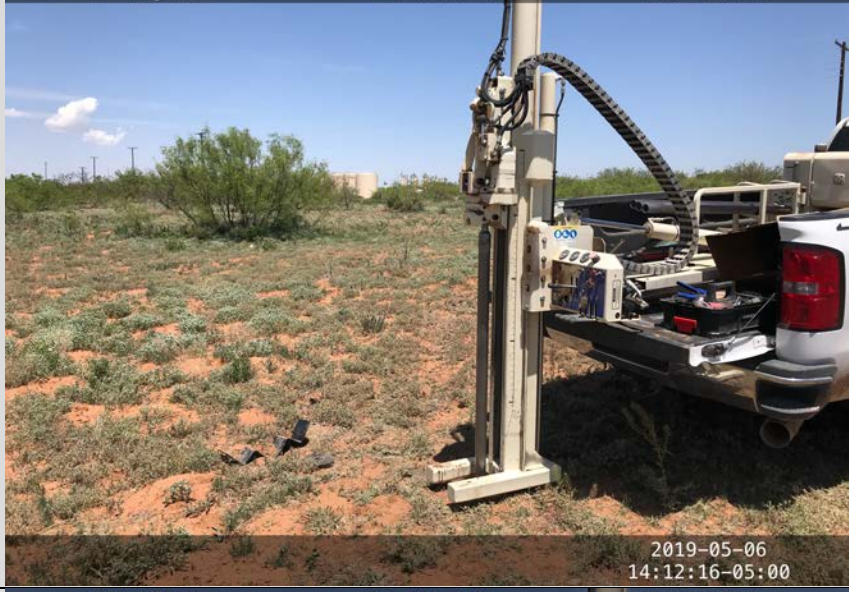
<div>2019-05-06 14:12:16-05:00</div></div></div>	<p>Soil boring 2 (SB2) sample location is pictured here. Photograph shows that vegetation is present at the subject site and that the topography matches the surrounding area.</p>
<div><div><div>DIRECTION 18 deg(T)</div><div>32.44140°N 103.14429°W</div><div>ACCURACY 4 m DATUM WGS84</div></div><div>

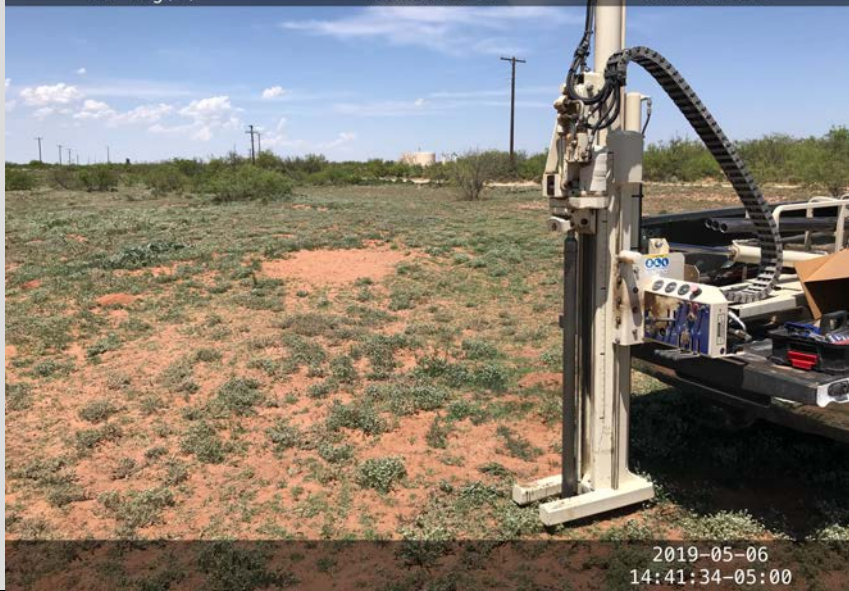
<div>2019-05-06 14:41:34-05:00</div></div></div>	<p>Soil boring 3 (SB3) sample location is pictured here. Photograph shows that vegetation is present at the subject site and that the topography matches the surrounding area.</p>

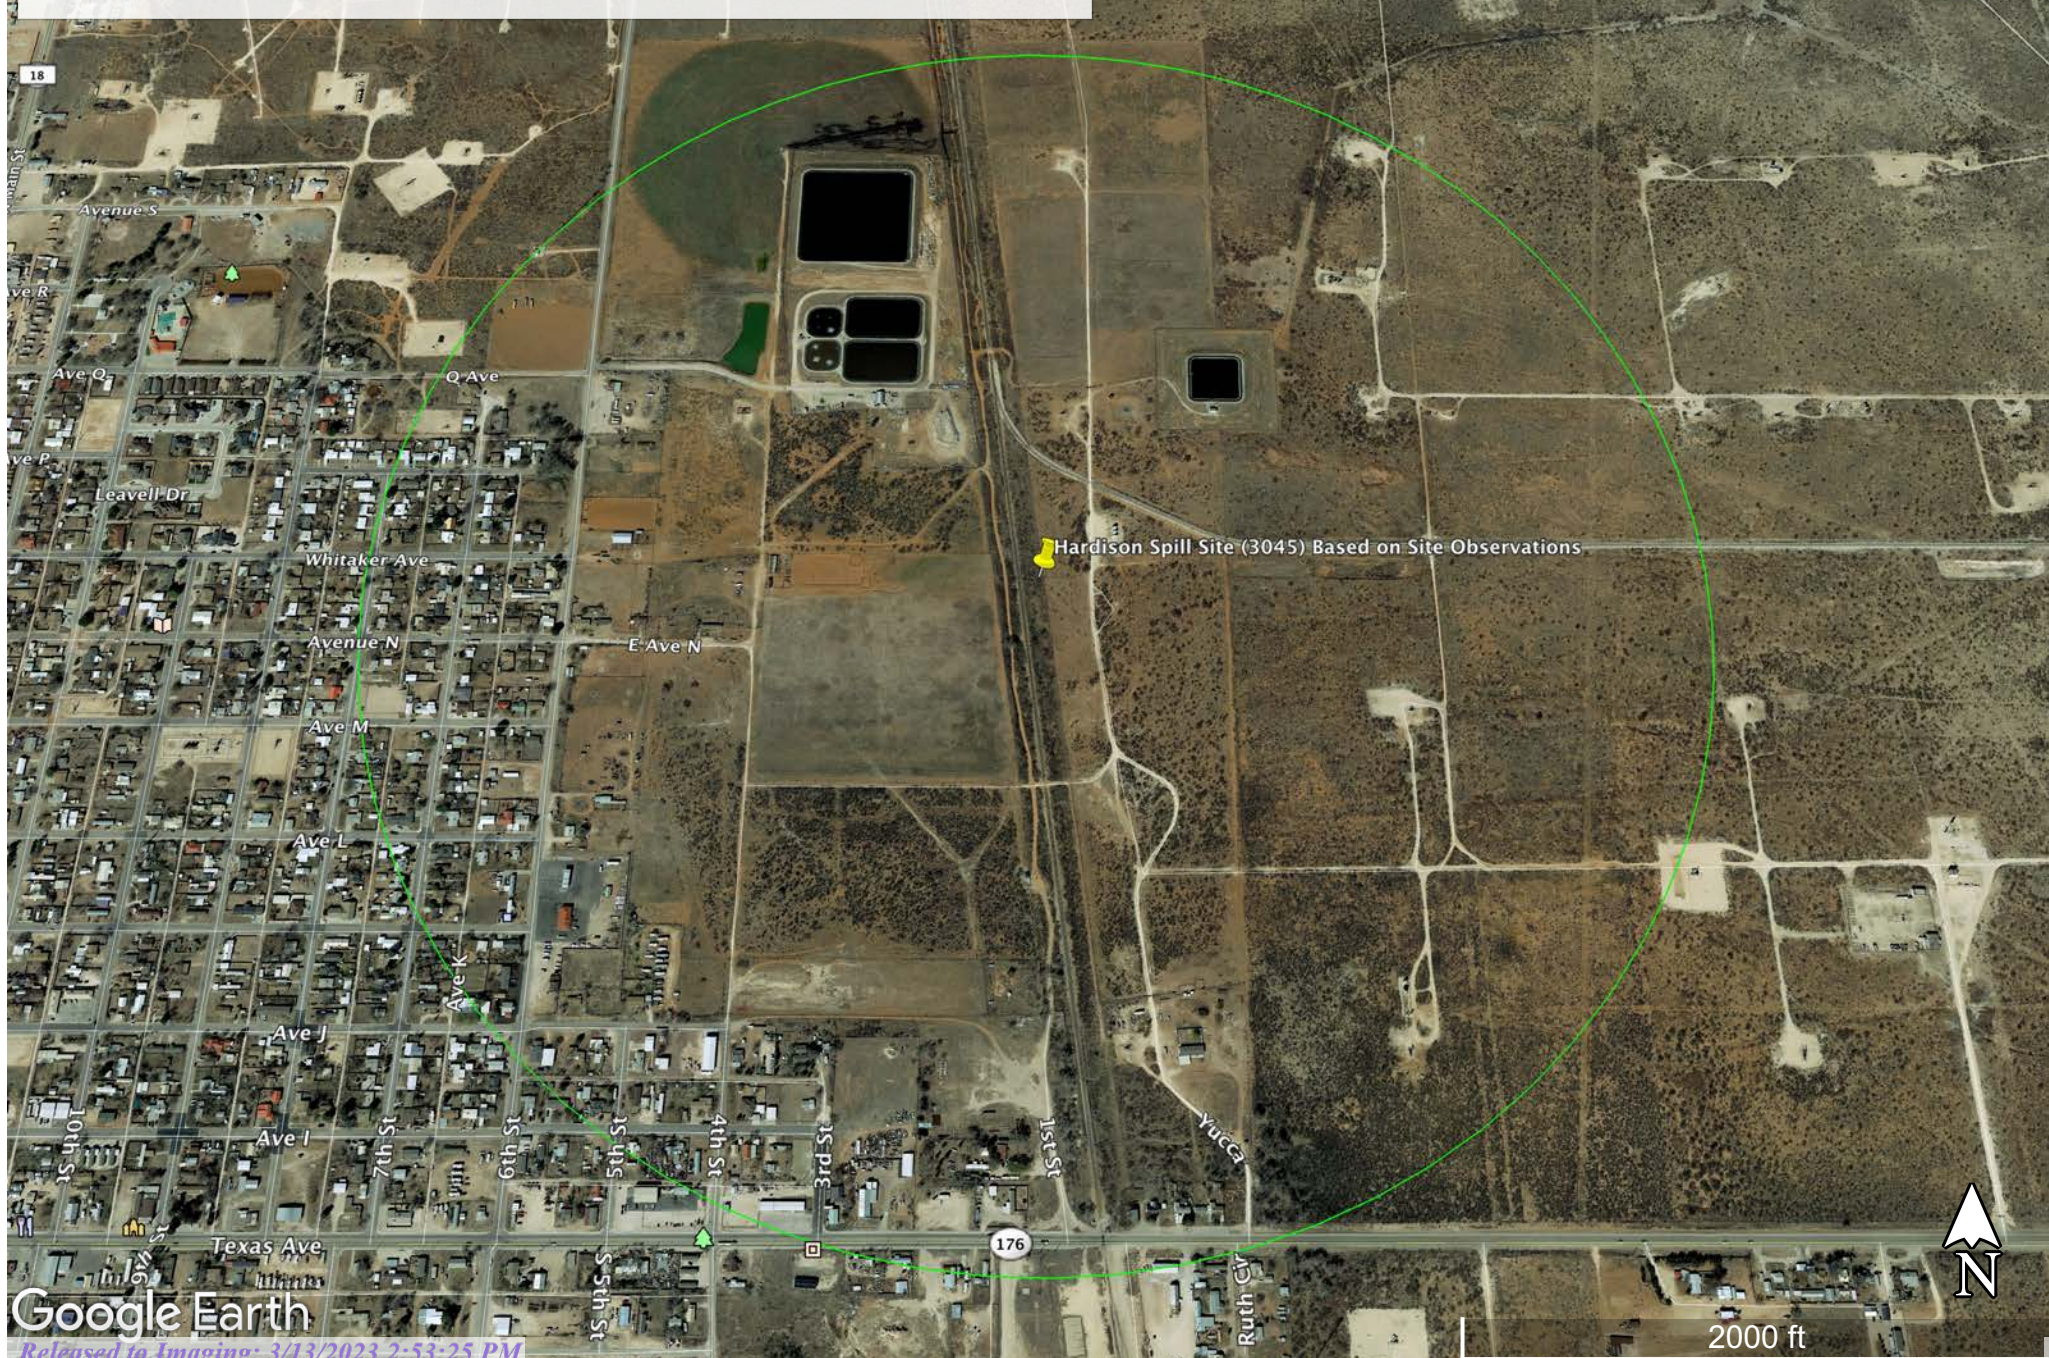
### 0.5-Mile Radius Map Demonstrating Absence of Major Watercourses

No major watercourses are present within a 0.5-mile radius of the subject site.

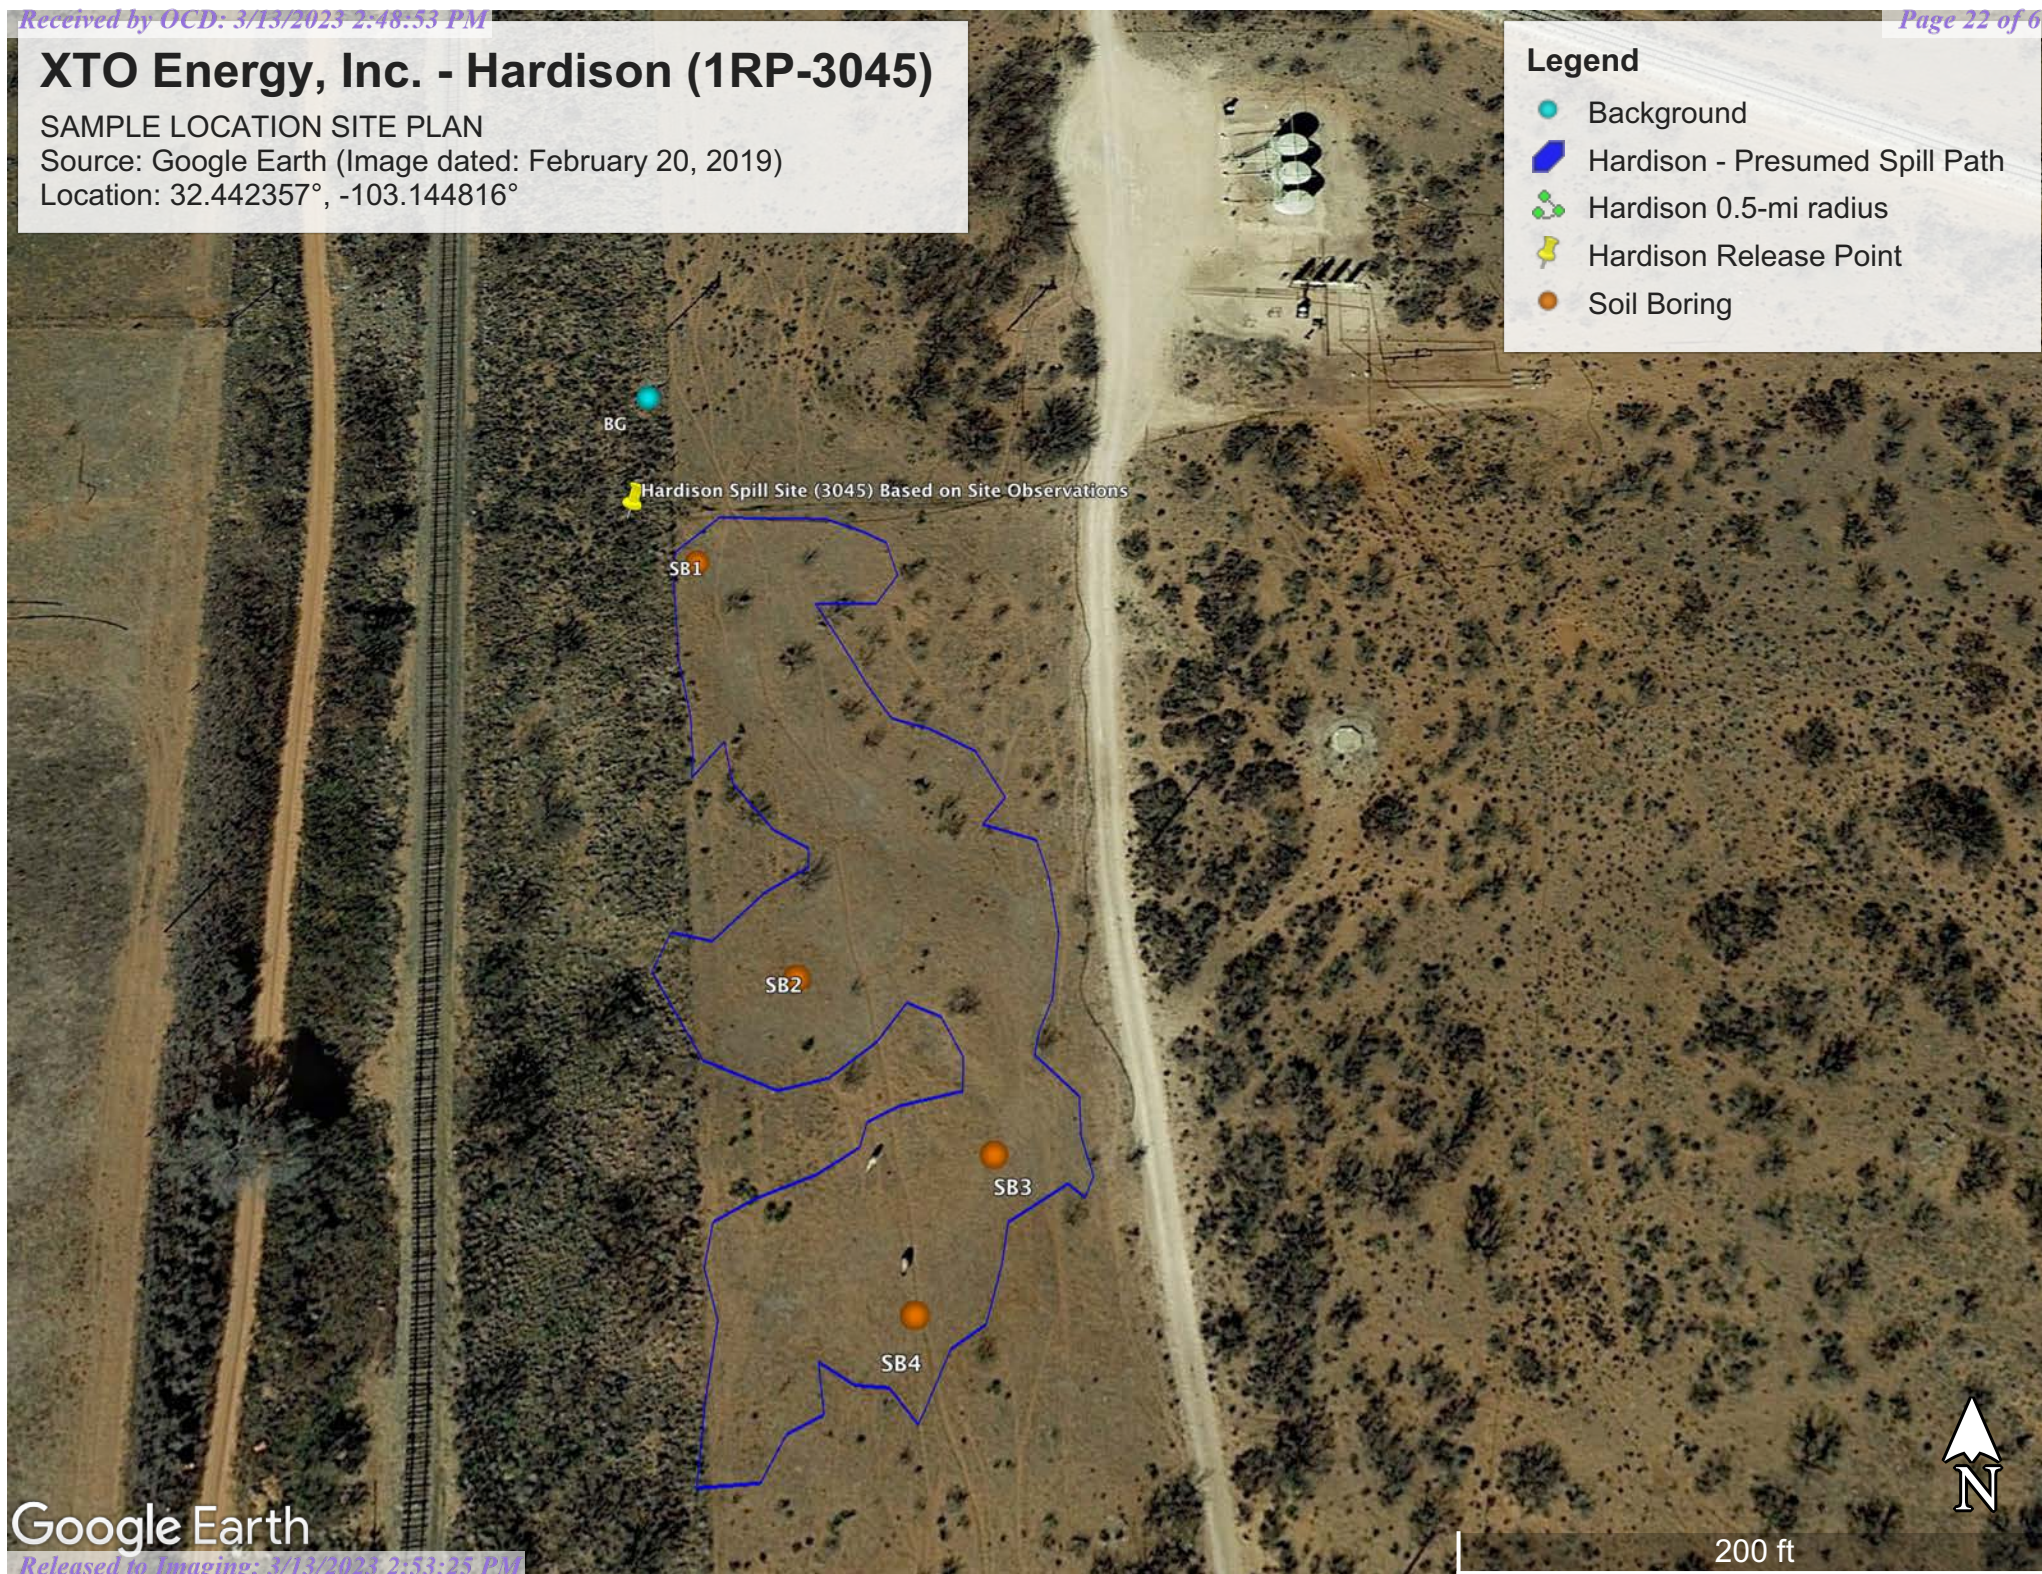
## SAMPLE LOCATION SITE PLAN

- Background
- Hardison - Presumed Spill Path
- Hardison 0.5-mi radius
- Hardison Release Point
- Soil Boring
