**Re: Release Characterization and Closure Request
ConocoPhillips
Heritage Concho
Osprey 20 State Com #003H Flare Release
Unit Letter K, Section 20, Township 21 South, Range 34 East
Lea County, New Mexico
Incident ID# nOY1823239315**

Release Characterization and Closure Request
March 2, 2023

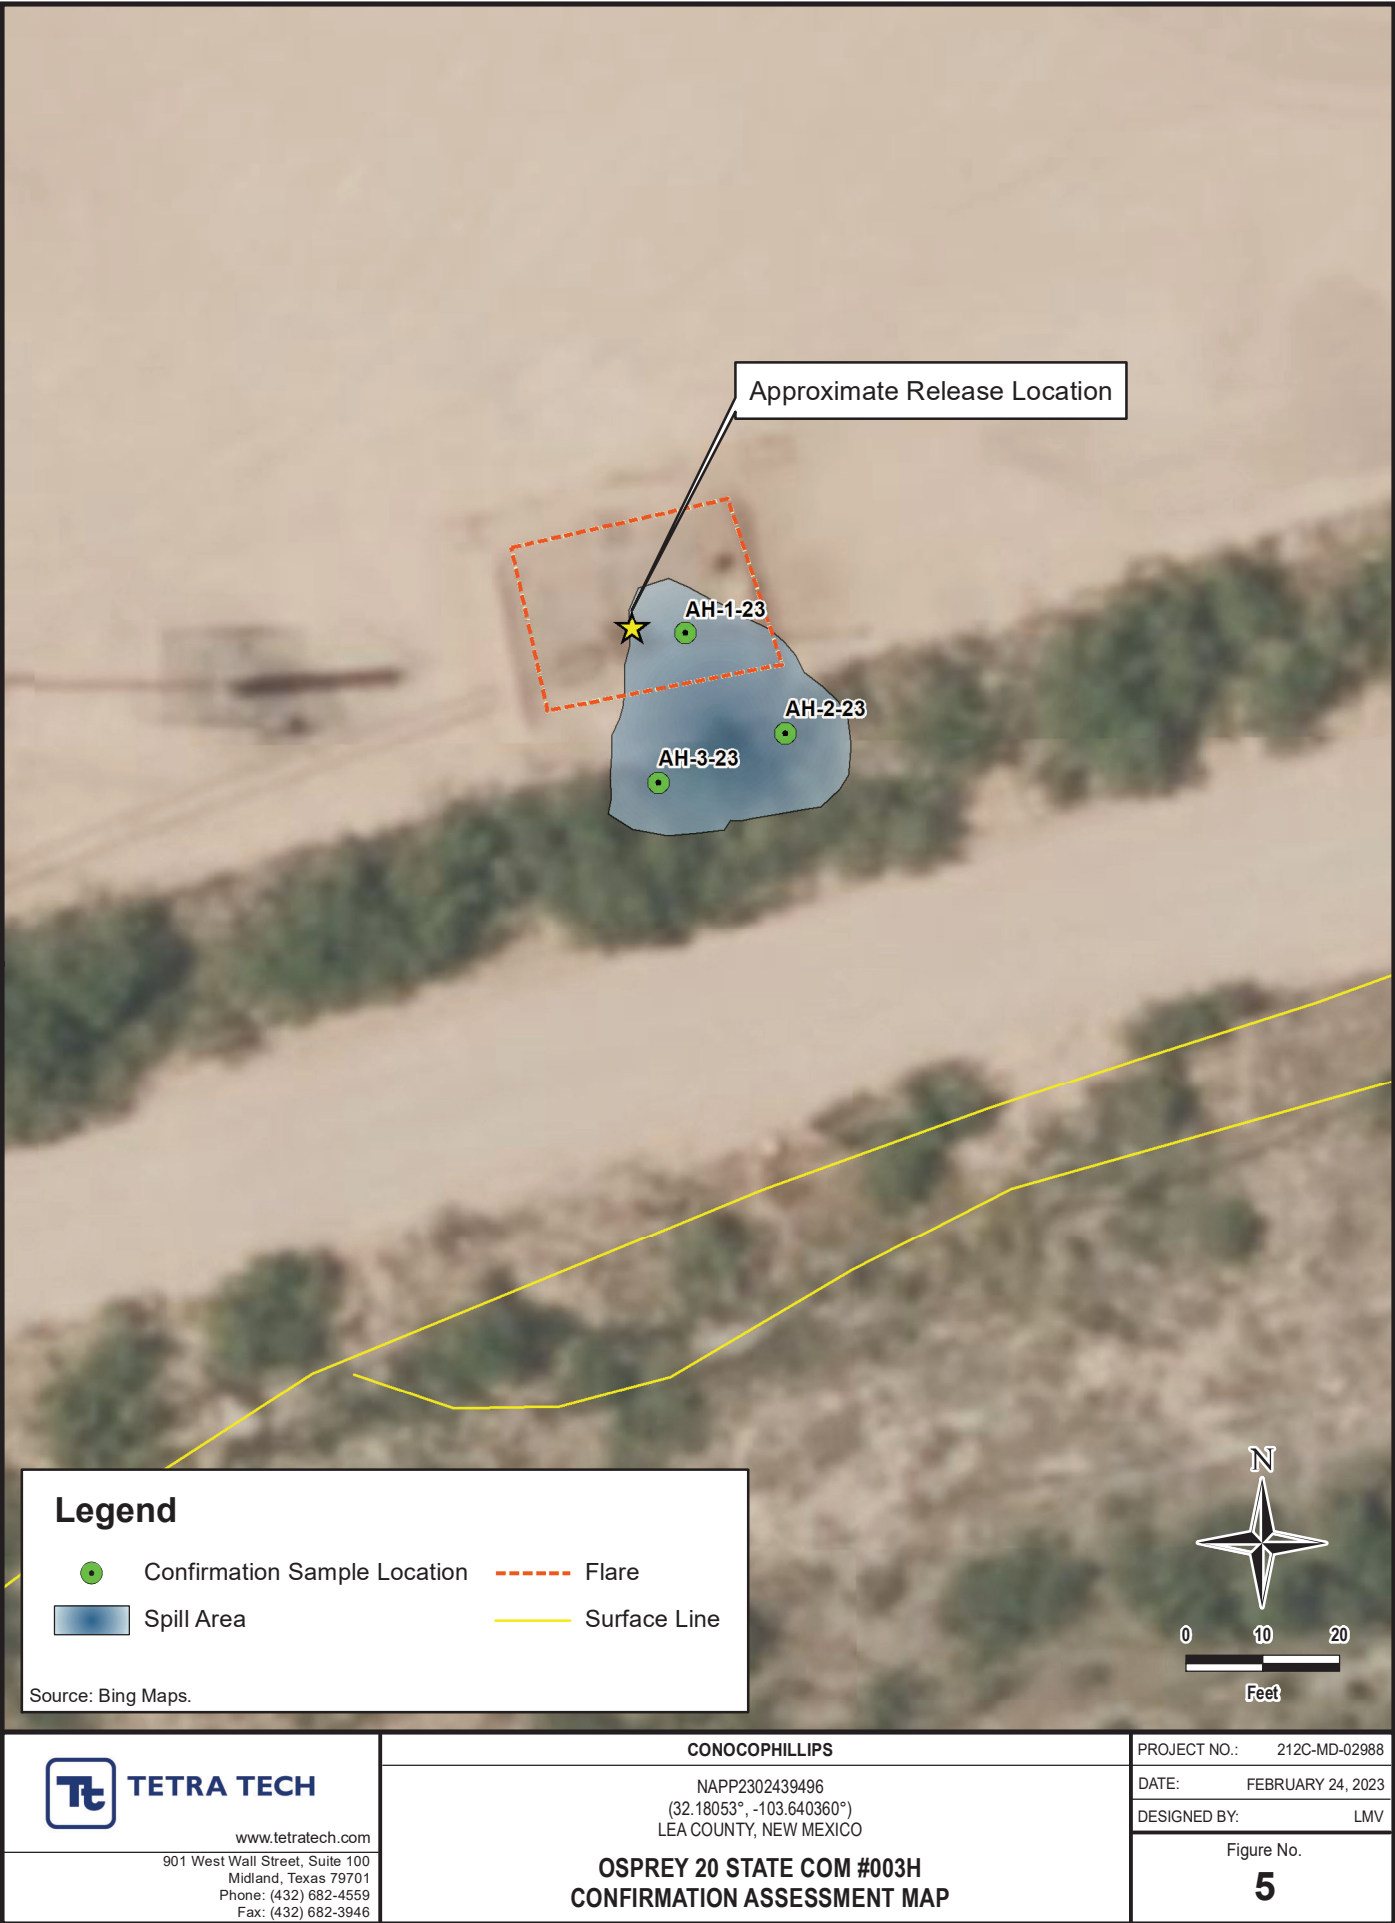
DOCUMENT PATH: C:\USERS\LISSA.VILLAMINON\DRIVE - TETRA TECH\INCDOCUMENTS\LISSA.VILLAMINON\OSPREY_20_COM_003H\MXD\FIGURE 5 CONFIRMATION ASSESS _OSPREY_20_COM_003H.MXD

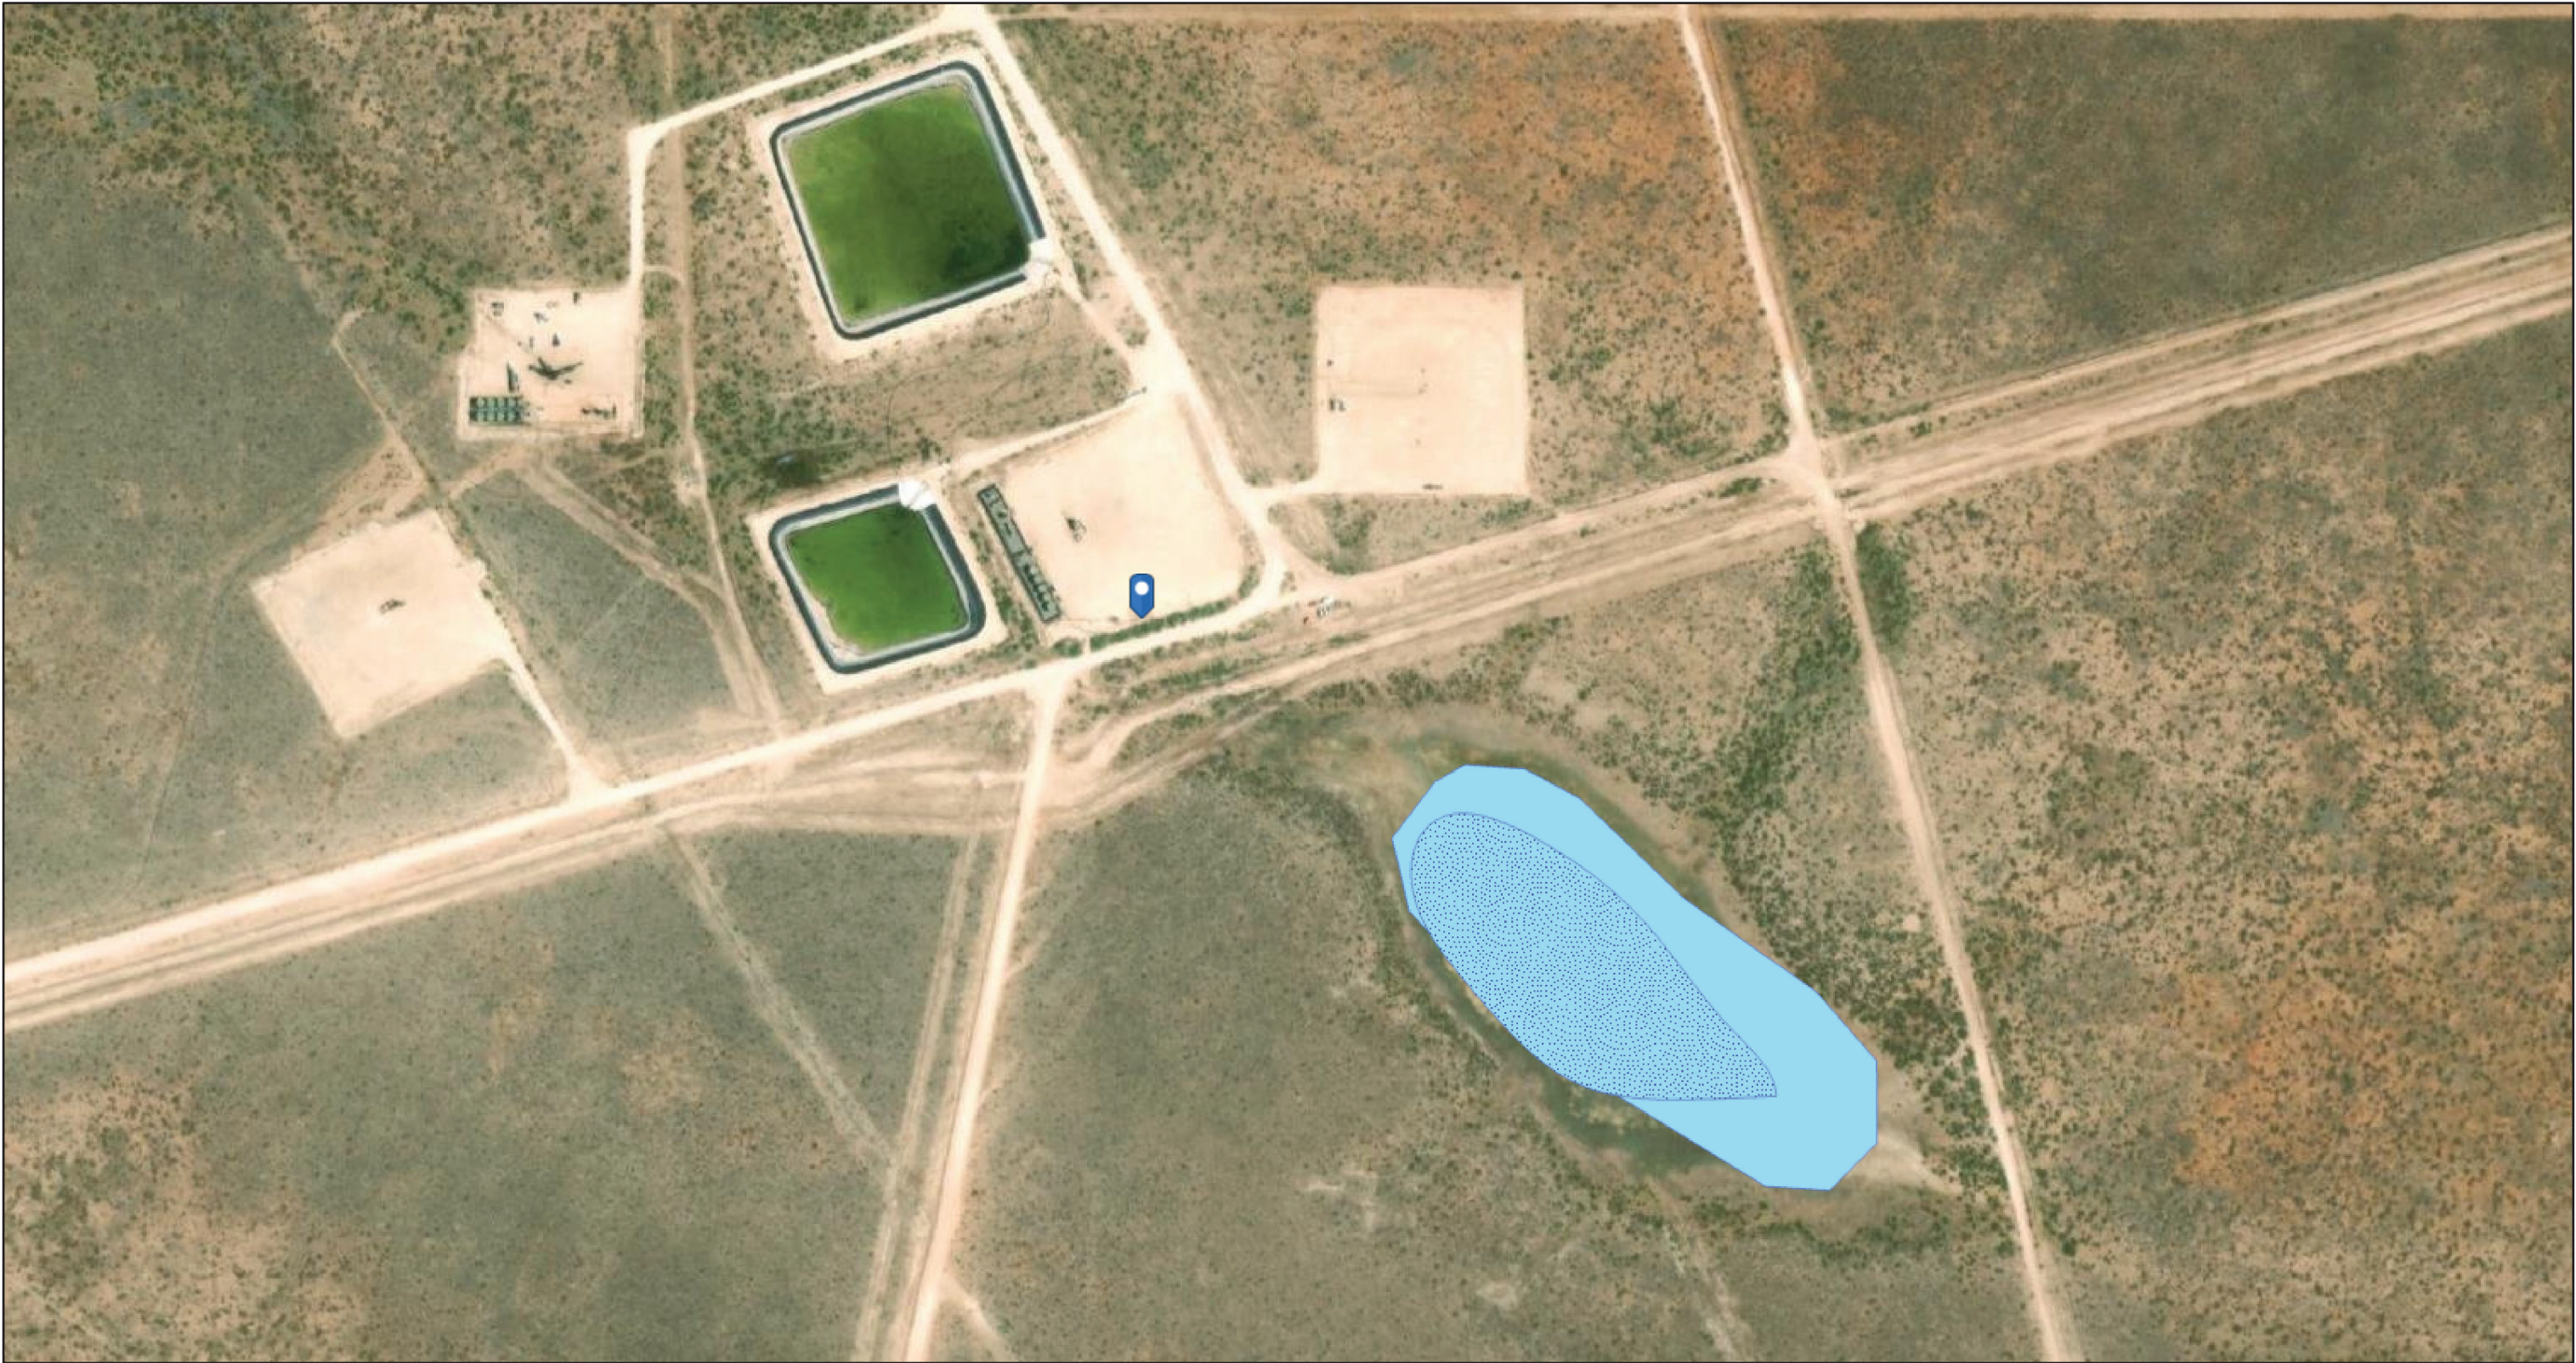
OCD Waterbodies Map

- OSW Water Bodys
- OSE Probable Playas

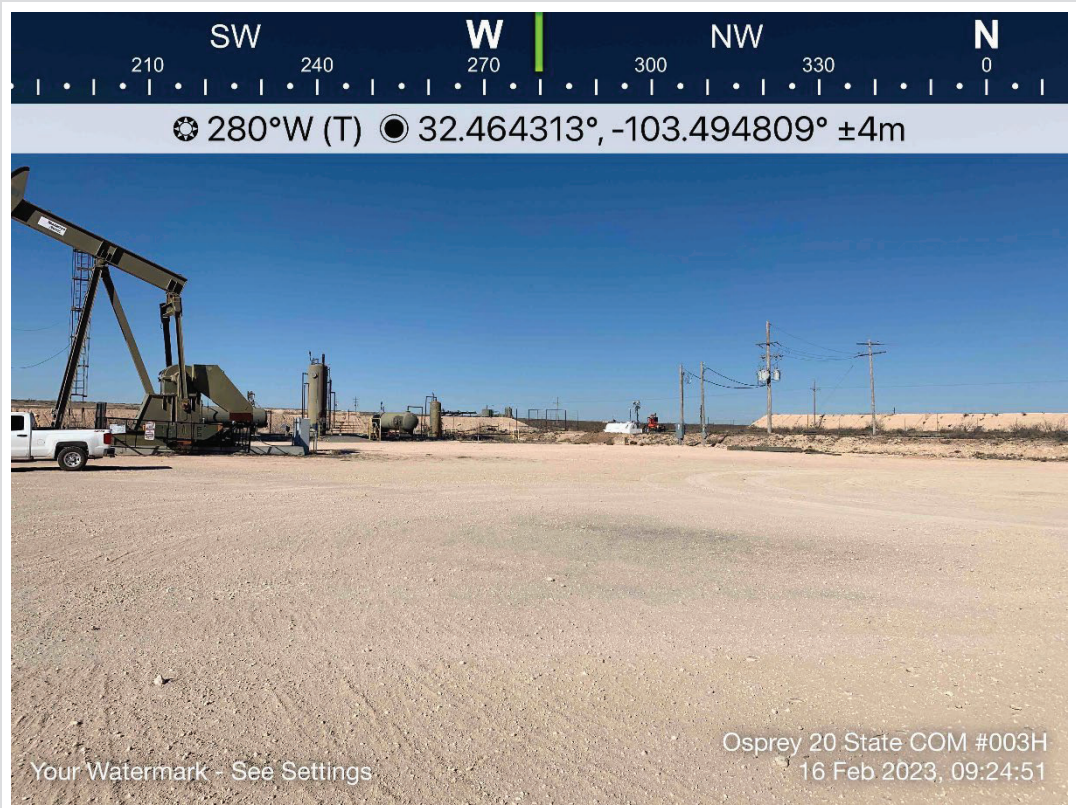
TETRA TECH, INC. PROJECT NO. 212C-MD-02988	DESCRIPTION	View west of general Site pad conditions. Pumping unit shown.	3
	SITE NAME	Osprey 20 State Com #003H	2/16/2023

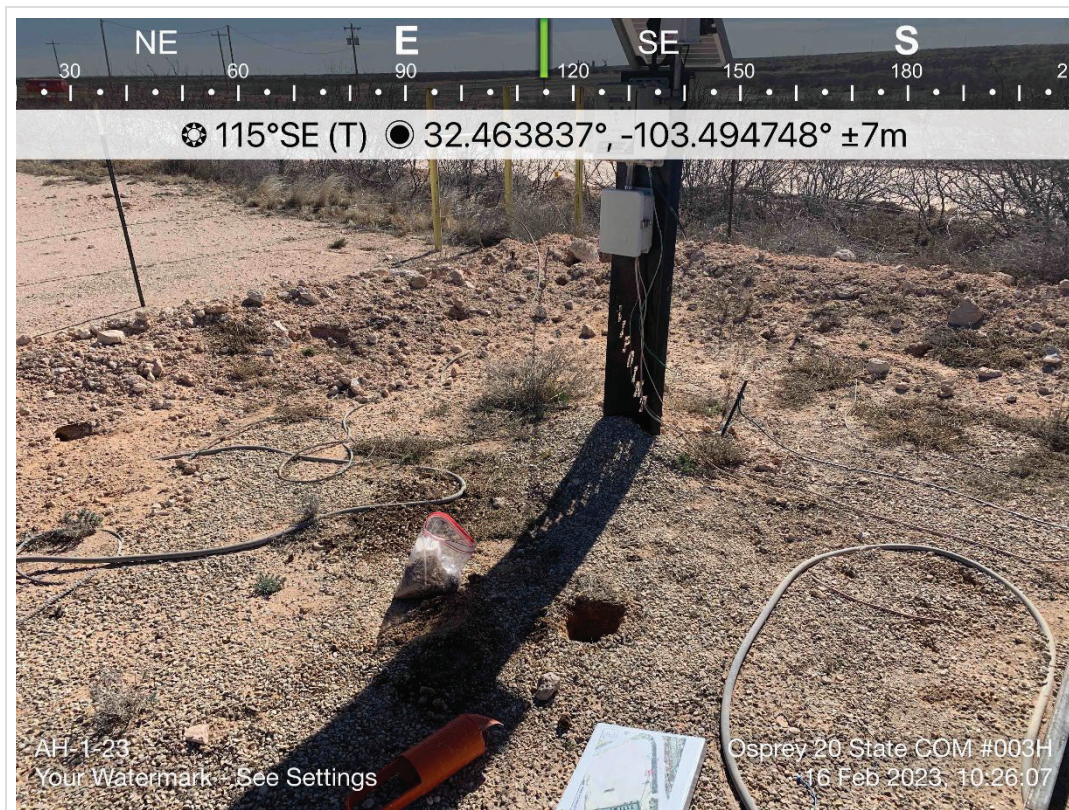
TETRA TECH, INC. PROJECT NO. 212C-MD-02988	DESCRIPTION	View east/southeast of AH-1-23 sampling location around flare stack.	7
	SITE NAME	Osprey 20 State Com #003H	2/16/2023

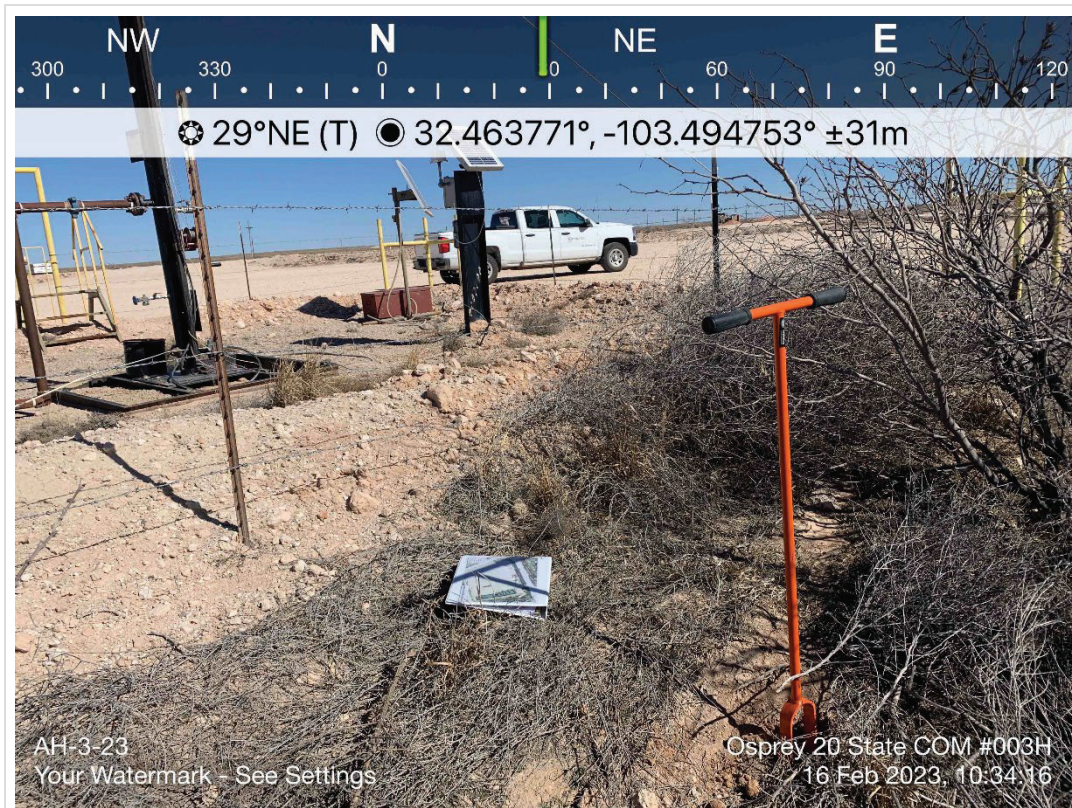
TETRA TECH, INC. PROJECT NO. 212C-MD-02988	DESCRIPTION	View north/northeast of AH-3-23 sampling location around flare stack.	9
	SITE NAME	Osprey 20 State Com #003H	2/16/2023

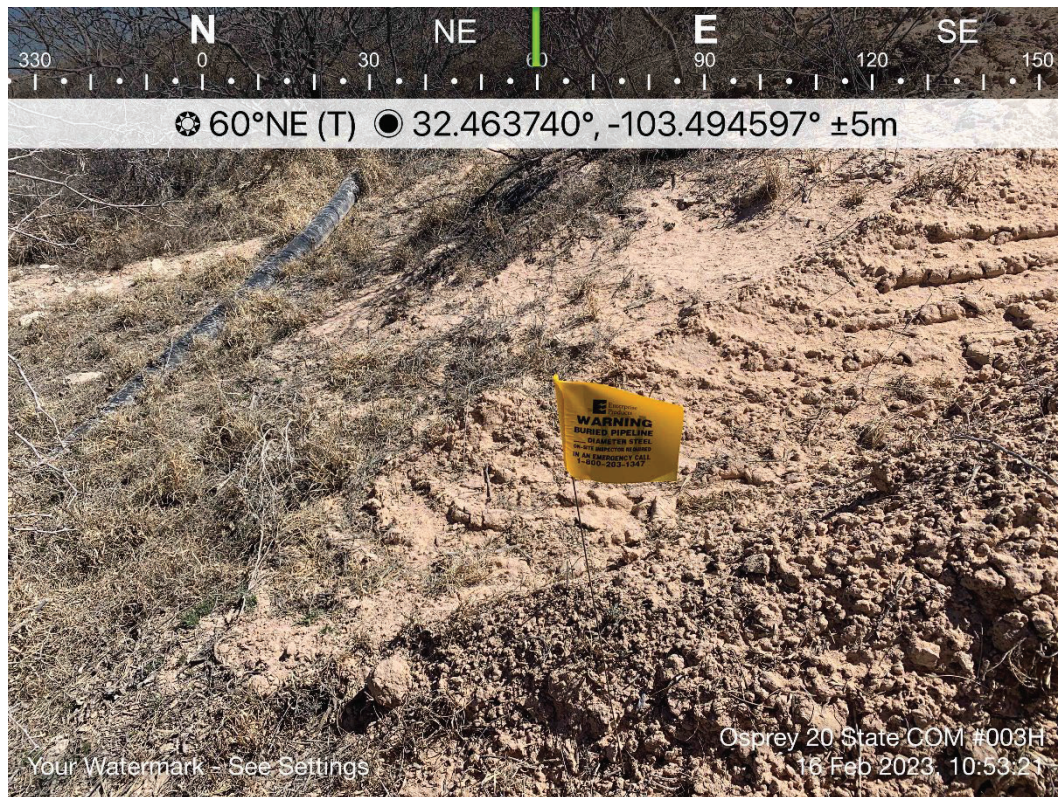
TETRA TECH, INC. PROJECT NO. 212C-MD-02988	DESCRIPTION	View northeast of subsurface pipeline and surface polylines.	10
	SITE NAME	Osprey 20 State Com #003H	2/16/2023
