Re: Site Assessment, Remediation, and Closure Report
Marwari 28 CTB 1
API No. N/A
GPS: Latitude 32.106210 Longitude -103.687828
UL -- D, 4, T25S, R32E
Lea County, NM
NMOCD Ref. No. NAPP2222026306

Pima Environmental Services, LLC. (Pima) has been contracted by Devon Energy Production Company, LP (Devon) to perform a spill assessment, remediation activities, and submit this closure report for a produced water release that occurred at the Marwari 28 CTB 1 (Marwari). The initial C-141 was submitted on August 18, 2022 (Appendix C). This incident was assigned Incident ID NAPP2222026306 by the New Mexico Oil Conservation Division (NMOCD).

Marwari 28 CTB 1

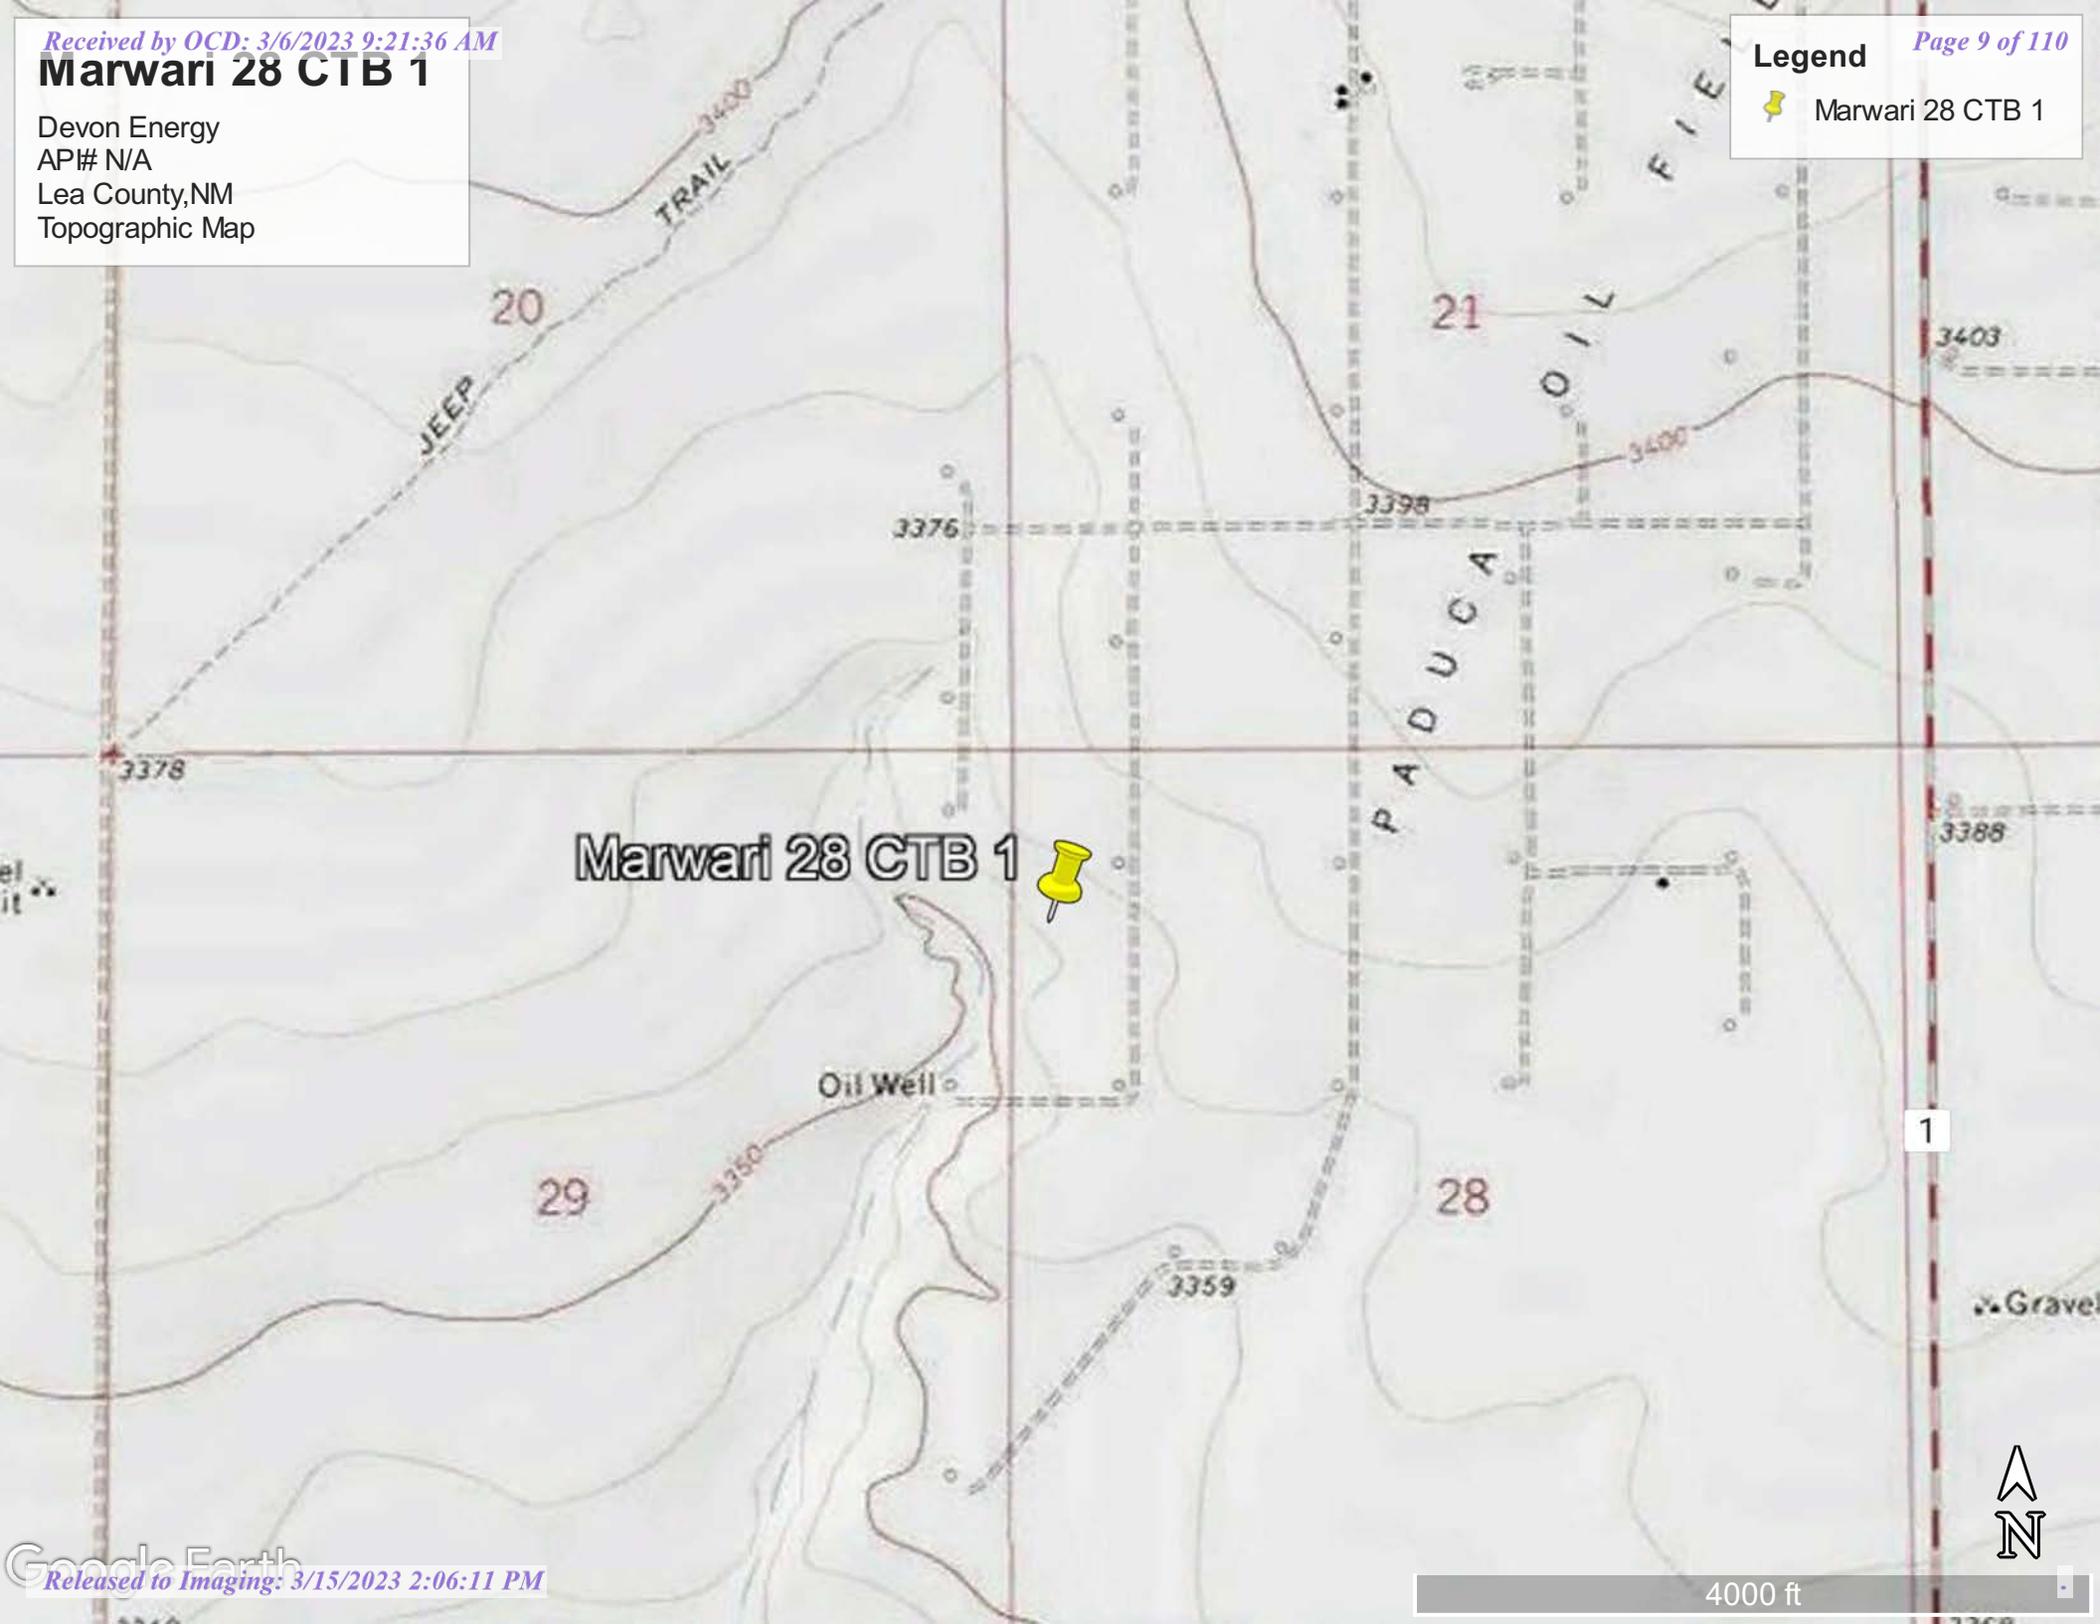
2-Topographic Map

Reference Figure 2 for a Topographic Map.

Devon Energy
API# N/A
Lea County, NM
Topographic Map

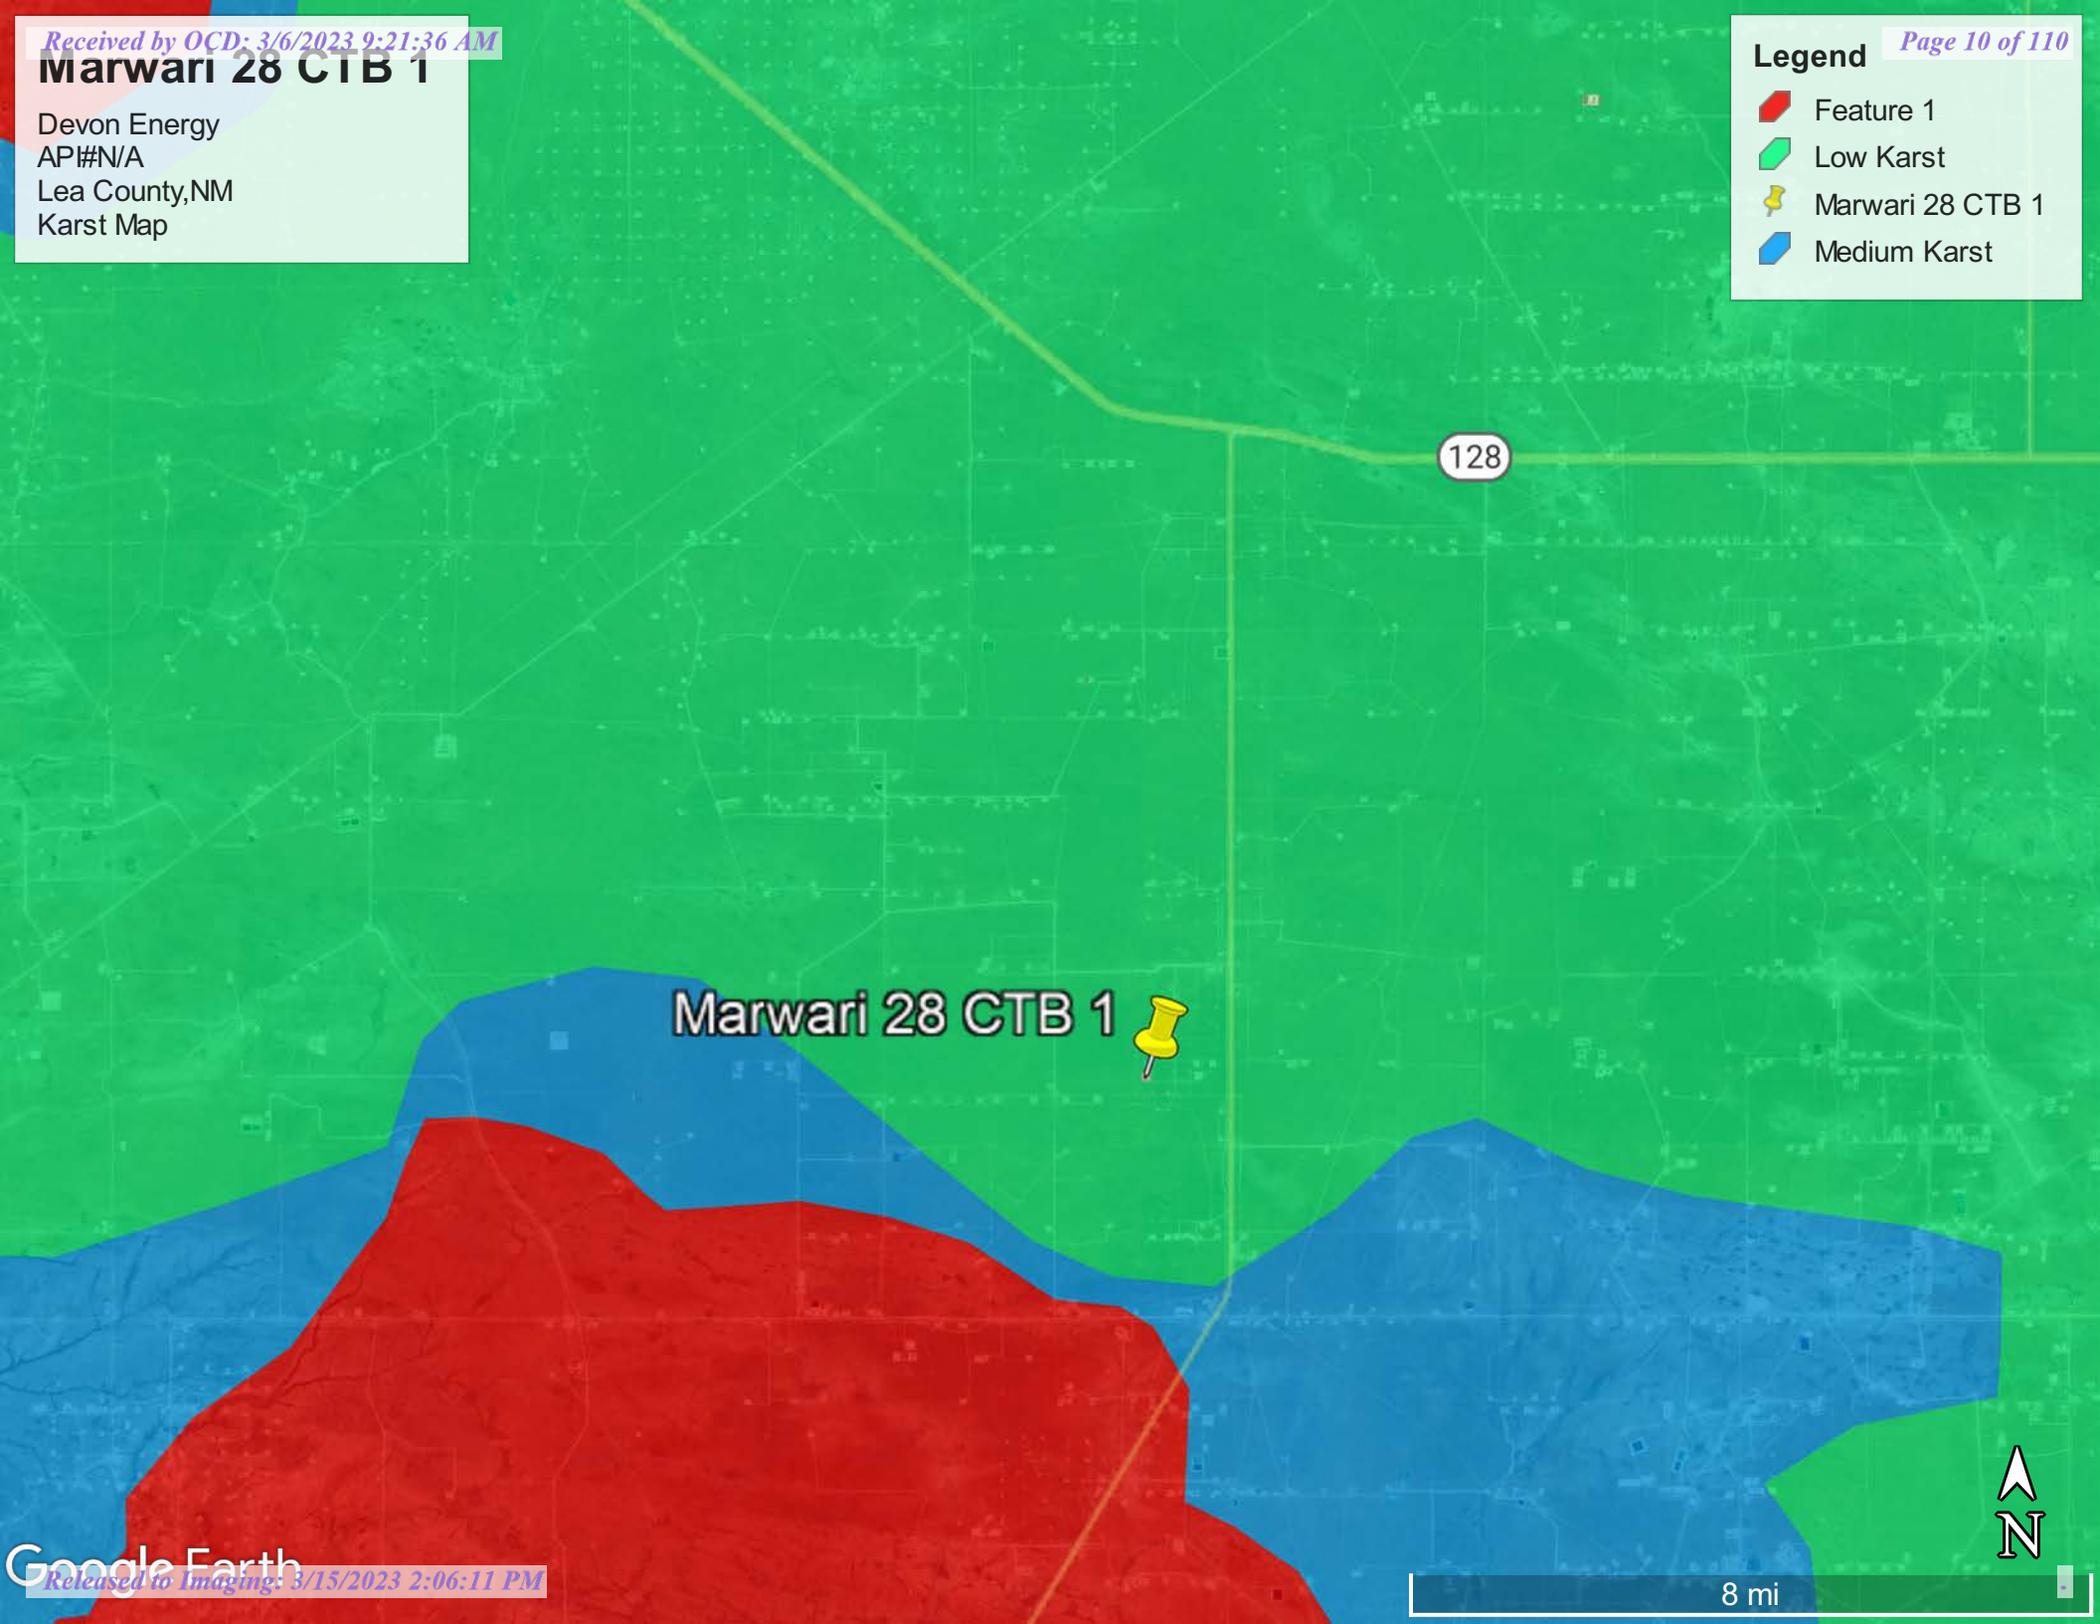
3-Karst Map

Per the New Mexico Bureau of Geology and Mineral Resources, the geology is made up of Interlayered eolian sands and piedmont-slope deposits along the eastern flank of the Pecos River valley, primarily between Roswell and Carlsbad. Typically capped by thin eolian deposits. The soil in this area is made up of Pyote loamy fine sands, 0 to 3 percent slopes according to the United States Department of Agriculture Natural Resources Conservation Service soil survey (Appendix B). The drainage class in this area is well drained. There is a low potential for karst geology to be present around the Marwari (Figure 3).

Devon Energy
API#N/A
Lea County, NM
Karst Map

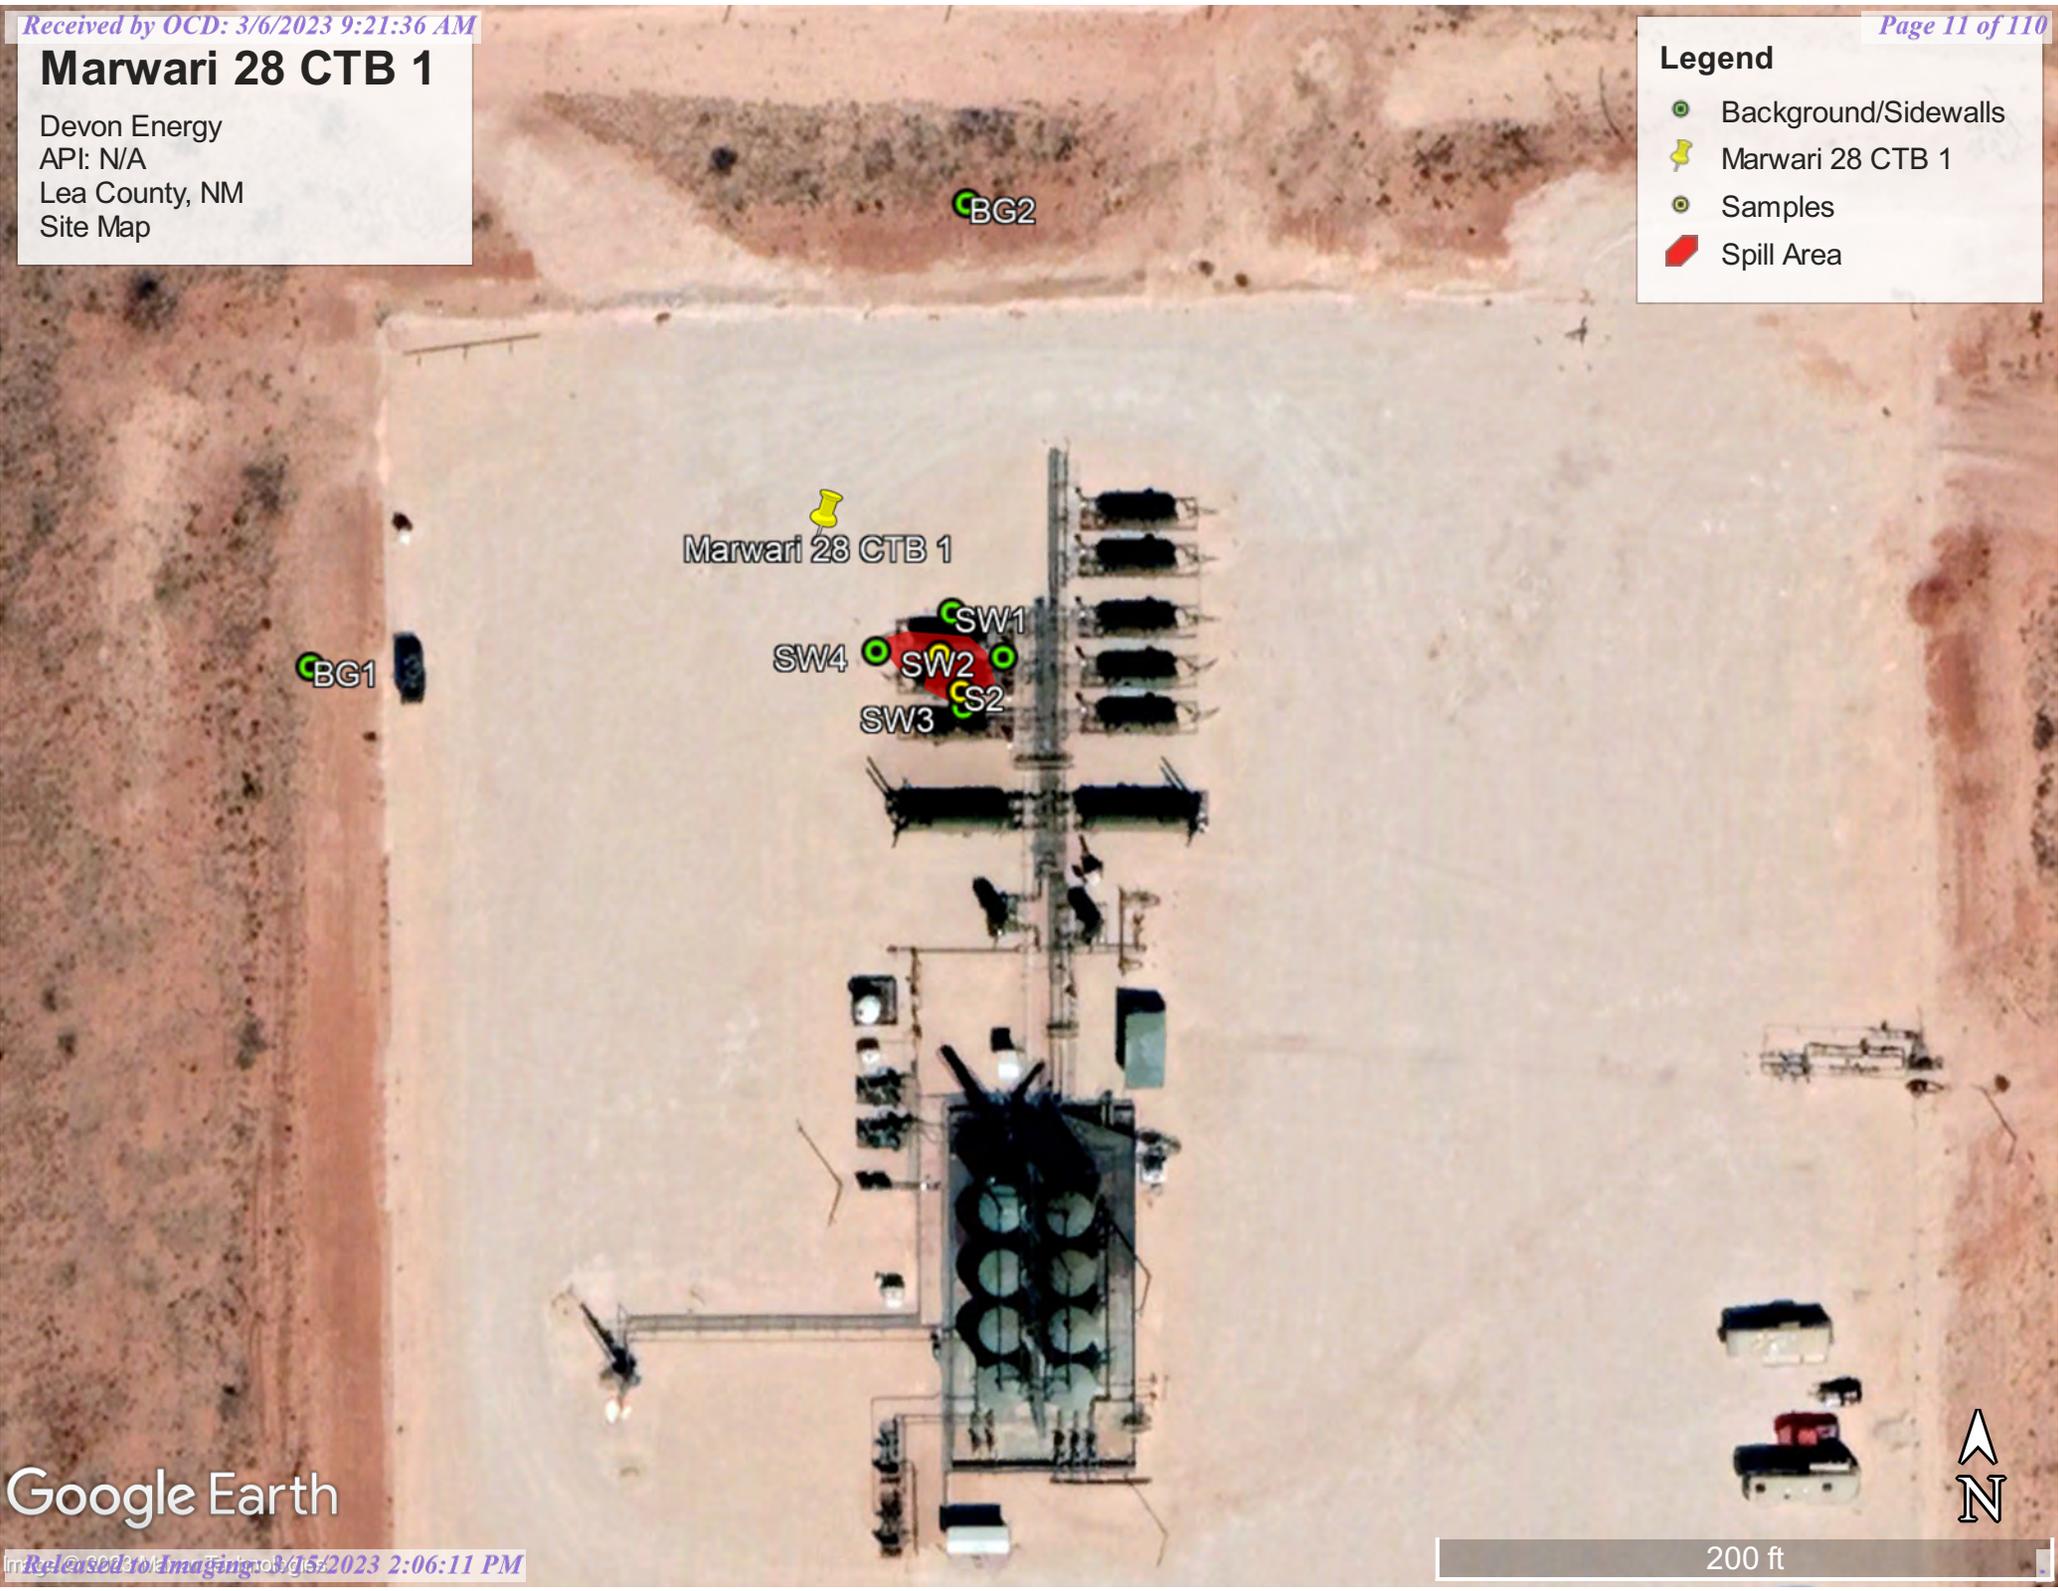
4-Site Map

On October 4, 2022, Pima mobilized personnel to the site to begin collecting soil samples from spill area. The laboratory results of this sampling event can be found in the following data table. A Site Map can be found in Figure 4.

Devon Energy
API: N/A
Lea County, NM
Site Map

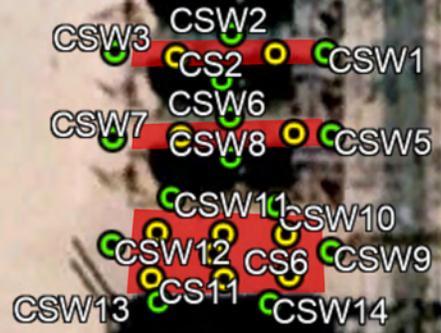
5-Confirmation Sample Map

On January 26, 2023, after sending a 48-hour notification (Appendix C), Pima returned to the site to collect confirmation samples of the excavation. The results of this sampling event can be found in the following table. A Confirmation Sample Map can be found in Figure 5.

Devon Energy
API: N/A
Lea County, NM
Confirmation Sample Map

Based on the sample results, the bottoms and sidewalls were below NMOCD Closure Criteria 19.15.29 NMAC. The contaminated material was removed then transported to an NMOCD approved disposal site. The excavation was then backfilled with clean like material, machine compacted and returned to its previous state. See Appendix D for Photographic Documentation.

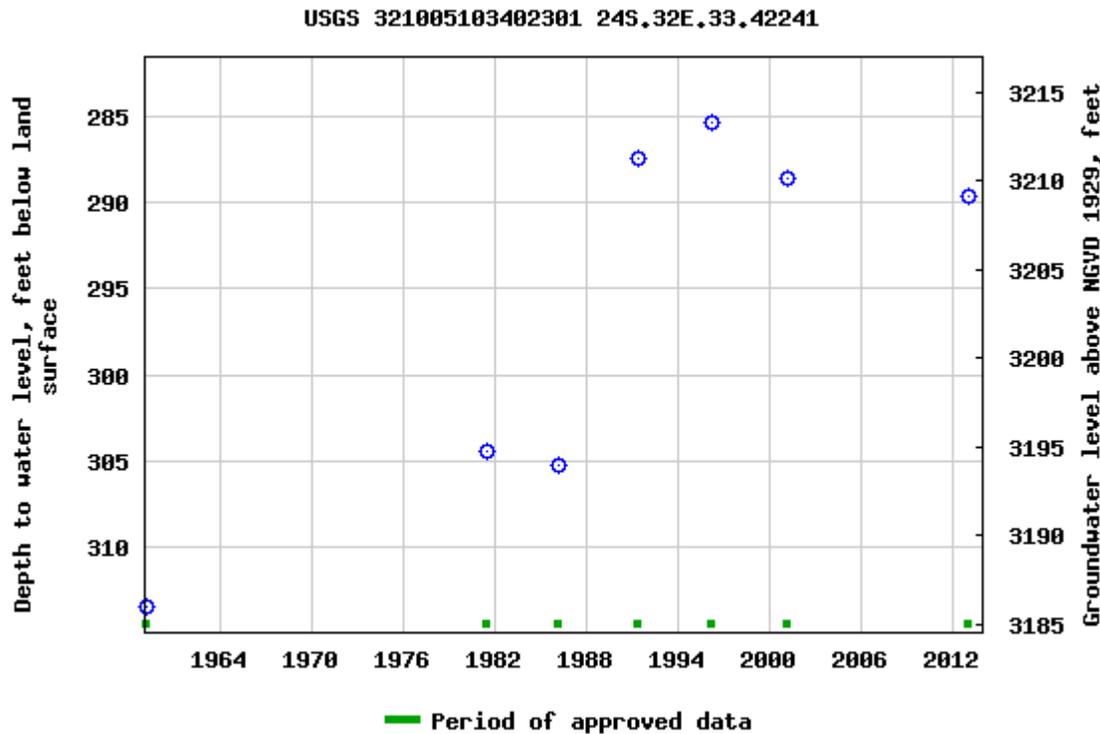
USGS 321005103402301 24S.32E.33.42241

The depth of the well is 367 feet below land surface.

Breaks in the plot represent a gap of at least one year between field measurements.

According to the New Mexico Office of the State Engineer, depth to the nearest groundwater in this area is 350 feet below grade surface (BGS). According to the United States Geological Survey (USGS), the nearest groundwater is 290 feet BGS. The closest waterway is Red Bluff Reservoir located approximately 18 miles to the southwest of this location. See Appendix A for referenced water surveys.

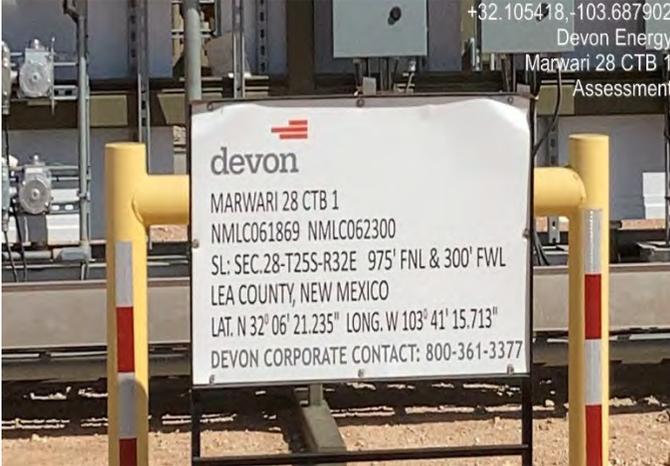
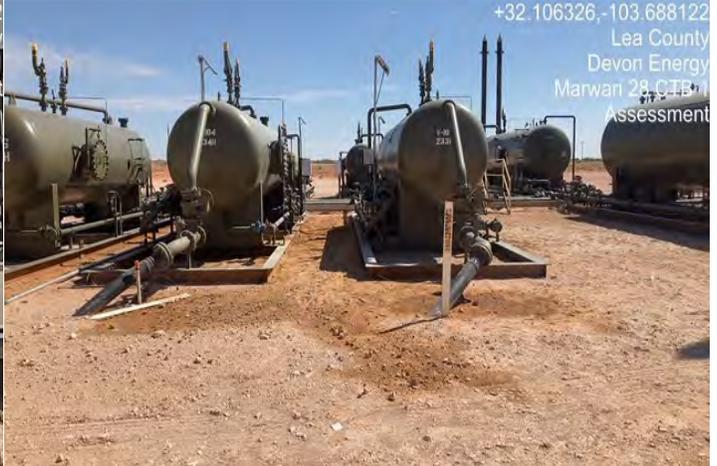
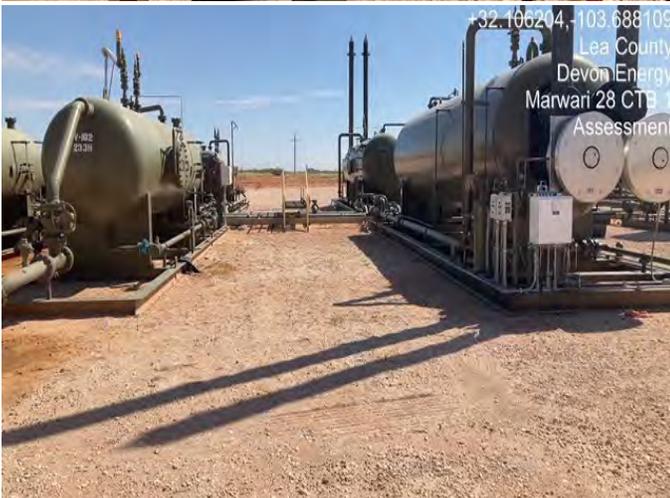
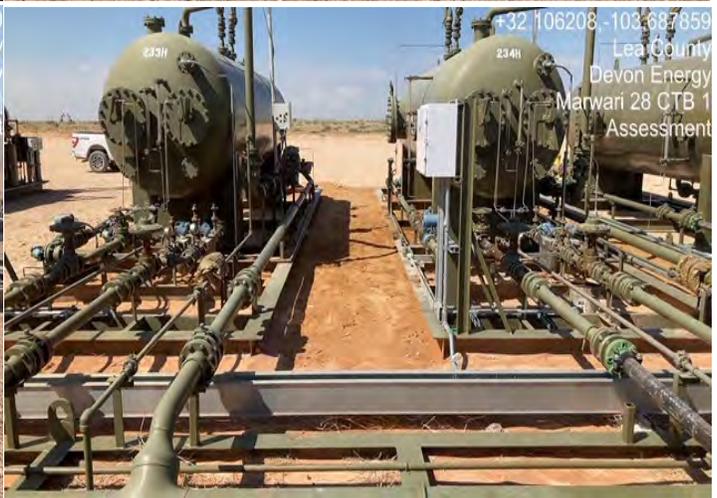
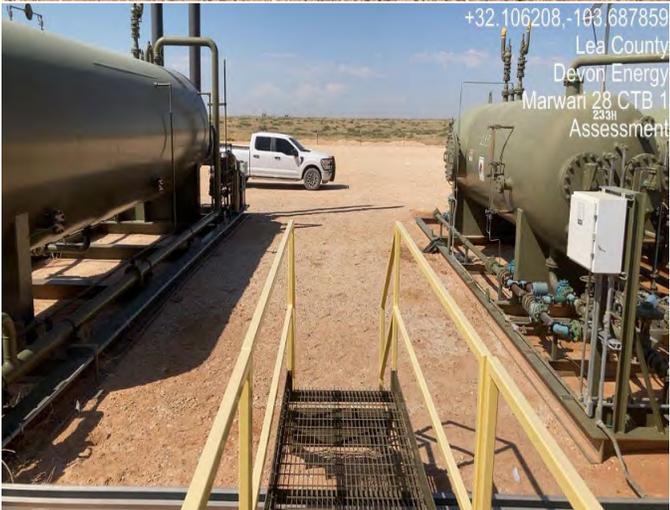
Site Assessment

NAPP2222026306: On August 4, 2022, fluid was released from a separator. The released fluids were calculated to be approximately 7 barrels (bbls) of produced water. No fluid was able to recover.

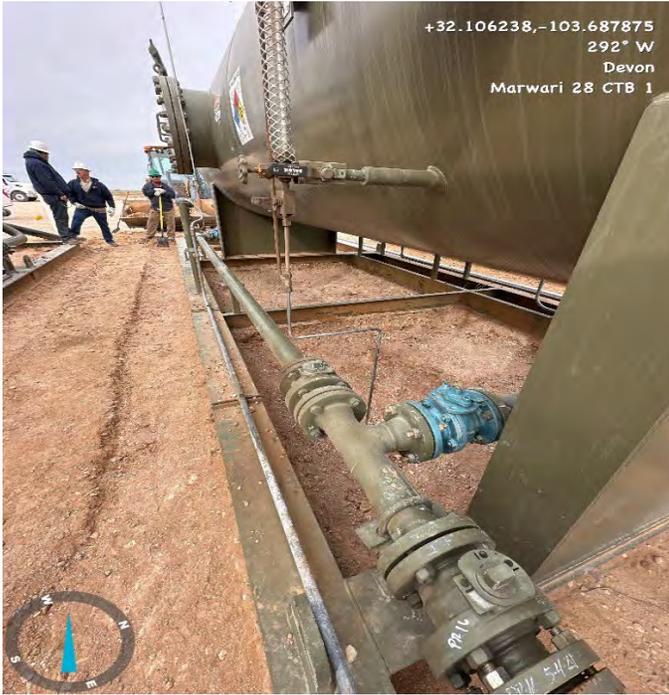
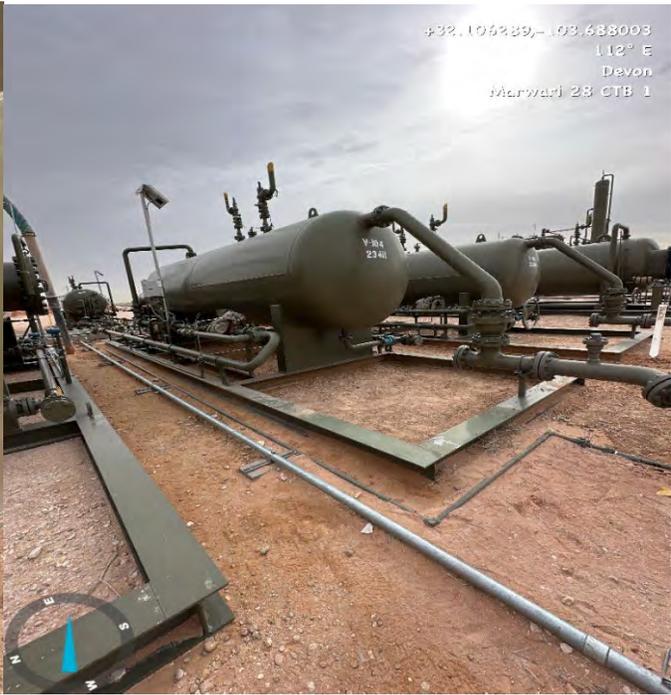
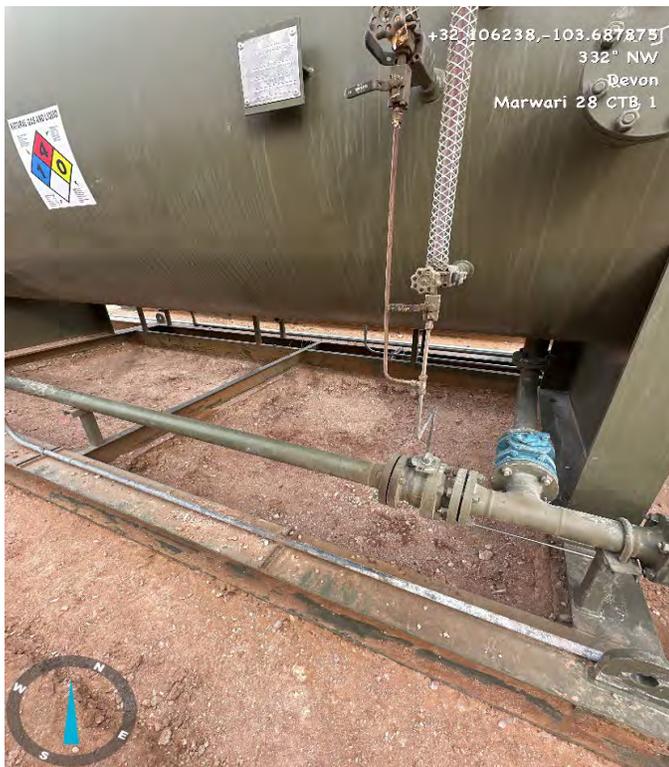
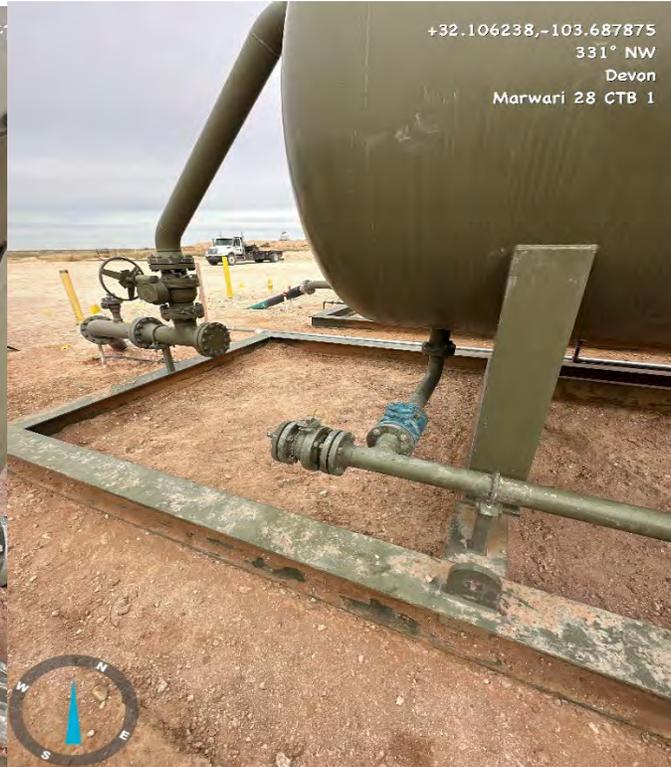
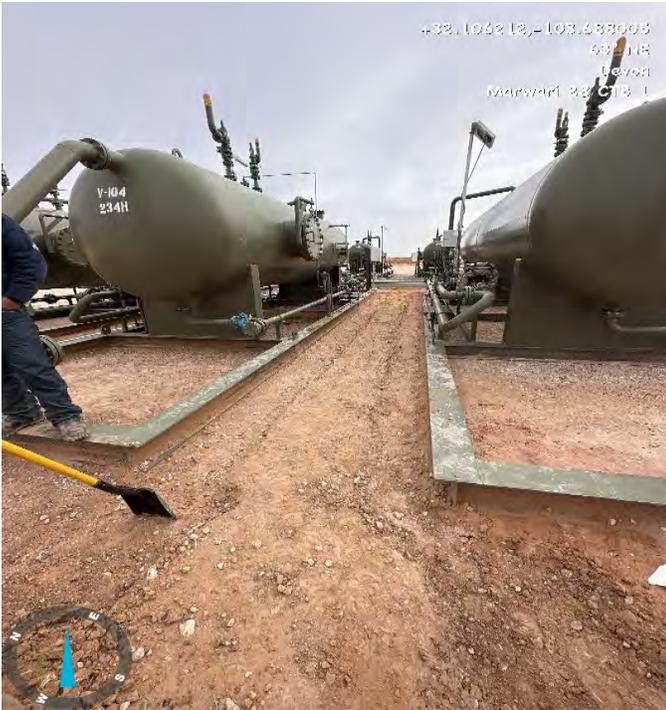
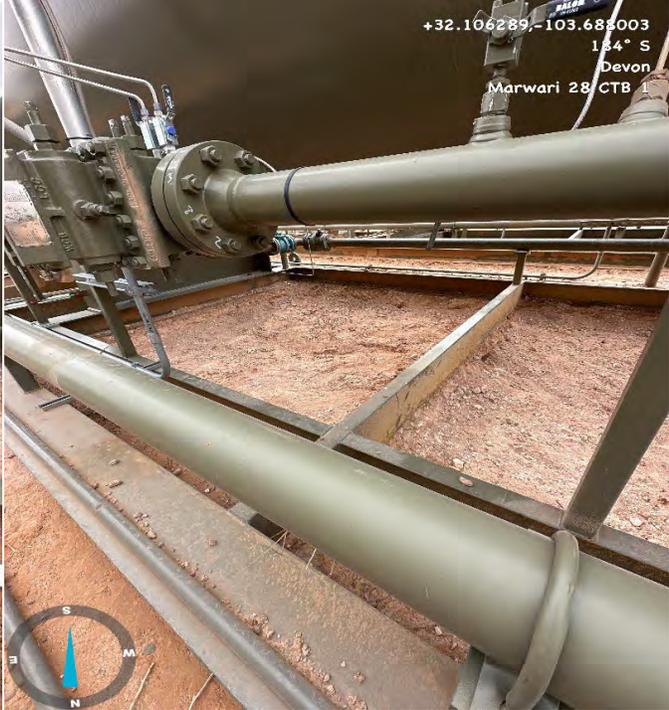
Excavation

On January 18, 2023, the Devon Construction Department mobilized personnel and equipment to begin immediate remediation activities. They began excavating the area to a depth of 2' BGS. The contaminated soil was hauled to an approved, lined disposal facility and clean backfill material was brought in.
