**Appendix E**  
**Photographic Documentation**

Tracking Number: nAPP2227365249  
Biocide Release Delineation and Closure Report  
Chevron USA, Inc., Sand Dunes CTB 10  
December 7, 2022

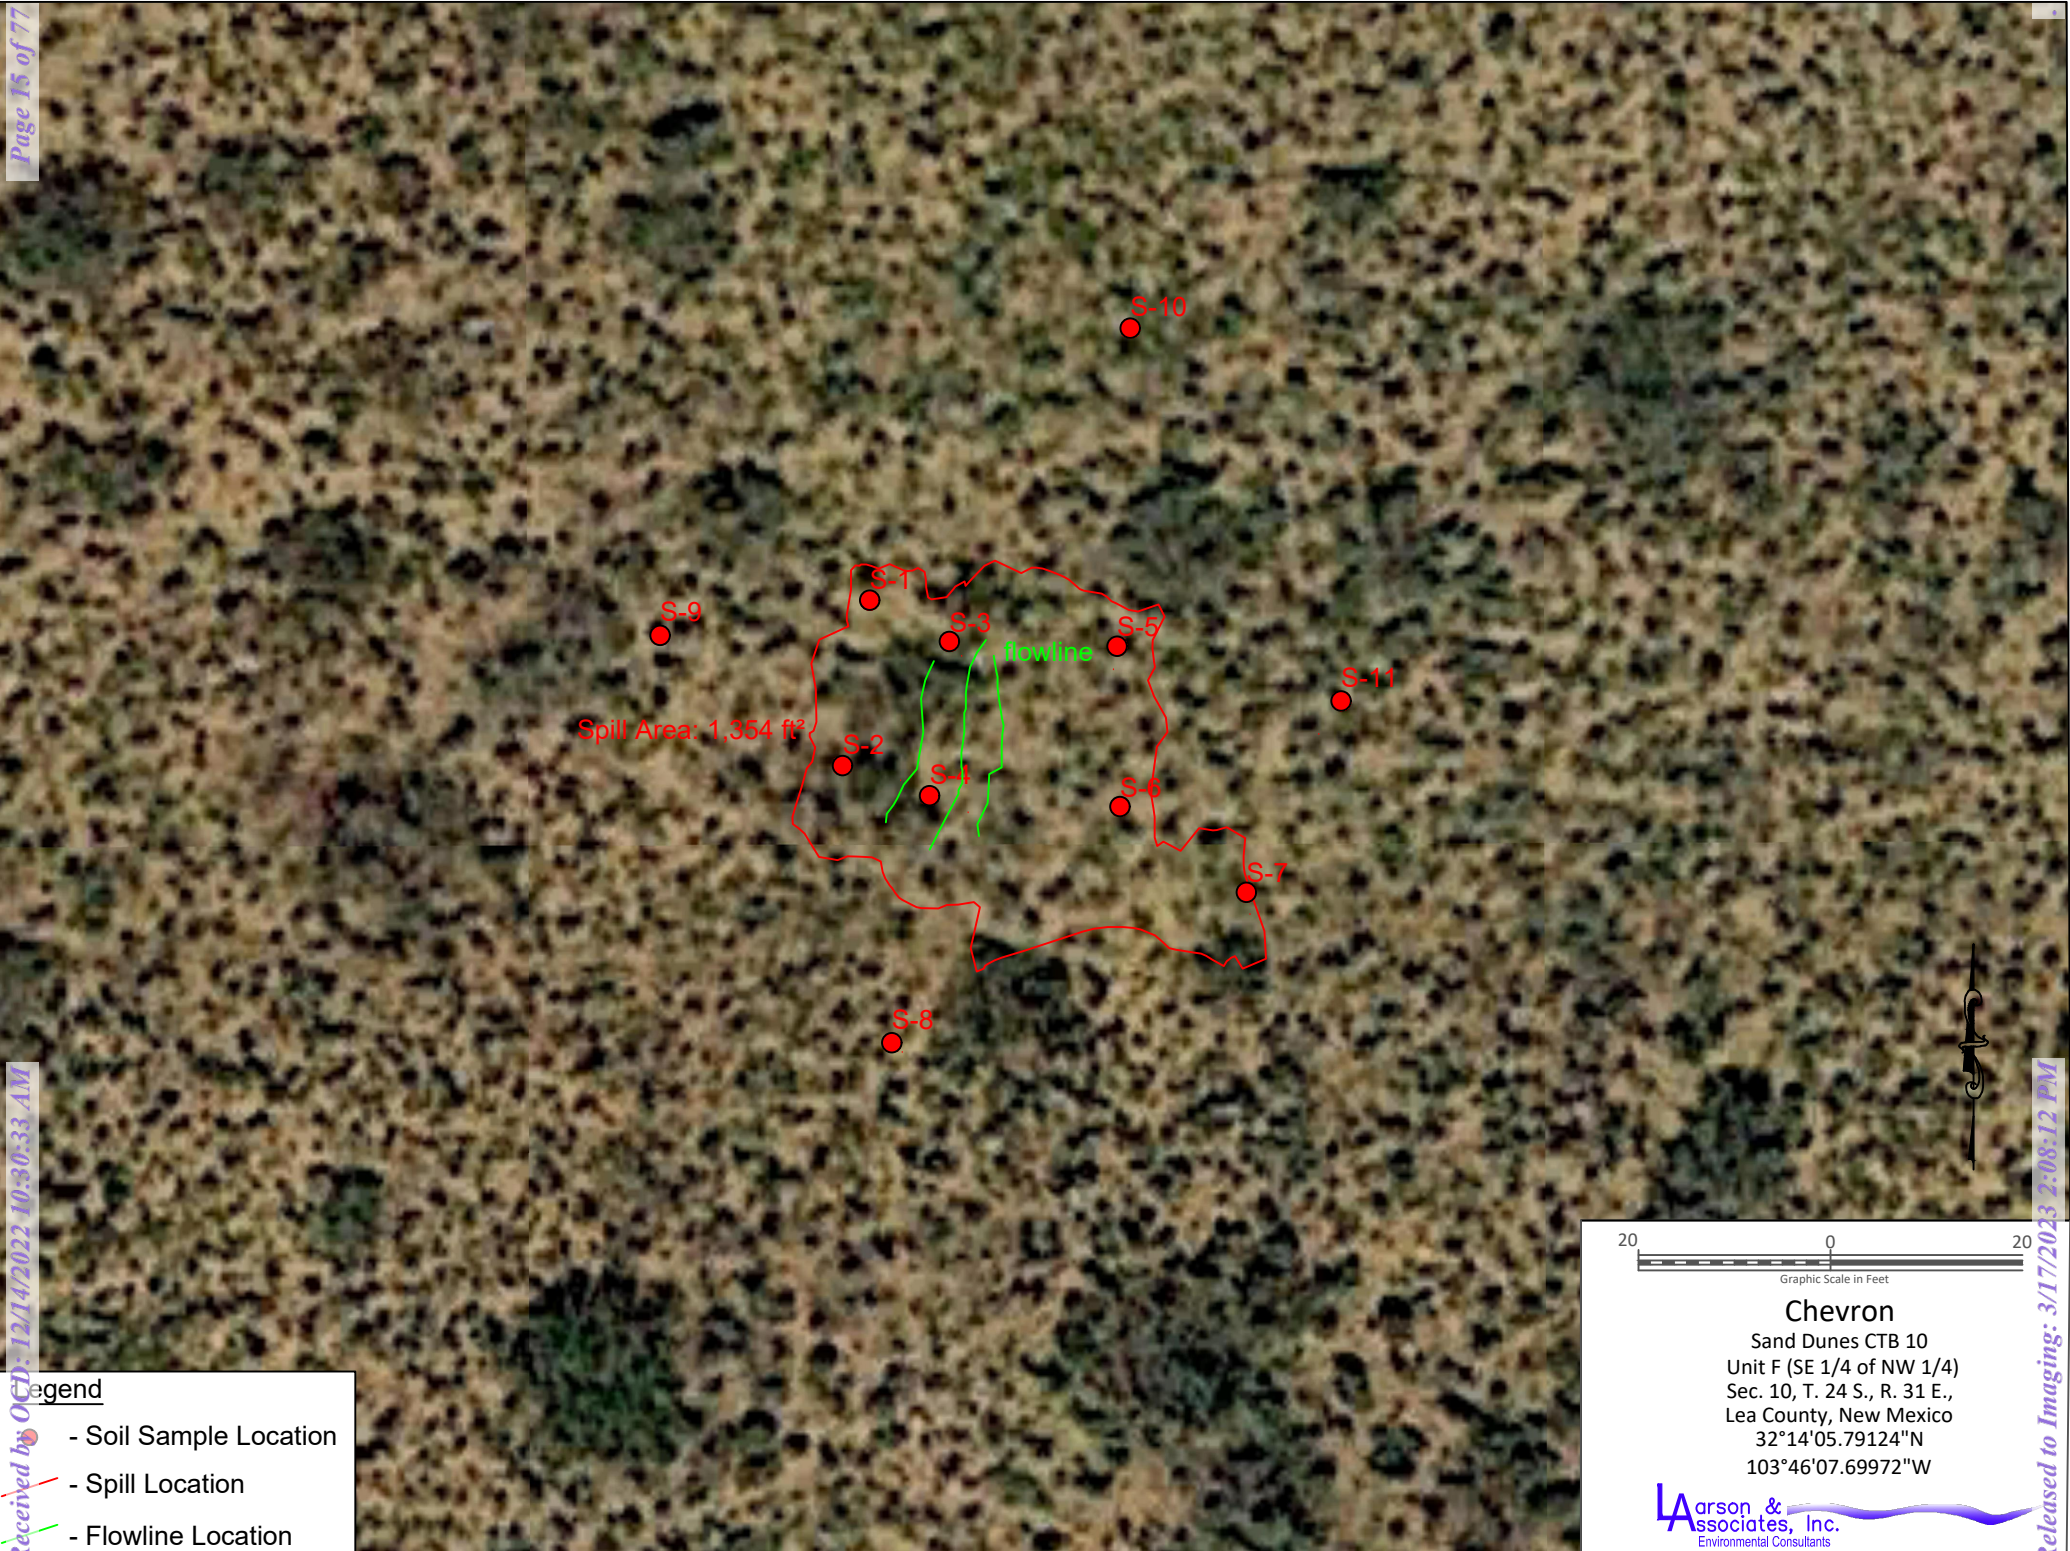
- Soil Sample Location
- Spill Location
- Flowline Location

On September 30, 2022, LAI personnel used a stainless-steel hand auger to collect soil samples from seven (7) locations (S-1 through S-7) inside the spill area and four (4) locations (S-8 through S-11) outside the spill area in each cardinal direction (north, south, east, and west). The release pooled in an area where underground flowlines located adjacent to an above ground riser were being installed at depths ranging from approximately three (3) to six (6) feet bgs.

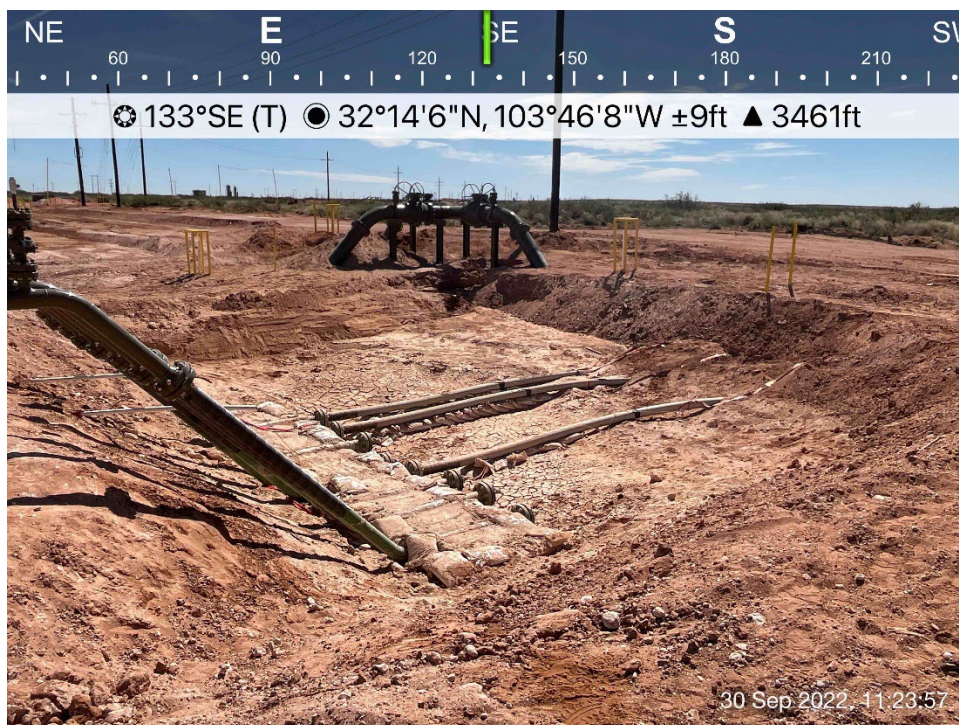
Impacted area viewing southeast, September 20, 2022

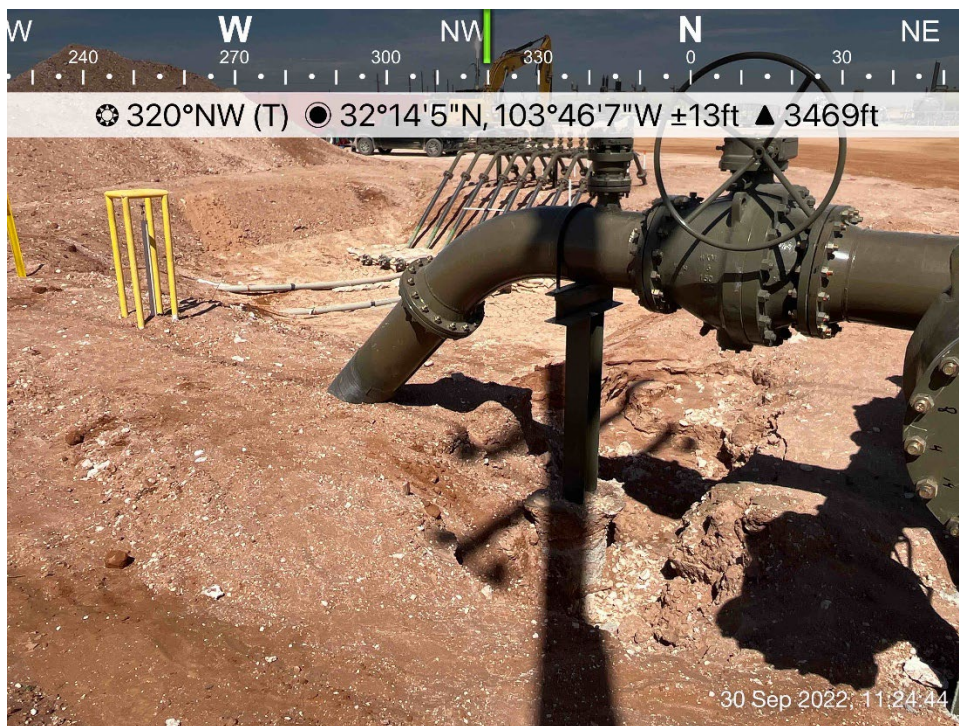
Impacted area viewing northwest, September 20, 2022

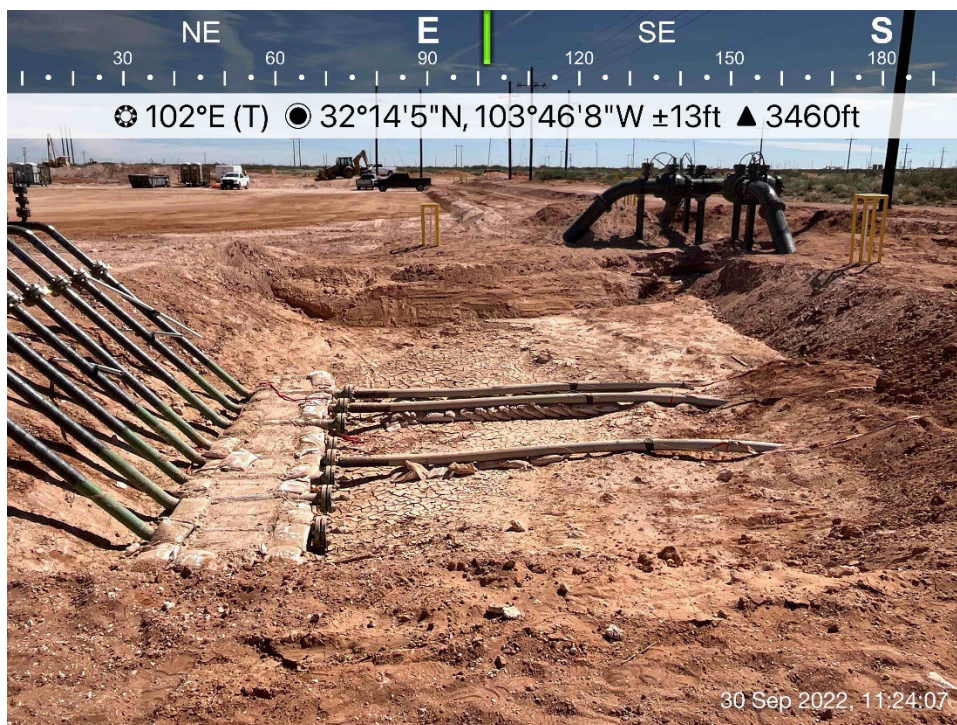
Impacted area viewing east, September 20, 2022

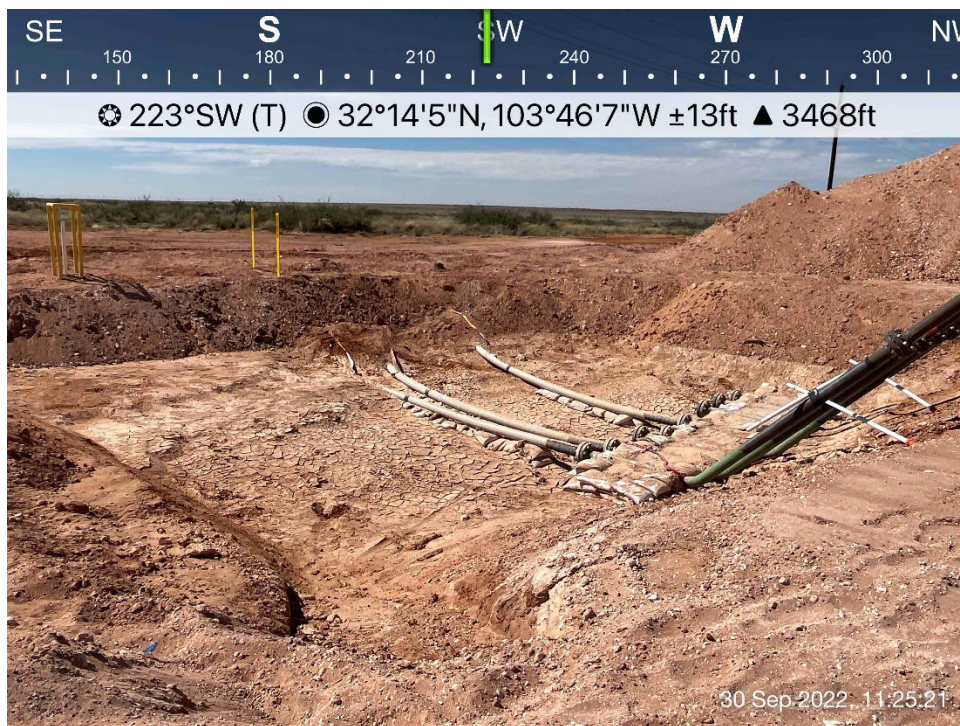
Impacted area viewing southwest, September 20, 2022

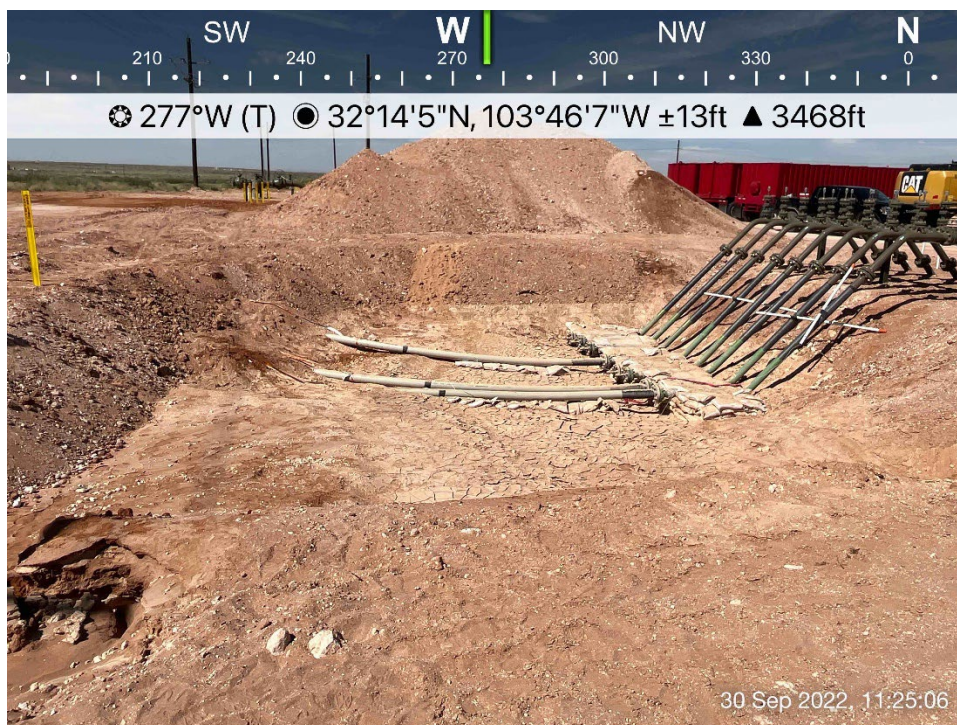
Impacted area viewing west, September 20, 2022

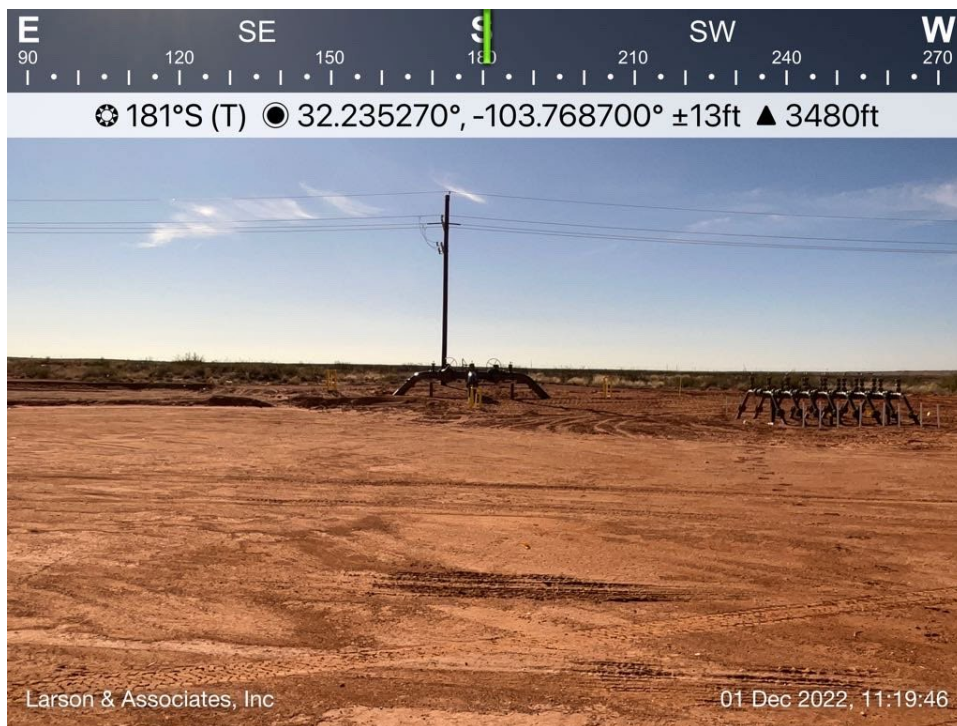
Backfilled area viewing south, December 1, 2022

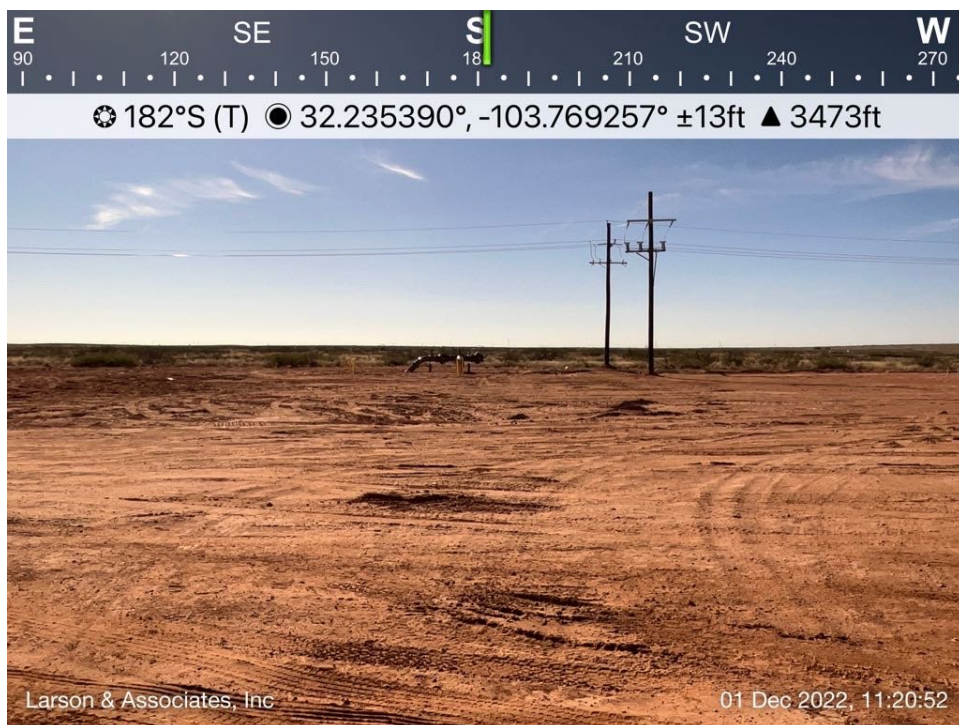
Backfilled area viewing south, December 1, 2022

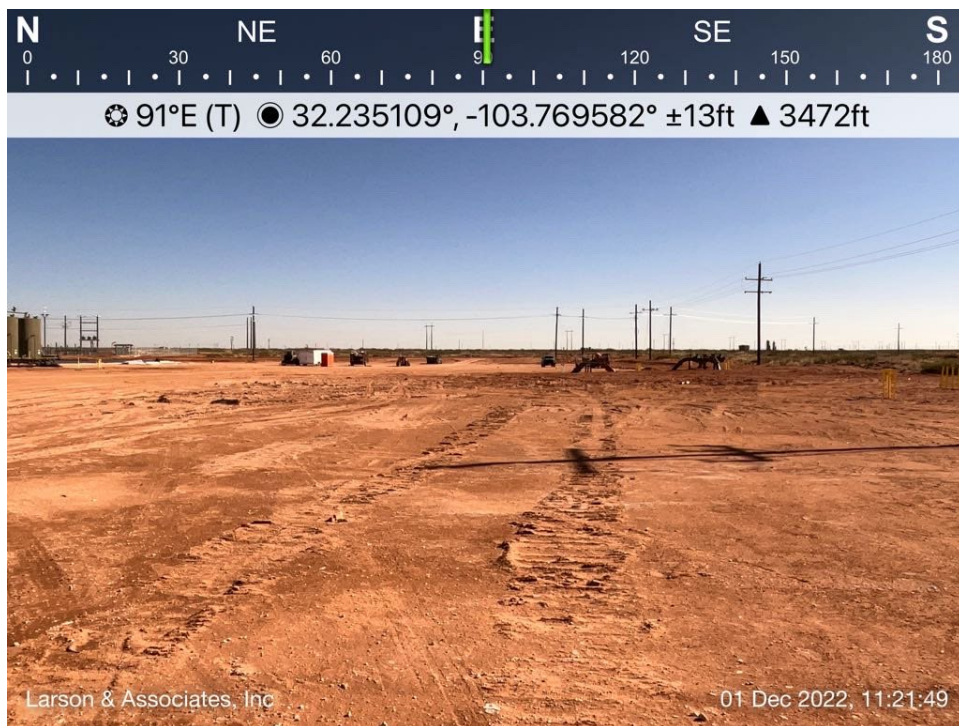
Backfilled area viewing east, December 1, 2022

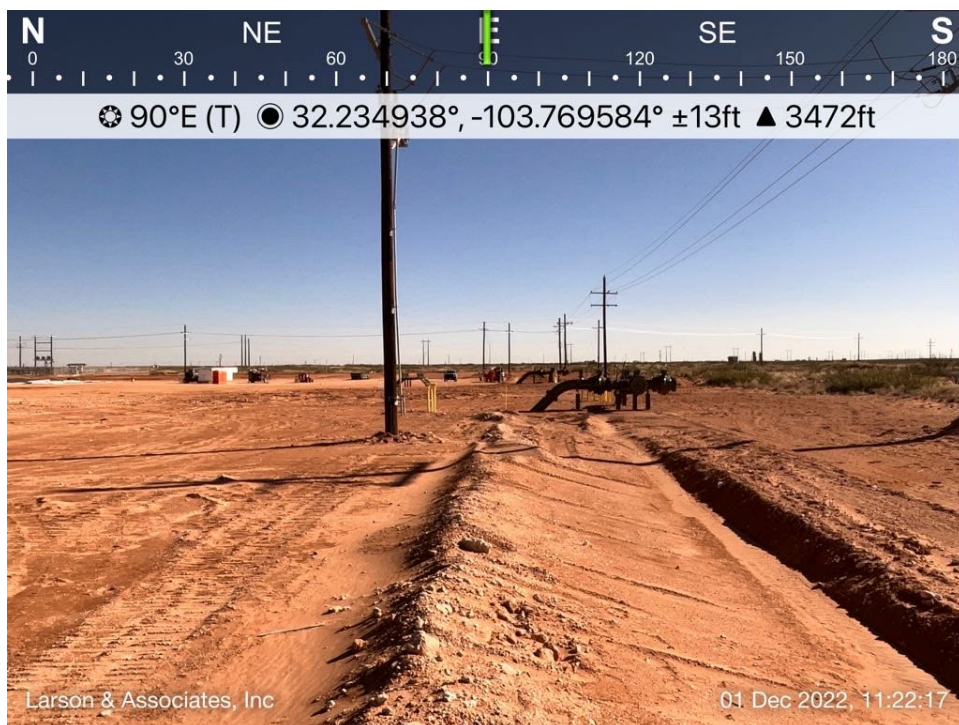
Backfilled area viewing east, December 1, 2022

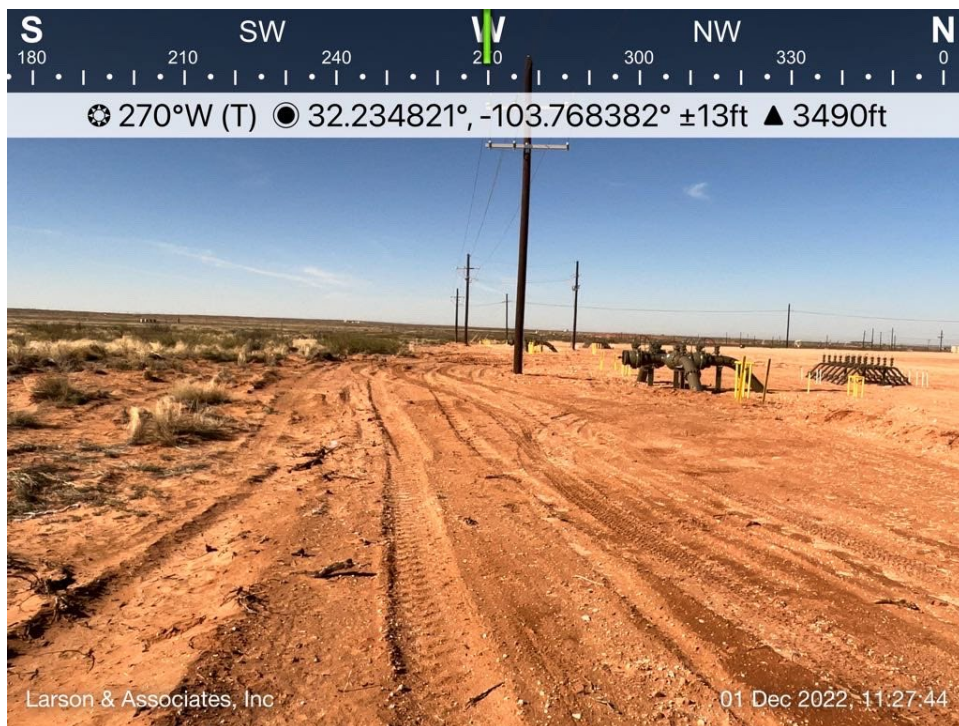
Backfilled area viewing west, December 1, 2022

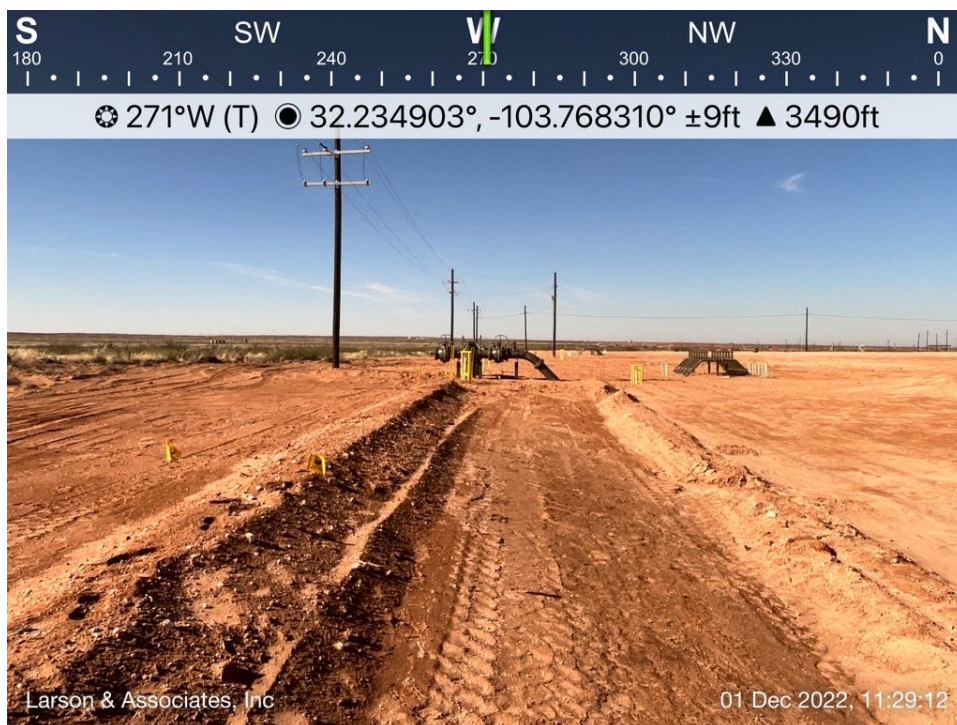
Backfilled area viewing west, December 1, 2022

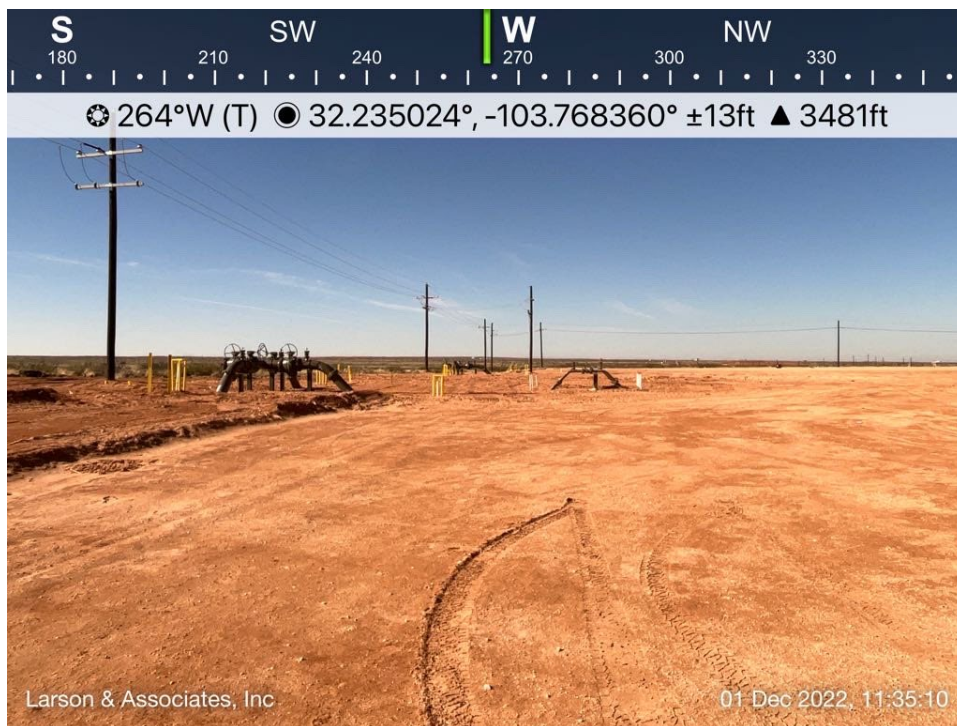
Backfilled area viewing west, December 1, 2022

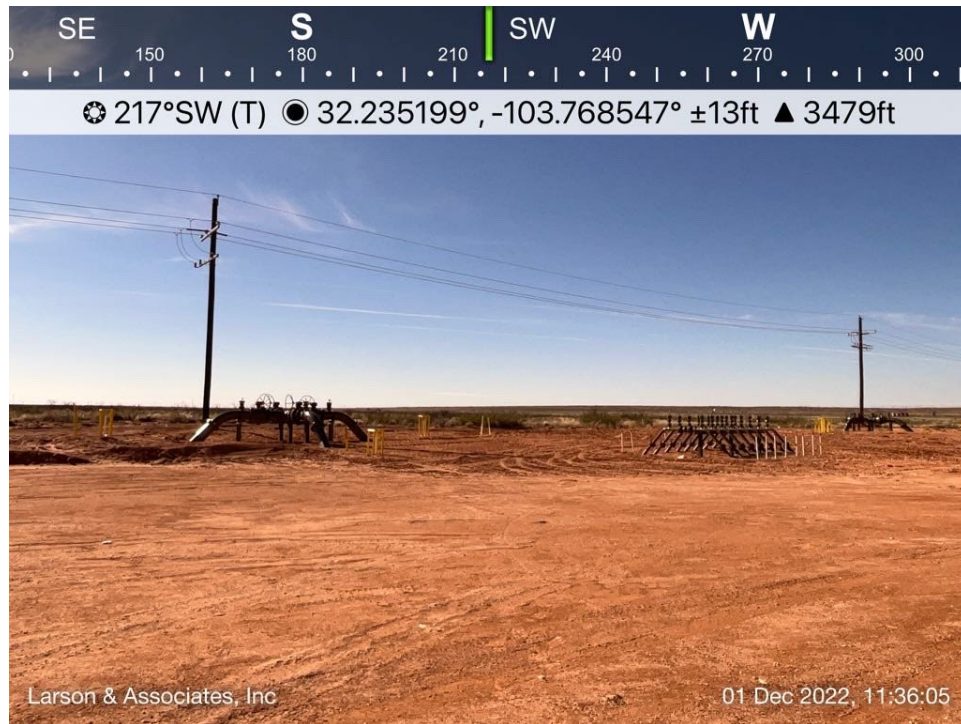
Backfilled area viewing southwest, December 1, 2022
