Report Type: Closure Report 1RP-2525

Site:	Vacuum Abo Battery #3 Suction Line Release (nGRL1013332423)					
Company:	ConocoPhillips					
Section, Township and Range	Unit Letter M	Sec. 34	T 17 S	R 35 E		
Lease Number:	Associated API No. 30-025-03011					
County:	Lea					
GPS:	32.787669°			-103.450060°		
Surface Owner:	State					
Mineral Owner:	State					
Directions:	Depart from Lovington (Main St/W Ave D), head south on Main St for 1.0 miles. Turn right (west) onto W Ave R for 0.2 miles. Turn left (south) onto NM-483 for 8.0 miles. Turn right (west) onto Buckeye Rd for 5.3 miles. Turn left (south) for 0.3 miles. Slight left (southwest) for 0.5 miles. Turn left (south) for 0.7 miles. Site will be on the left (south).

**Re: Release Characterization and Closure Request
ConocoPhillips
Vacuum Abo Battery #3 Suction Line Release
Unit Letter M, Section 34, Township 17 South, Range 35 East
Lea County, New Mexico
1RP-2525
Incident ID nGRL1013332423**

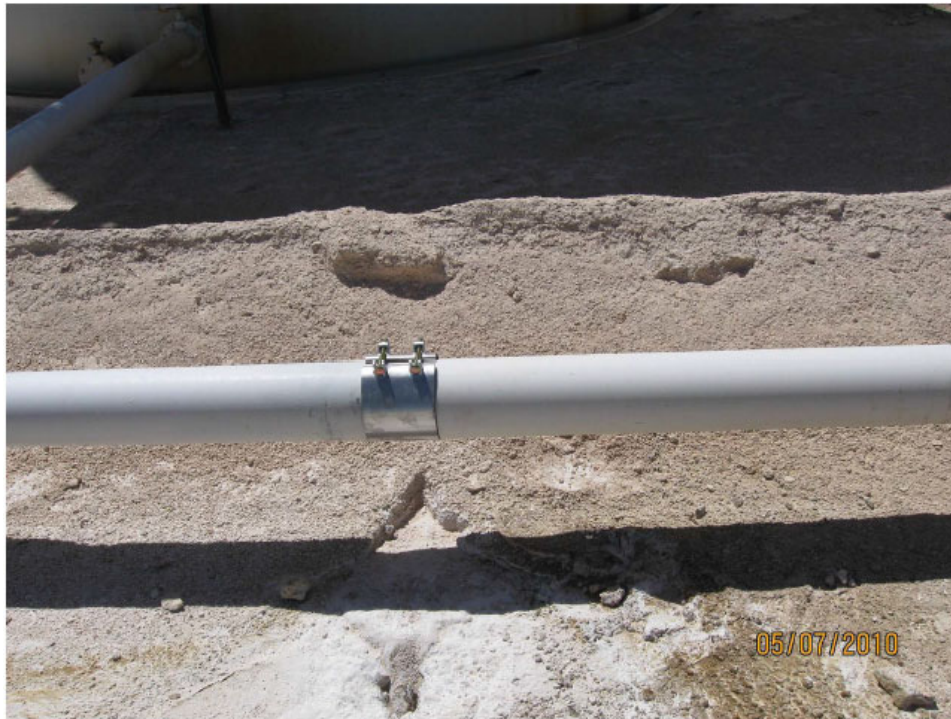
2" split on bottom of 6" steel suction line due to suspected internal corrosion. A work order has been generated to make necessary repairs.

TETRA TECH, INC. PROJECT NO. 212C-MD-02336	DESCRIPTION	View facing west of release point and clamp.	1
	SITE NAME	East Vacuum Abo Battery #3 Suction Line Release	5/7/2010

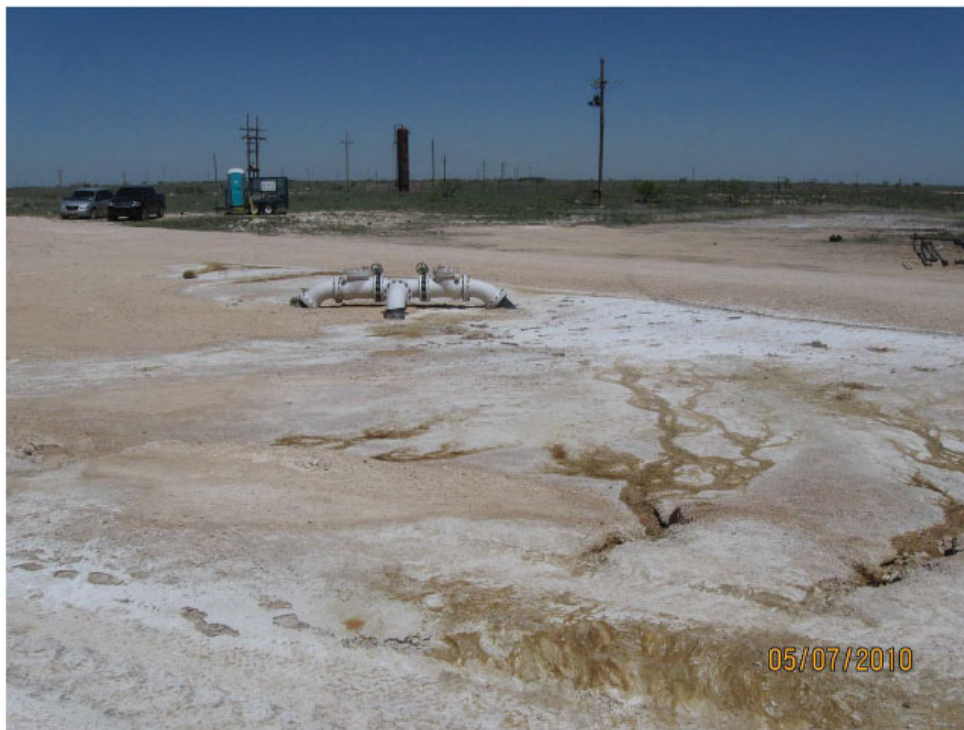
TETRA TECH, INC. PROJECT NO. 212C-MD-02336	DESCRIPTION	View facing northeast of release point.	2
	SITE NAME	East Vacuum Abo Battery #3 Suction Line Release	5/7/2010

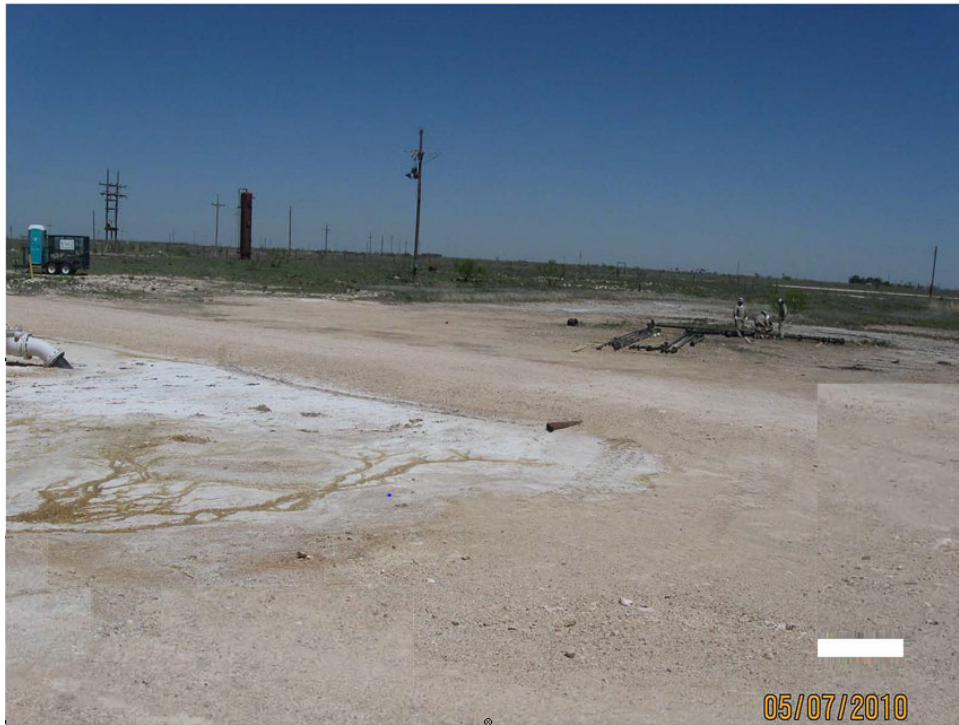
TETRA TECH, INC. PROJECT NO. 212C-MD-02336	DESCRIPTION	View facing northeast of release area (Note Culvert).	3
	SITE NAME	East Vacuum Abo Battery #3 Suction Line Release	5/7/2010

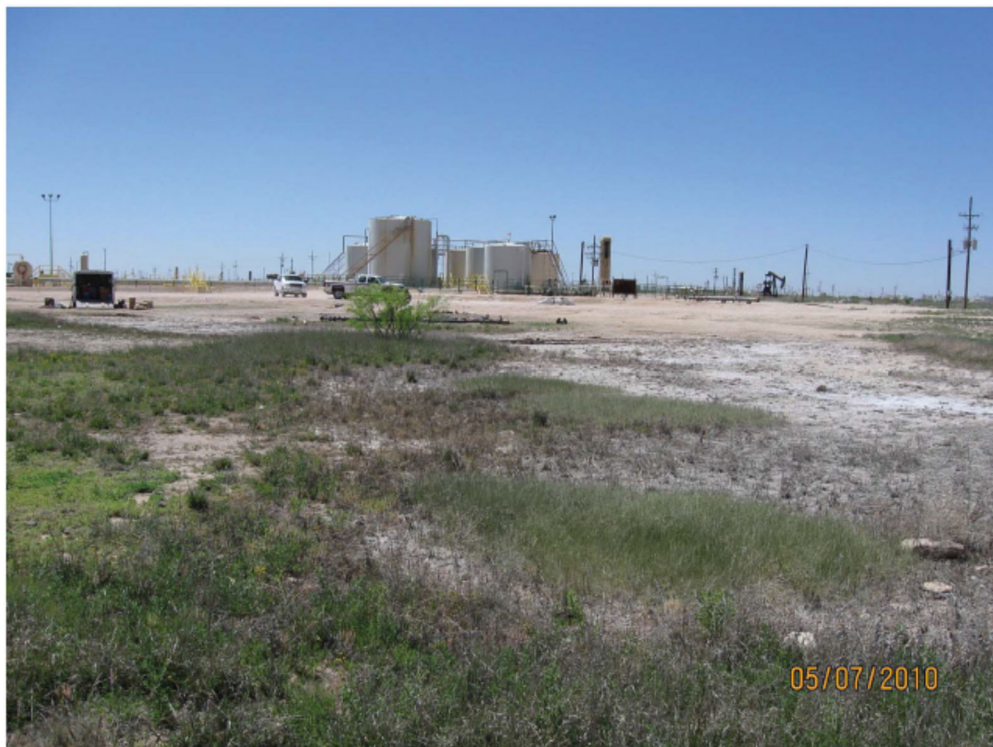
TETRA TECH, INC. PROJECT NO. 212C-MD-02336	DESCRIPTION	View facing northwest of release area.	4
	SITE NAME	East Vacuum Abo Battery #3 Suction Line Release	5/7/2010

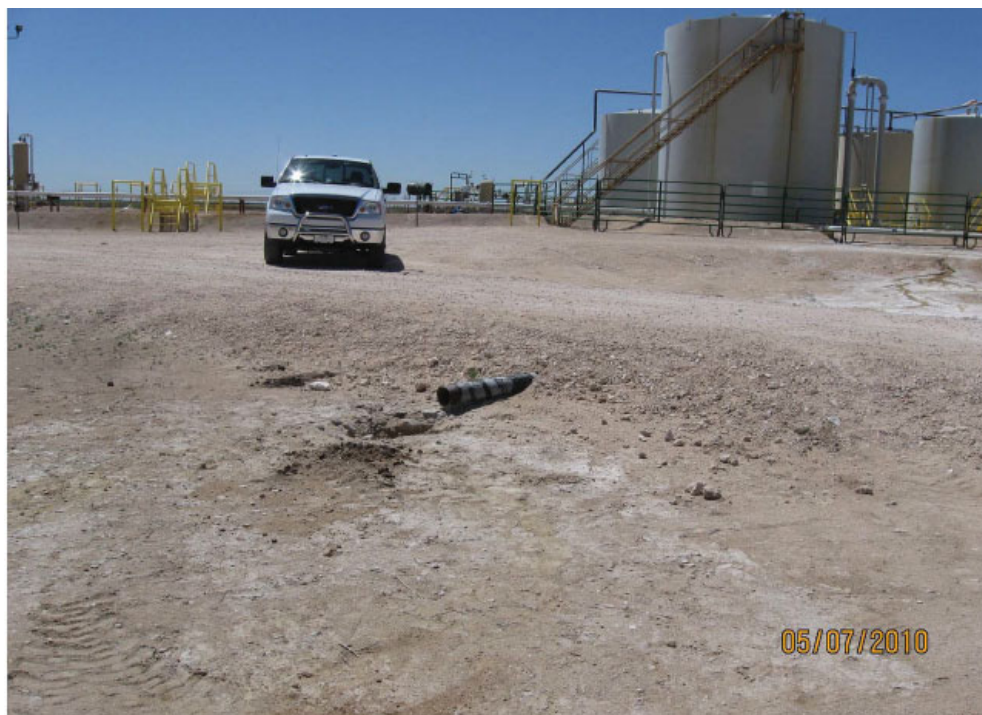
TETRA TECH, INC. PROJECT NO. 212C-MD-02336	DESCRIPTION	View facing southwest of east side of culvert.	5
	SITE NAME	East Vacuum Abo Battery #3 Suction Line Release	5/7/2020

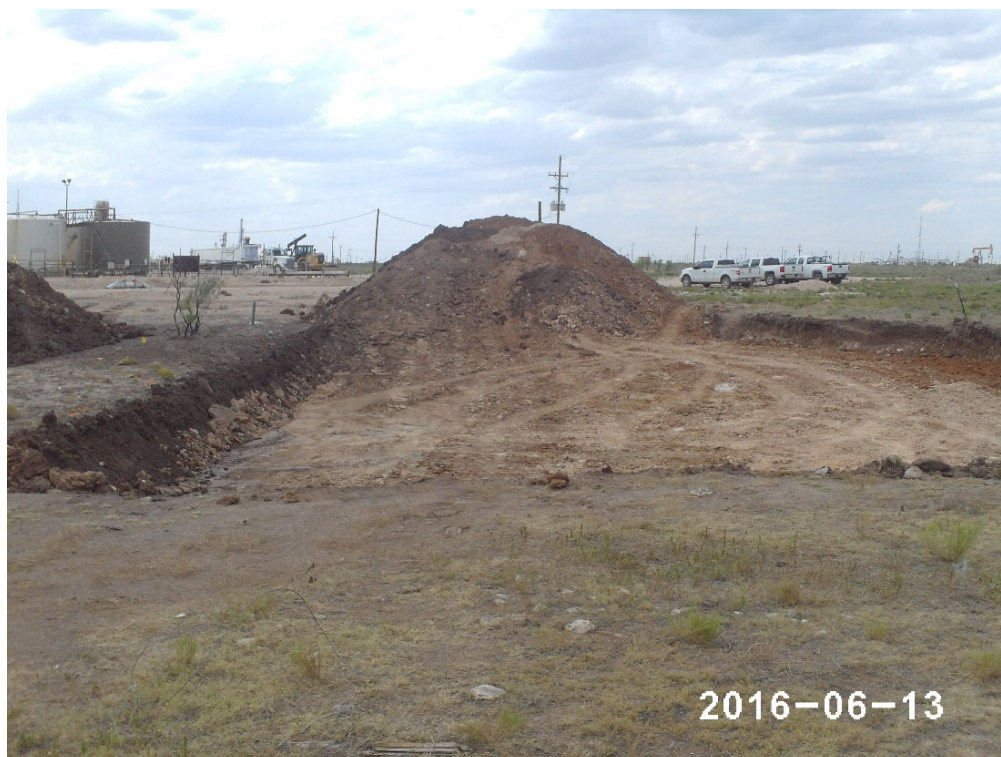
TETRA TECH, INC. PROJECT NO. 212C-MD-02336	DESCRIPTION	View northwest. 1RP-3555 excavation activities consuming 1RP-2525 southeast of lease pad	6
	SITE NAME	East Vacuum Abo Battery #3 Suction Line Release	6/13/2016

Basin began remedial activities of the 1RP-3555 release in June 2016. In accordance with the NMOCD-approved CAP, the pastureland southeast of the production pad associated with 1RP-3555 release were excavated to a depth of 4 ft bgs. At the base of the excavation, a 20-mil reinforced poly liner was installed and properly seated.

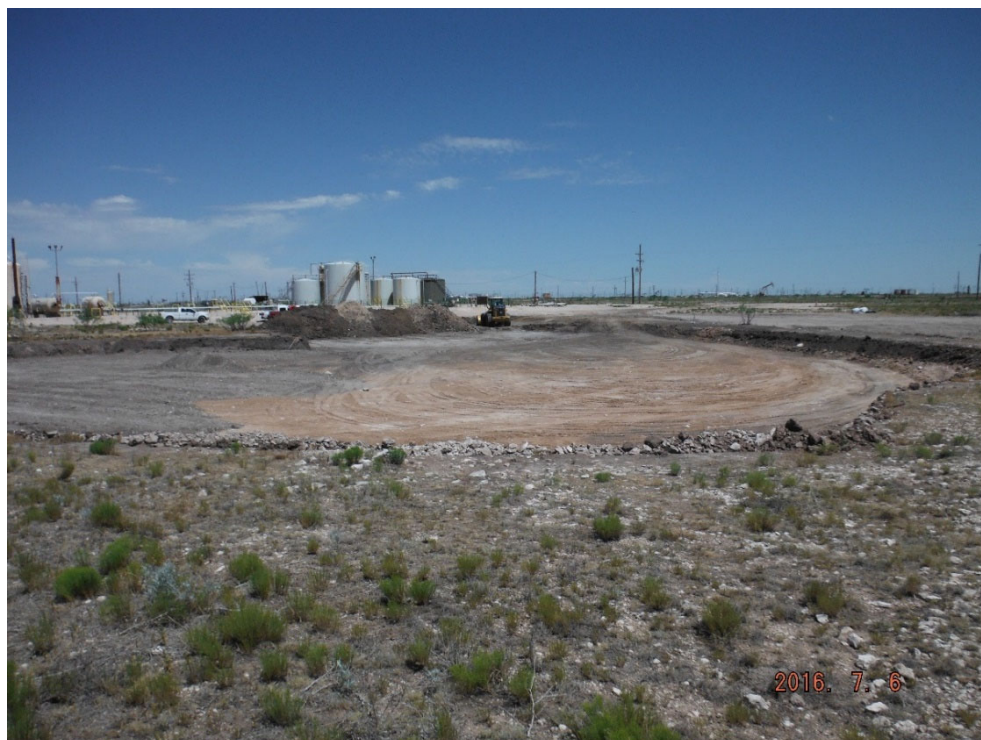
TETRA TECH, INC. PROJECT NO. 212C-MD-02336	DESCRIPTION	View facing southeast of 1RP-3555 excavation consuming 1RP-2525 extent.	7
	SITE NAME	East Vacuum Abo Battery #3 Suction Line Release	7/6/2016

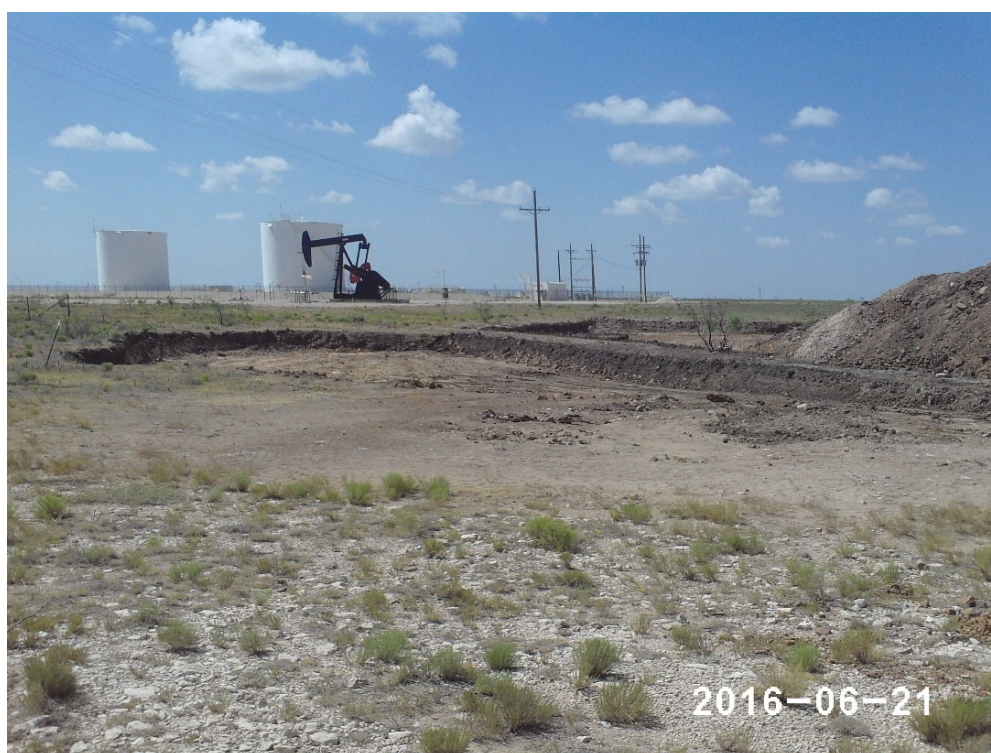
TETRA TECH, INC. PROJECT NO. 212C-MD-02336	DESCRIPTION	View facing southeast of 1RP-3555 excavation consuming 1RP-2525.	8
	SITE NAME	East Vacuum Abo Battery #3 Suction Line Release	6/21/2016

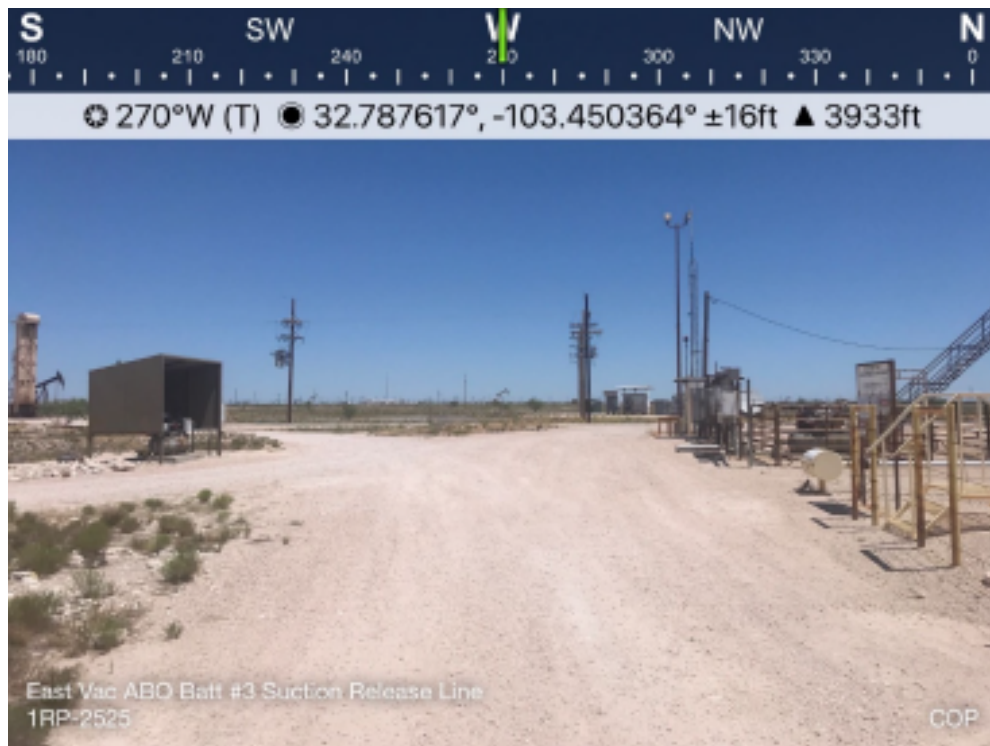
TETRA TECH, INC. PROJECT NO. 212C-MD-02336	DESCRIPTION	View facing west of lease road access.	9
	SITE NAME	East Vacuum Abo Battery #3 Suction Line Release	6/8/2020

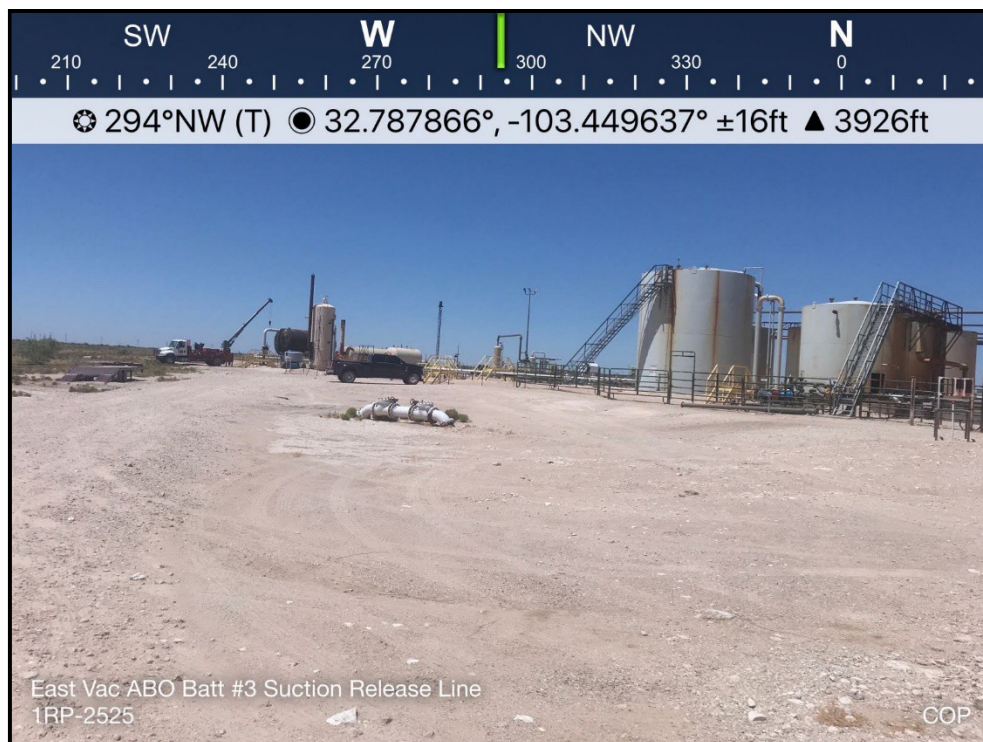
TETRA TECH, INC. PROJECT NO. 212C-MD-02336	DESCRIPTION	View facing northwest of battery tank area.	10
	SITE NAME	East Vacuum Abo Battery #3 Suction Line Release	6/8/2020

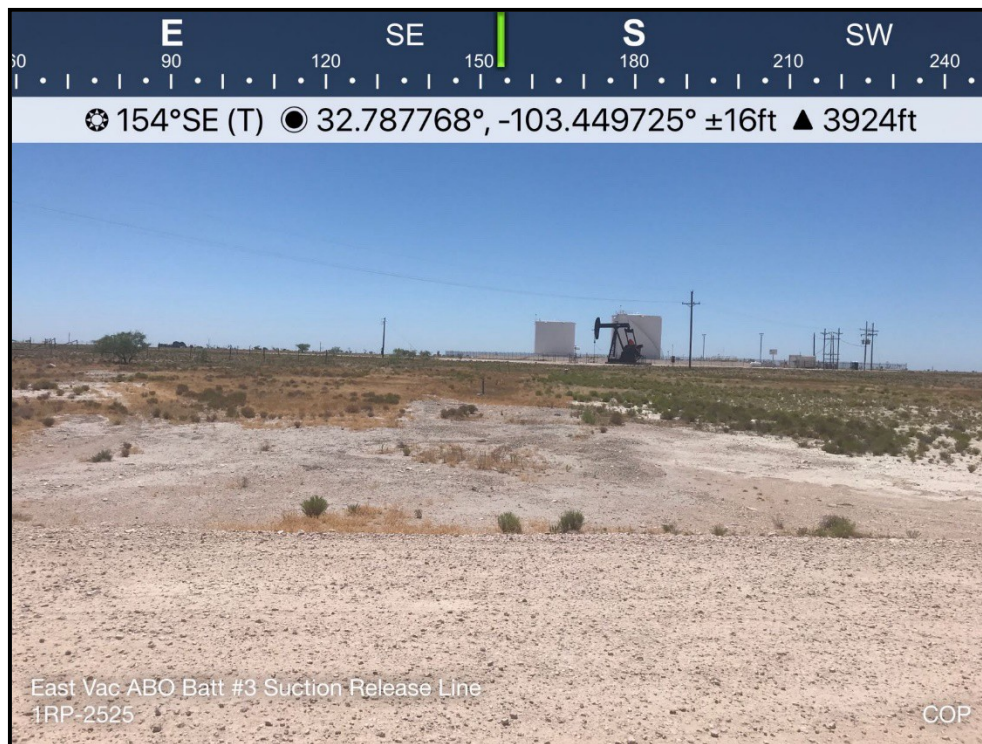
On behalf of COP, Tetra Tech personnel conducted a Visual Site Investigation on June 8, 2020 for the release associated with 1RP-2525. The site investigation revealed no evidence of staining on-pad or in the pasture within the assumed release footprint. The areas of the pasture east of the battery/production pad were addressed during work performed under the 1RP-3555 remedial activities (Figure 4) and show no signs of staining. The impacted pasture east of the production pad was wholly addressed with the remedial activities associated with 1RP-3555. Photographs from the site investigation are located in Appendix D.

TETRA TECH, INC. PROJECT NO. 212C-MD-02336	DESCRIPTION	View facing southeast of former release area.	11
	SITE NAME	East Vacuum Abo Battery #3 Suction Line Release	6/8/2020

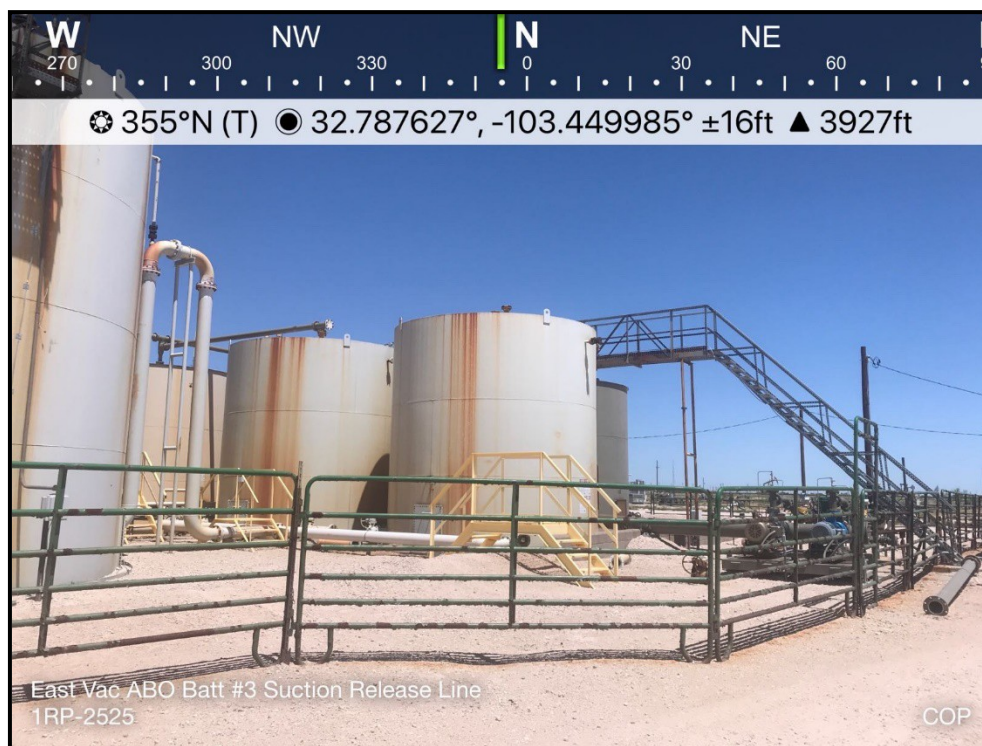
TETRA TECH, INC. PROJECT NO. 212C-MD-02336	DESCRIPTION	View facing north of battery tank area.	12
	SITE NAME	East Vacuum Abo Battery #3 Suction Line Release	6/8/2020

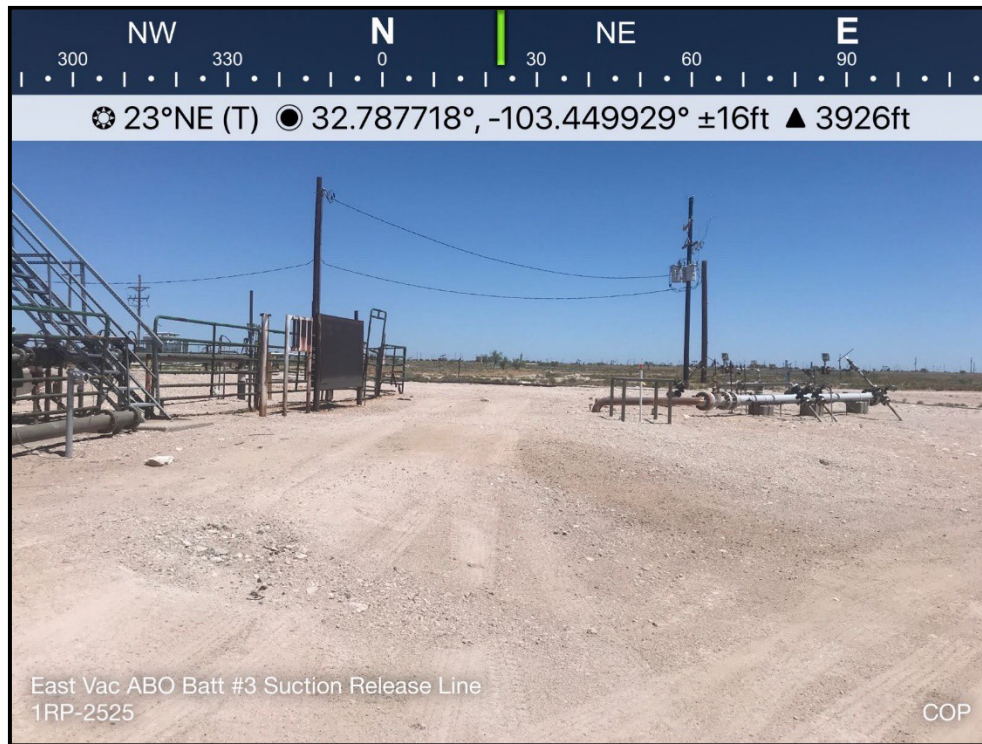
TETRA TECH, INC. PROJECT NO. 212C-MD-02336	DESCRIPTION	View facing northeast of former release area.	13
	SITE NAME	East Vacuum Abo Battery #3 Suction Line Release	6/8/2020

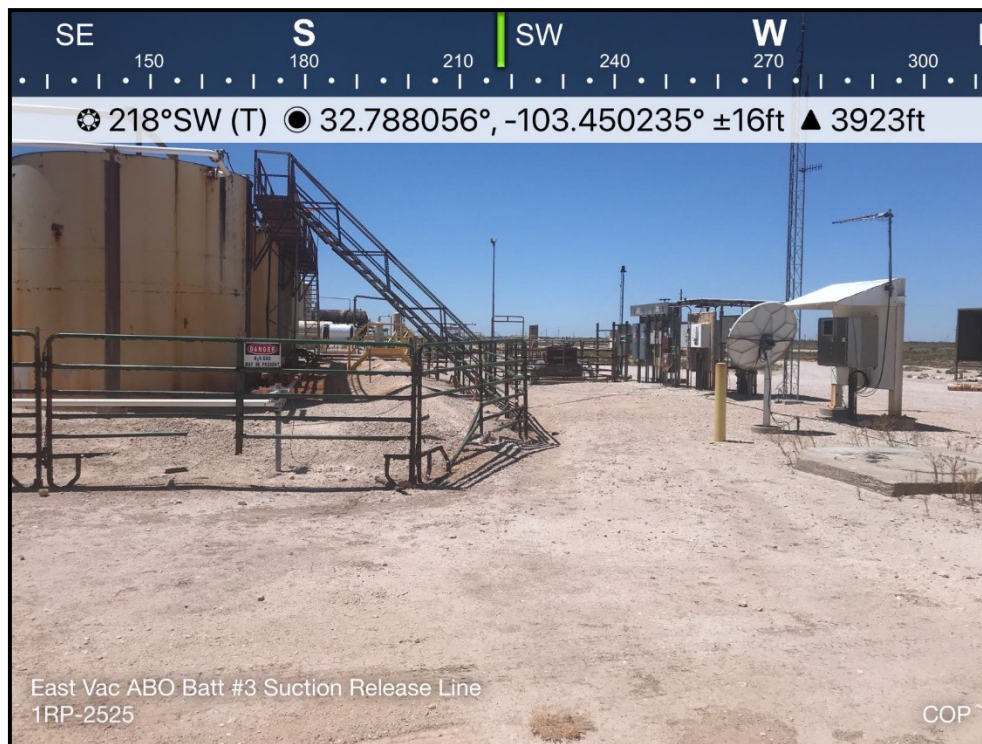
TETRA TECH, INC. PROJECT NO. 212C-MD-02336	DESCRIPTION	View facing southwest of battery tank area.	14
	SITE NAME	East Vacuum Abo Battery #3 Suction Line Release	6/8/2020

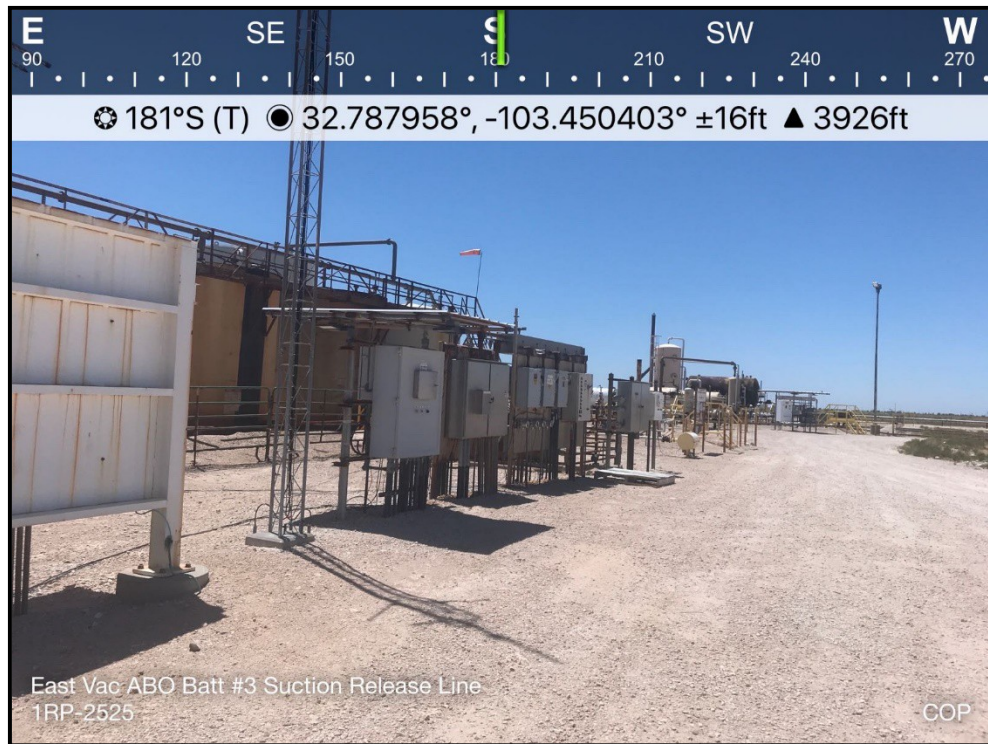
TETRA TECH, INC. PROJECT NO. 212C-MD-02336	DESCRIPTION	View facing south of battery tank control panels.	15
	SITE NAME	East Vacuum Abo Battery #3 Suction Line Release	6/8/2020

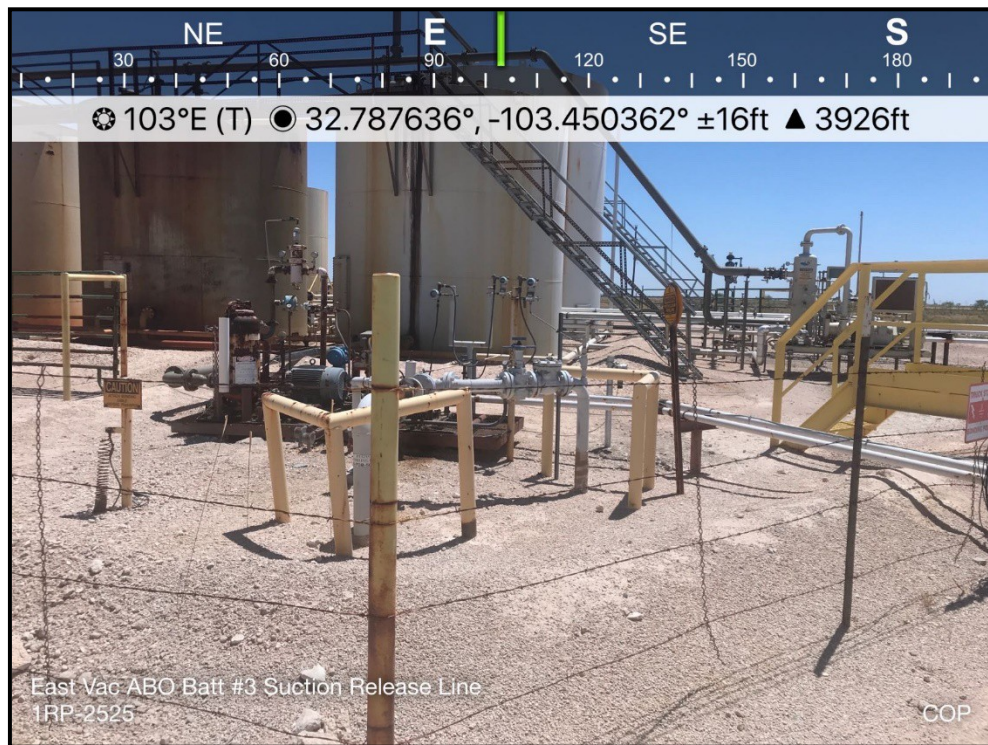
TETRA TECH, INC. PROJECT NO. 212C-MD-02336	DESCRIPTION	View facing east of former release area.	16
	SITE NAME	East Vacuum Abo Battery #3 Suction Line Release	6/8/2020
