Release Notification and Corrective Action

Name of Company	OXY USA INC	Contact	WADE DITTRICH
Address	PO BOX 4294; HOUSTON, TX 77210	Telephone No.	575-390-2828
Facility Name	MADERA 35 FEDERAL #1H CTB	Facility Type	BATTERY

On 08/09/2017 and 12/27/2017, OXY USA, Inc. reported releases at the Madera 35 Federal #1H CTB. The releases were caused by a compilation of lightning and equipment failure. The referenced incidents were commingled to account for overlap and to maintain remedial integrity. Approximately 6,803 sqft. of the Pad and Containment was impacted over the extent of the two releases.

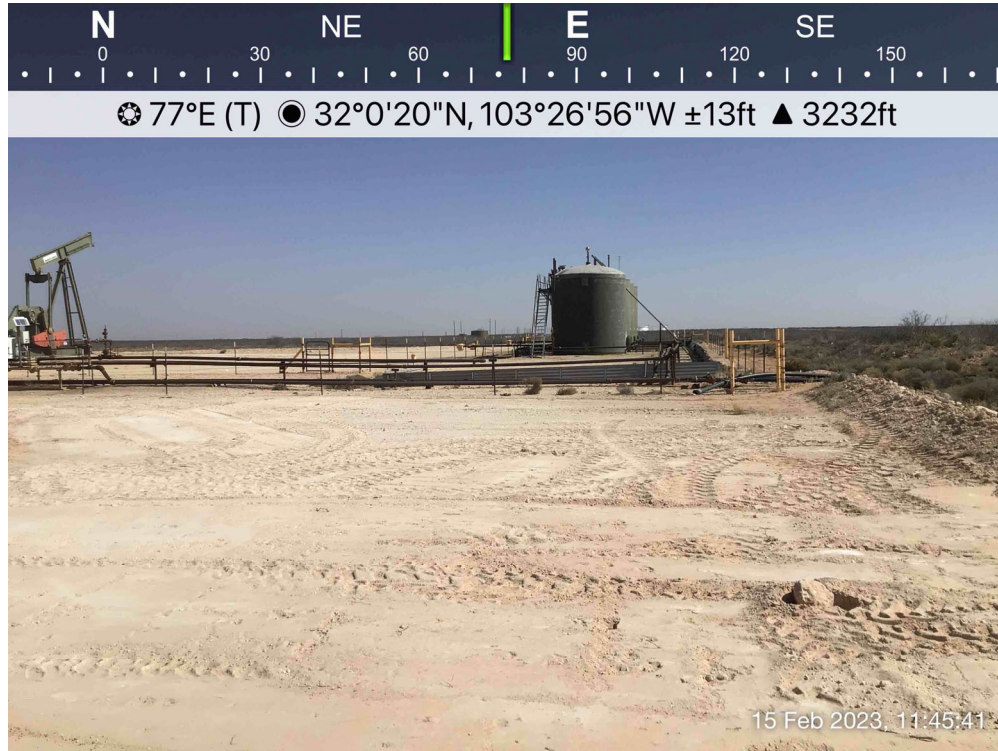
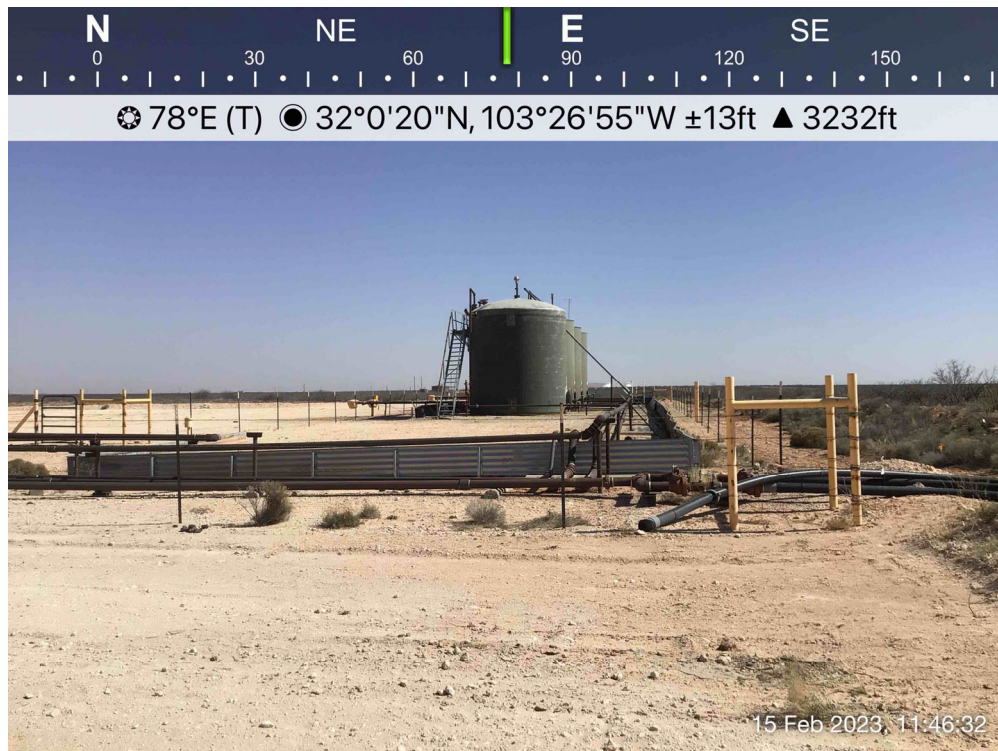
Excavation

Pad:

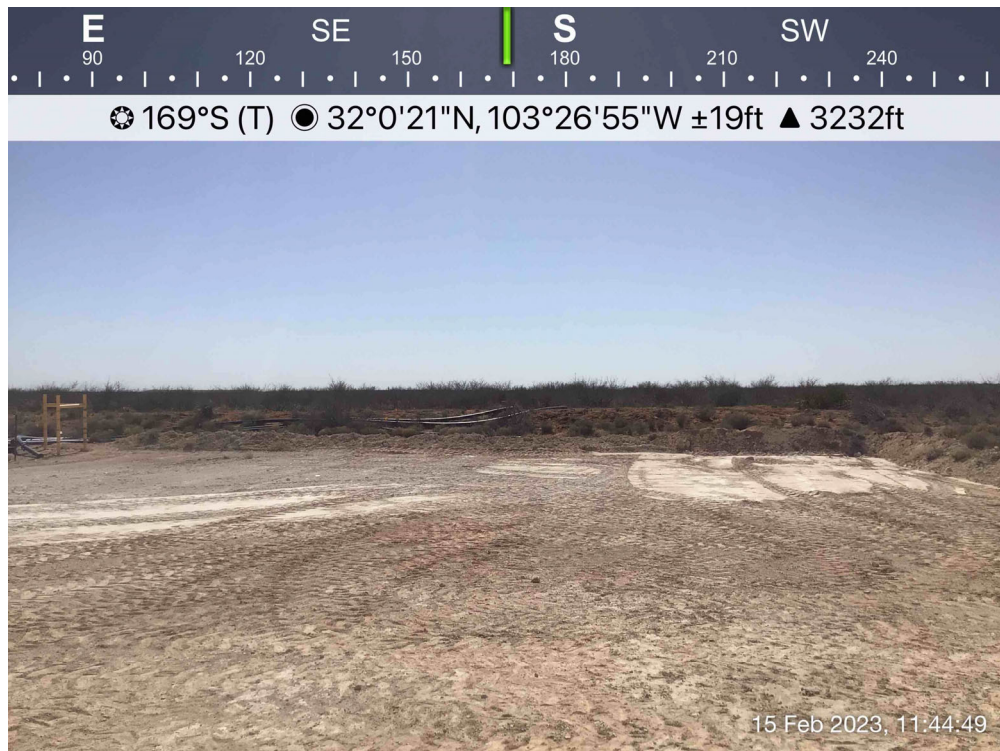
Excavation

Pad:

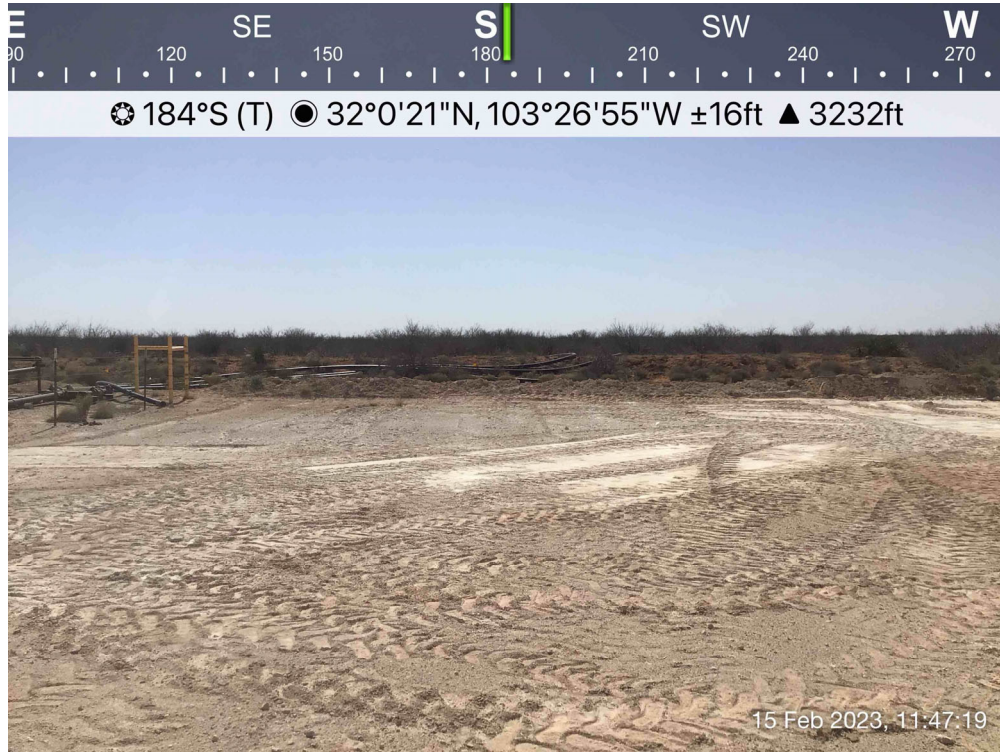
Excavation

Pad:
