Release Notification

Site Name: Sims Mesa CDP Tank Battery	Site Type: Compressor station
Date Release Discovered: 01/09/2023 1:41 PM	API# (if applicable)

Sims Mesa CDP tank spill

nAPP2300953706

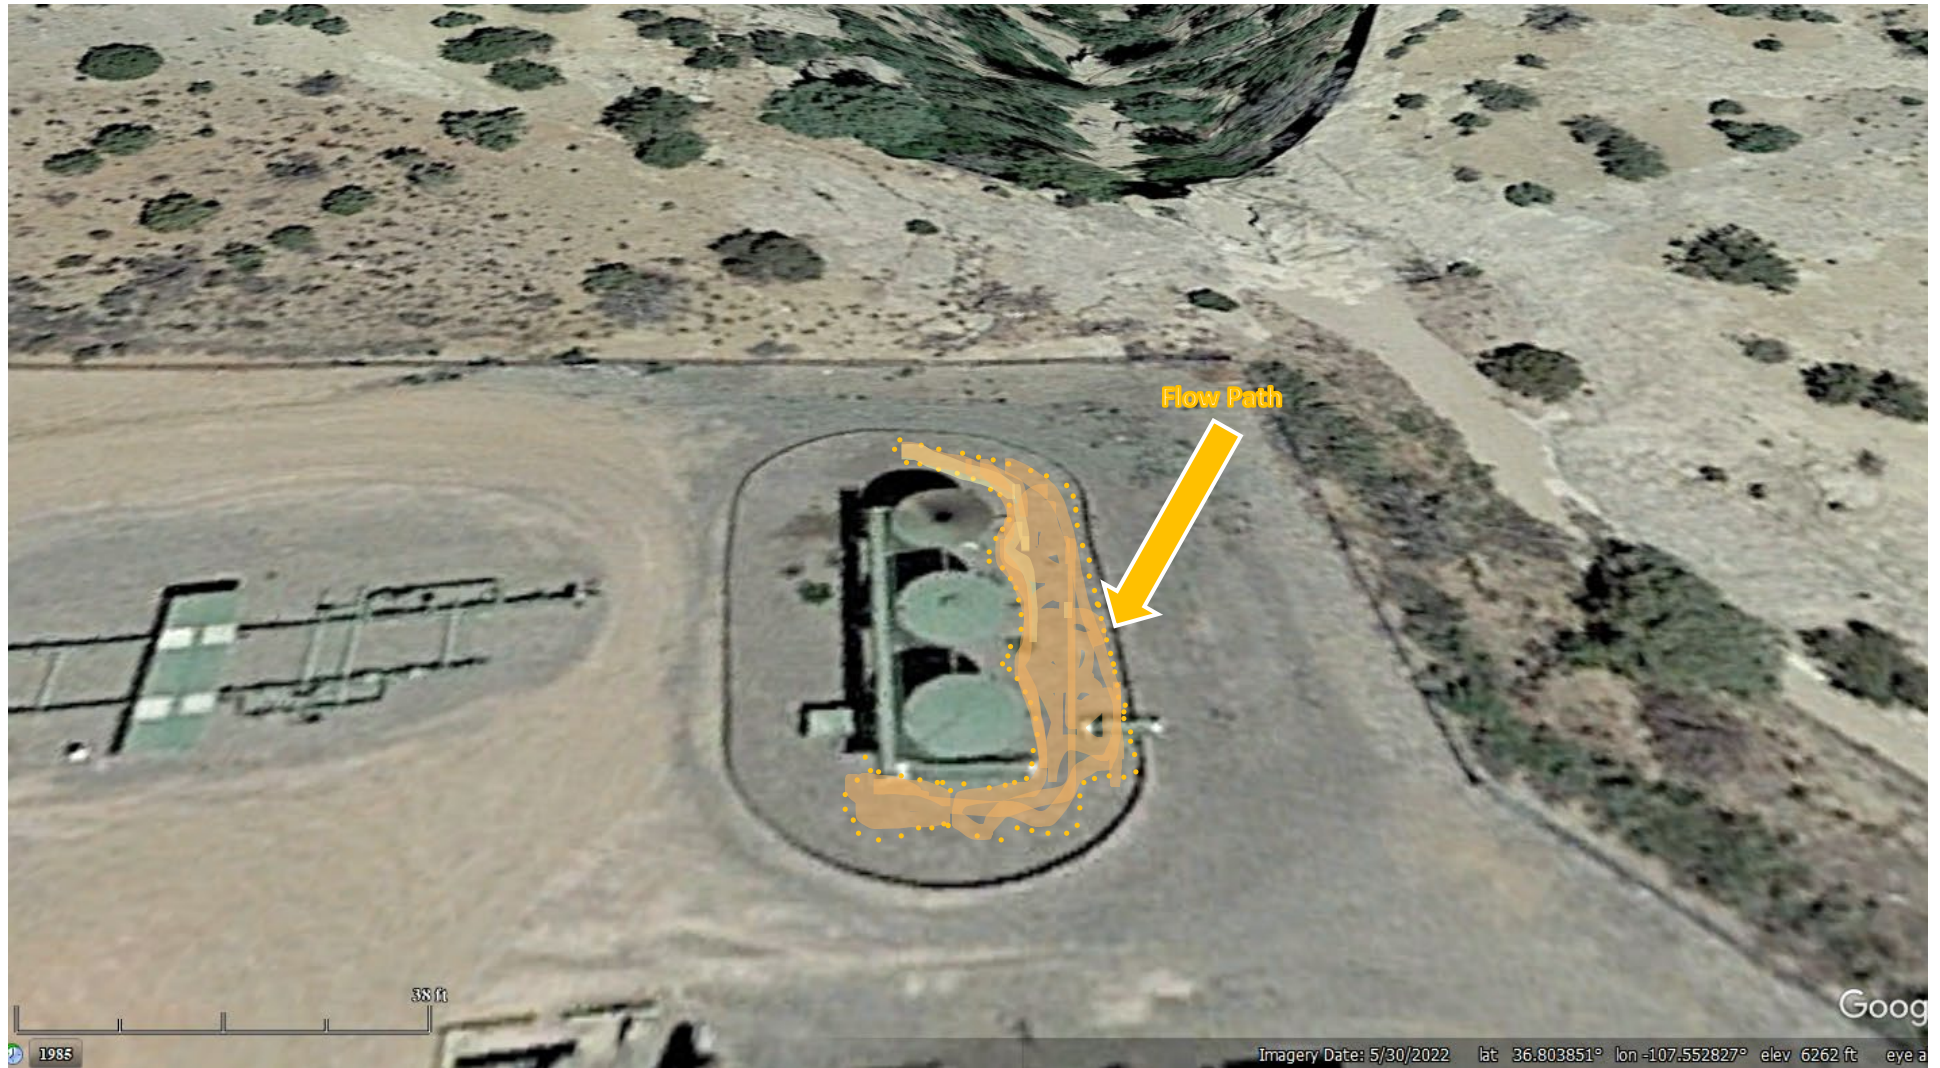
Spill Map

Cause of Release: Upon arrival onto location fluids and layer of ice were noted within the lined secondary containment of the tank battery. Further investigation noted there had been a freeze in the load line that appears to have pushed the plug out of the line. Equipment was shut in and LOTO performed. A water truck was dispatched to location to recover standing fluids from within the containment and drain the remainder of fluids from the tank. The water truck recovered 131 bbls of fluid. Layer of ice remains in containment.

All impacts are contained in secondary containment which is metal ring lined with poly liner.
Remediation if needed will be determined upon receipt and review of soil analytics.

The release was contained in the secondary containment that has metal containment with poly liner.

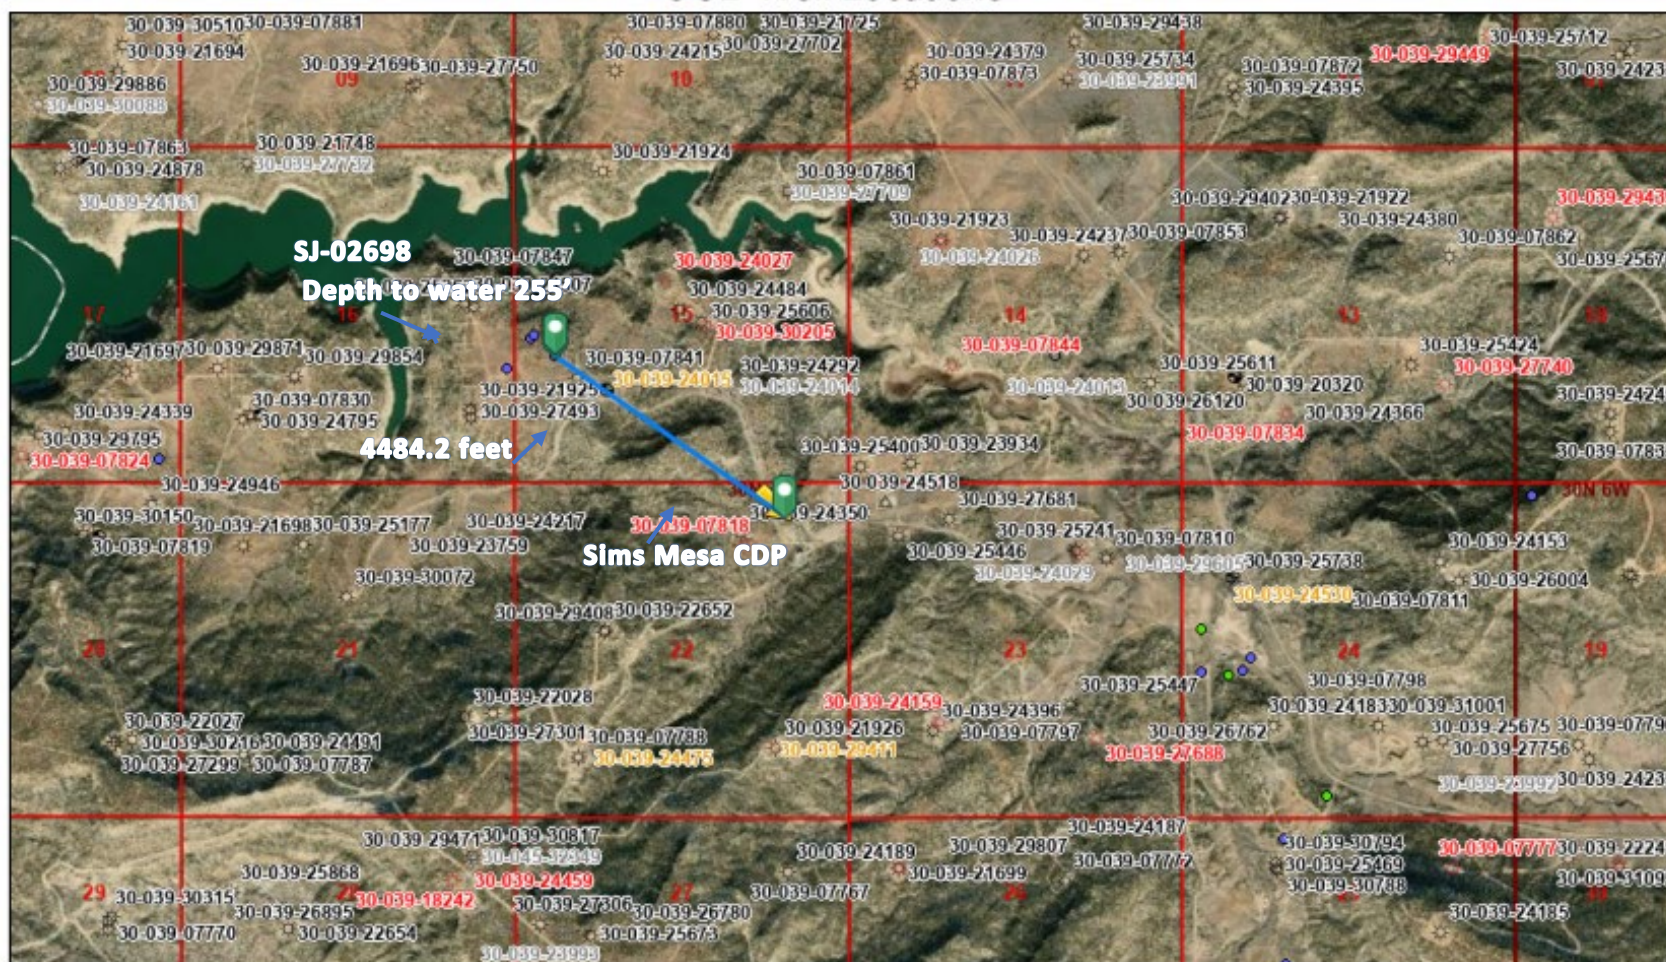
OCD Well Locations

Ground water depth is estimated to be greater than 100 feet reference SJ-02698 water well depth 402' and depth to water 255' is the closest water well at 4484.2 feet to the NW of the CDP location.

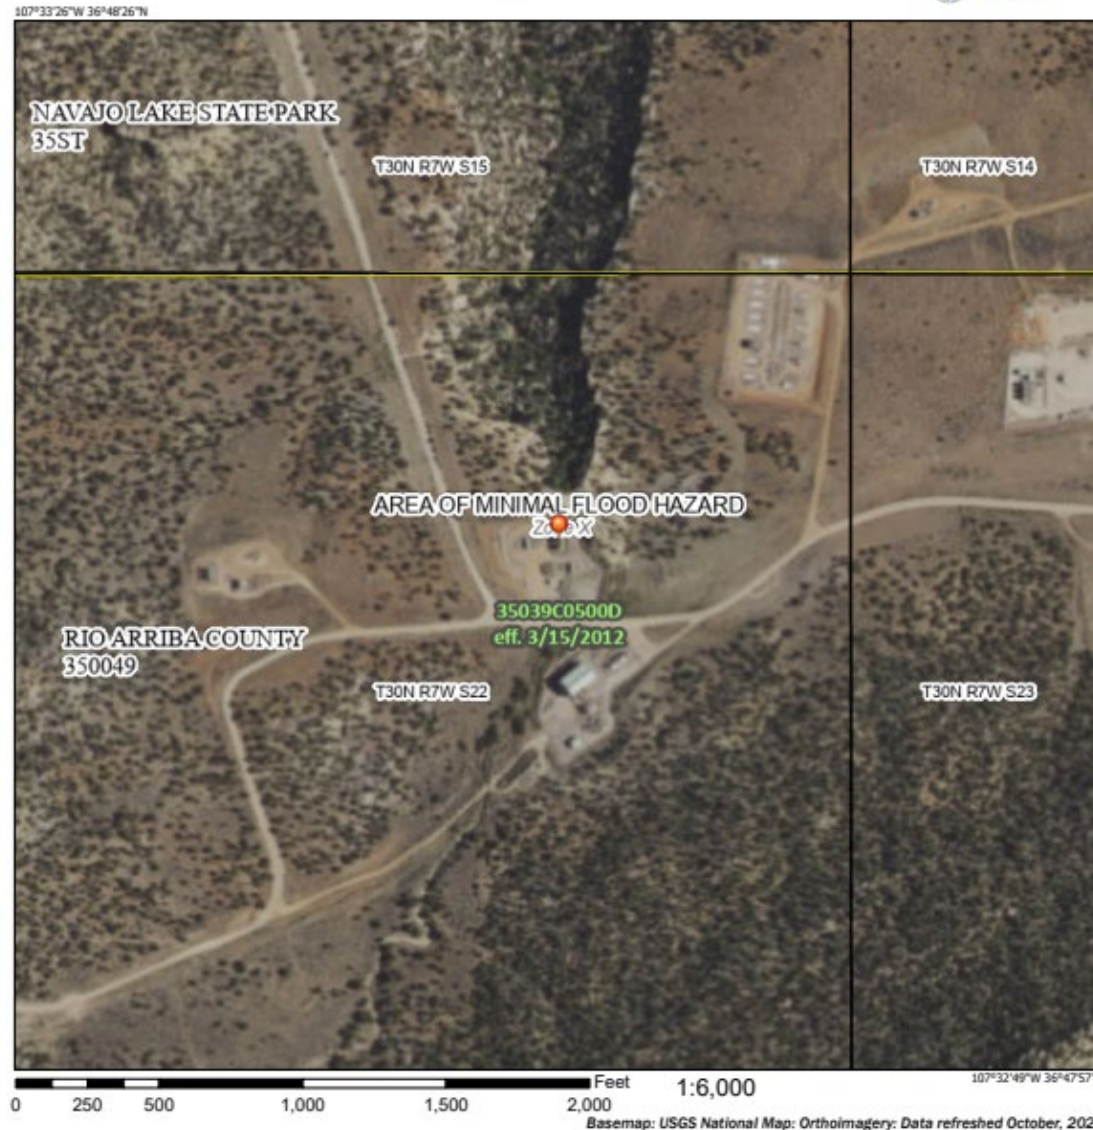
FEMA Flood map

Location is not within a 100-year flood plain.
