Incident ID	nAPP2236030437
District RP	
Facility ID	
Application ID

Site Assessment/Characterization

Based on laboratory analytical results and field activities conducted to date, Etech recommends Mewbourne Oil Company provide copies of this *Remediation Summary & Soil Closure Request* to the appropriate agencies and request closure be granted to the ARWMS Deer Booster release site.

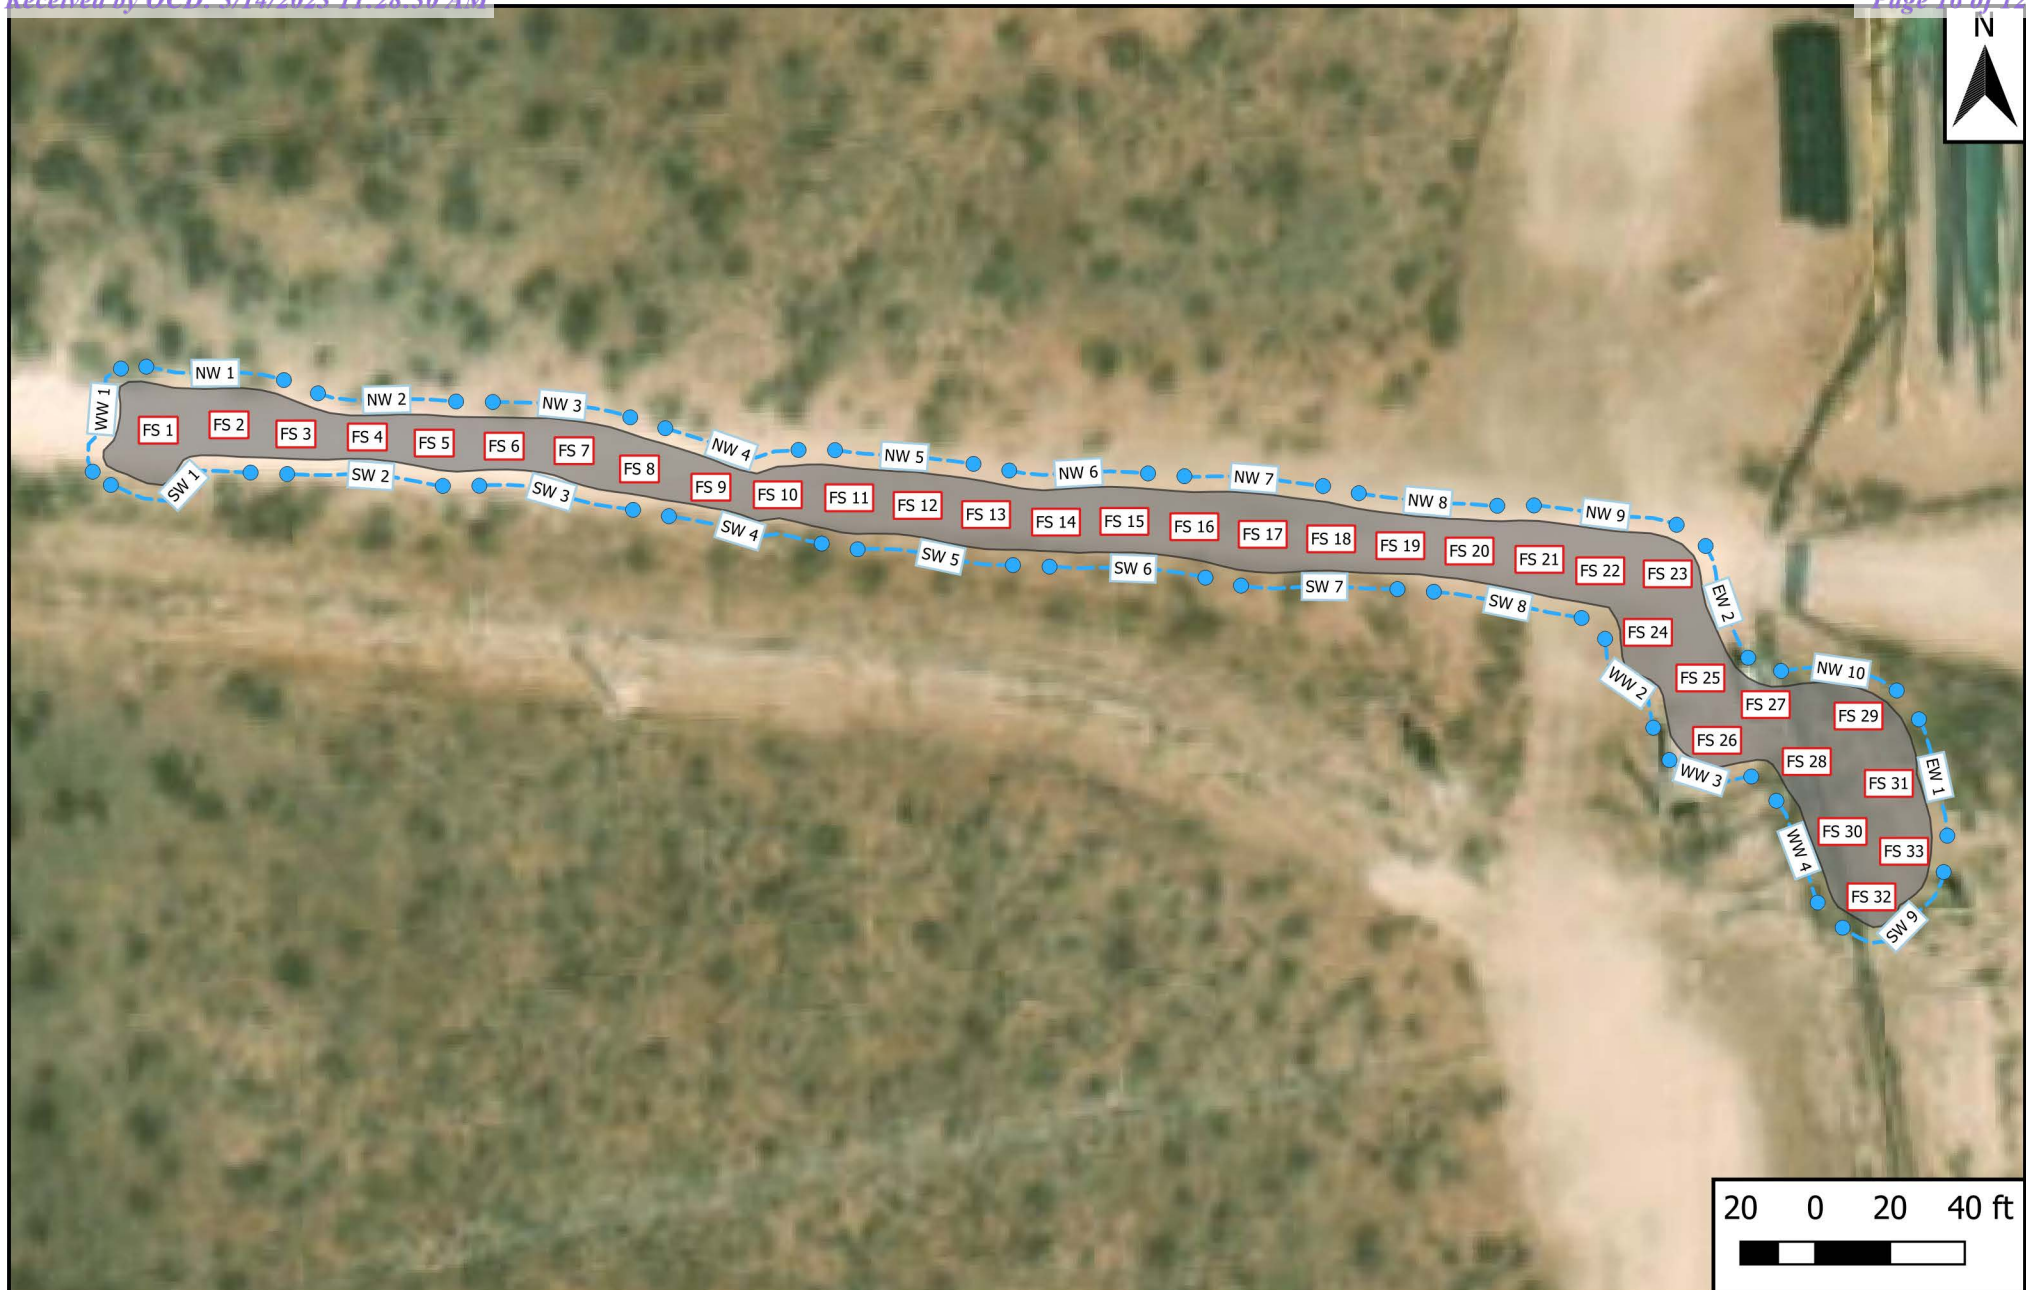
Figure 3

Site & Sample Location Map

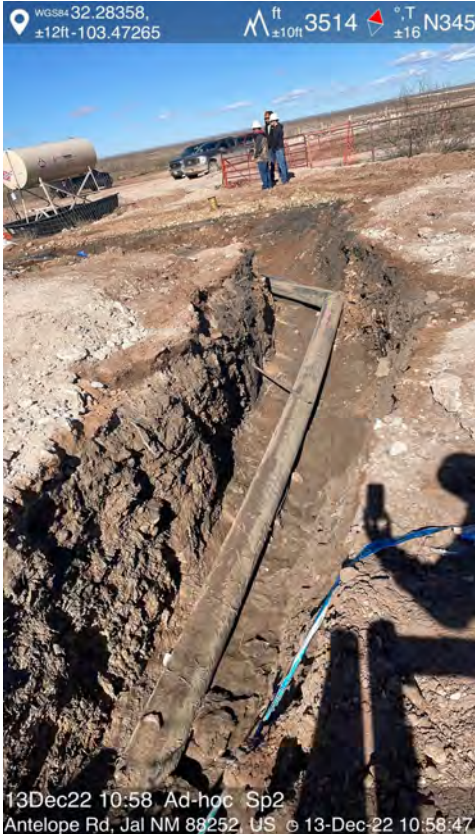
Photo Number: 1

Photo Direction: North-Northwest	
Photo Description: View of the affected area.

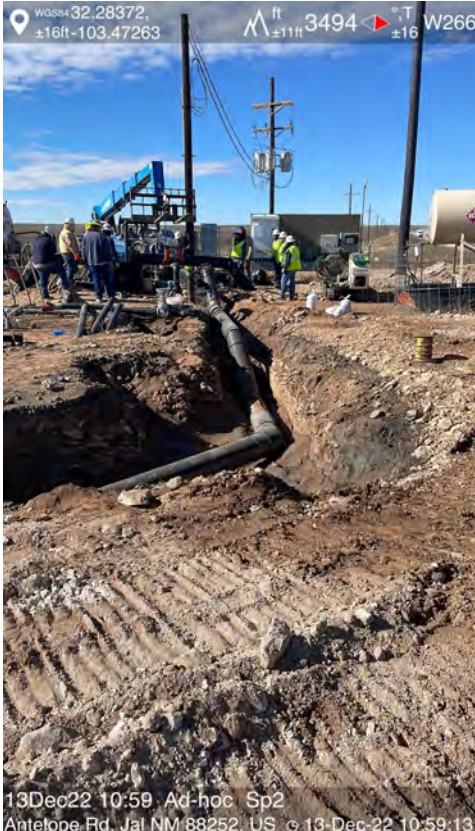
Photo Number: 2

Photo Direction: West	
Photo Description: View of the affected area.

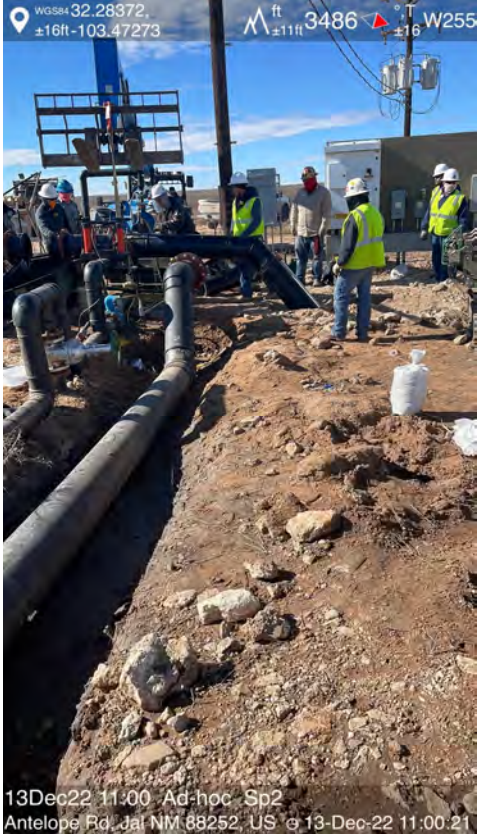
Photo Number: 3

Photo Direction: West-Southwest	
Photo Description: View of the affected area.

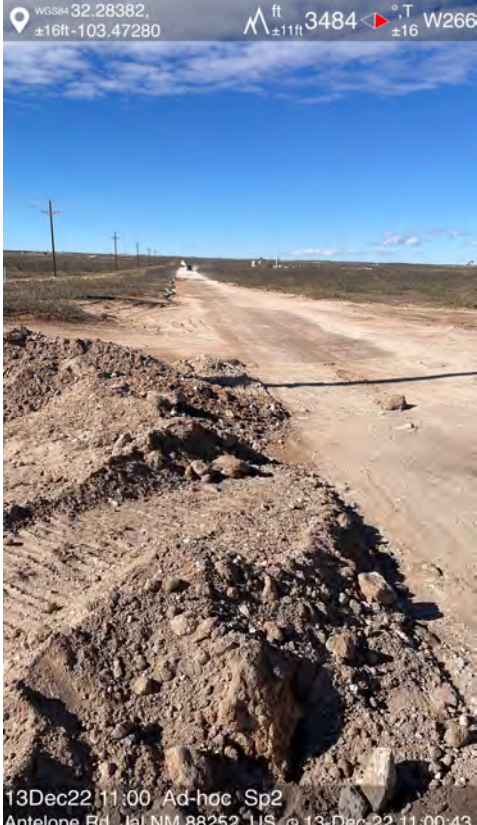
Photo Number: 4

Photo Direction: West	
Photo Description: View of the affected area.

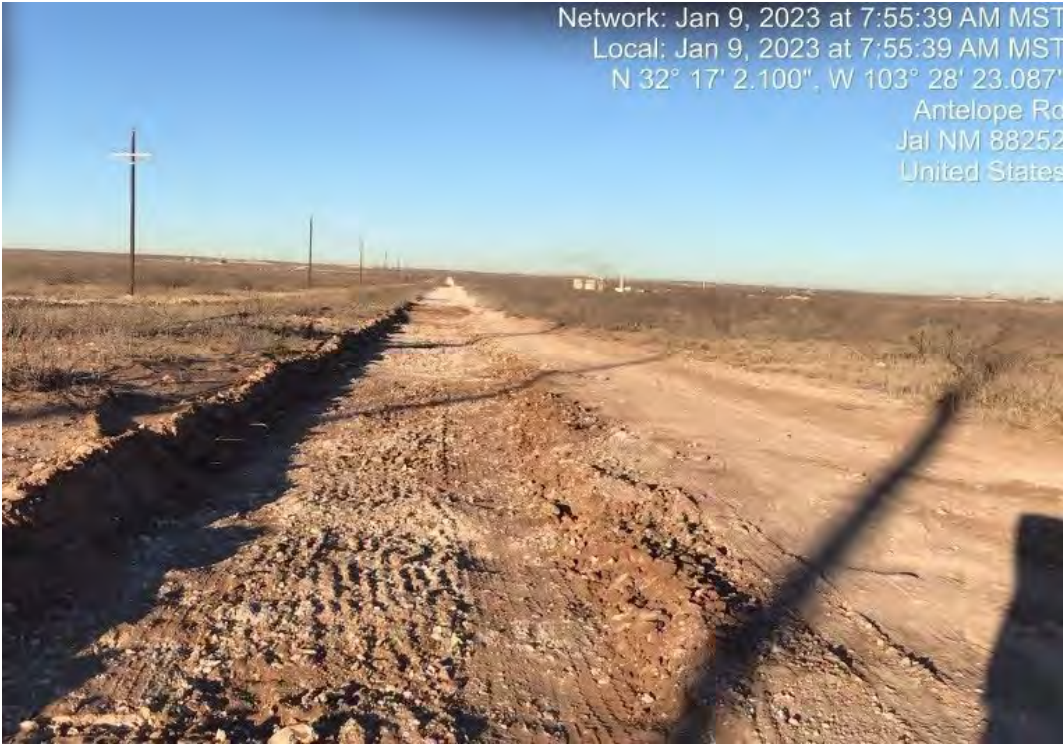
Photo Number: 5

<p>Network: Jan 9, 2023 at 7:55:39 AM MST Local: Jan 9, 2023 at 7:55:39 AM MST N 32° 17' 2.100", W 103° 28' 23.087" Antelope Rd Jal NM 88252 United States</p>
Photo Direction: South	
Photo Description: View of the excavated area.

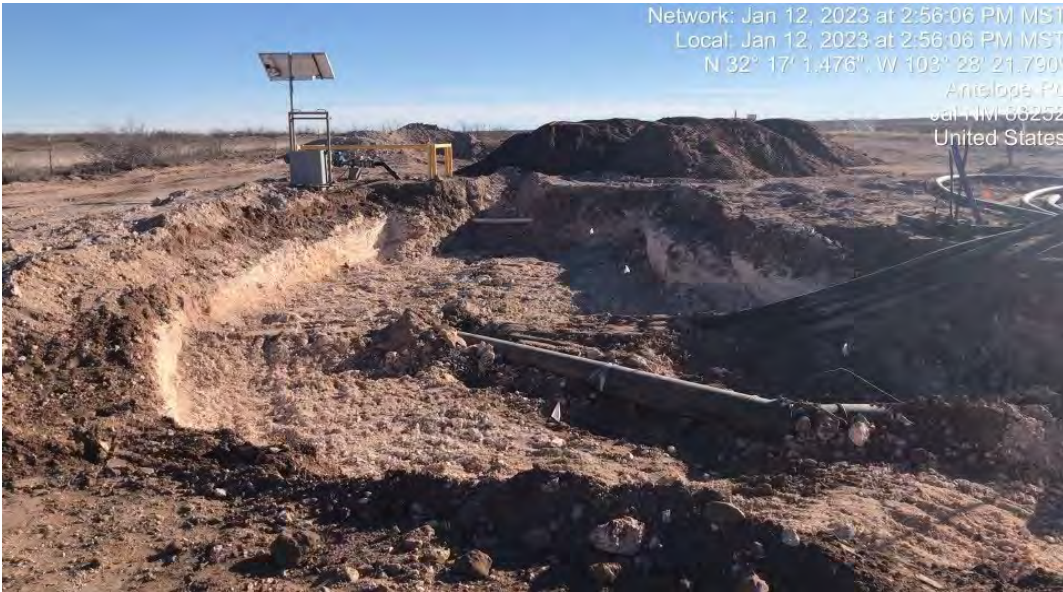
Photo Number: 9

<p>Network: Jan 12, 2023 at 2:56:06 PM MST Local: Jan 12, 2023 at 2:56:06 PM MST N 32° 17' 1.476", W 103° 28' 21.790" Antelope Rd Jal NM 88252 United States</p>
Photo Direction: South	
Photo Description: View of the excavated area.

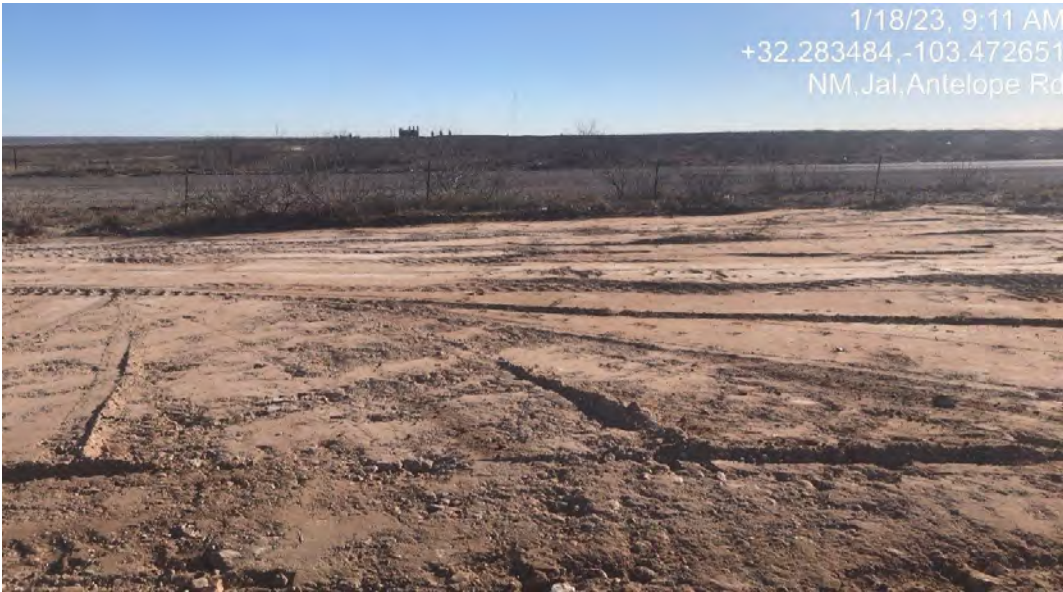
Photo Number: 11

<p>1/18/23, 9:11 AM +32.283484,-103.472651 NM,Jal,Antelope Rd</p>
Photo Direction: East	
Photo Description: View of the remediated area after backfill and regrading.

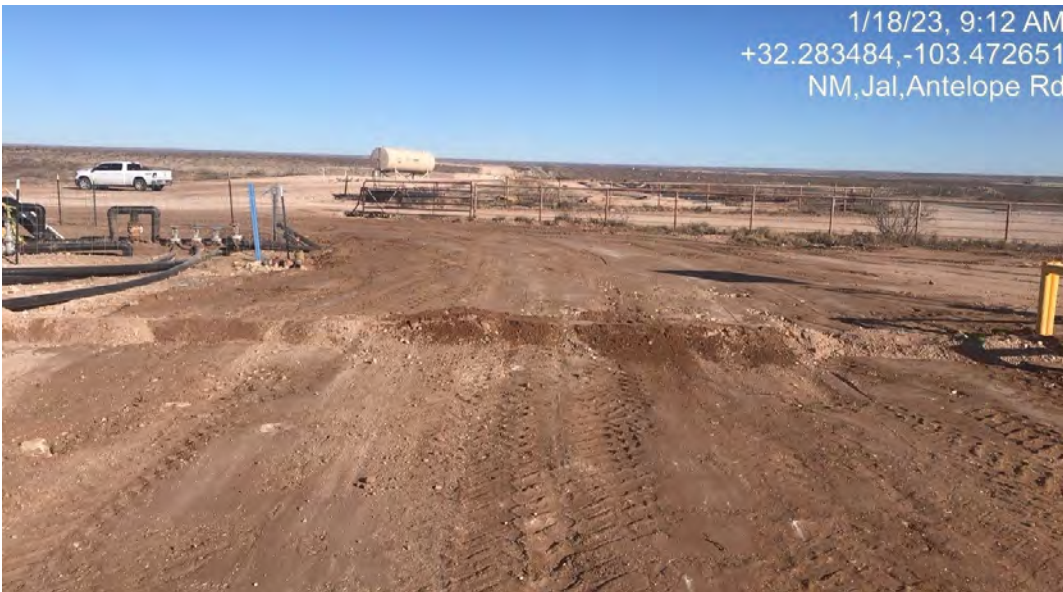
Photo Number: 12

<p>1/18/23, 9:12 AM +32.283484,-103.472651 NM,Jal,Antelope Rd</p>
Photo Direction: North	
Photo Description: View of the remediated area after backfill and regrading.

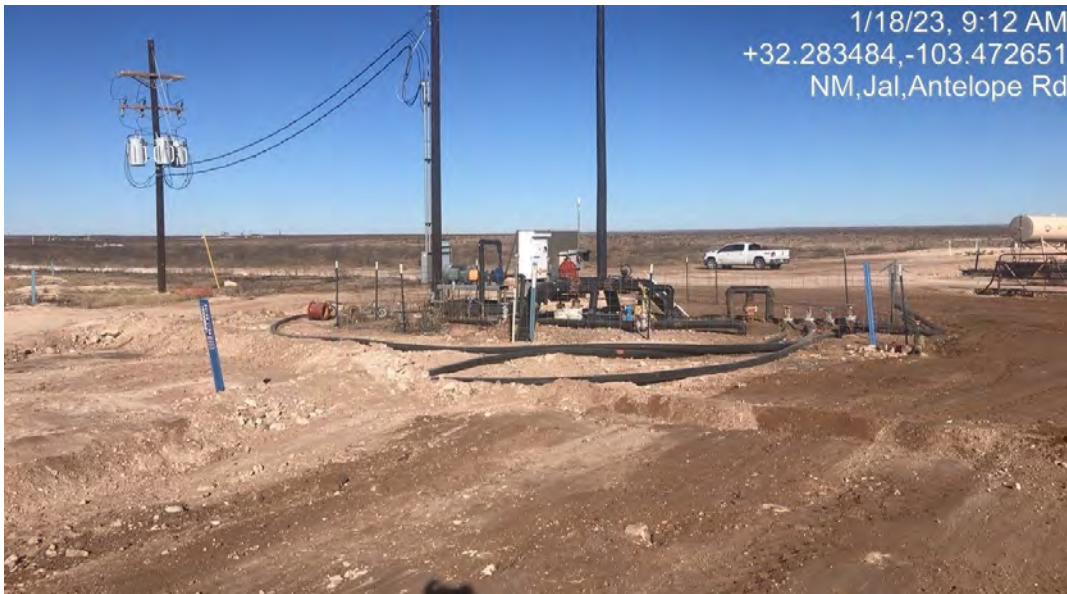
Photo Number: 13

Photo Direction: Northwest	
Photo Description: View of the remediated area after backfill and regrading.
