**Frontier Field Services****Boyd X Battery****Section: 16 Township: 19S Range: 25E****NMOCD Reference # NMAP1825641927****Terracon Project # KH227002**

**Closure Report**

Boyd X Battery  
Section 16, Township 19 South, Range 25 East  
Eddy County, New Mexico  
Terracon Project No. KH227002

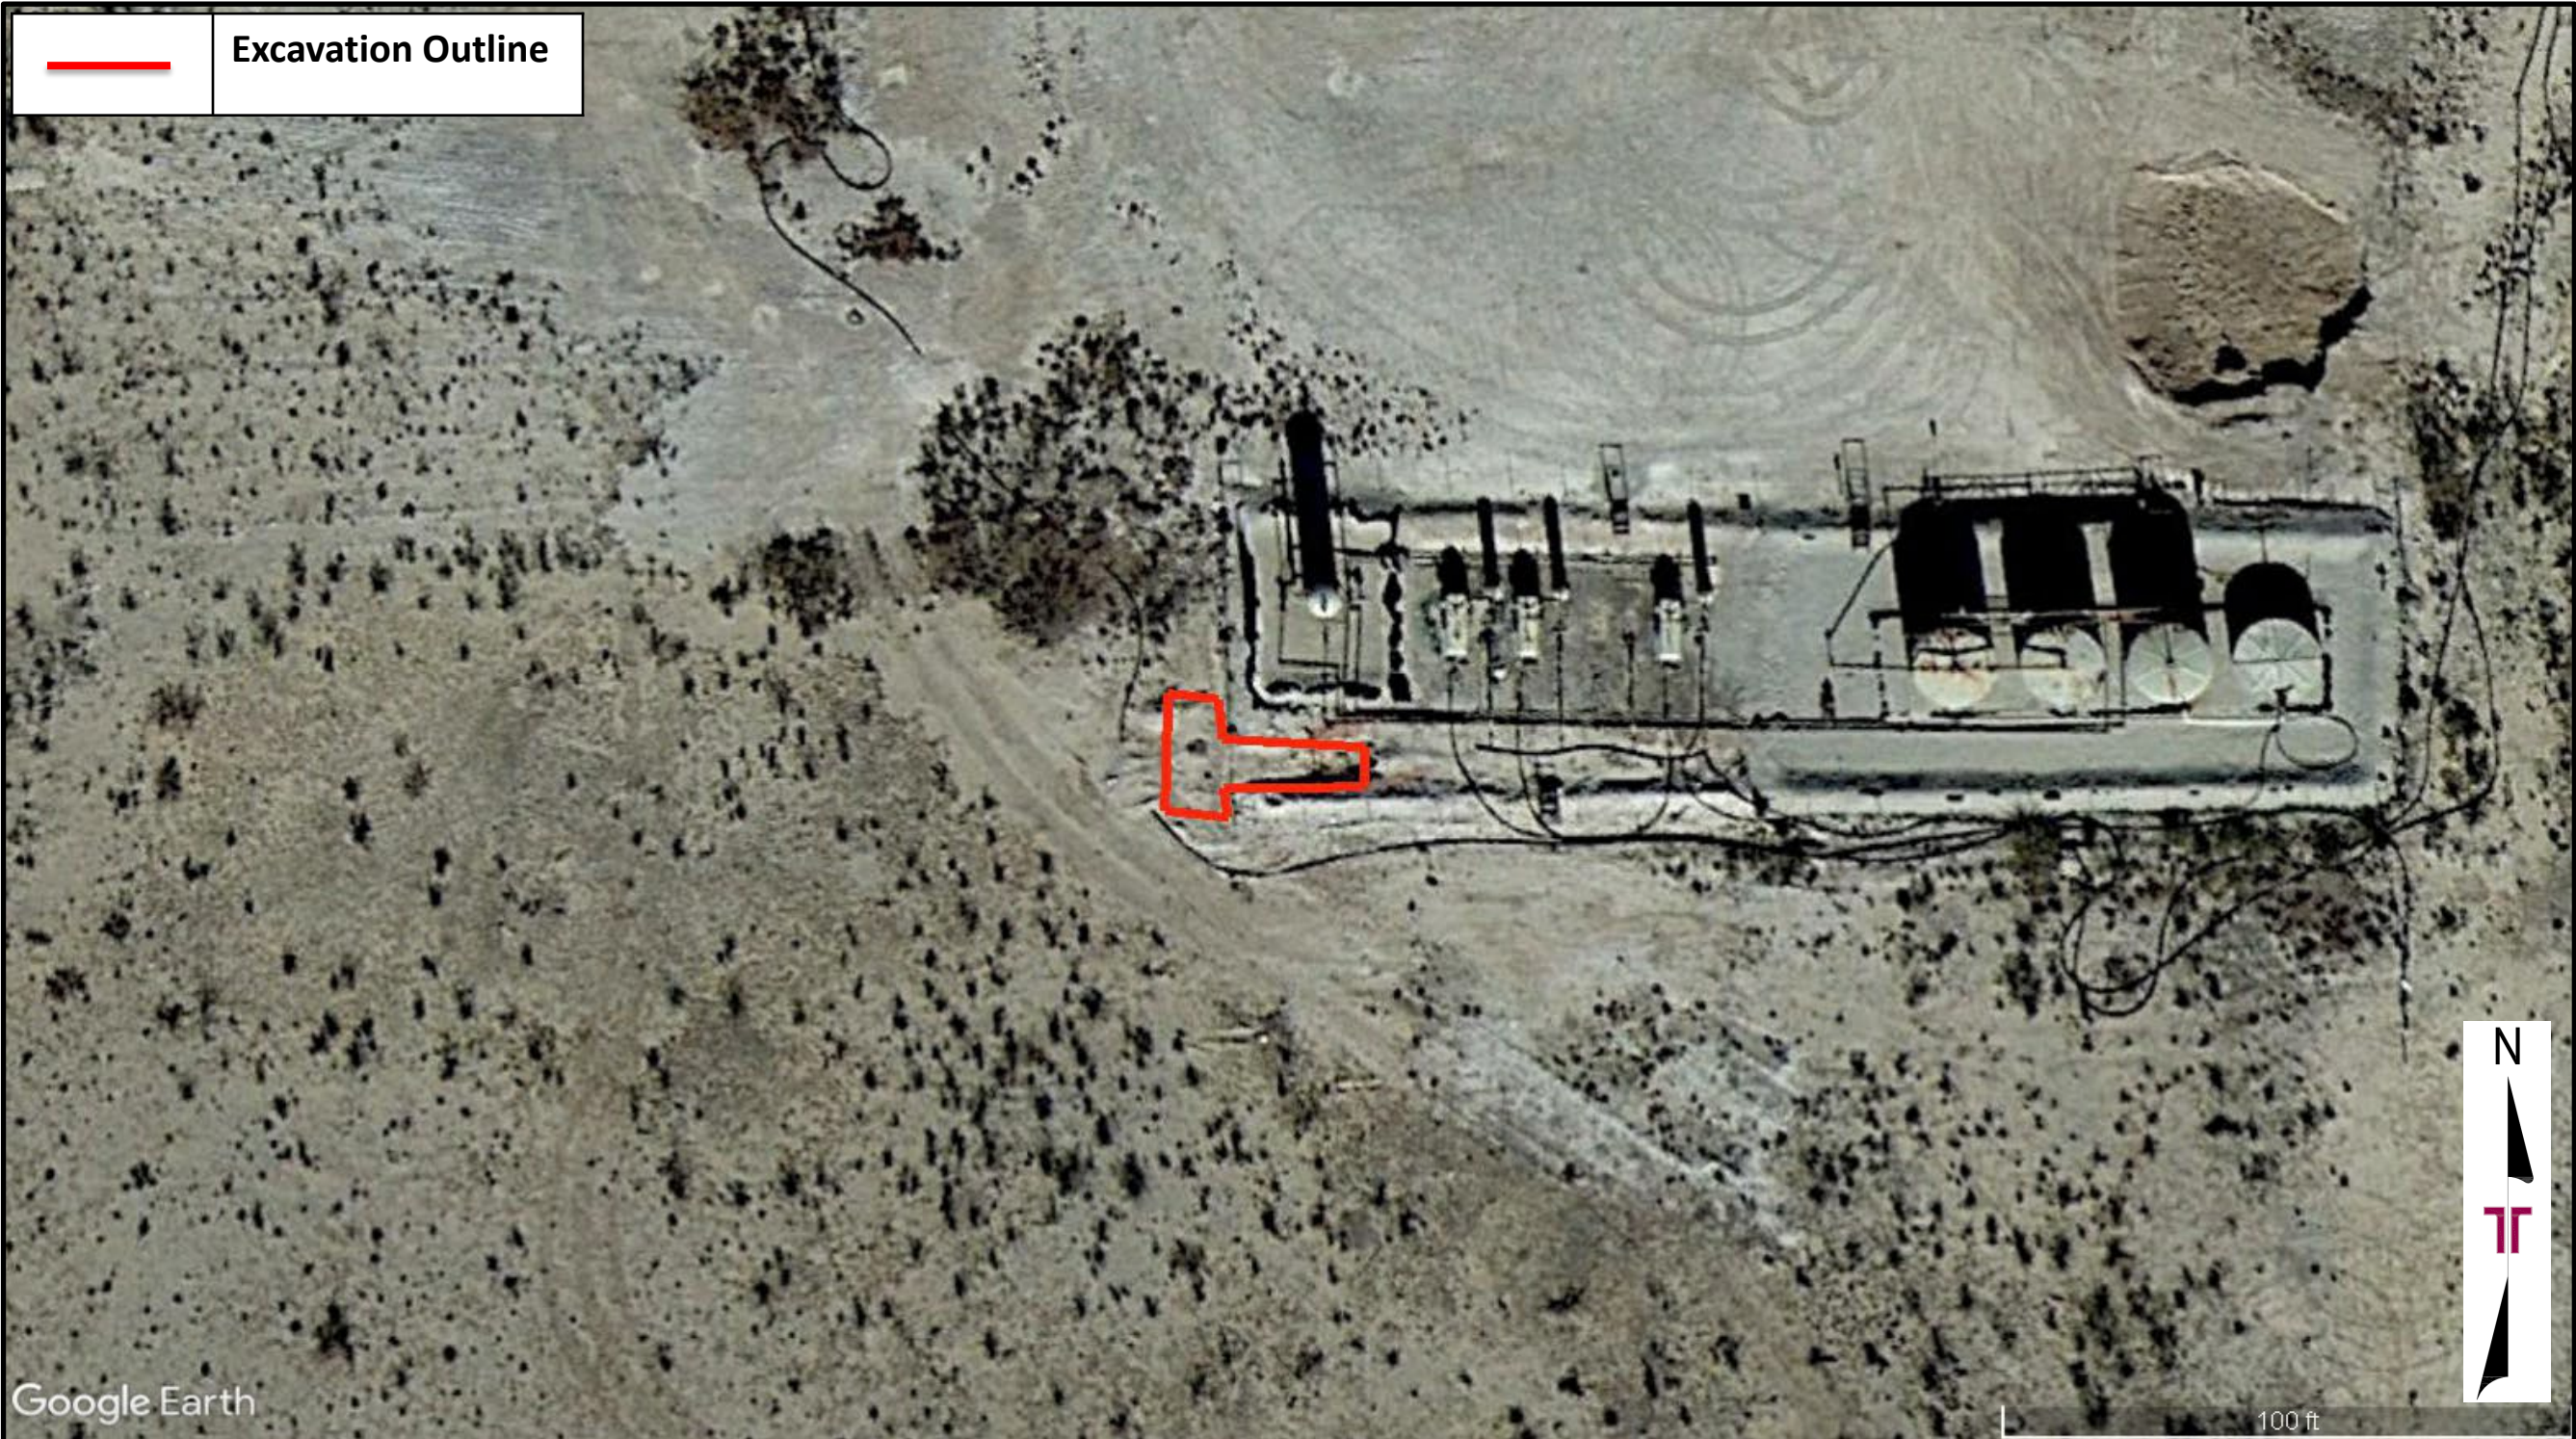
Project No. KH227002		Exhibit 2 – Site Map	
Scale: As Shown		Boyd x Battery	
Source: Google Earth		32.655099°, -104.487621°	
Date: 10/2022		Eddy County, New Mexico

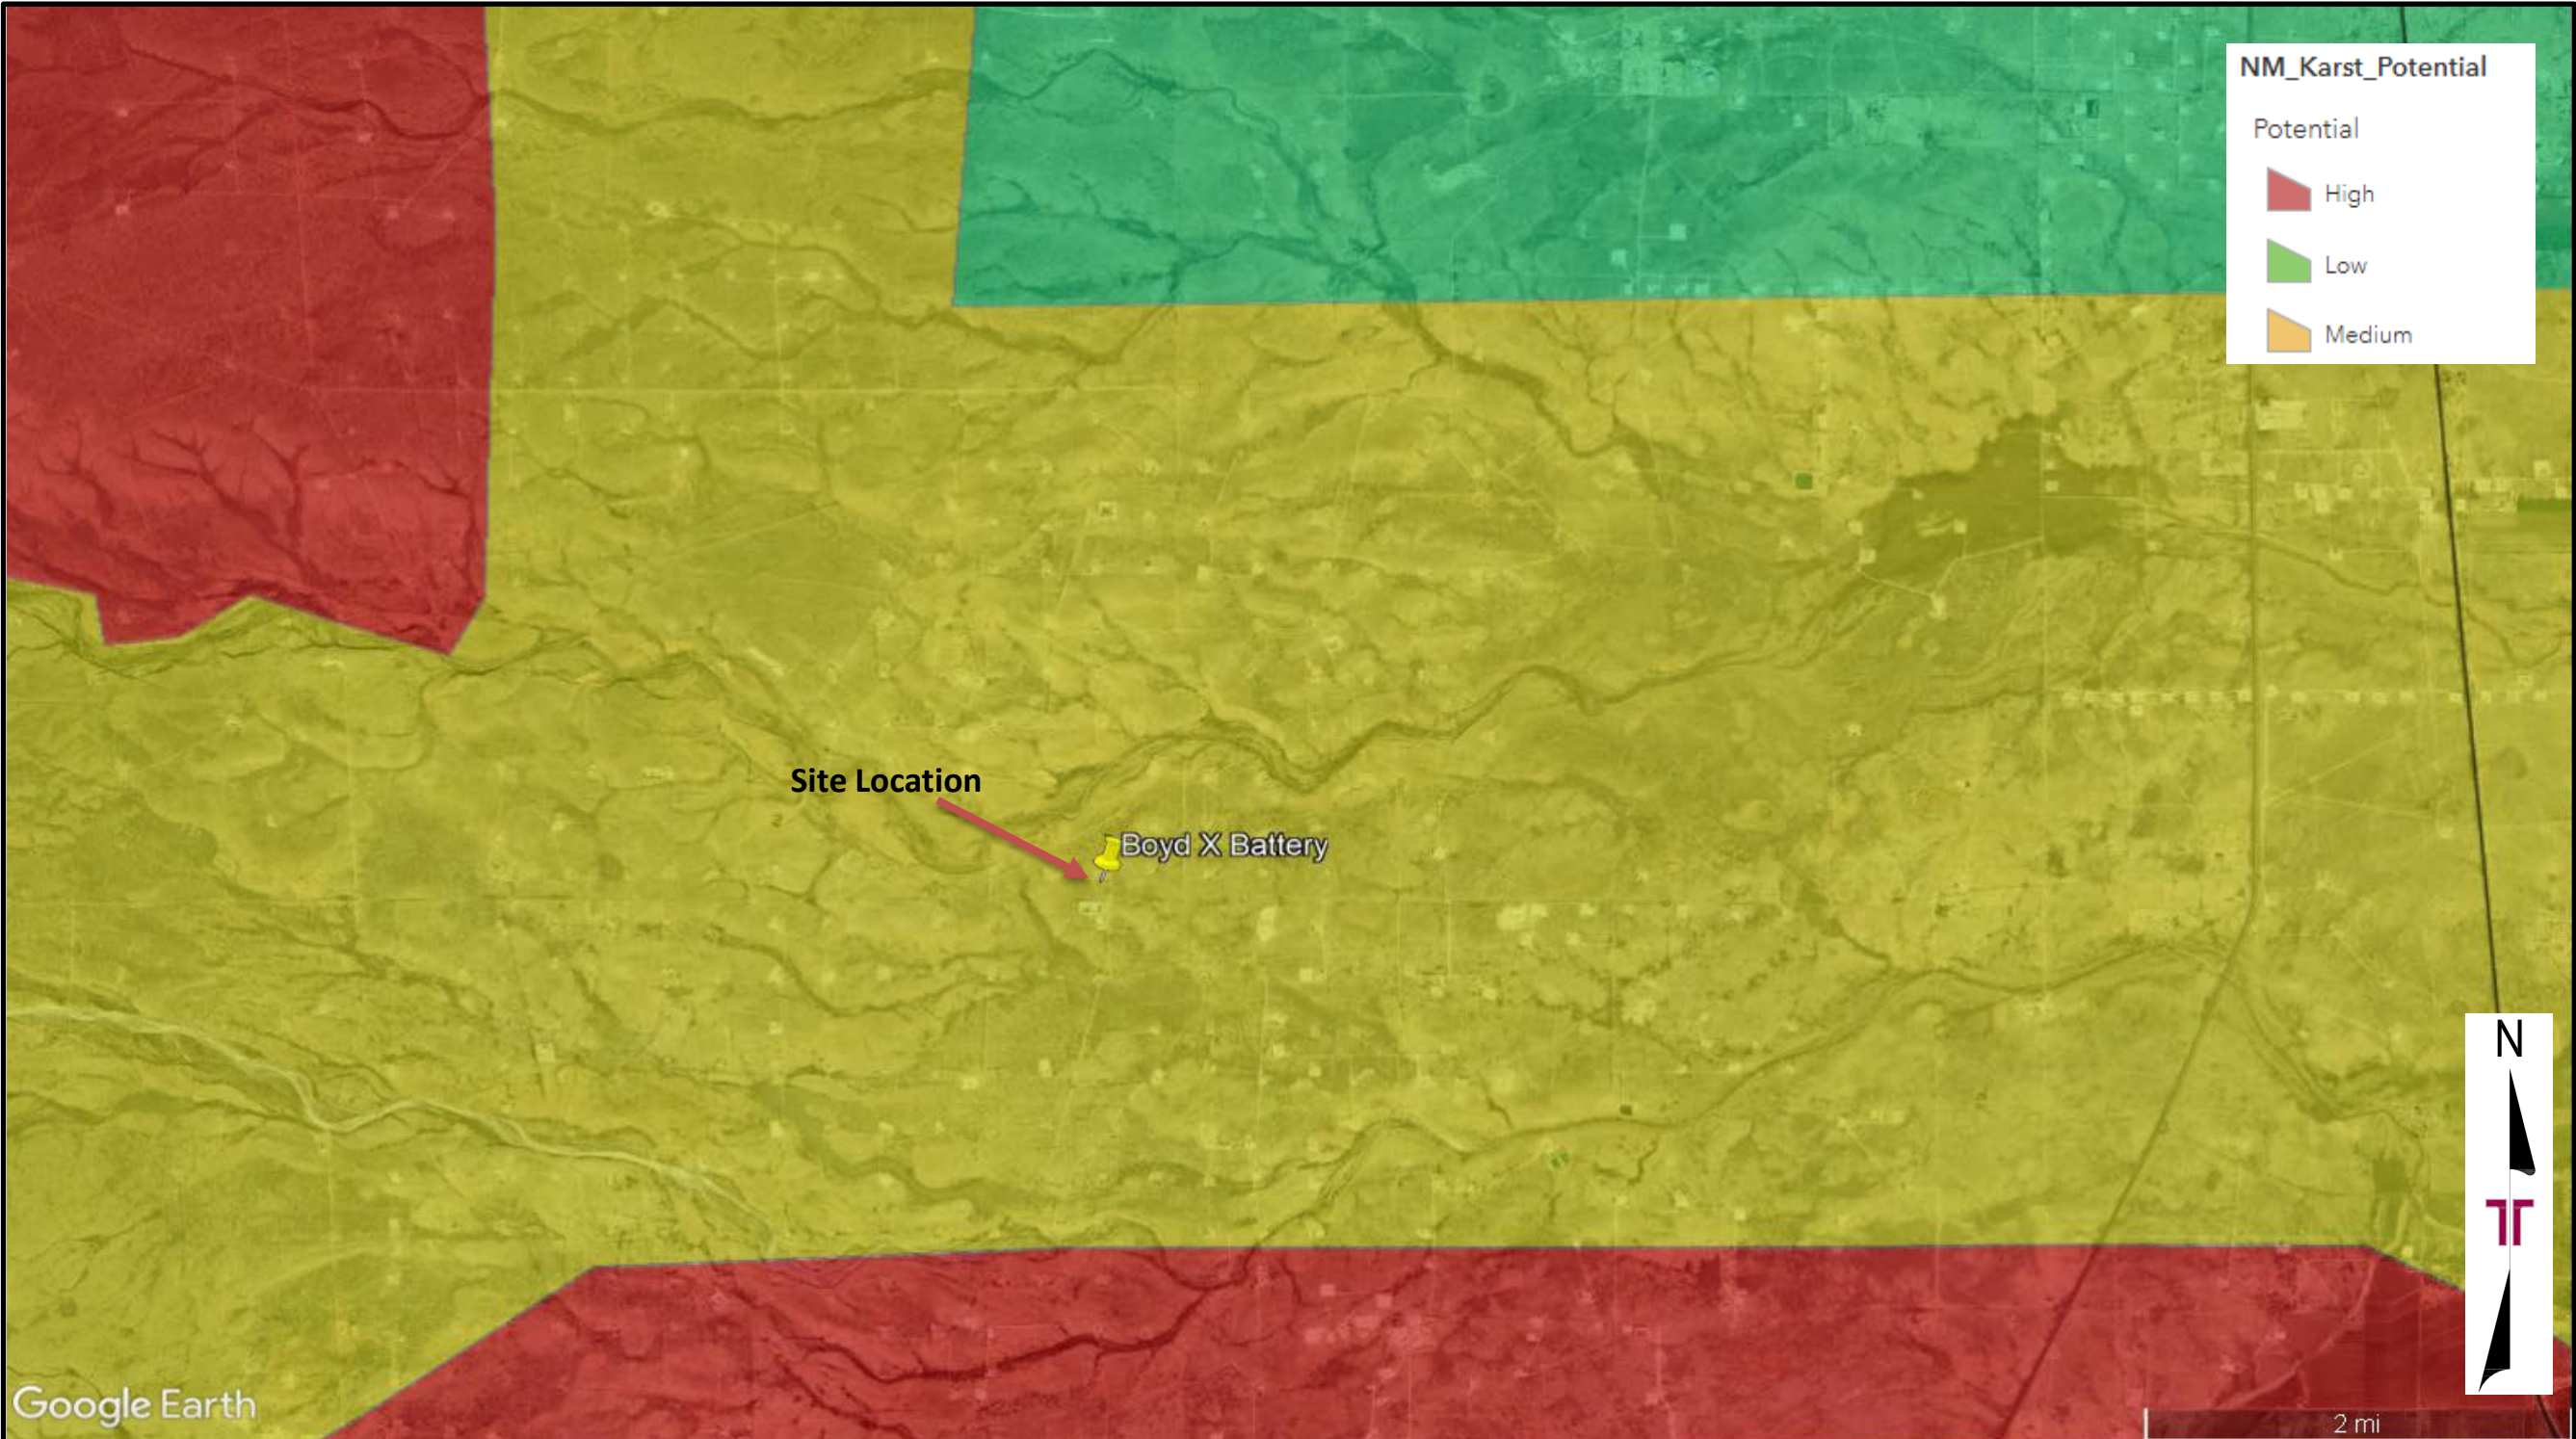
Project No.	KH227002	Exhibit 6 - Cave Karst Public UCP Map	
Scale:	As Shown	Boyd X Battery	
Source:	Google Earth	32.655099°, -104.487621°	
Date:	12/29/2019	Eddy County, New Mexico

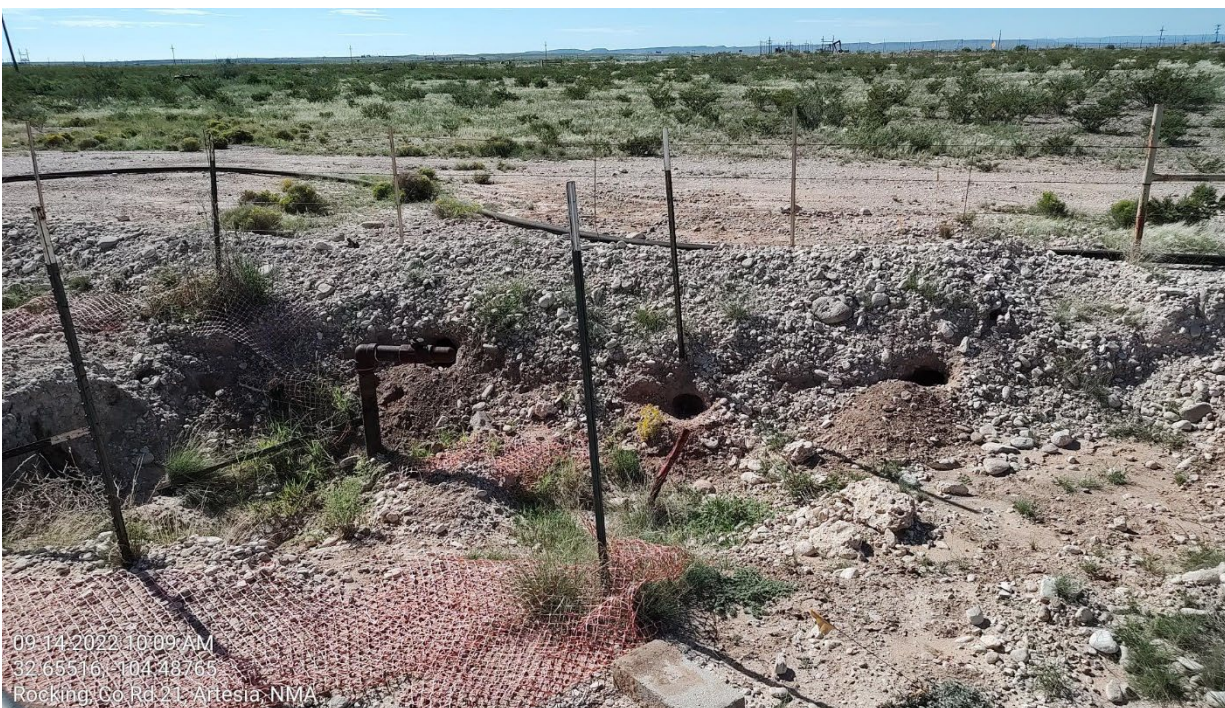
**PHOTO 1:** View of area prior to Excavation from the North

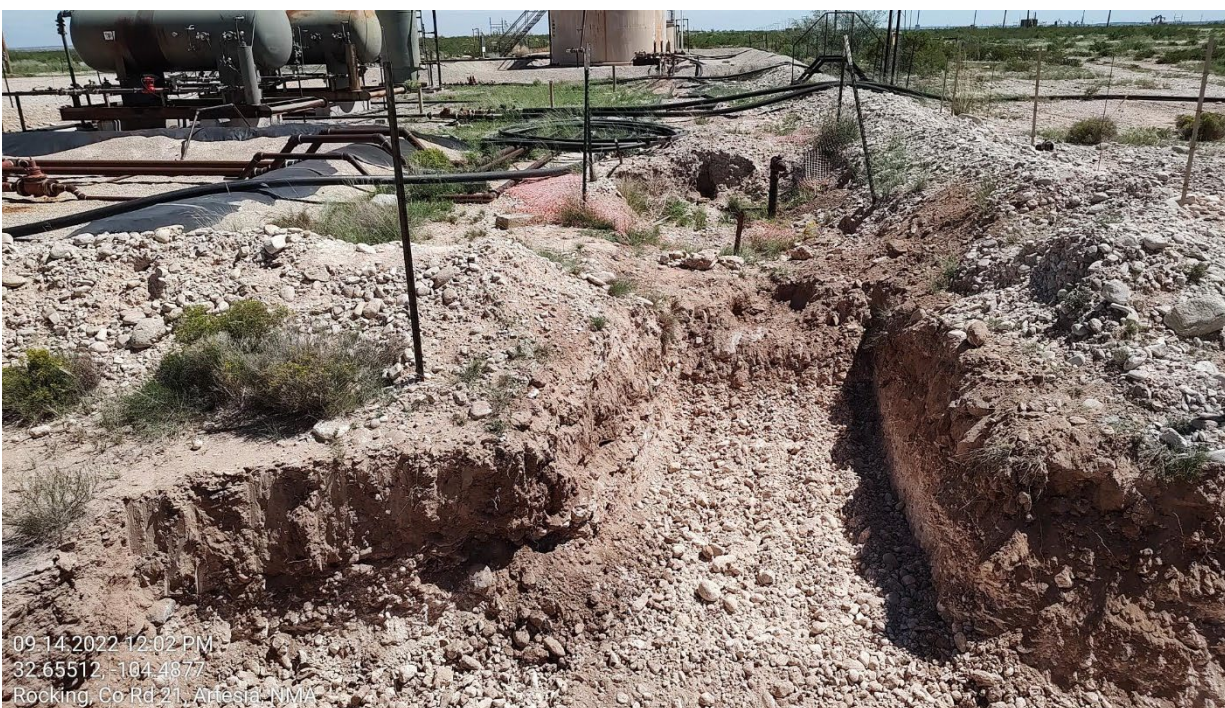
**PHOTO 2:** View of Excavation from the West

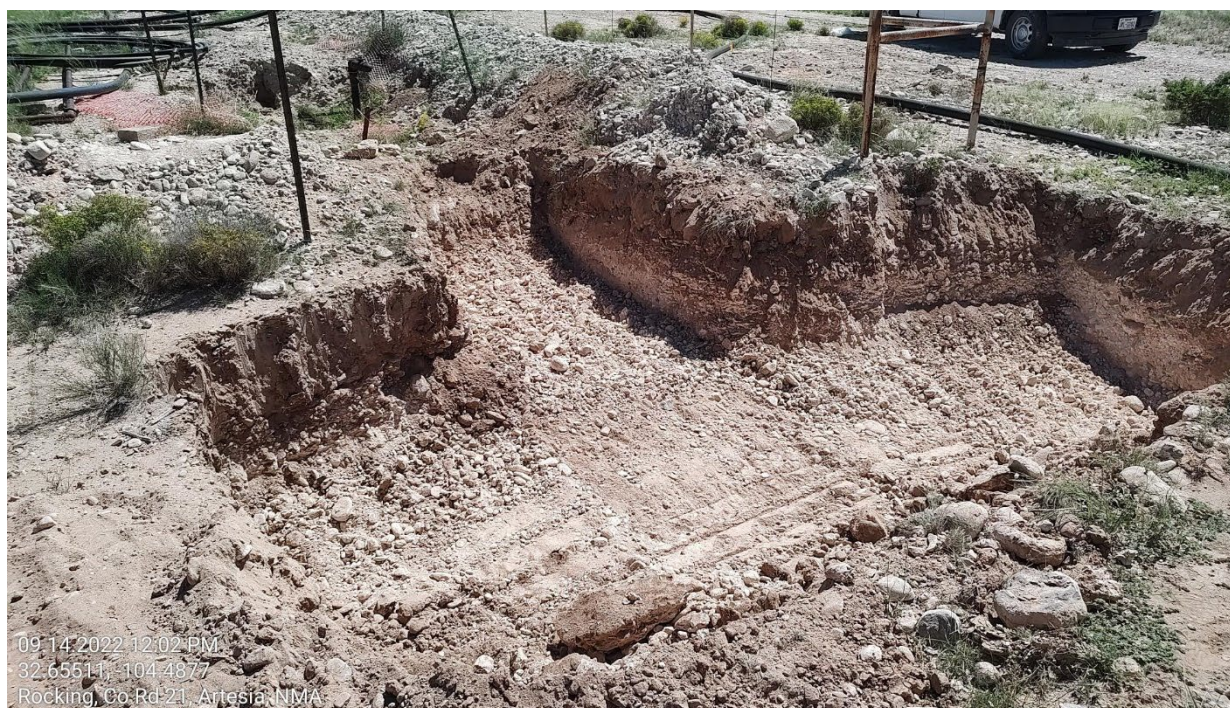
**PHOTO 3:** View of Excavation from the Northwest looking Southeast

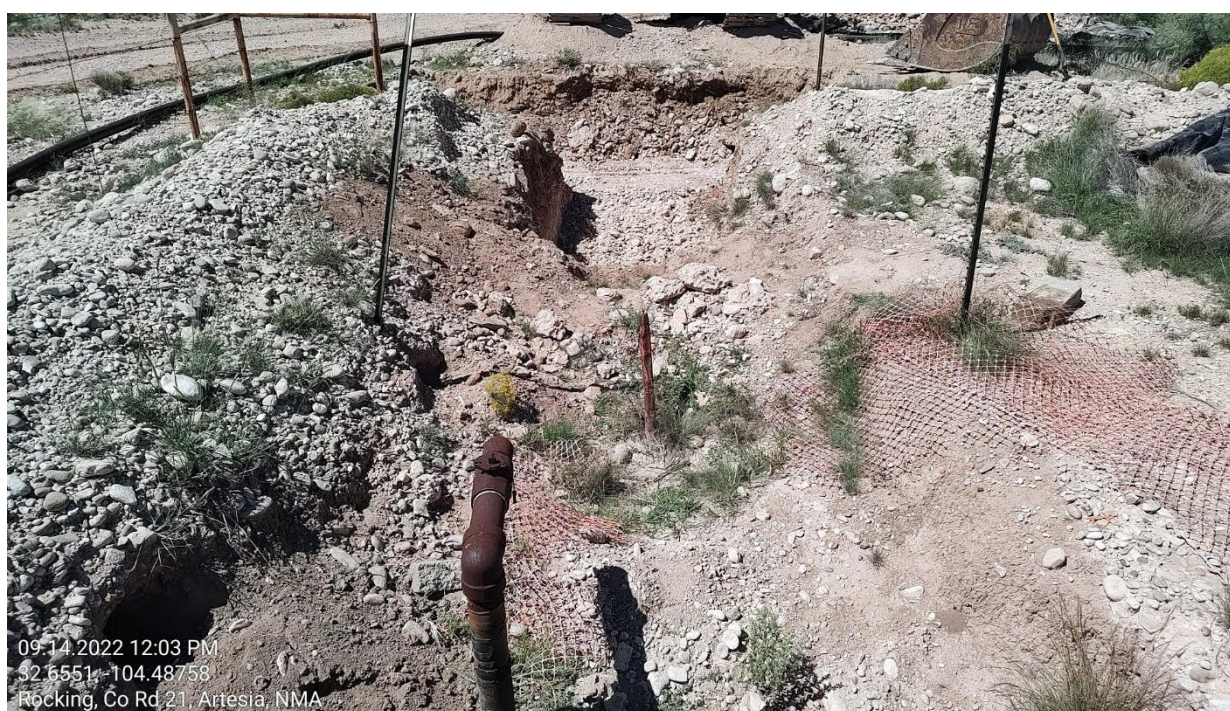
**PHOTO 4:** View of Excavation from the East looking West
