Remediation Summary and Closure Request

Frontier Field Services, LLC

Geronimo 6"

NMOCD Incident # nAPP2233326239

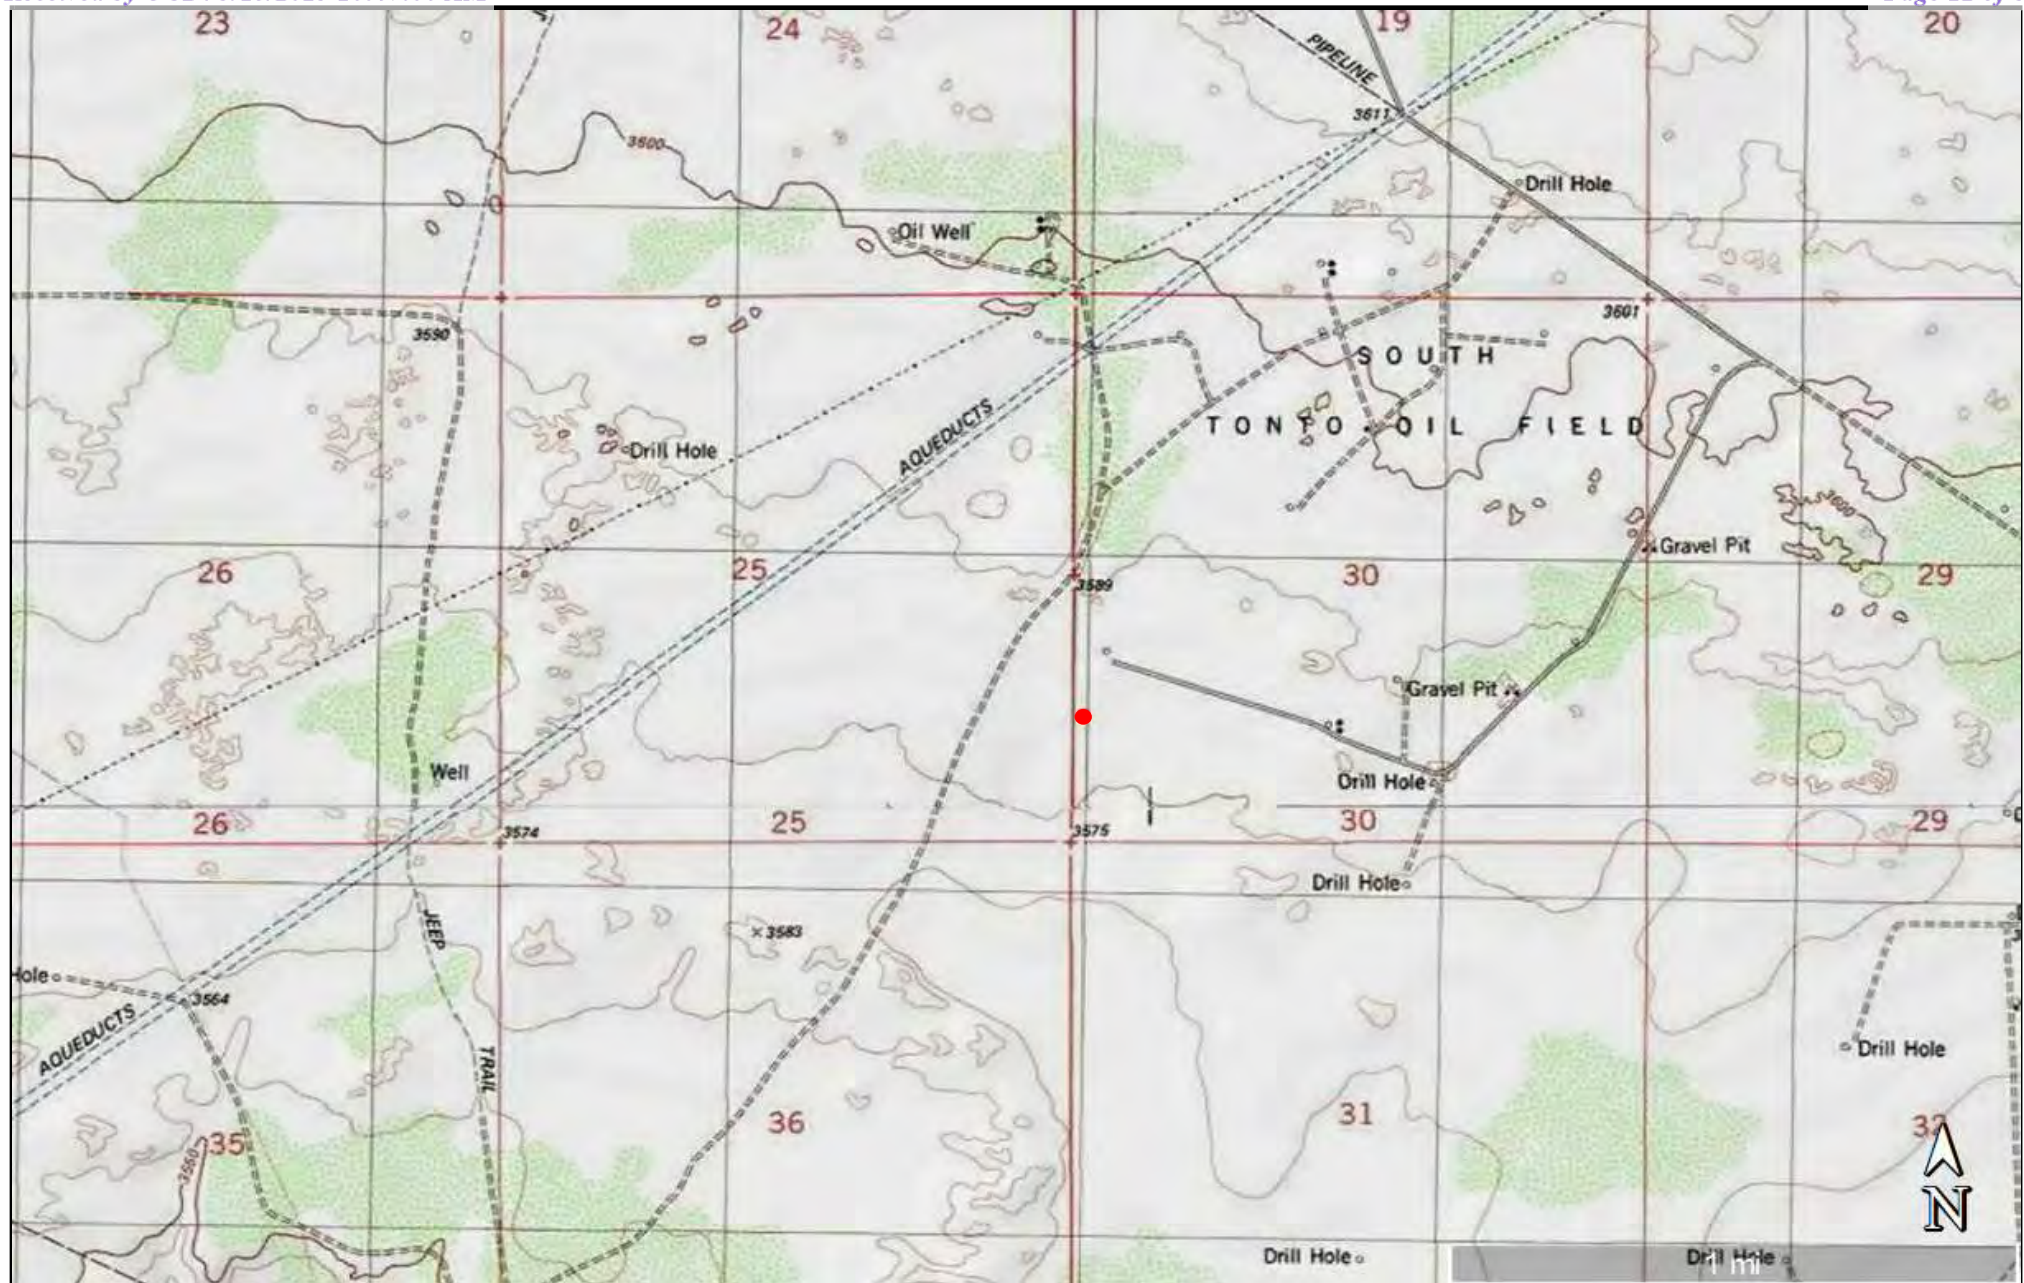
**Figure 1**

Topographic Map
 Frontier Field Services, LLC
 Geronimo 6"
 GPS: 32.62748, -103.71086
 Lea County

The site is located in Unit Letter M (SW/SW), Section 30, Township 19 South, Range 33 East, approximately sixteen miles south of Maljamar, in Lea County, New Mexico. The site is located on Bureau of Land Management land. Topographic Map, OSE POD Locations Map, and USGS Well Locations Map are included as Figure 1, Figure 2, and Figure 3, respectively.

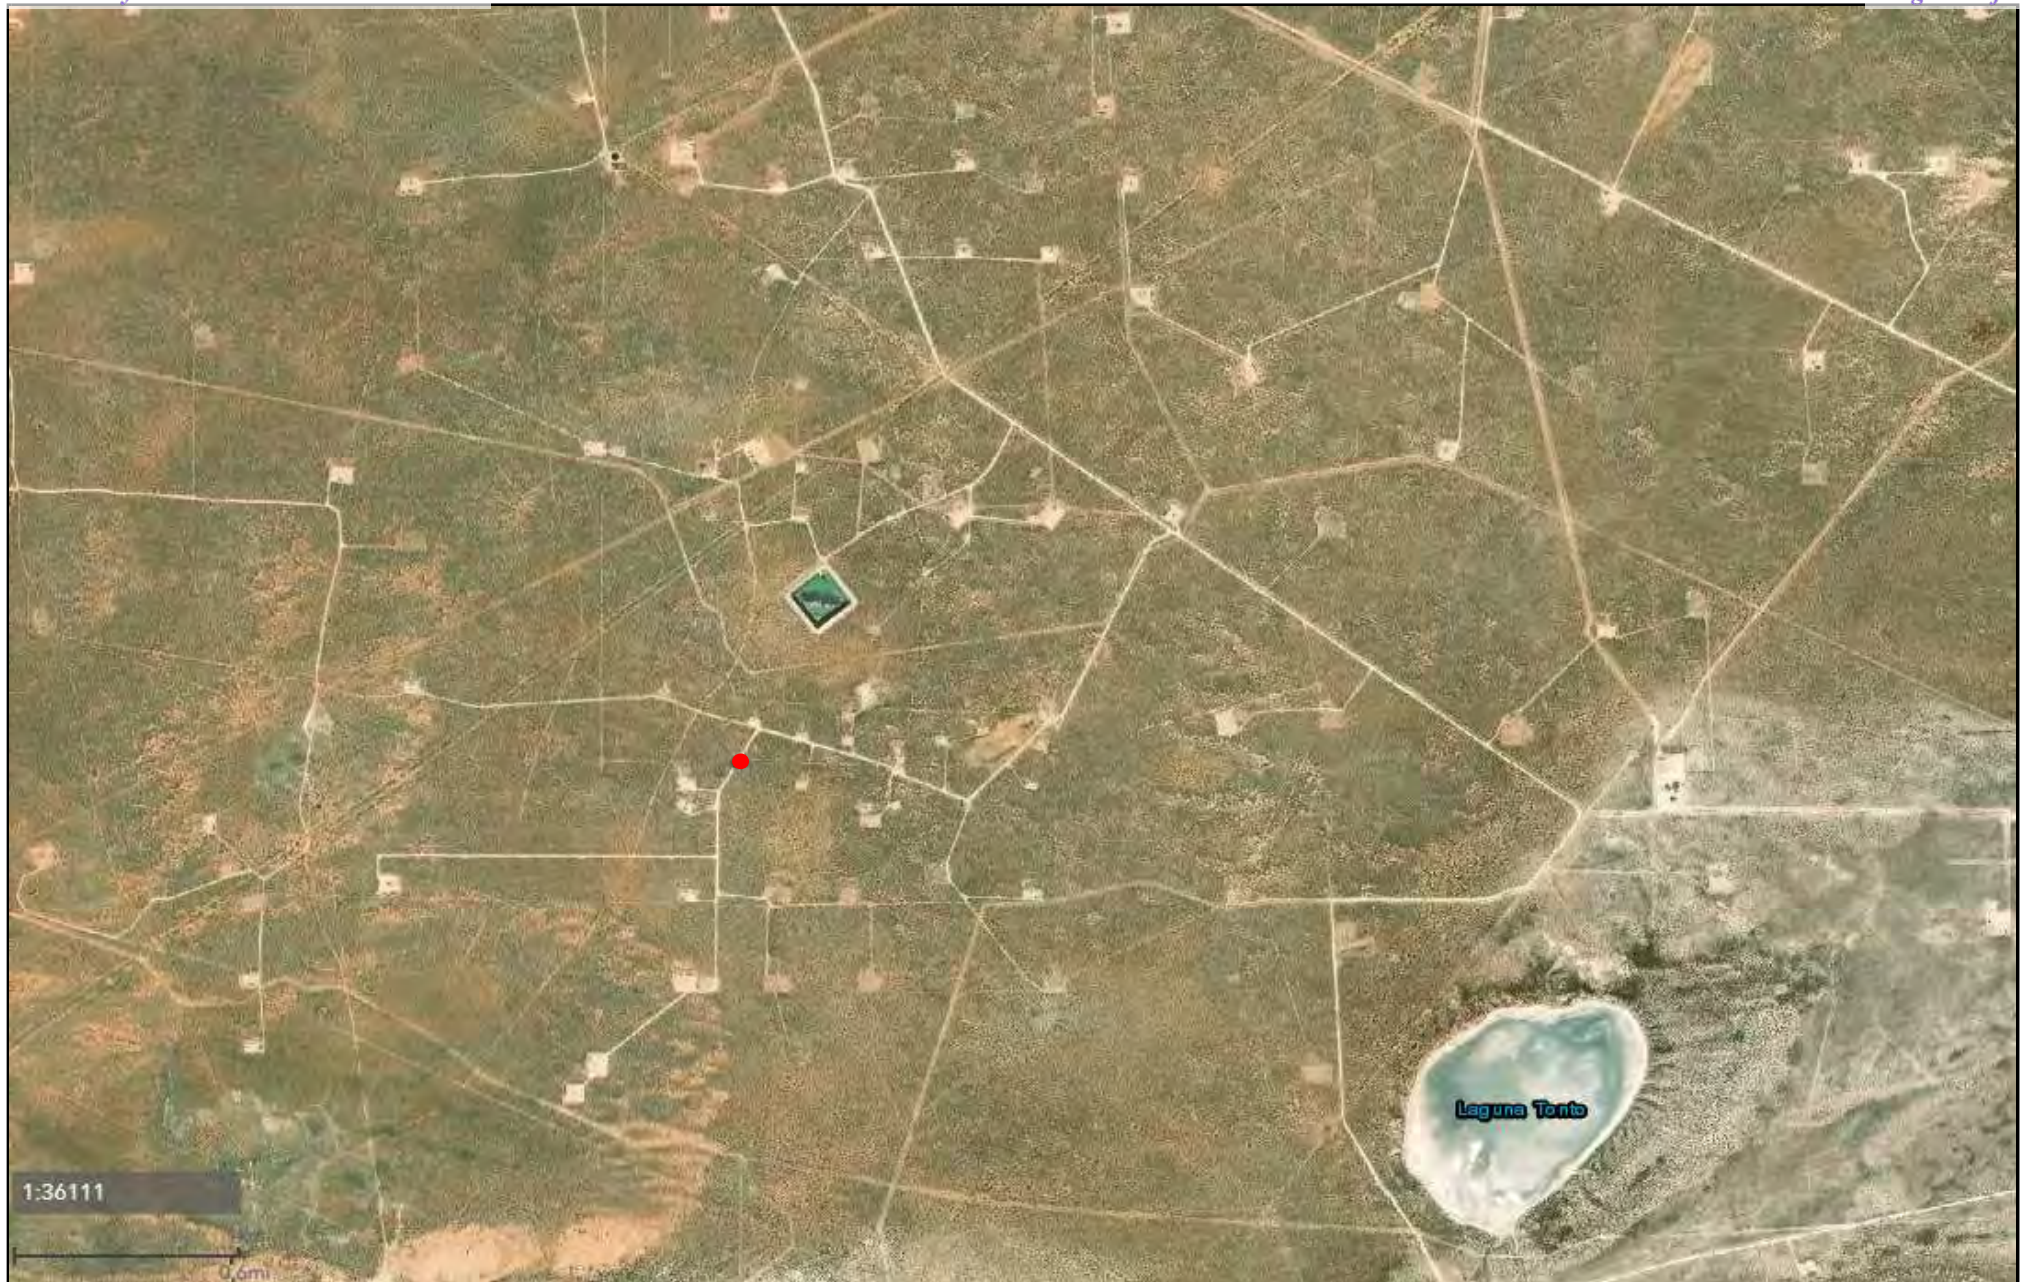
**Figure 2**

OSE POD Locations Map
Frontier Field Services, LLC
Geronimo 6"
GPS: 32.62748, -103.71086
Lea County

A search of the New Mexico Office of the State Engineer (NMOSE) and United States Geological Survey (USGS) groundwater databases was completed in an effort to determine the horizontal distance to known water sources within a half mile radius of the Release Site. Approximate depth to groundwater was determined using maintained and published water well data. Karst mapping indicates the site is not located in a Karst designated area. Karst and Wetland Maps are provided as Attachment I. Depth to groundwater information is provided as Attachment IV and the results are depicted on Figures 2 & 3.

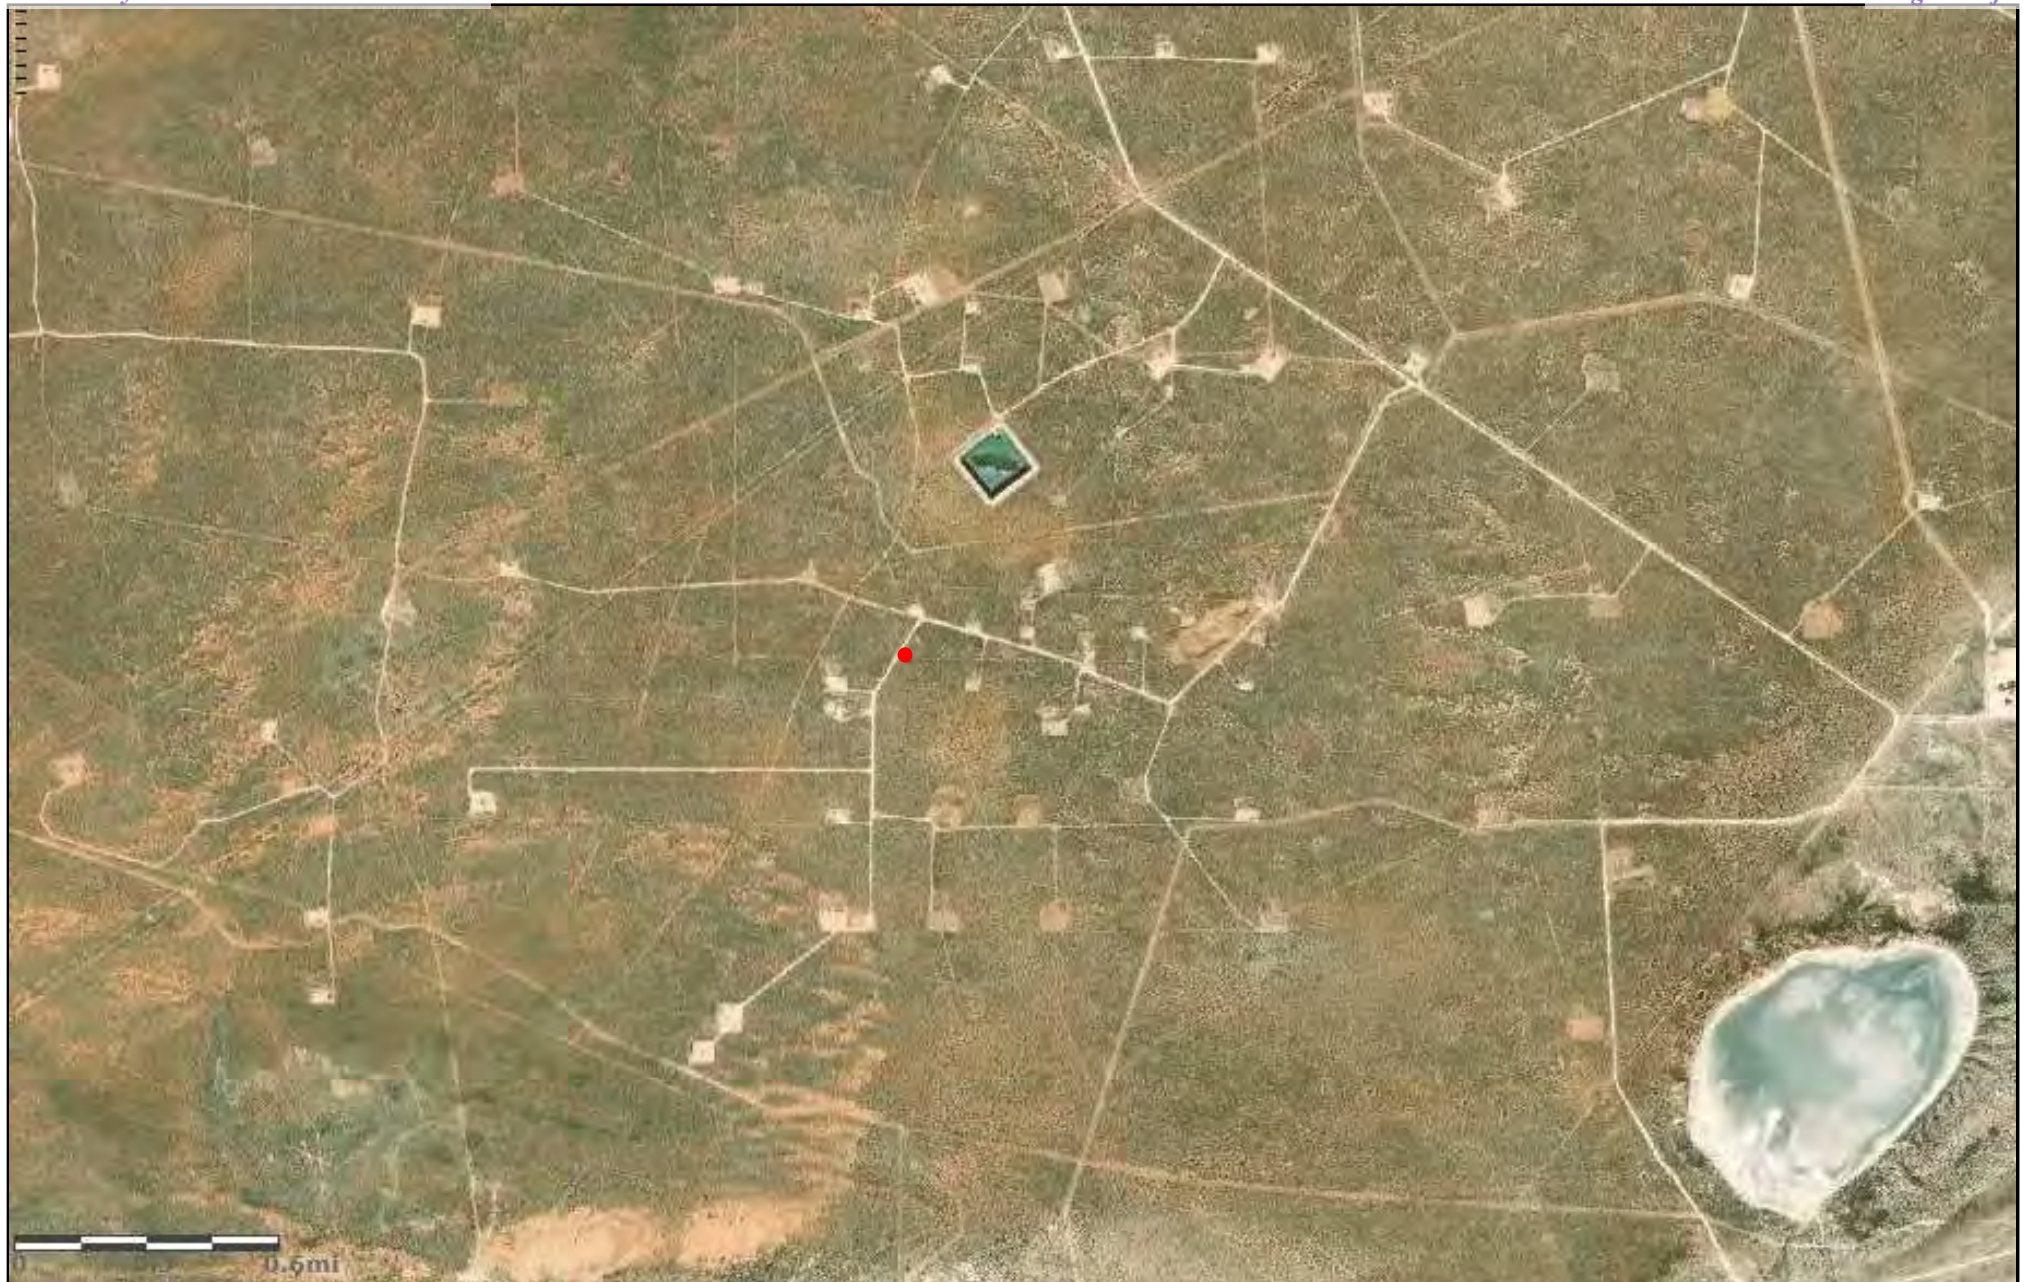
**Figure 3**

USGS Well Locations Map
Frontier Field Services, LLC
Geronimo 6"
GPS: 32.62748, -103.71086
Lea County

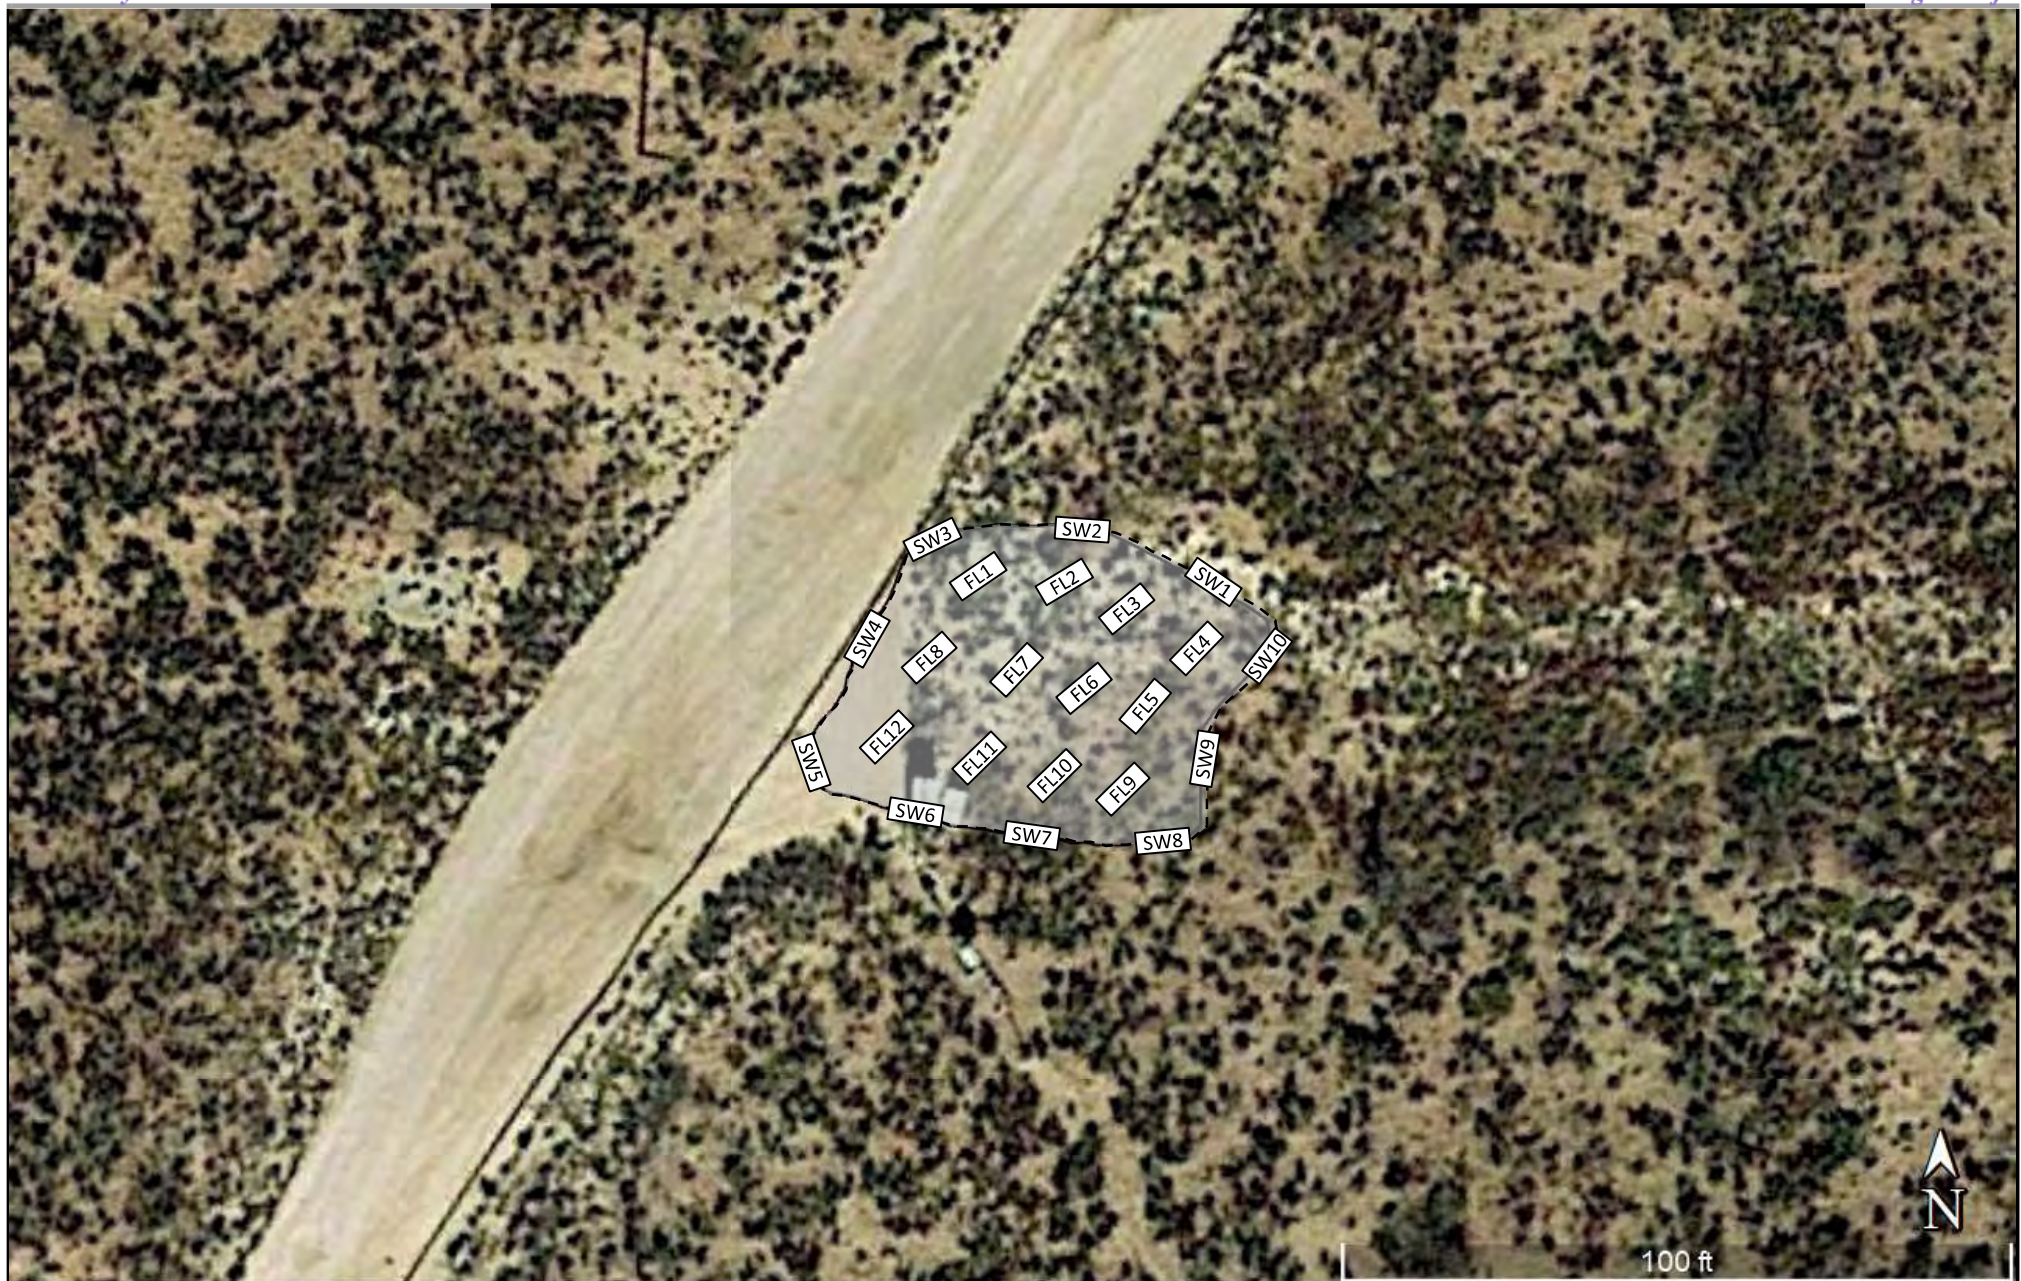
**Figure 5**

Excavation Sample Map
Frontier Field Services, LLC
Geronimo 6"
GPS: 32.62748, -103.71086
Lea County
