Report Type: Closure Report 1RP-4937

Site:	Green Frog Café Federal #1H					
Company:	Marathon Oil Permian, LLC					
Section, Township and Range	Unit B	Sec. 18	T 20S	R 33E		
Lease Number:	API No. 30-025-40828					
County:	Lea County					
GPS:	32.5781898° N			103.7015533° W		
Surface Owner:	Federal					
Mineral Owner:	Federal					
Directions:	From the intersection of Highway 62 and Laguna Road, travel north on Laguna Road an go for approximately 1.5 miles , turn right (east) on Tonto Road, go 0.6 mile and turn left and road curve right and go 0.3 mile to location .

**Re: Closure Request for the Marathon Oil Company, Green Frog Cafe Federal #1H, Unit B, Section 18, Township 20 South, Range 33 East, Lea County, New Mexico.
1RP-4937.**

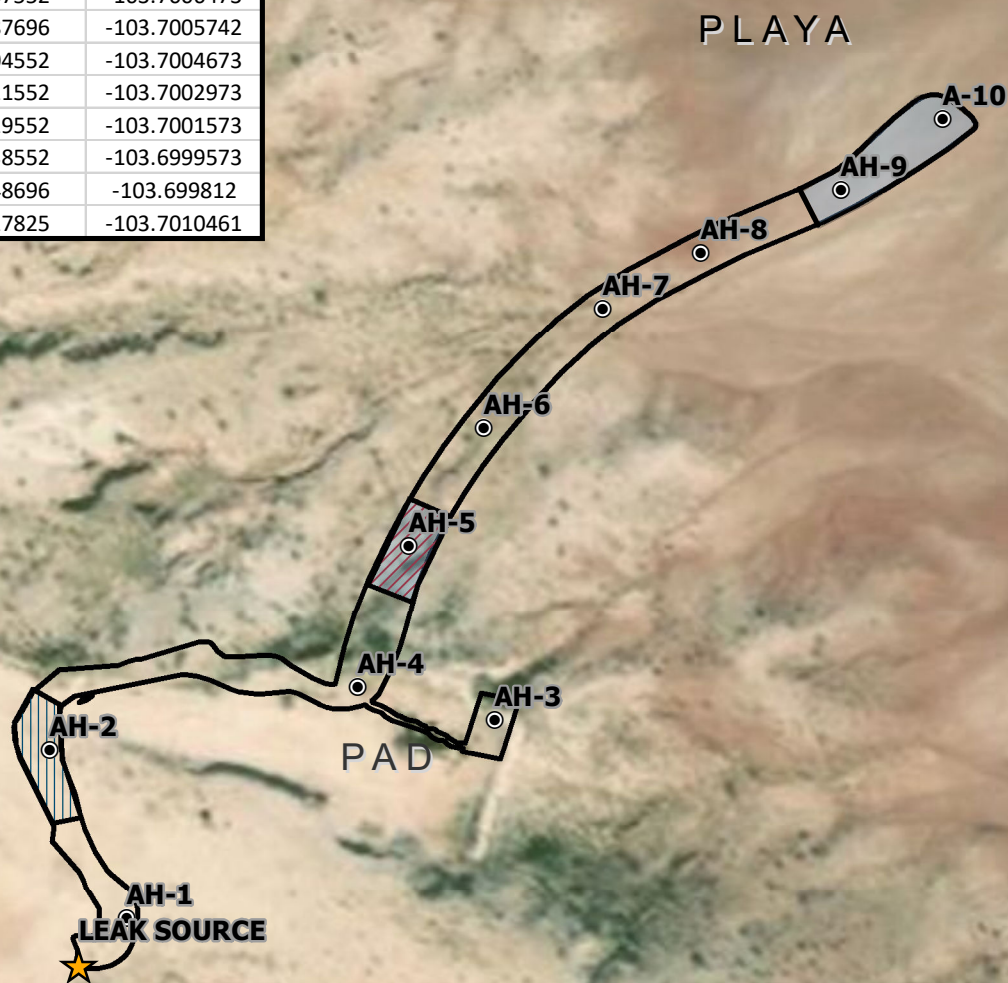
AUGER HOLE DESIGNATIONS	LATITUDE	LONGITUDE
AH-1	32.57834552	-103.7009773
AH-2	32.57858552	-103.7010873
AH-3	32.57862827	-103.7004521
AH-4	32.57867552	-103.7006473
AH-5	32.57887696	-103.7005742
AH-6	32.57904552	-103.7004673
AH-7	32.57921552	-103.7002973
AH-8	32.57929552	-103.7001573
AH-9	32.57938552	-103.6999573
AH-10	32.57948696	-103.699812
LEAK SOURCE	32.57827825	-103.7010461

- AUGER HOLE SAMPLE LOCATIONS
- ★ LEAK SOURCE
- AREA MICRO BLAZED
- 4.0' EXCAVATED DEPTH AREA
- 1.0' EXCAVATED DEPTH AREA

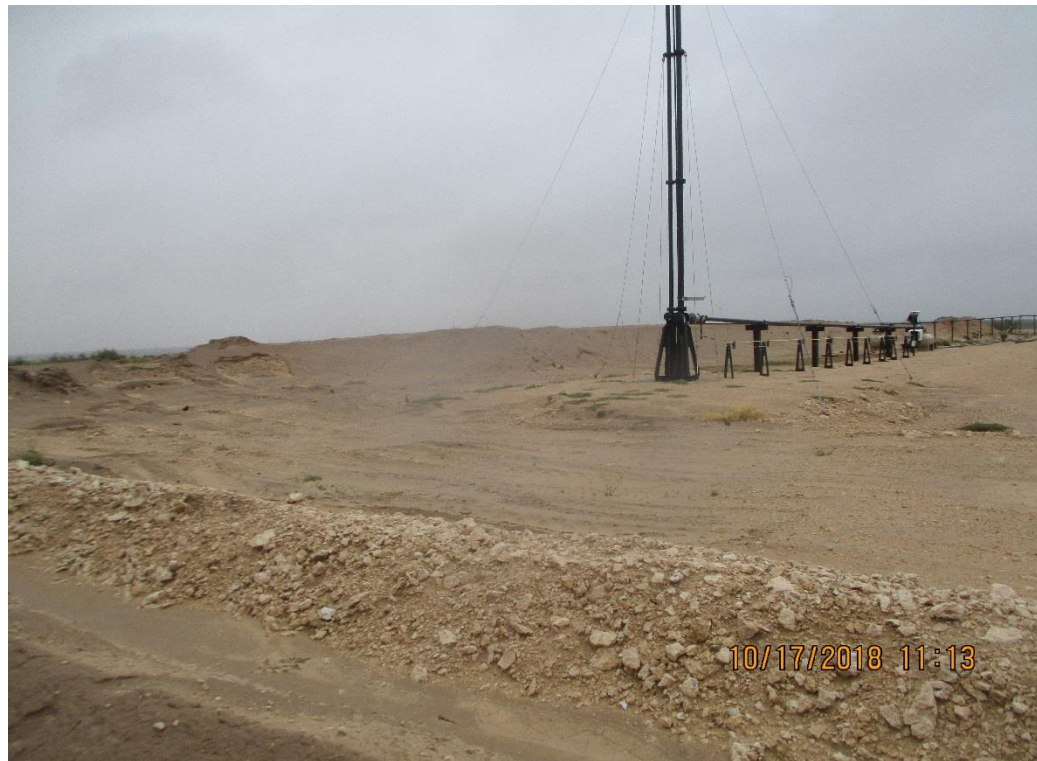
View West – Area of AH-1

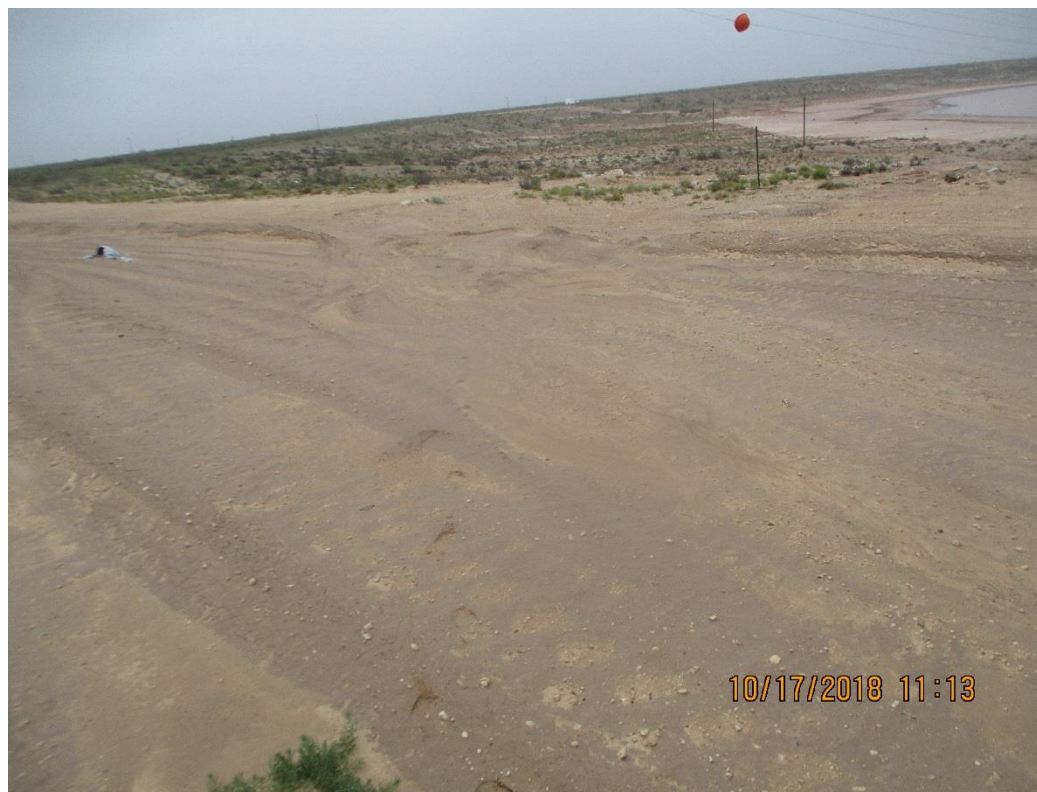
View Northeast– Area of AH-2

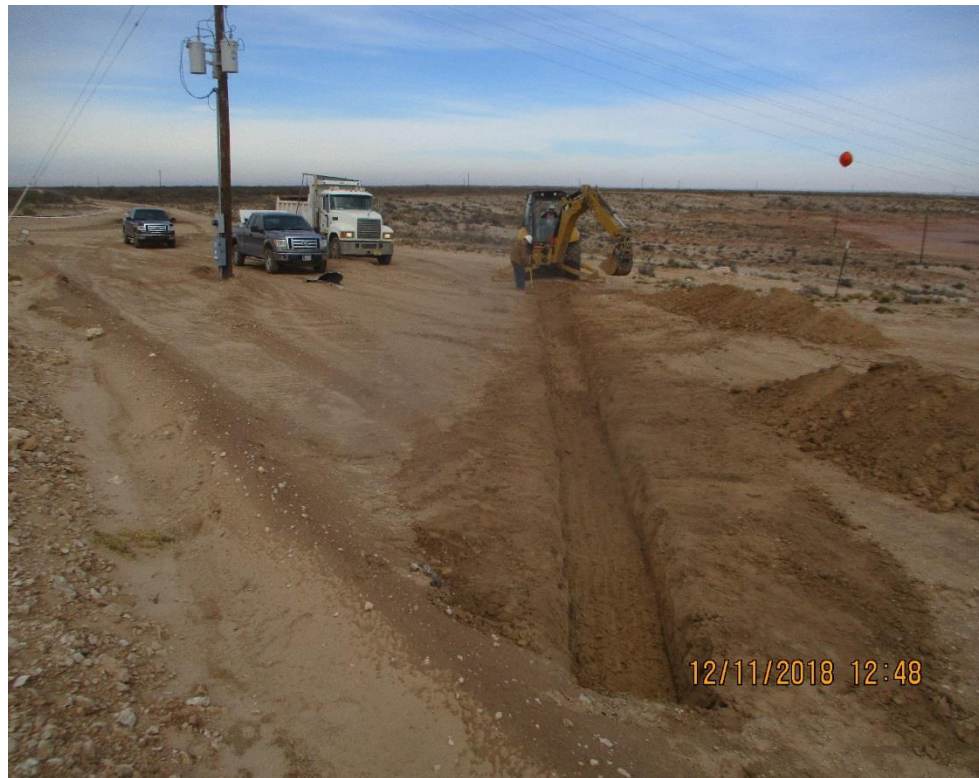
View Northeast – Excavated Area of AH-1

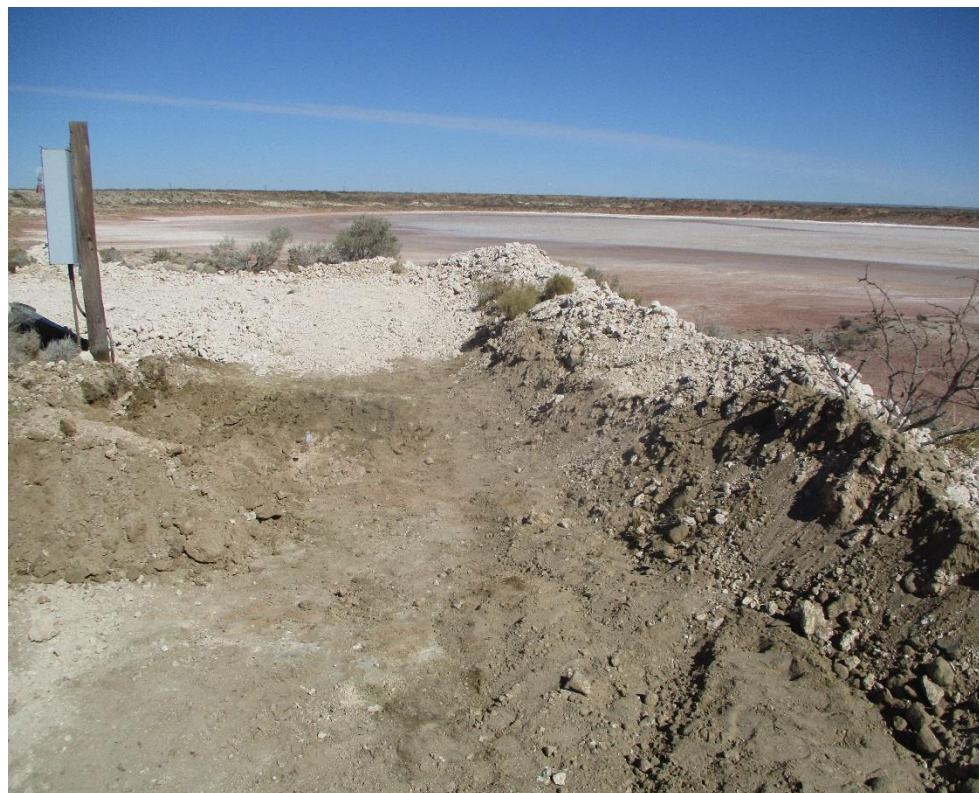
View East – Area of AH-3

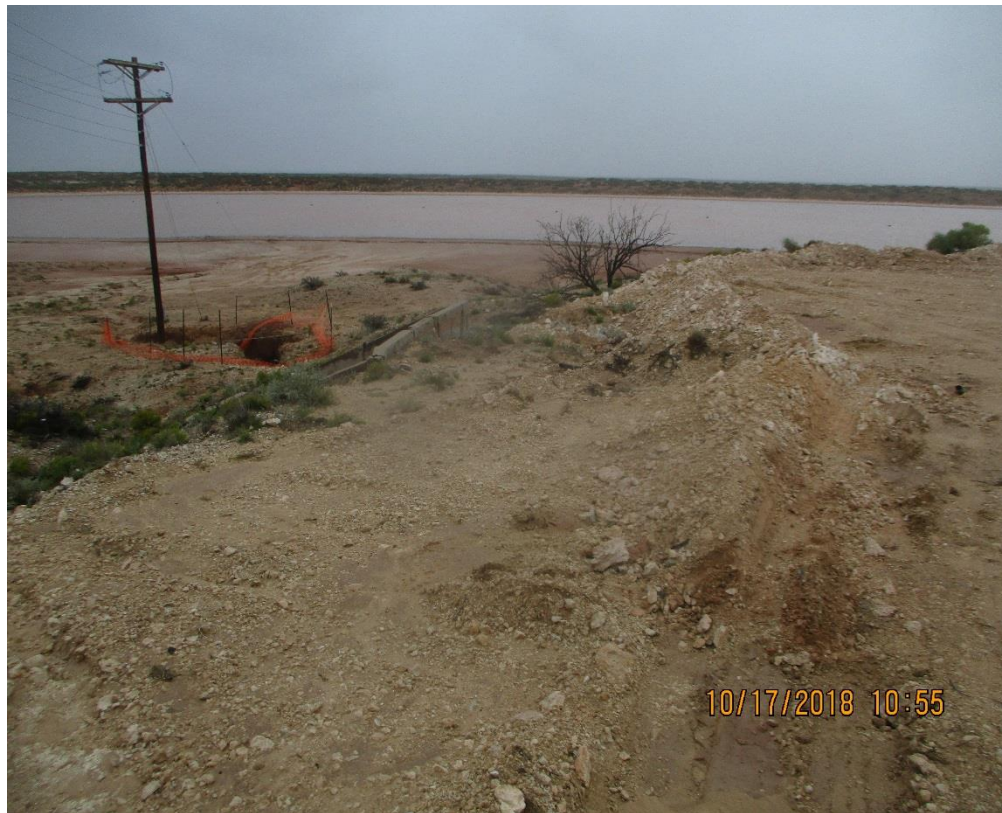
View South – Area of AH-4

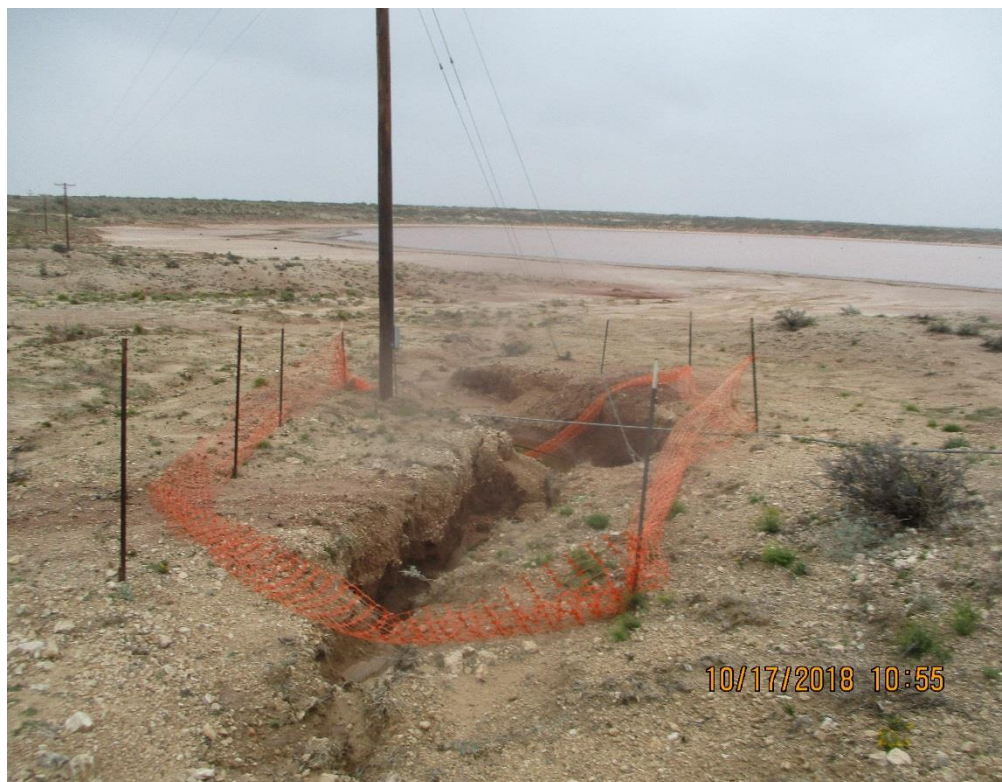
View East – Area of AH-5

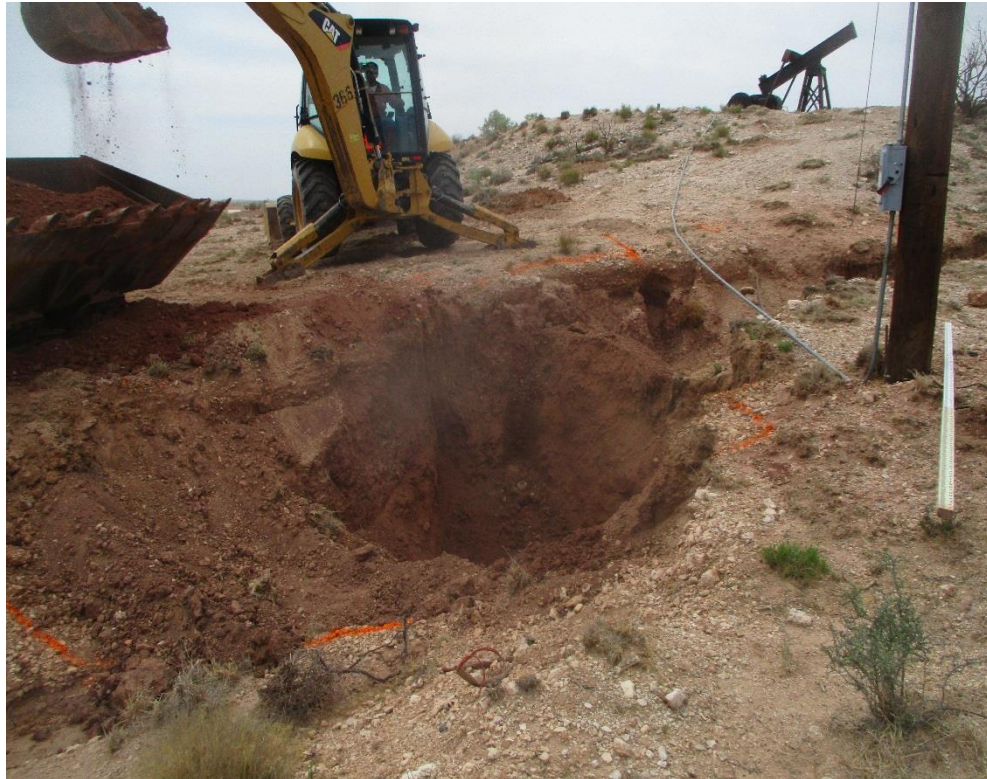
View West – Excavated Area of AH-5

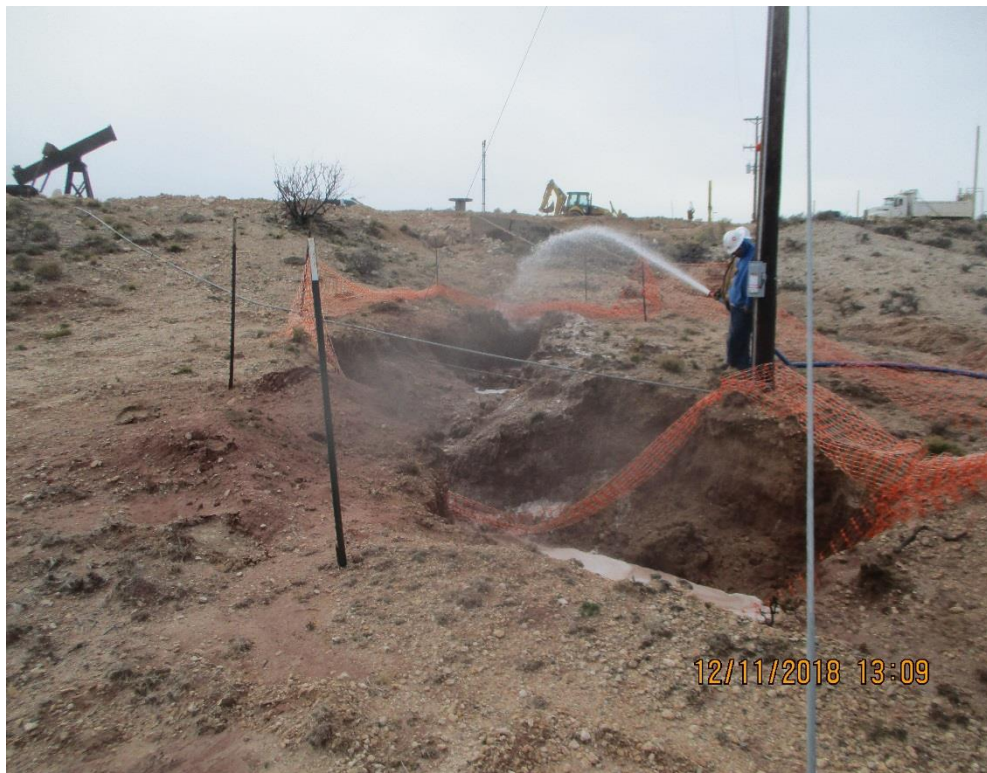
View West – Area of AH-5 Micro-blazed

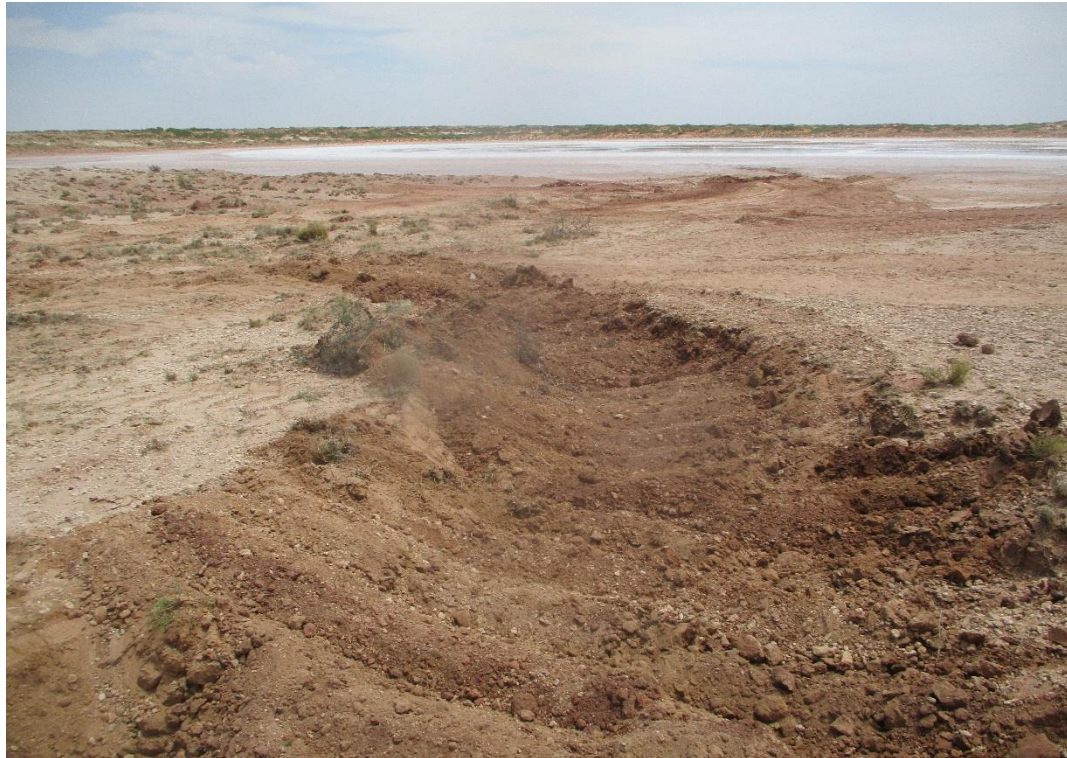
View East – Area of AH-6

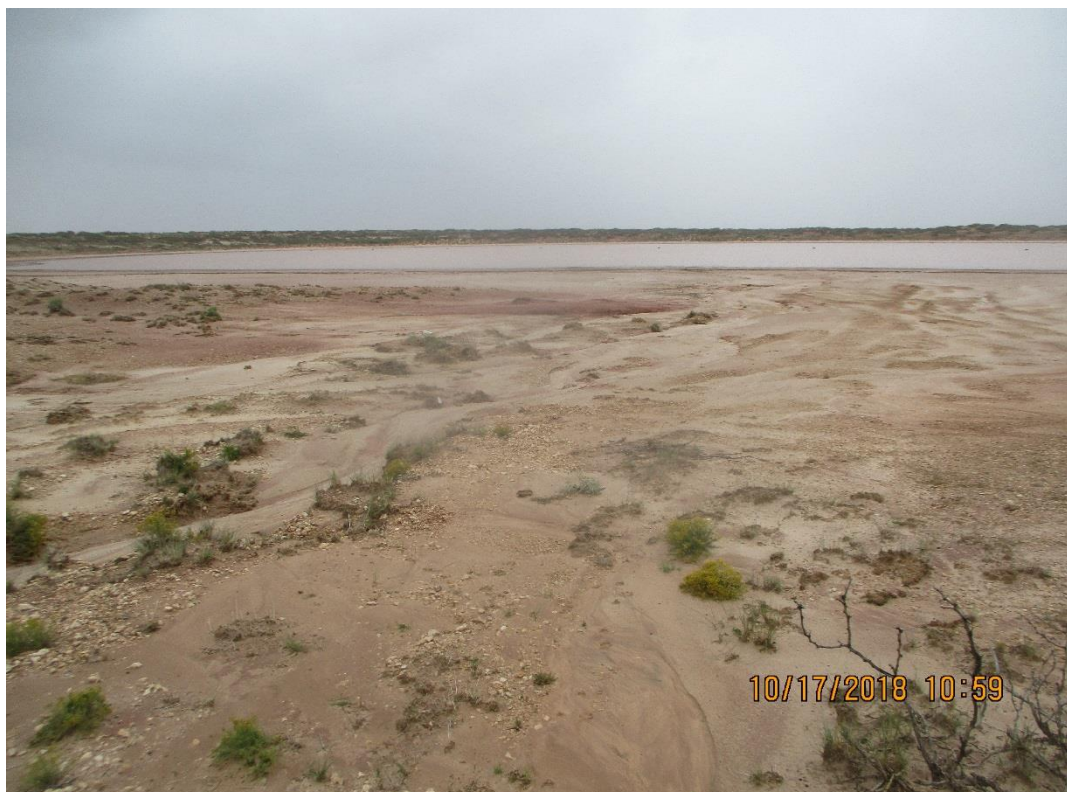
View East – Area of AH-7 and AH-8

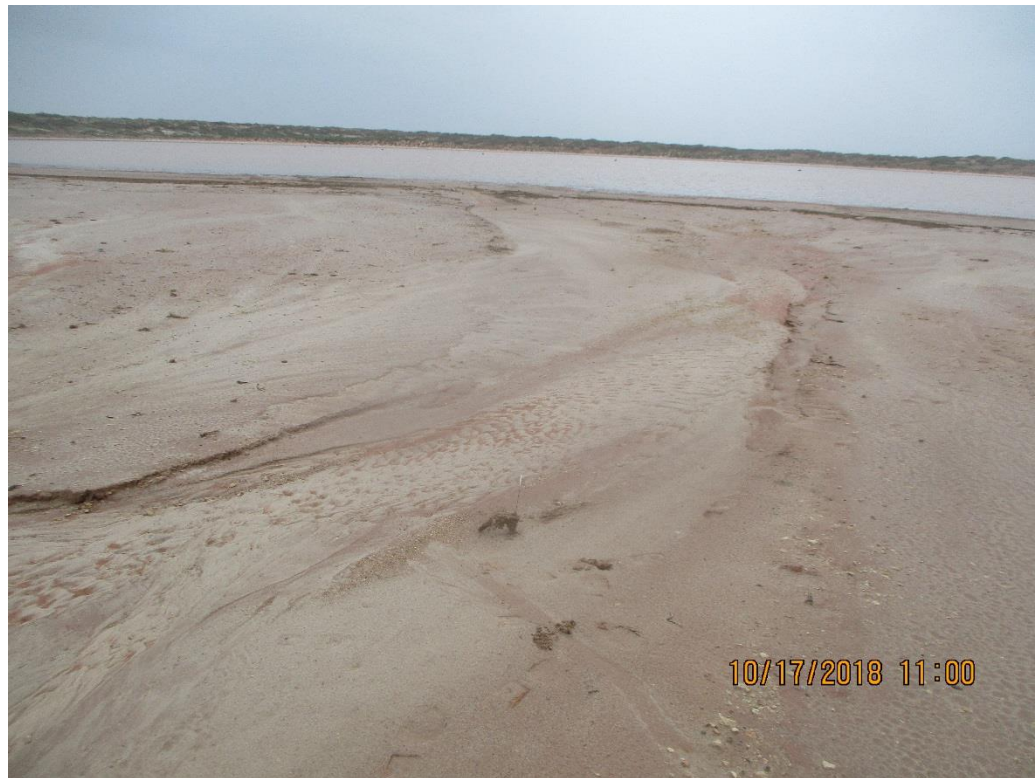
View East – Area of AH-9

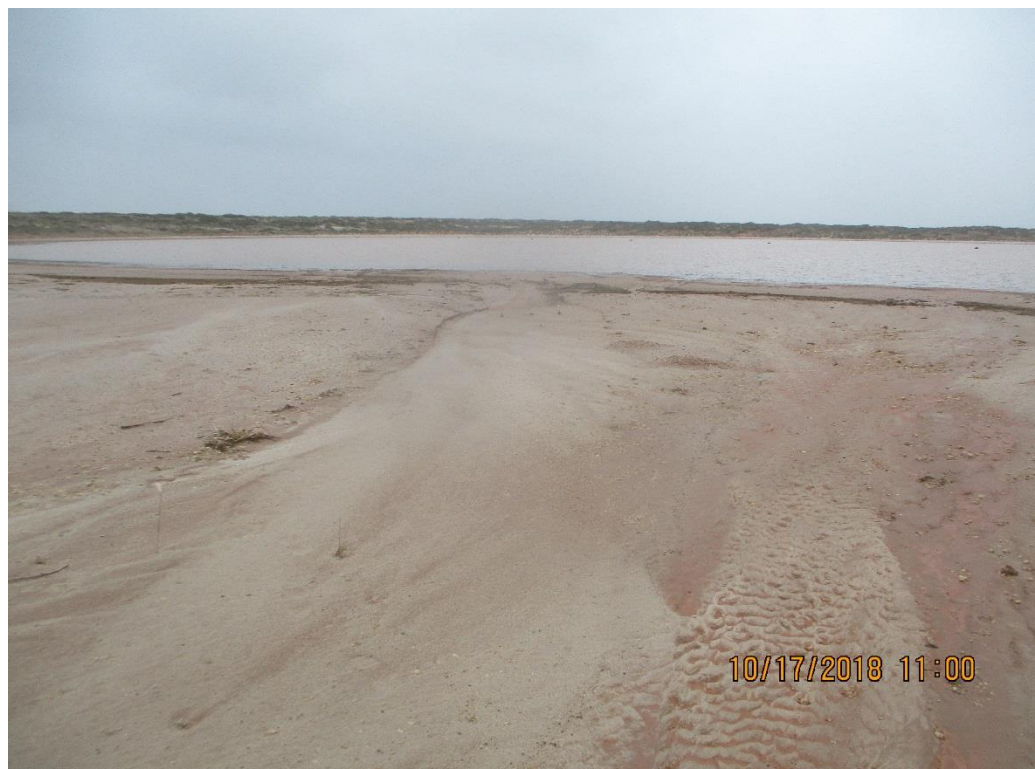
View East – Area of AH-10

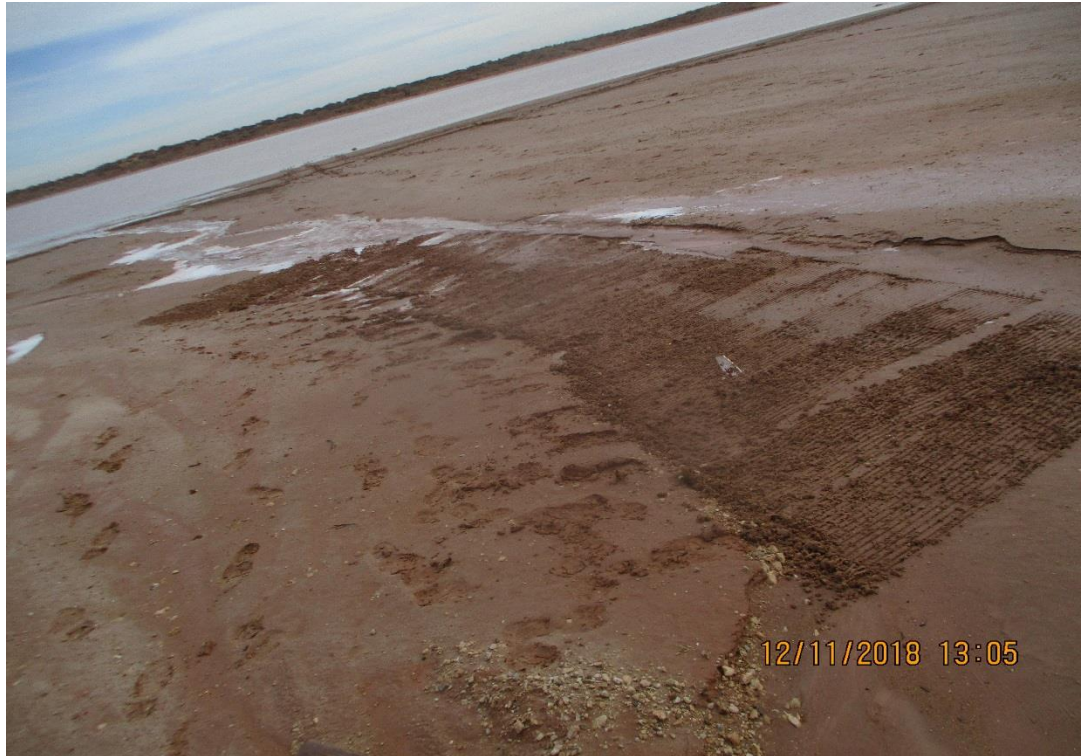
View East – Area of AH-10 Micro-blazed
