On November 25, 2015, a release was discovered at the Scottsdale Federal #1 site due to equipment failure causing a release of thirty (30) bbls crude oil from the stuffing box. The affected area covered the pad, the lease road, and a portion of a pasture located to the west of the location. Figure 1 illustrates the vicinity and site location, Figure 2 illustrates the release location. The final C-141 form is included in Appendix A.

SMA recommends no further action (other than reclamation upon facility shut-down) and requests closure of Incident Number #nAB1604236407.

Site Map
Scottsdale Federal #001 - Judah Oil LLC
Eddy County, New Mexico

Scottsdale Federal #1 Work Plan
SMA Ref #5B25501-BG2
2/17/17

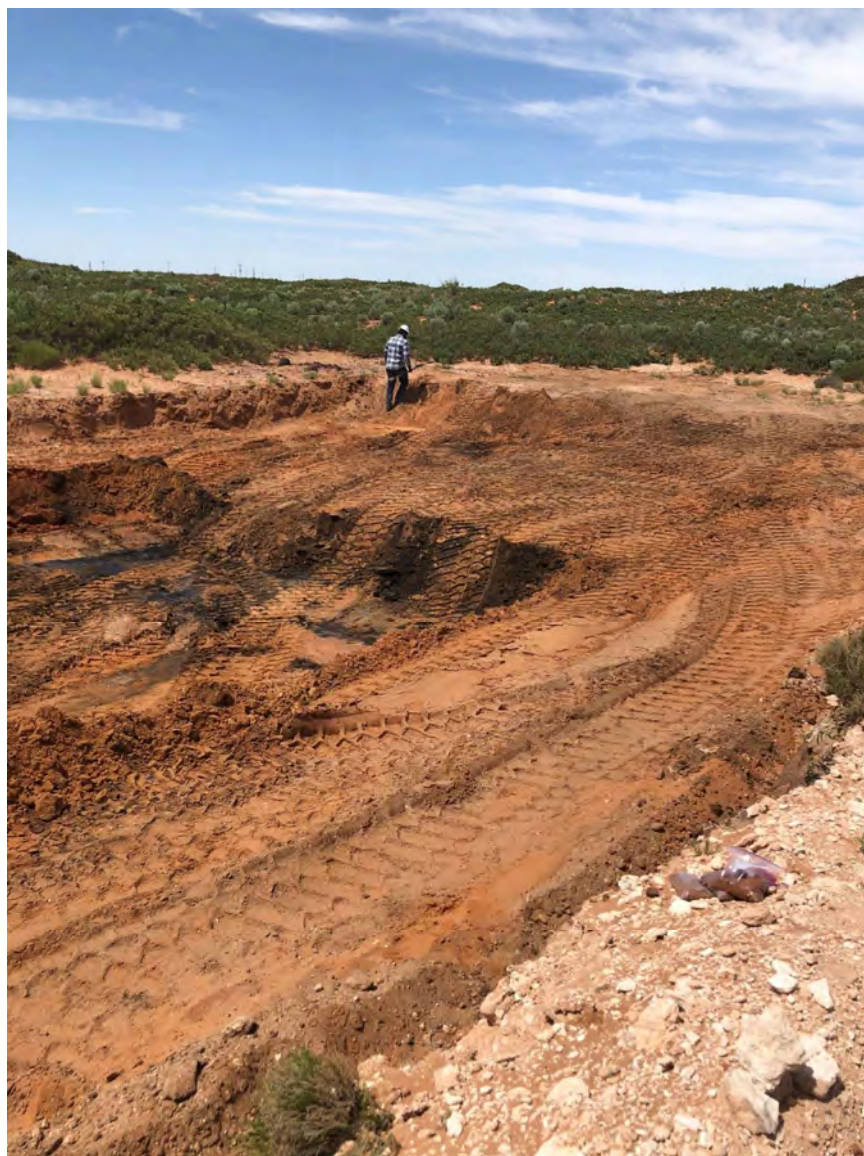
View of excavation, 4-foot and 6-foot depths

By committing to remove and replace the top four (4) feet of the horizontally delineated area (1977 square feet, 237 cubic yards) of remnant contaminated soil.

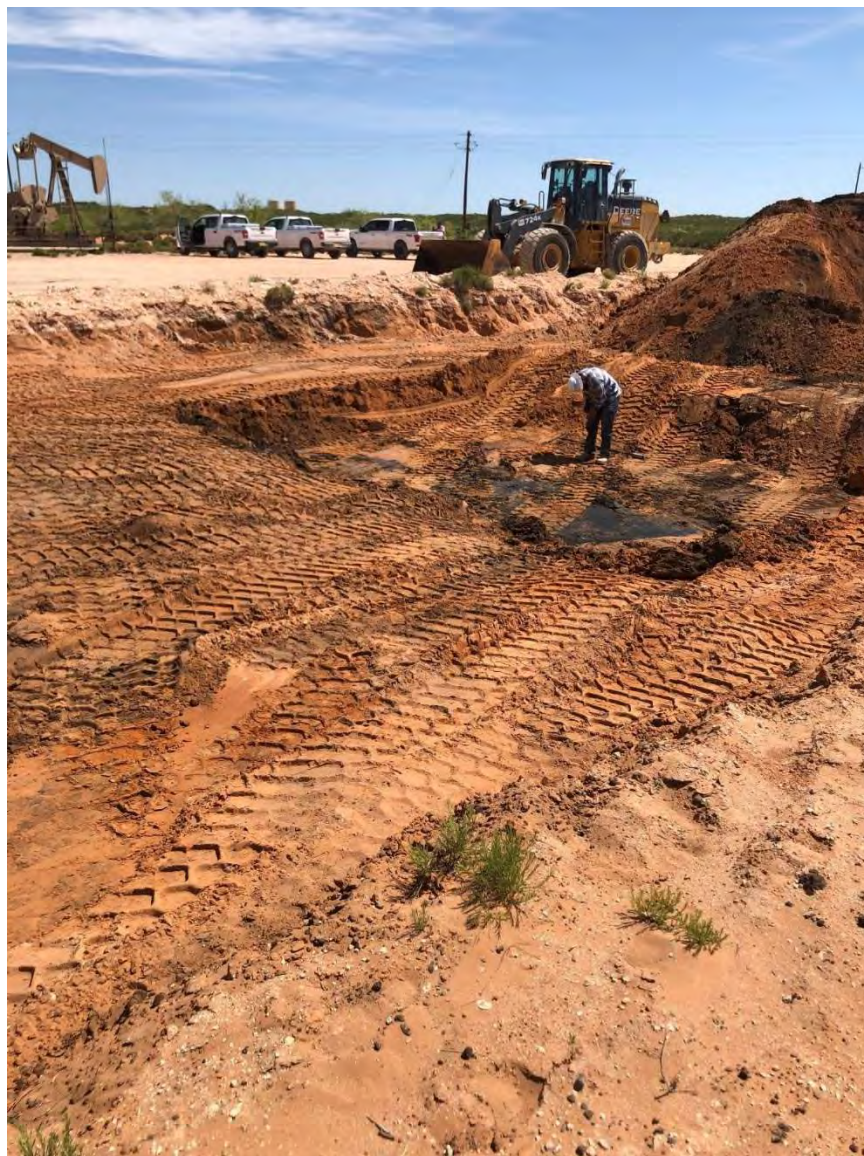
View of excavation, 4-foot and 6-foot depths

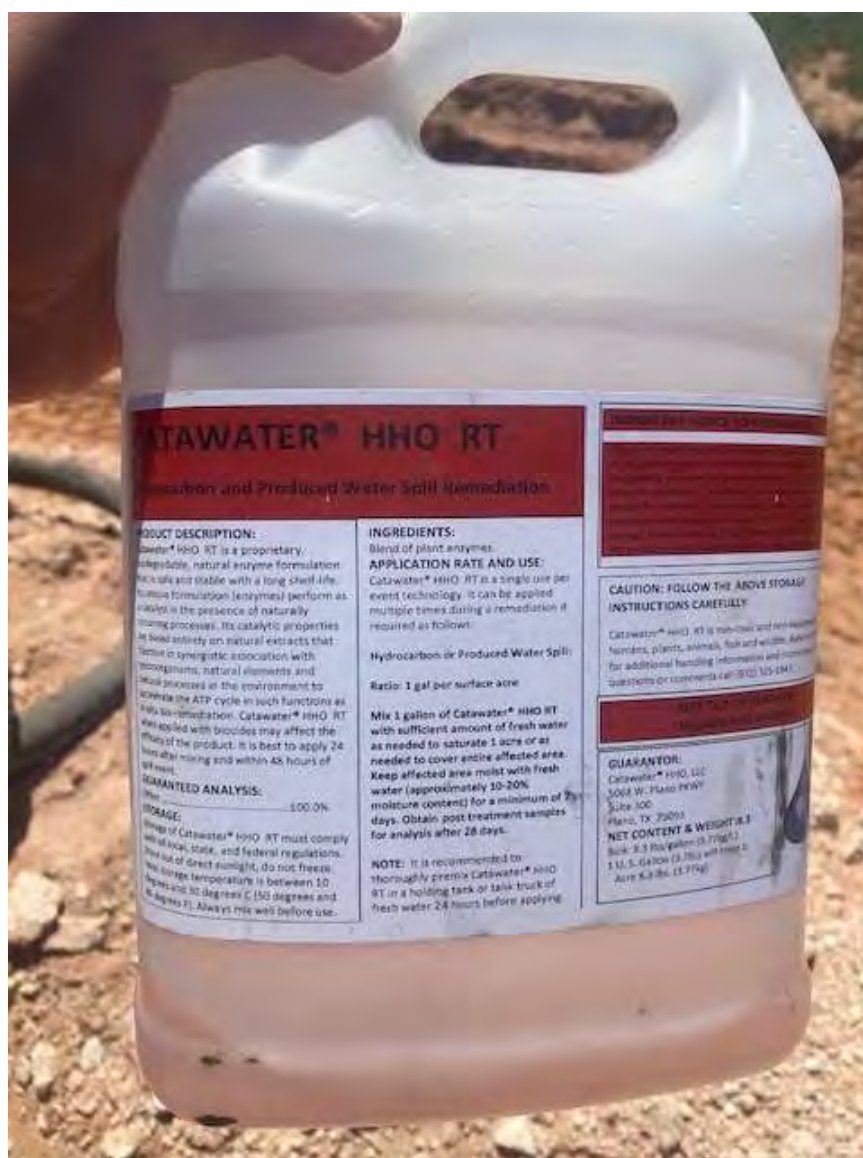
Label of bio-catalyst product applied to excavation area

Use of the chemical assistance for biodegradation of hydrocarbons as indicated is APPROVED by the OCD in this instance.

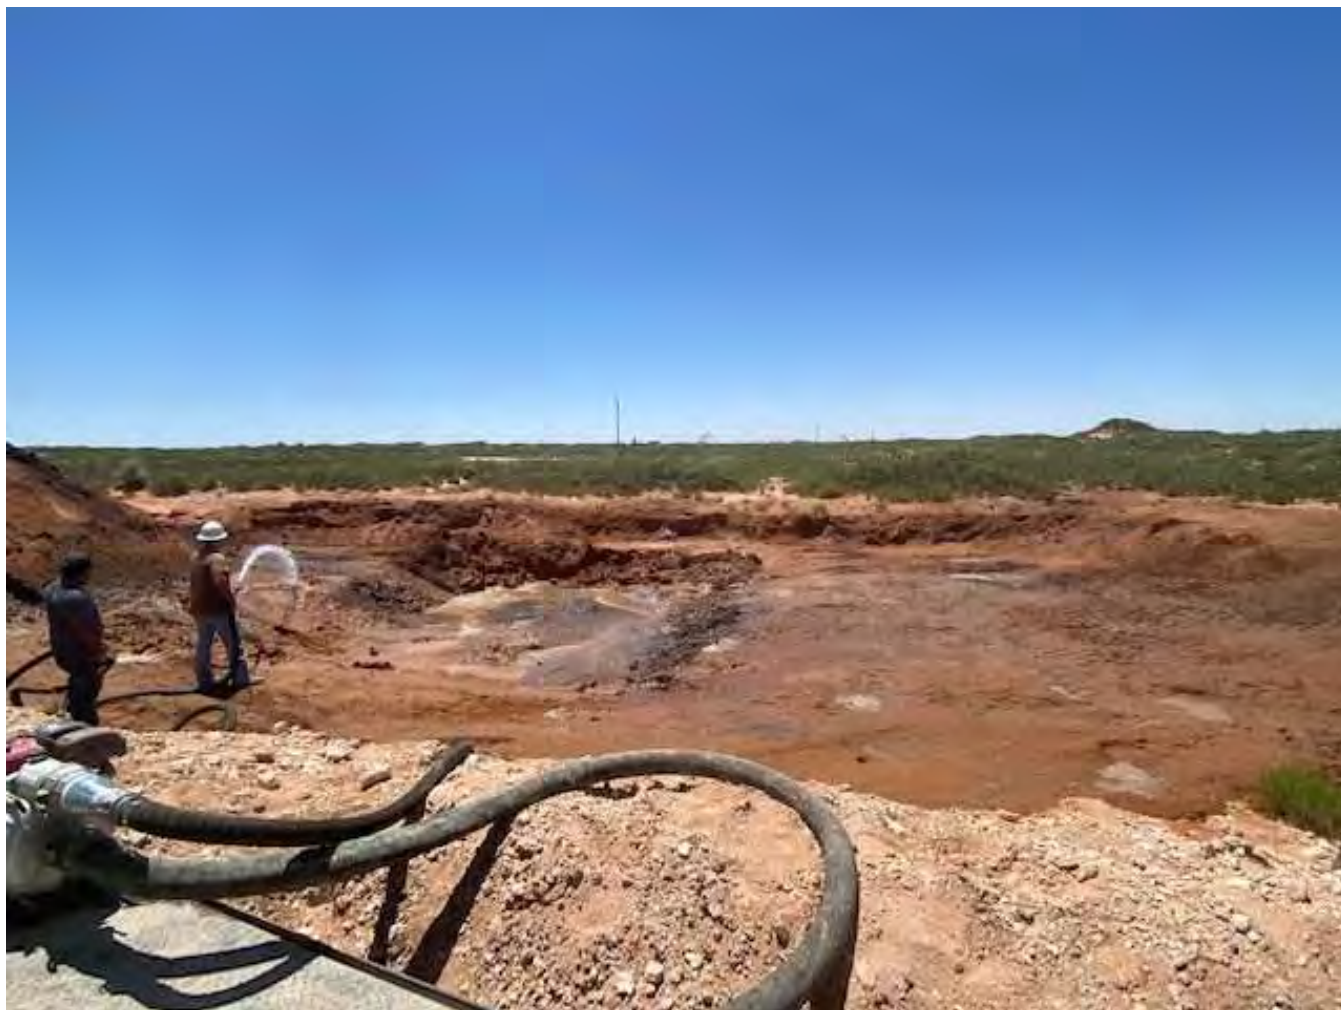
Application of bio-catalyst

2. **Confirmatory samples for side walls and bottom of excavation for laboratory analysis should be collected. Total TPH (MRO, GRO and DRO) only.**
3. **Use of chemical assistance for biodegradation of hydrocarbons**

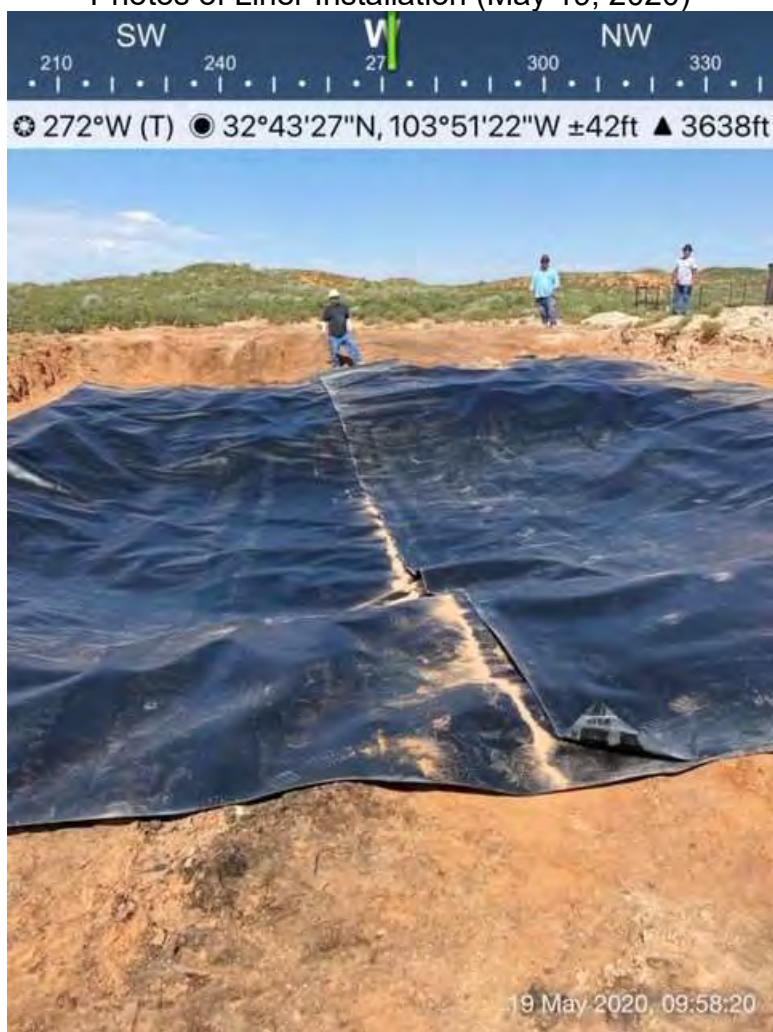
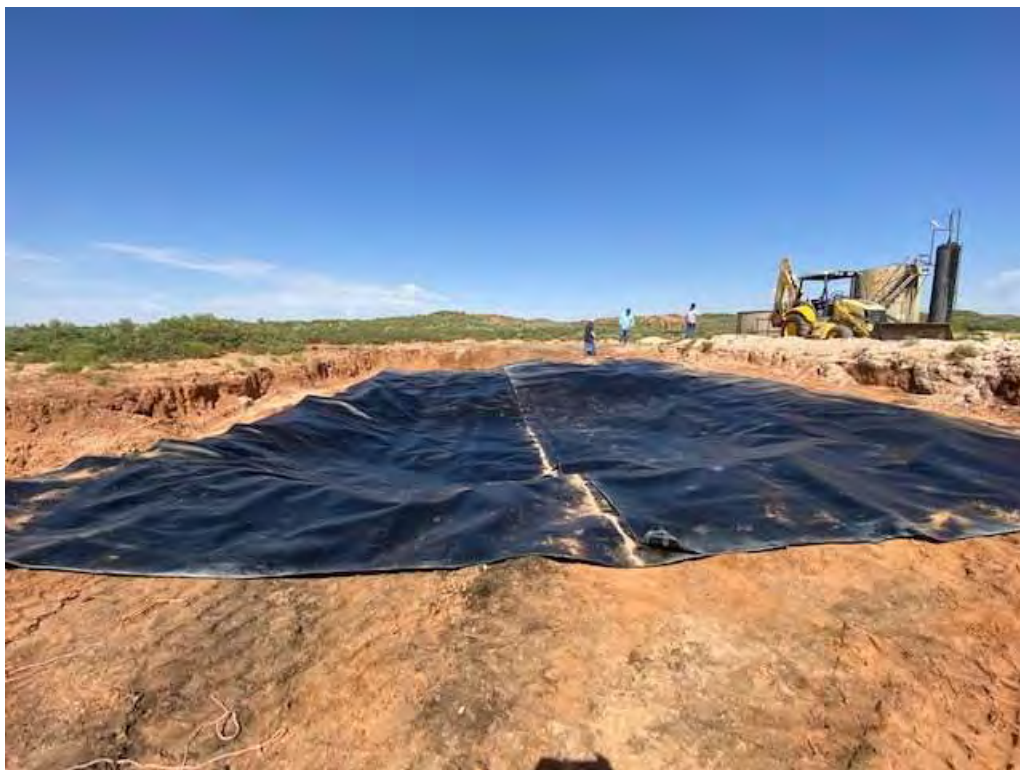
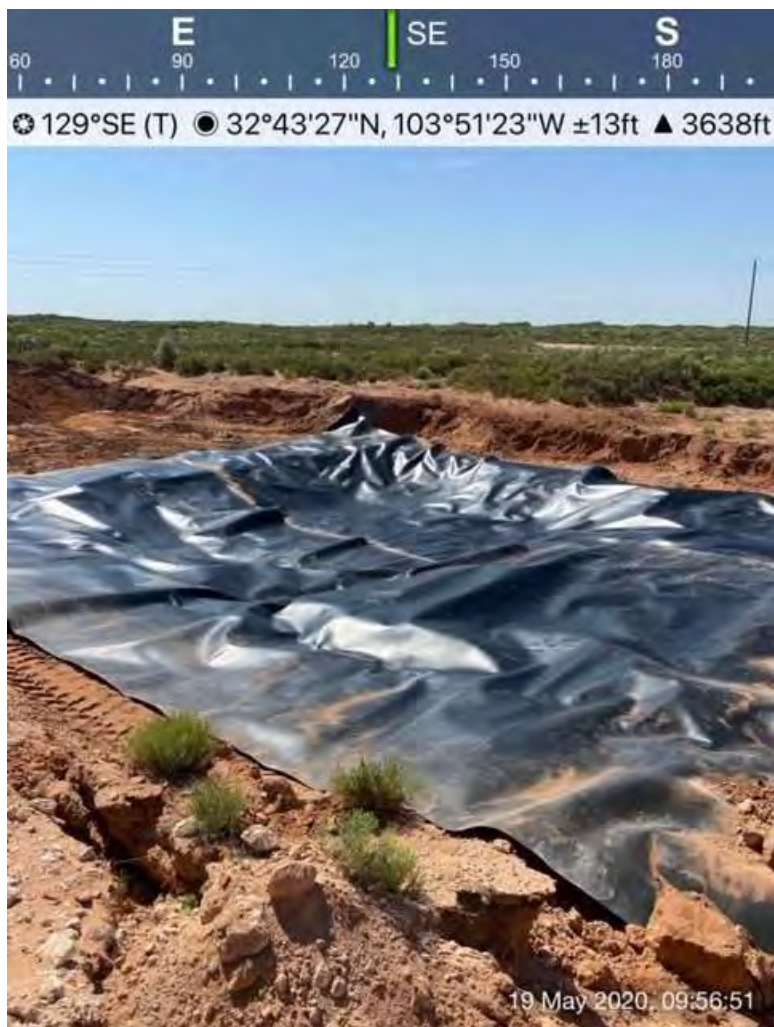
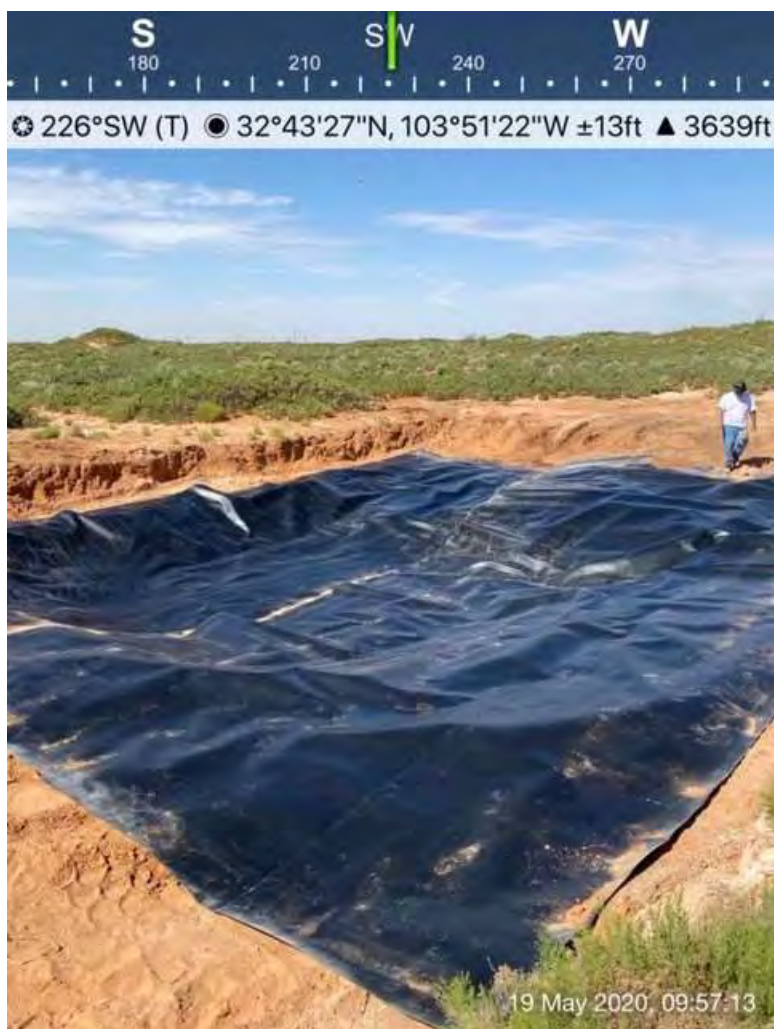
Photos of Liner Installation (May 19, 2020)

It would be topped with 4 feet of fresh soil that will be BLM-approved mix seeded ASAP for regrowth, which combined with the encapsulation will prevent future precipitated moisture from gravity percolation driving the in-situ contaminants further downward.
