Release Notification

Site Name: Owen 2A	Site Type: Well Site
Date Release Discovered: 4/18/2022	API# (if applicable)

Company: **Roddy Production**
Well Name: **Owen 2A**
API: **30-045-30235**
Sec **19**, Twn **31N**, Rge **12W**
San Juan County, New Mexico
Lease: **SF-078243**
Lat: **36.889009** Long: **-108.131296**

Owen #2A Analytical Data

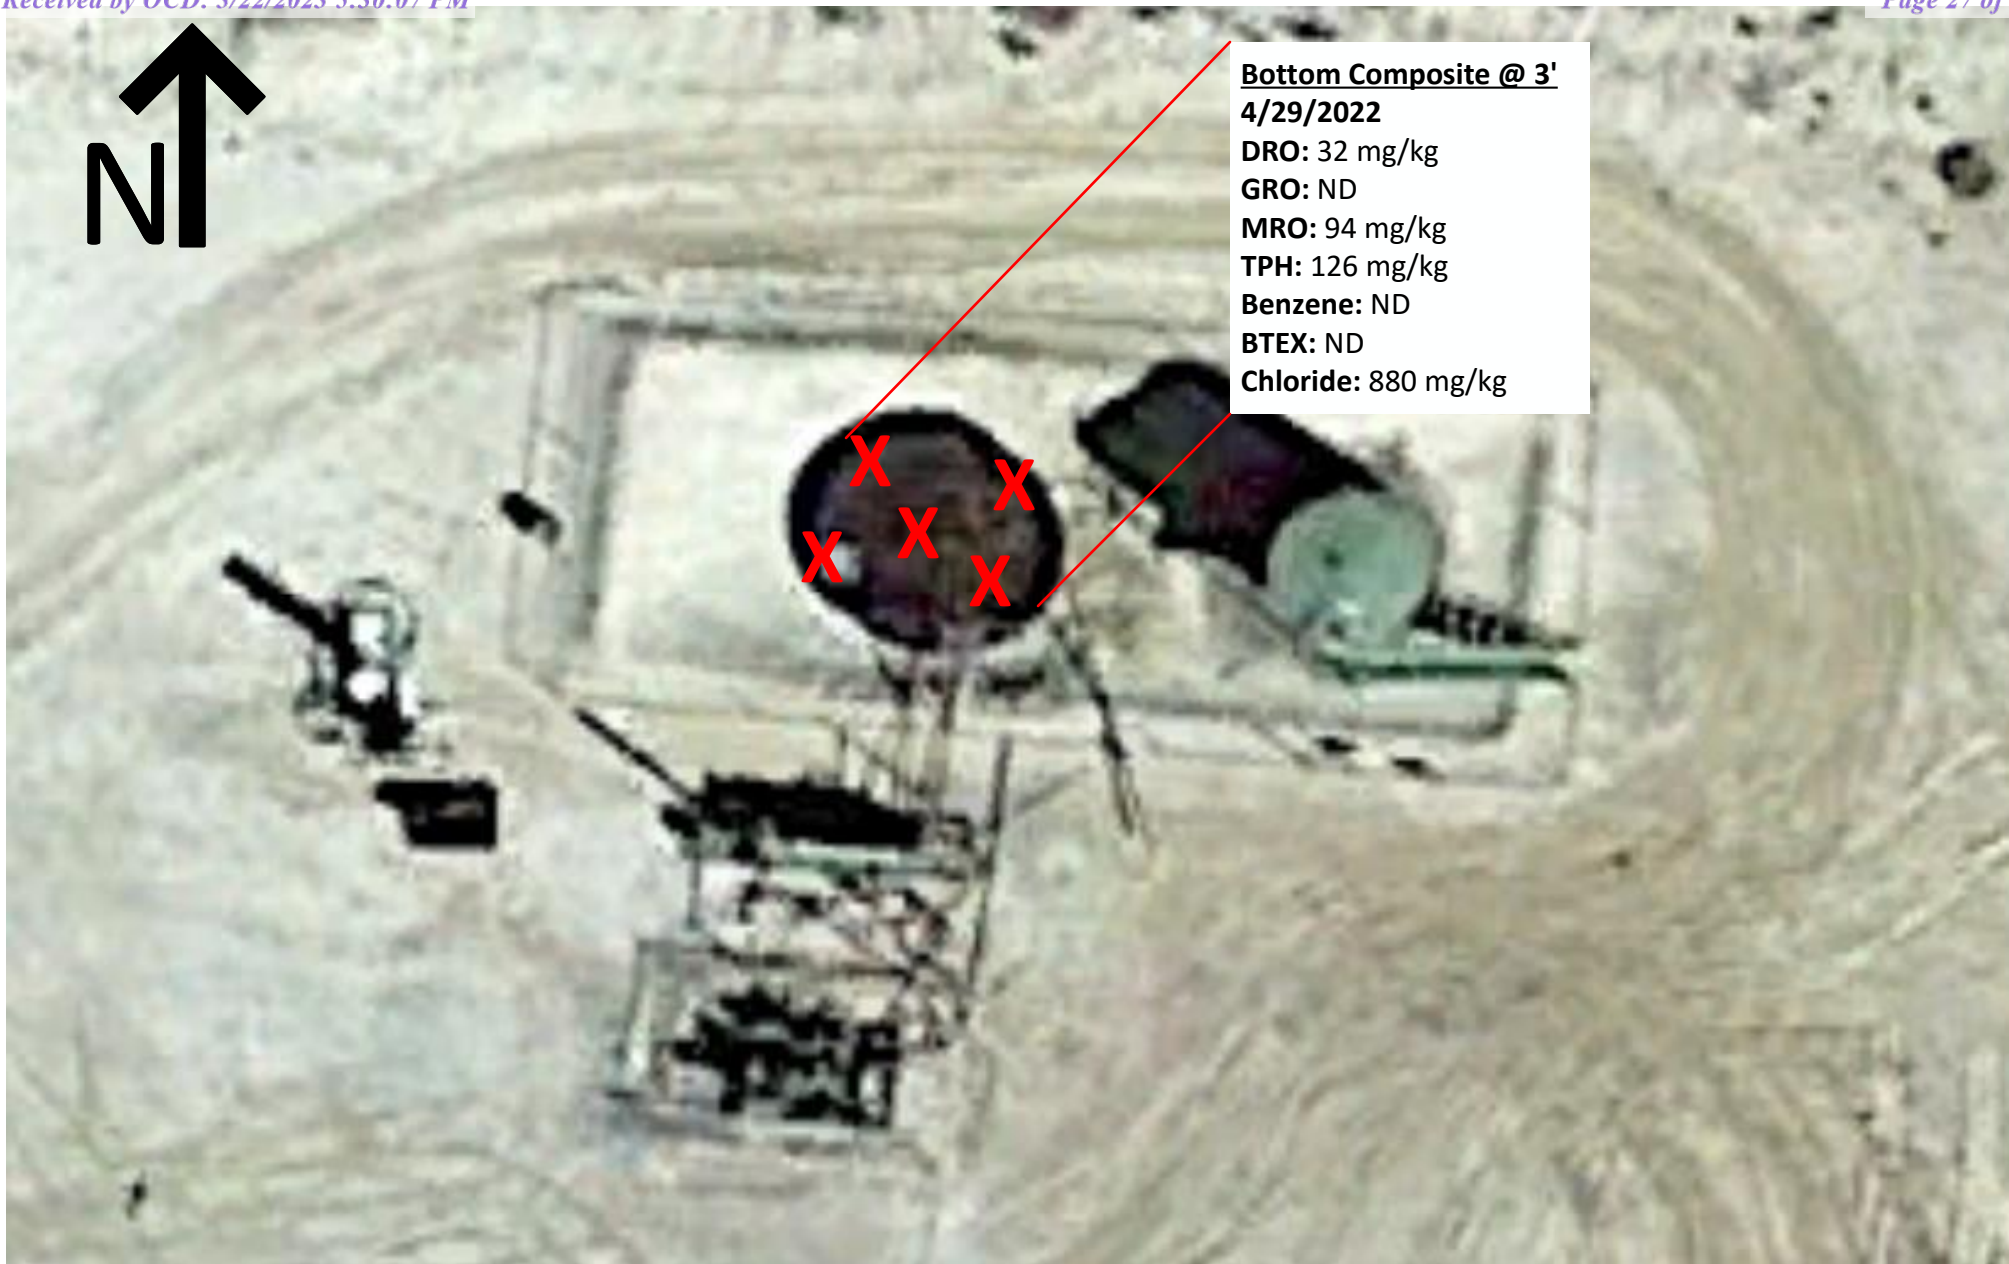
**Bottom Composite @ 3'****4/29/2022****DRO: 32 mg/kg****GRO: ND****MRO: 94 mg/kg****TPH: 126 mg/kg****Benzene: ND****BTEX: ND****Chloride: 880 mg/kg****SAMPLING MAP****Drawn By: James McDaniel****Date: 5/18/2022**

JAKD Personnel, Roddy Production personnel, Knock-Out Construction and Emanuel Adeloye with the BLM were on-site for BGT closure activities. Approximately 1 foot of soil was excavated from the BGT cellar beneath the former location of the BGT due to visual salt staining on the surface. A hard sandstone layer was encountered at 3' below ground surface (1' below the BGT bottom), and additional excavation could not take place. A composite sample was collected at 3' below ground surface of the sandstone material beneath the former location of the BGT. The sample was analyzed at Hall Environmental Laboratory.
