Report Type: Closure Report 2RP-4557

Site:	El Presidente State #4H					
Company:	Marathon Oil Permian, LLC					
Section, Township and Range	Unit O	Sec. 02	T 24S	R 27E		
Lease Number:	API No. 30-015-44165					
County:	Eddy County					
GPS:	32.24030° N			104.16053° W		
Surface Owner:	State					
Mineral Owner:						
Directions:	From the intersection of US 285 and Black River Village Rd in Malaga, travel west on Black River Village for approximatey 1.7 mi, turn north onto Higby Hole Rd for approx. 2.85 mi, turn west and continue for 2.05 mi, turn south for 2.0 miles to location.

Re: Closure Report for the Marathon Oil Company, El Presidente State #4H, Unit O, Section 02, Township 24 South, Range 27 East, Eddy County, New Mexico. 2RP-4557.

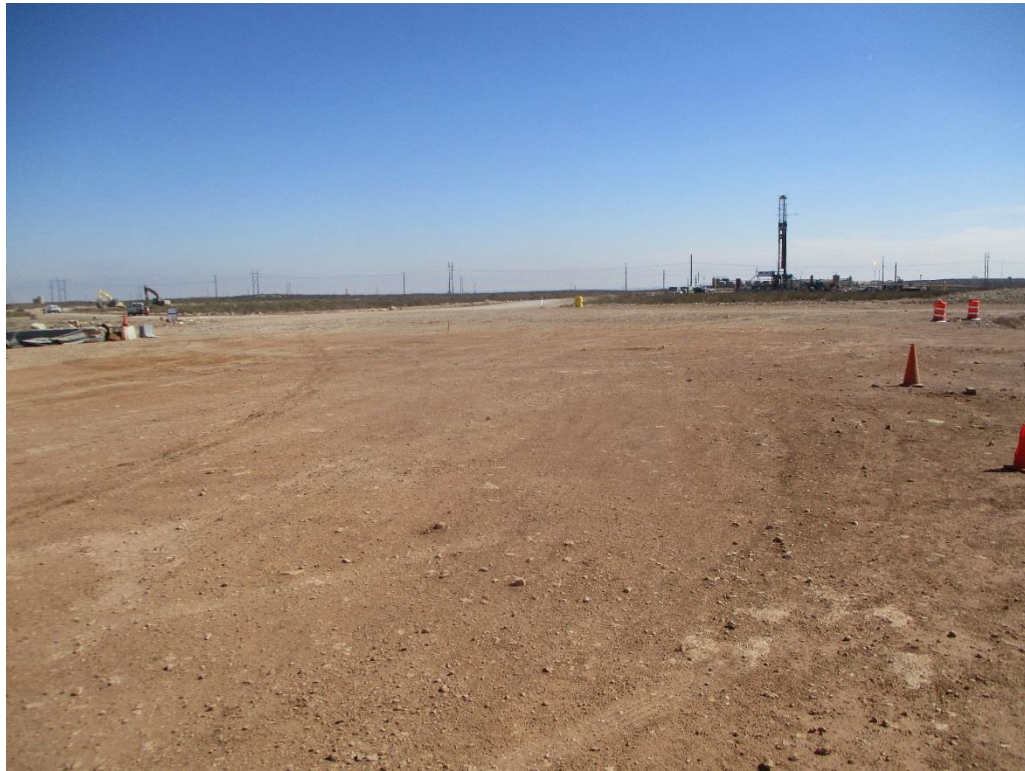
View East – Area of AH-1 and AH-2

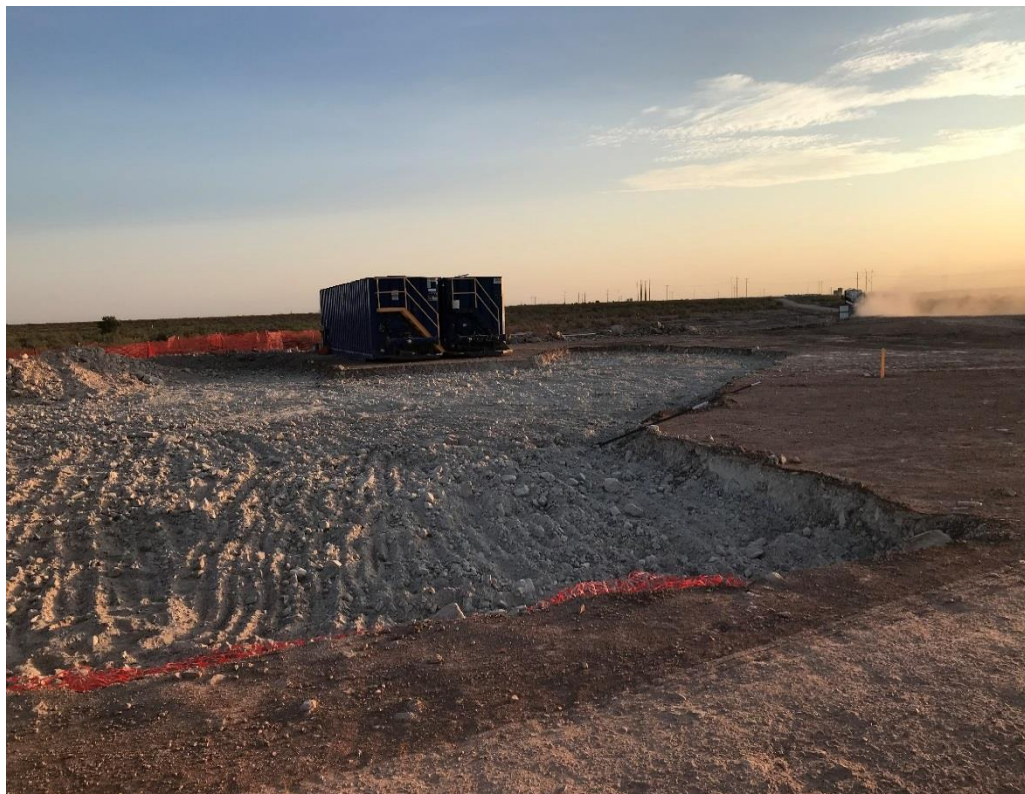
View North – Excavated Area of AH-2 and AH-3

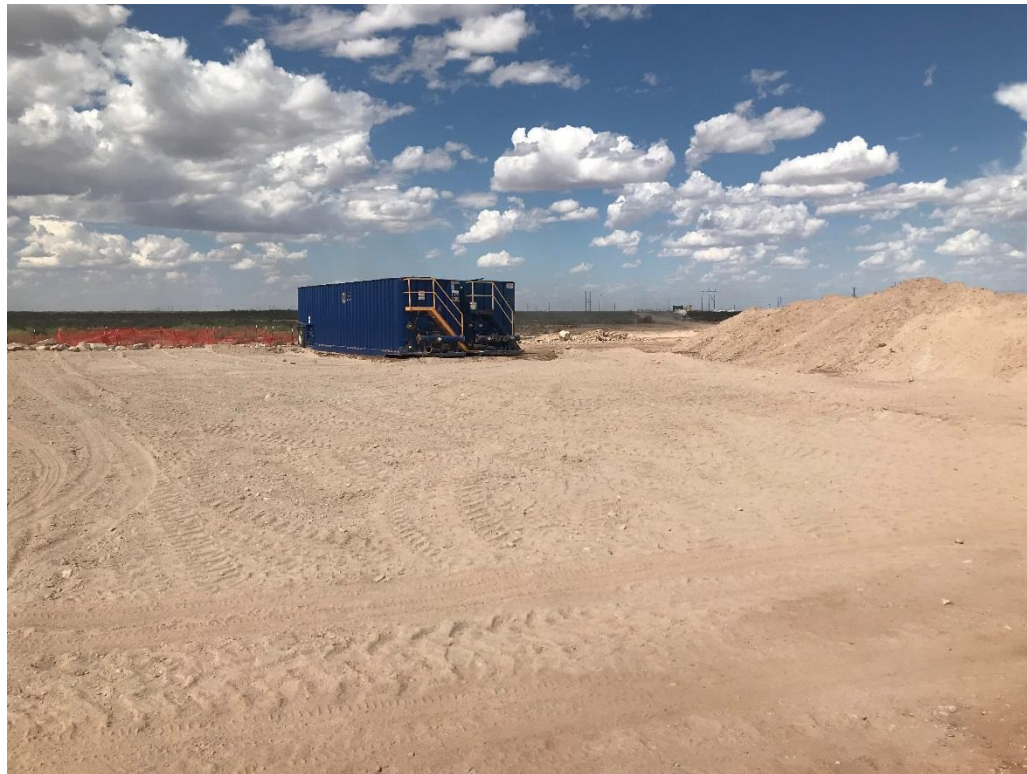
View North –Backfilled Area of AH-2 and AH-3

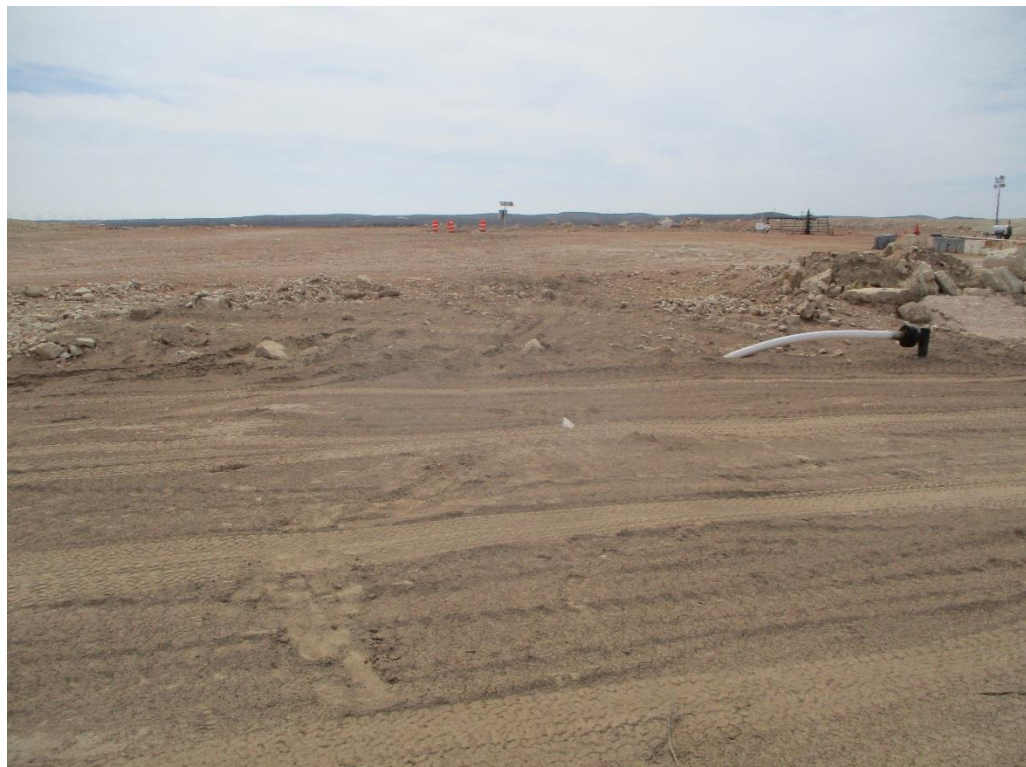
View South – Area of AH-4

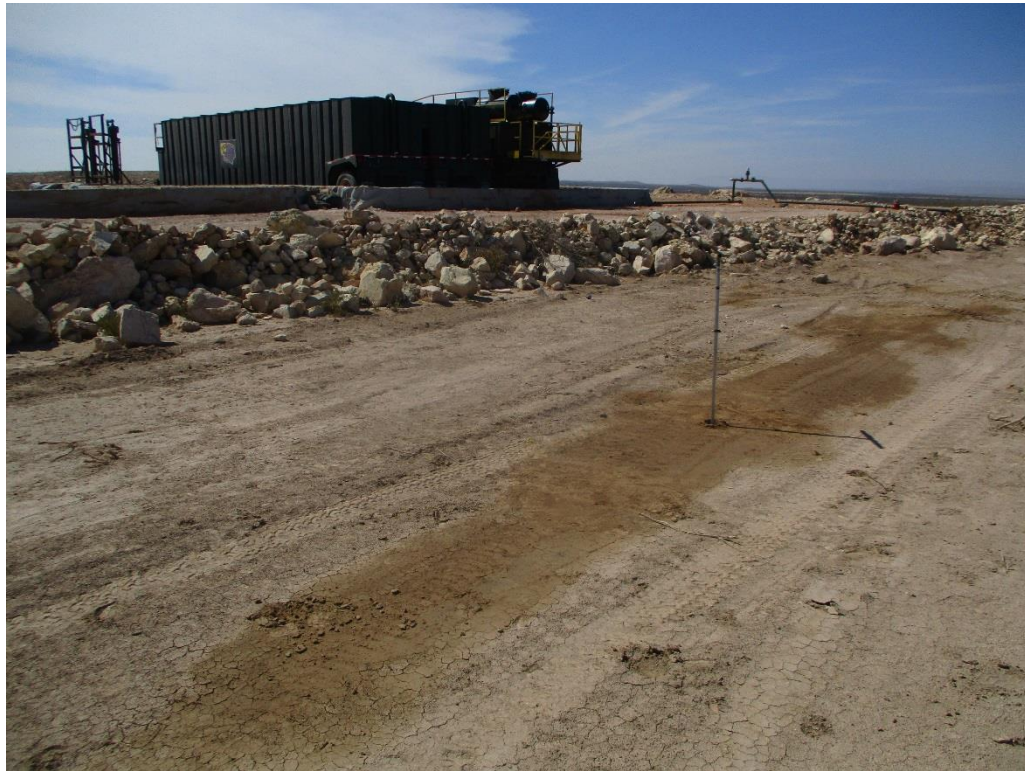
View Southwest – Area of AH-5

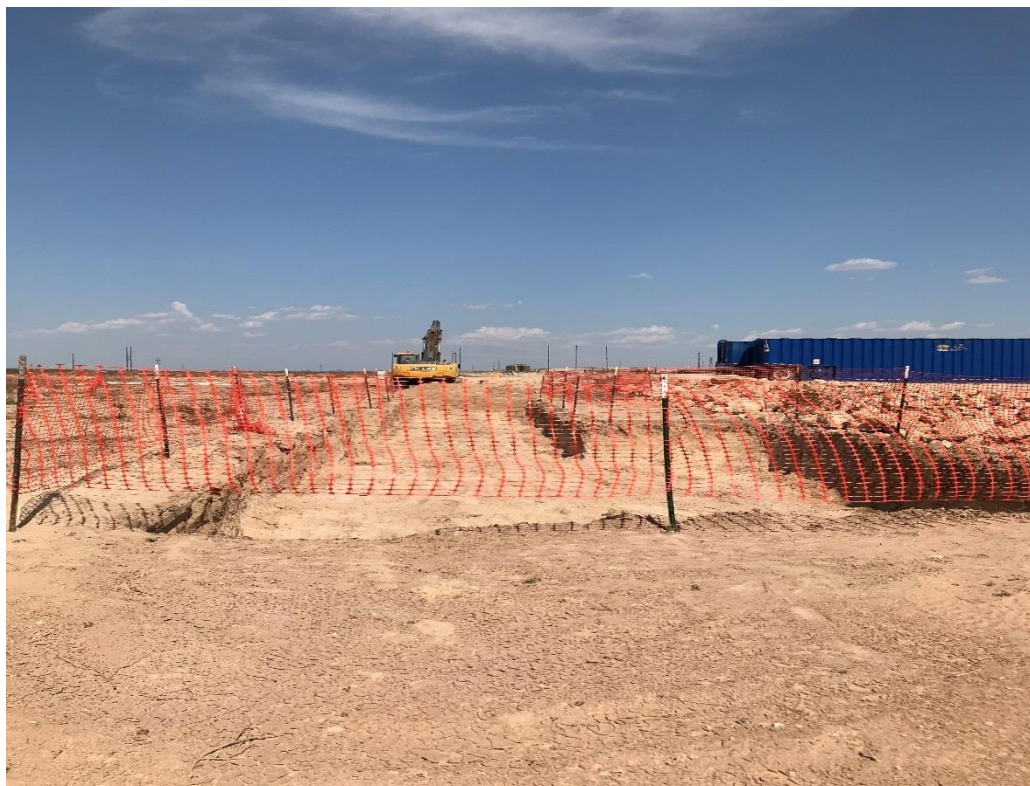
View East – Excavated Area of AH-5

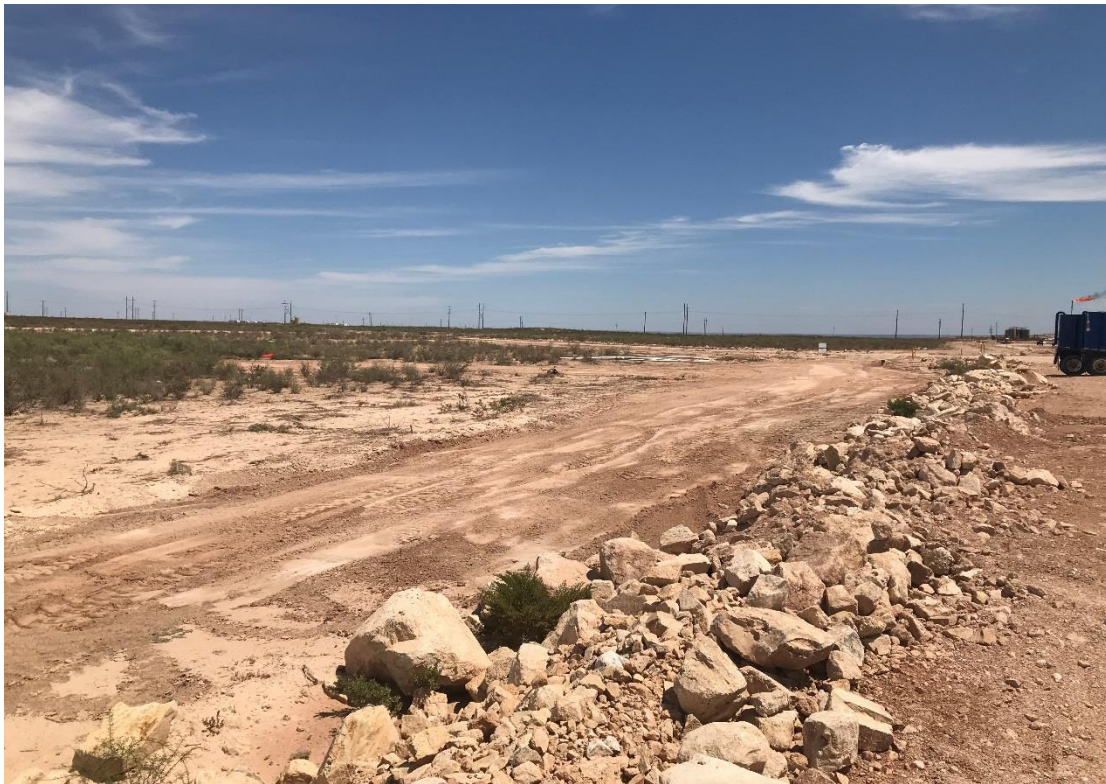
View East – Backfilled Area of AH-5

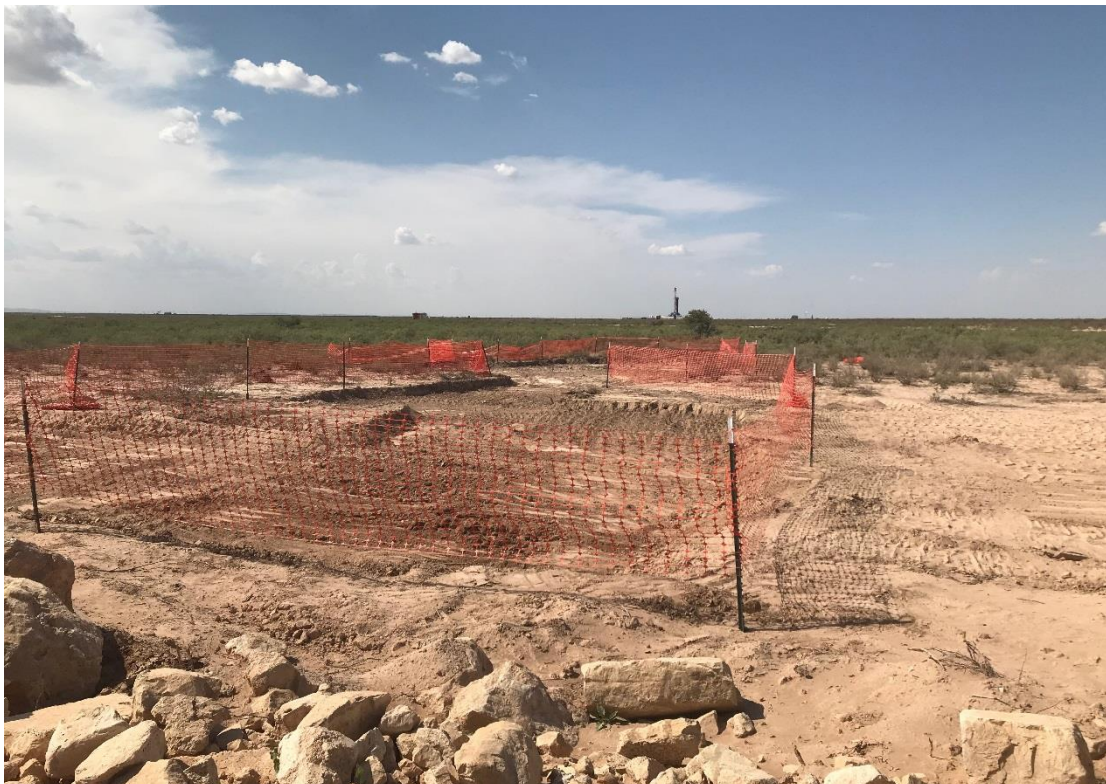
View Northwest – Area of AH-6

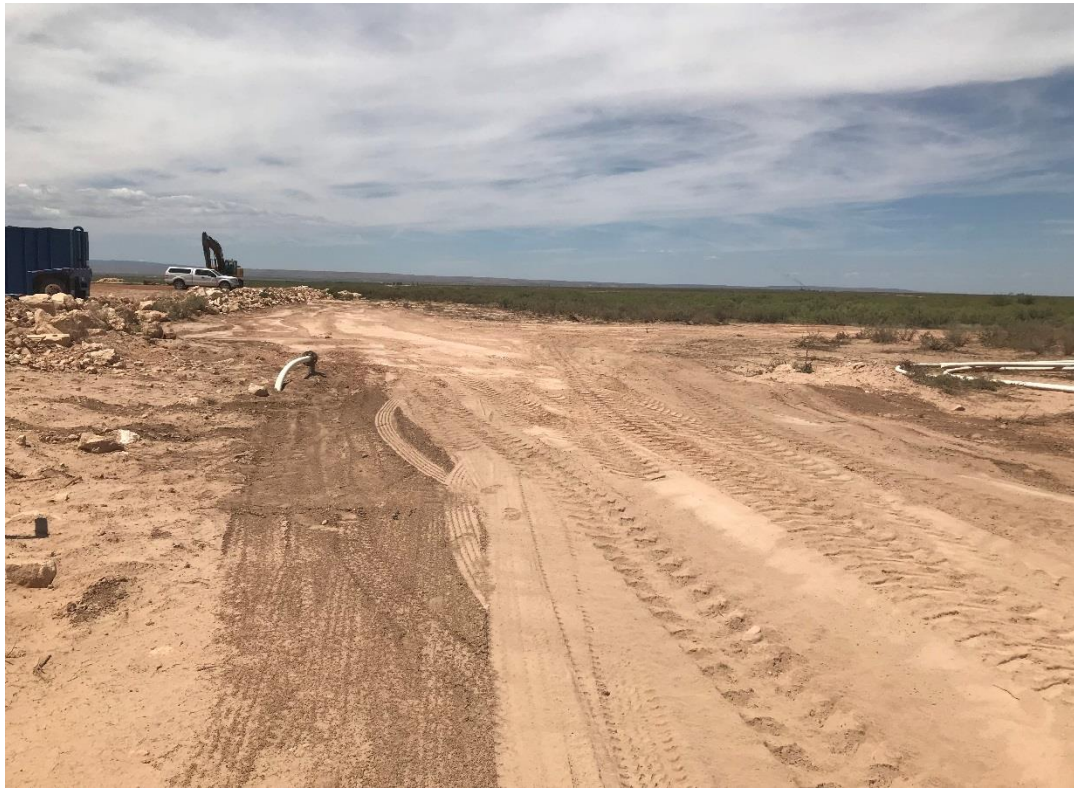
View West- Backfilled Area of AH-6

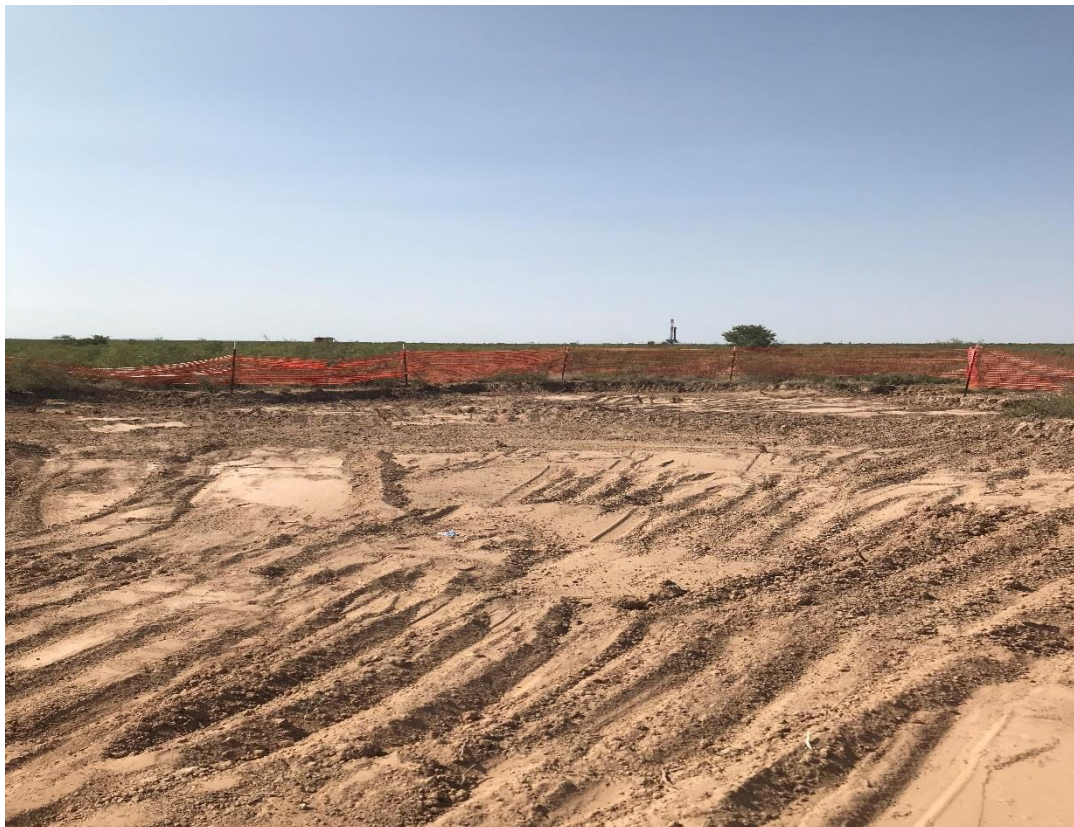
View North – Excavated Area of AH-7 and AH-8

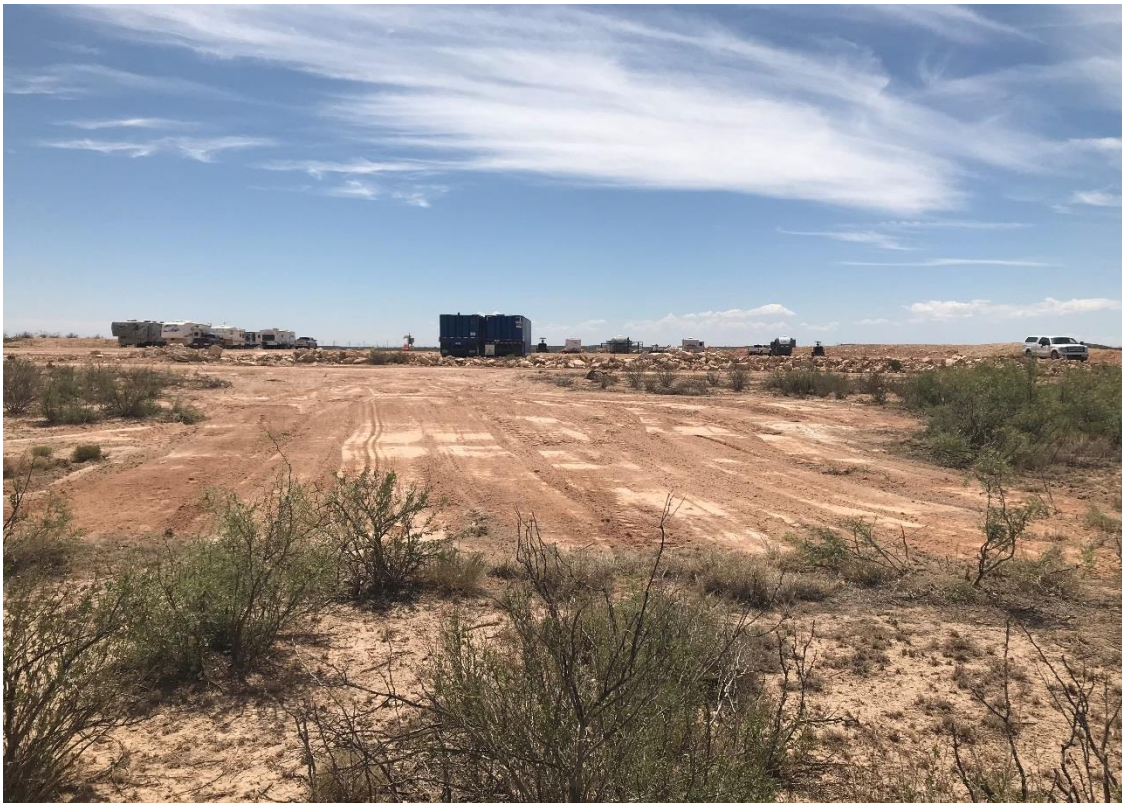
View South- Backfilled Area of AH-7 and AH-8
