## Site Closure Report

Devon Thistle 28 CTB

Enterprise: T16-079

Talon Project #700348.343.01

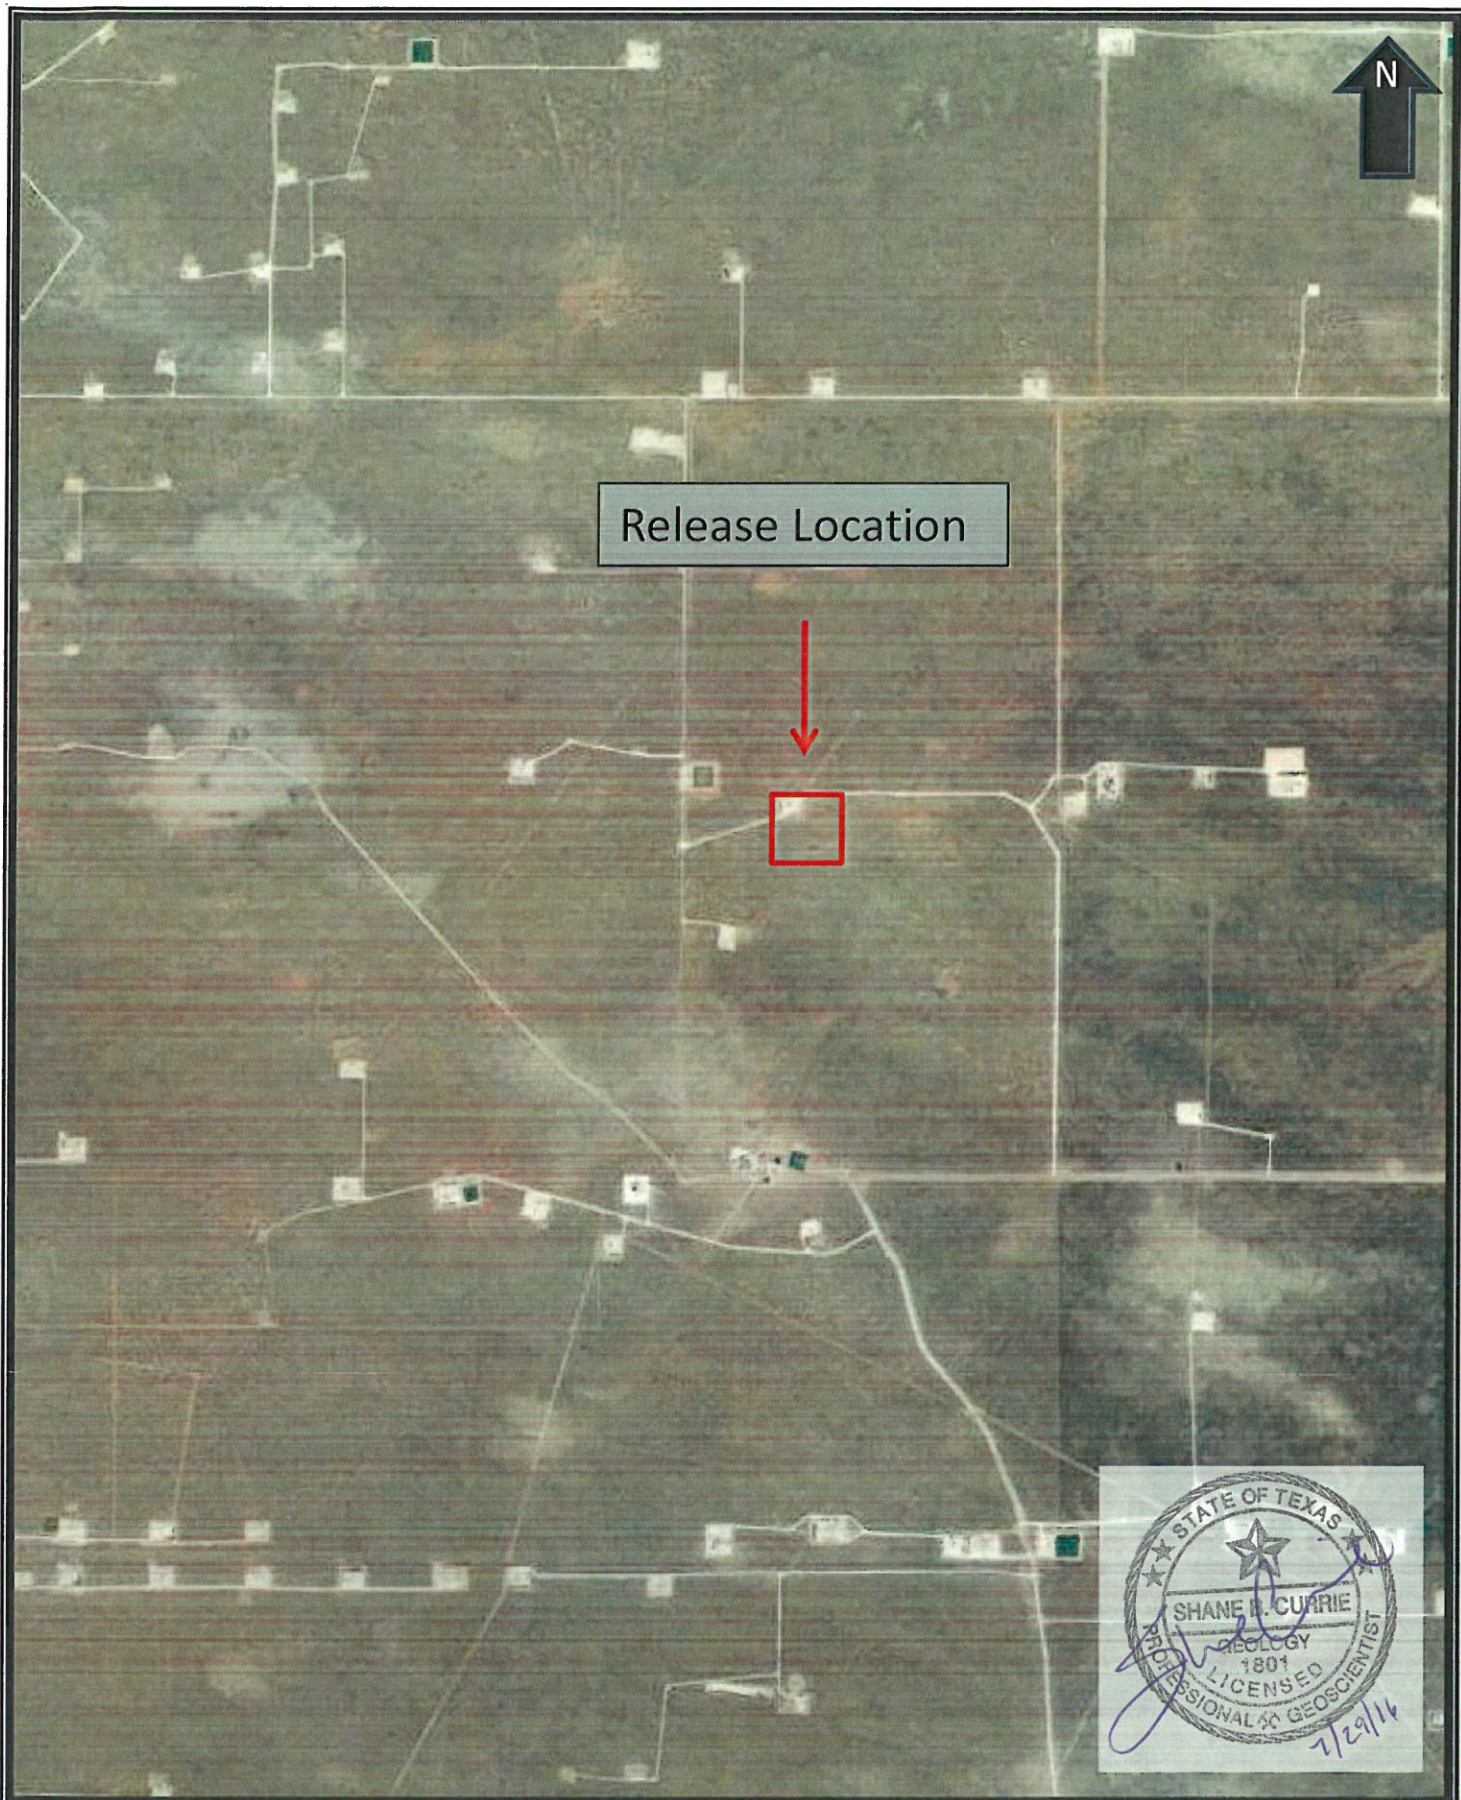
**FIGURE 2**

Release Location

Aerial Map  
Devon Thistle 28 CTB  
Prepared For: Enterprise Crude Oil  
Lea County, New Mexico

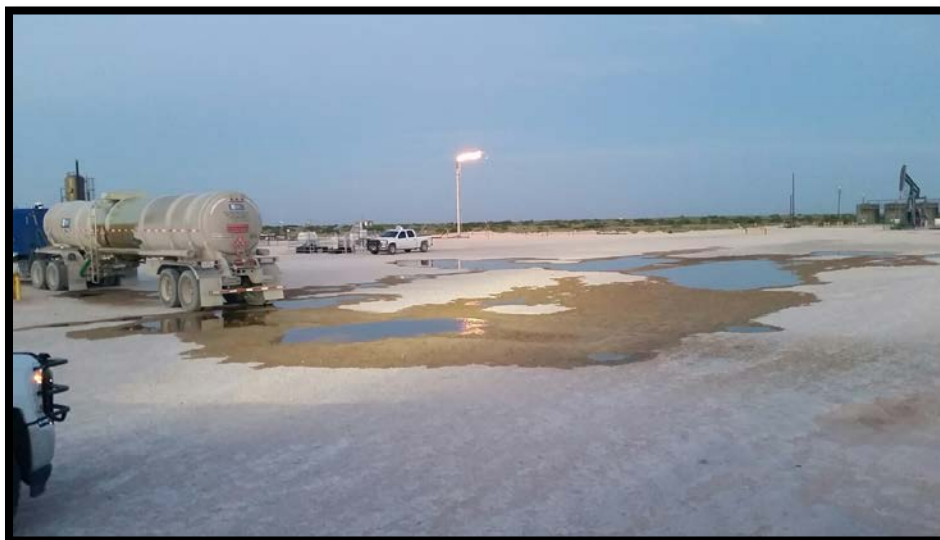
**Direction:**  
Southwest

**Description:**  
Source of crude oil  
release and flowpath.

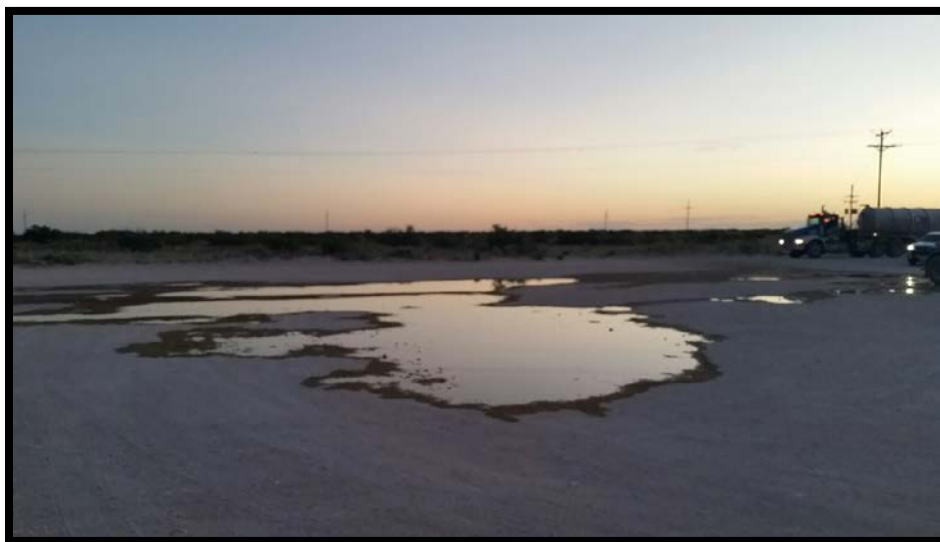
Photograph No. 2

**Direction:**  
Northeast

**Description:**  
Crude oil flowpath.

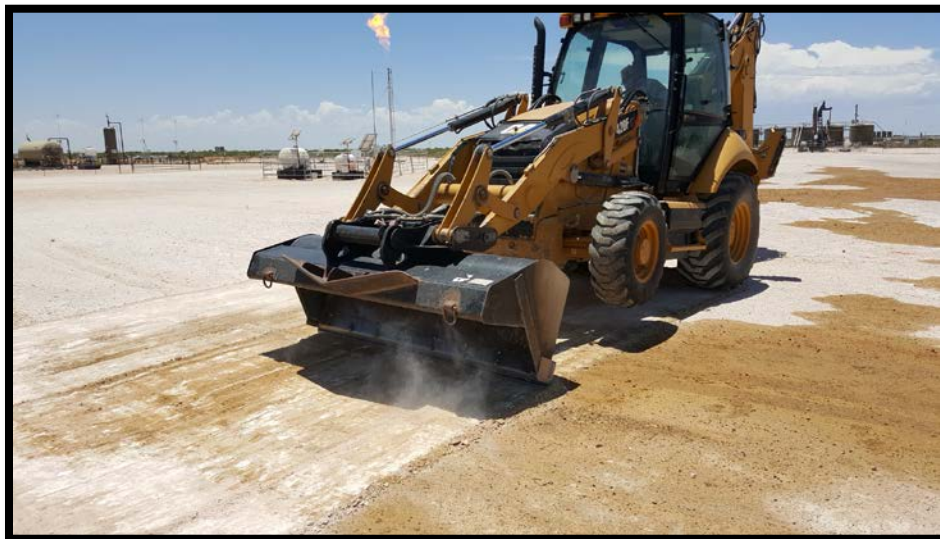
**Direction:**  
Southwest

**Description:**  
Rubber tired backhoe  
performing excavation  
activities.

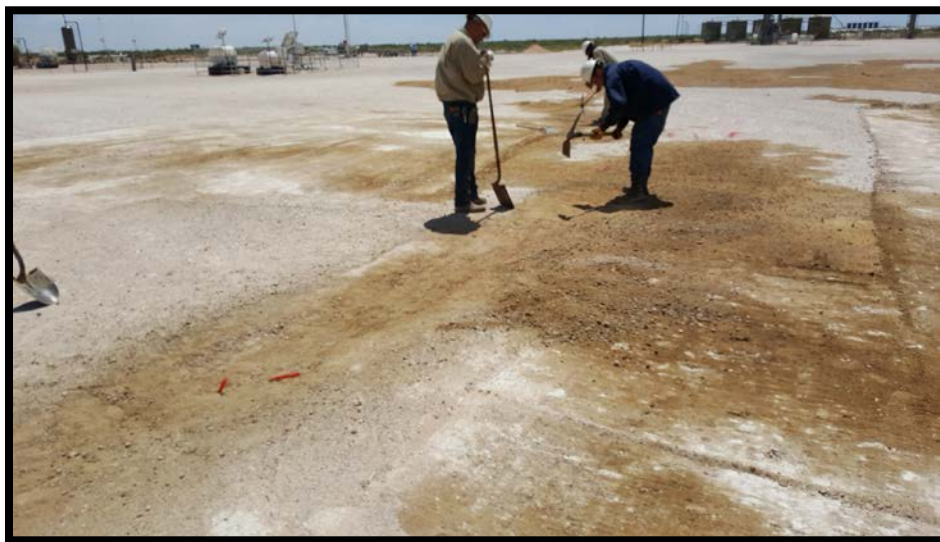
Photograph No. 4

**Direction:**  
Southwest

**Description:**  
Excavation with hand  
tools around conduit  
lines.

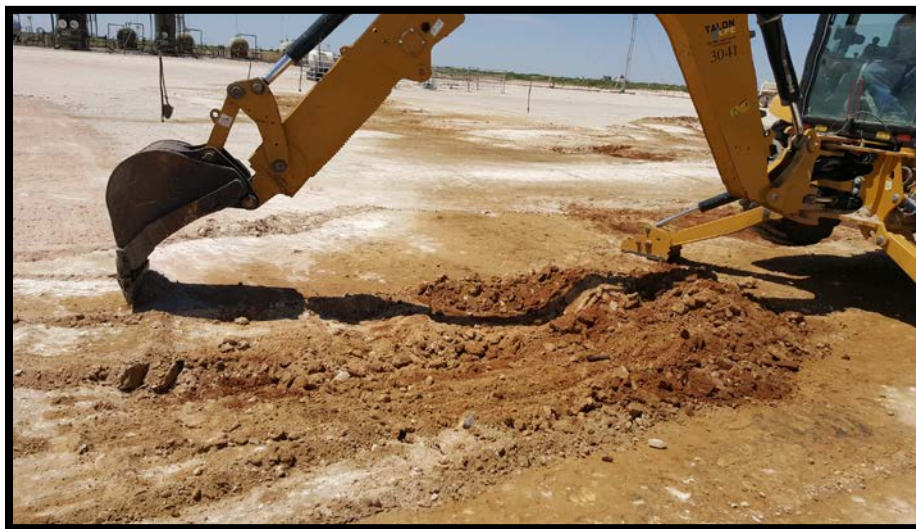
**Direction:**  
South

**Description:**  
View of excavation  
activities.

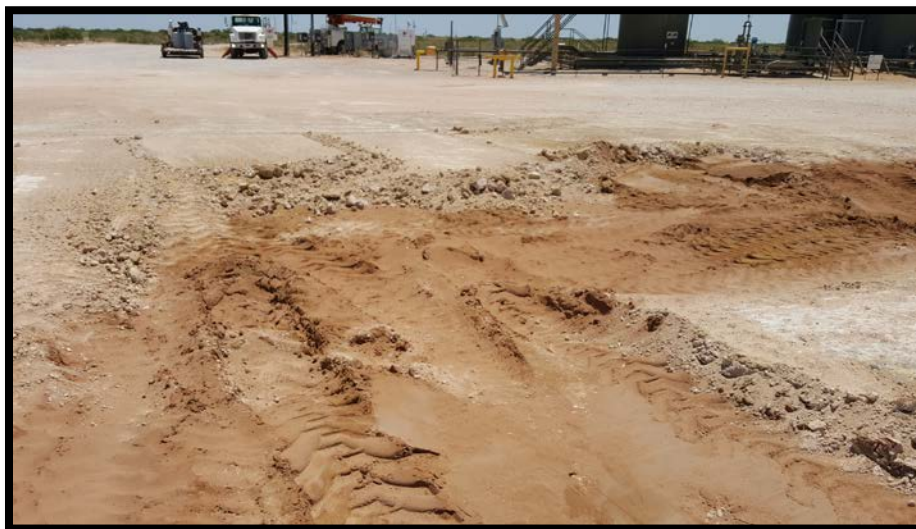
Photograph No. 6

**Direction:**  
East

**Description:**  
Release site following  
excavation activities.

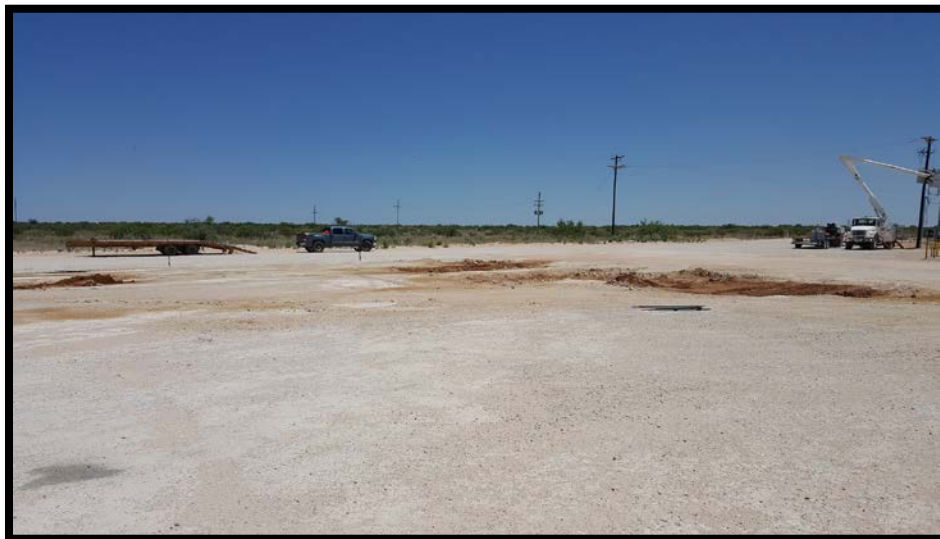
**Direction:**  
Northeast

**Description:**  
View of excavation site  
following excavation  
activities.

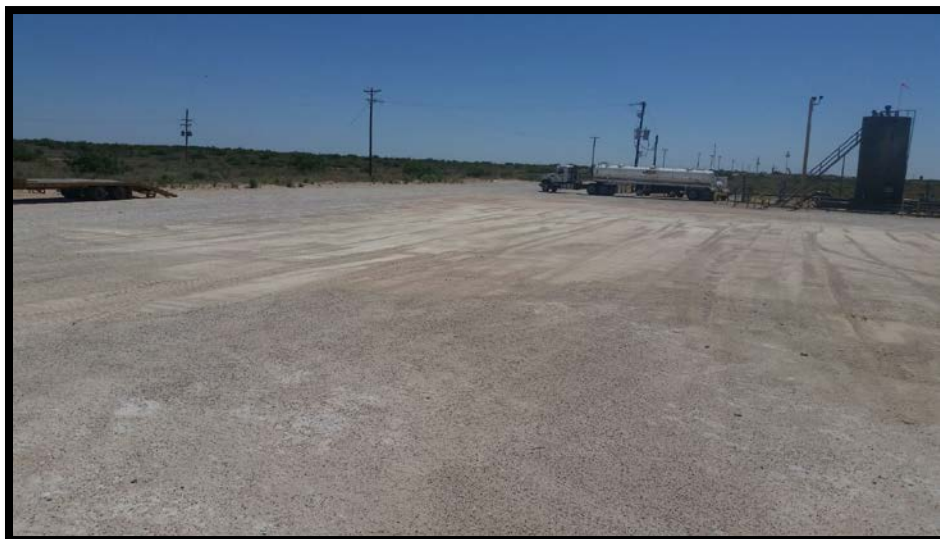
Photograph No. 8

**Direction:**  
Northeast

**Description:**  
Release site following  
backfilling activities.

On July 11, 2016, and July 12, 2016, the excavated area was backfilled and graded to match pre-release conditions. Fresh soil procured from Lea Land was utilized as backfill material. Backfill activities were completed by utilizing a rubber tired backhoe.
