**Re: Release Characterization and Closure Request
ConocoPhillips
Heritage Concho
Queso State #007H Release
Unit Letter O, Section 36, Township 23 South, Range 32 East
Lea County, New Mexico
Incident ID# nOY1709757773**

Release Characterization and Closure Request
April 5, 2023

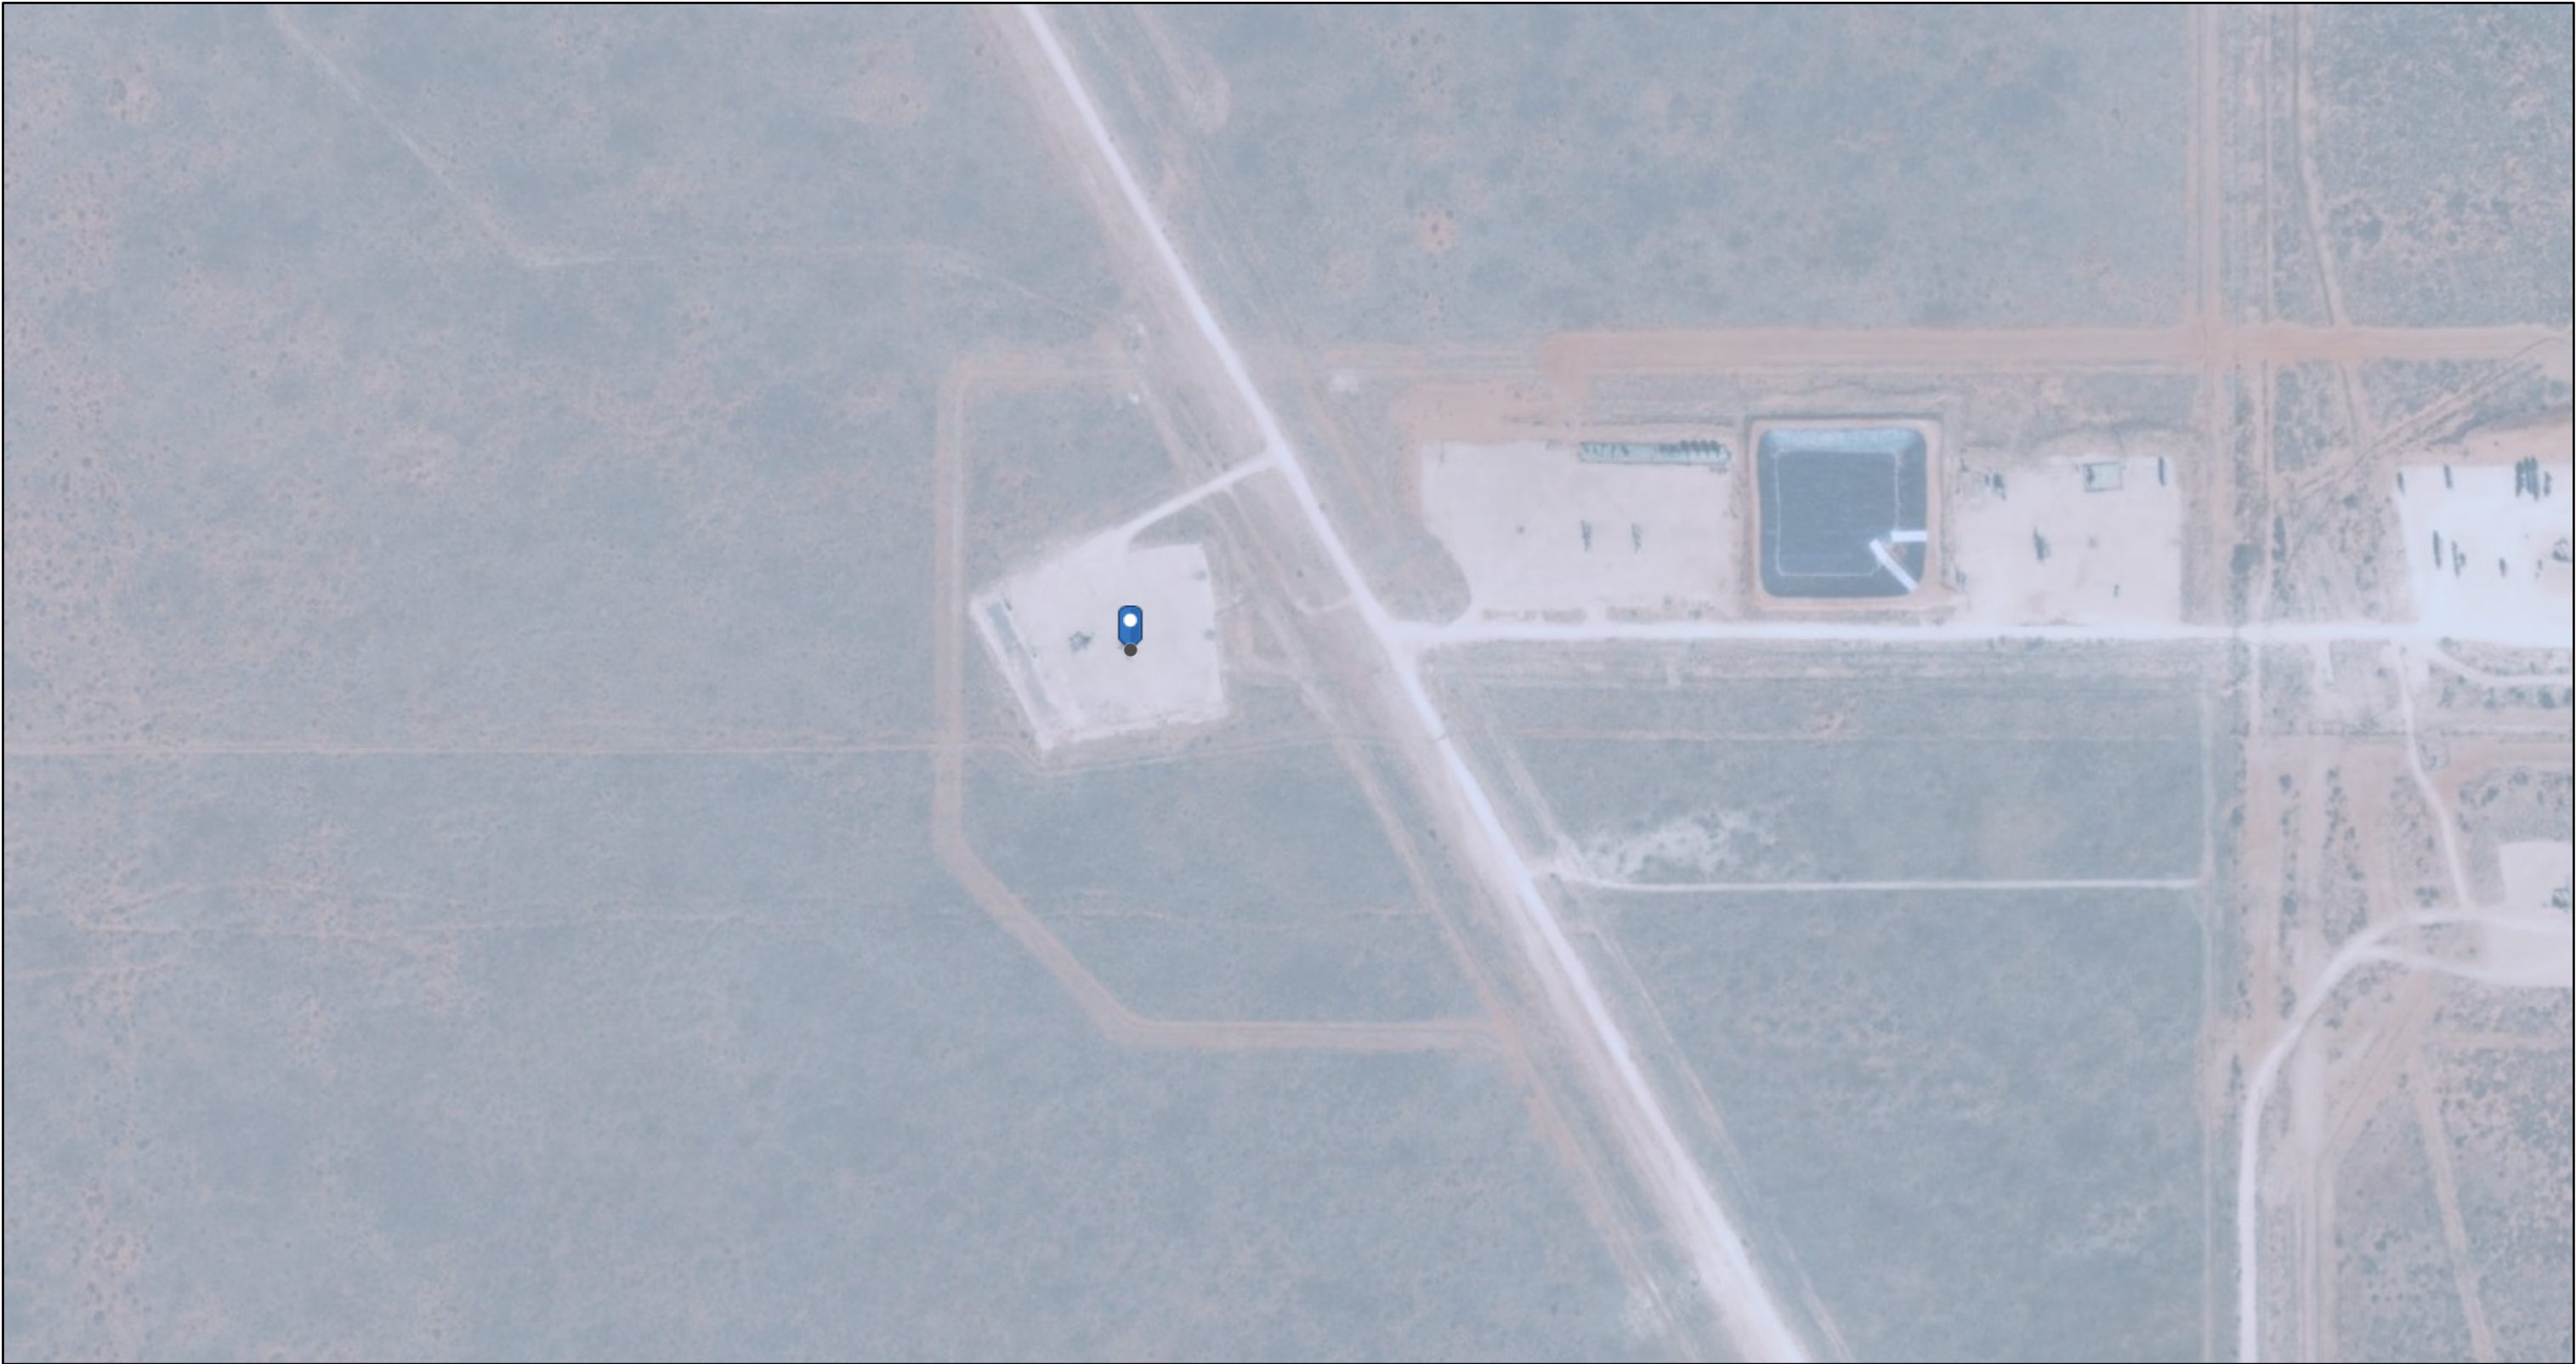
OCD Potential Karst Map

Karst Occurrence Potential

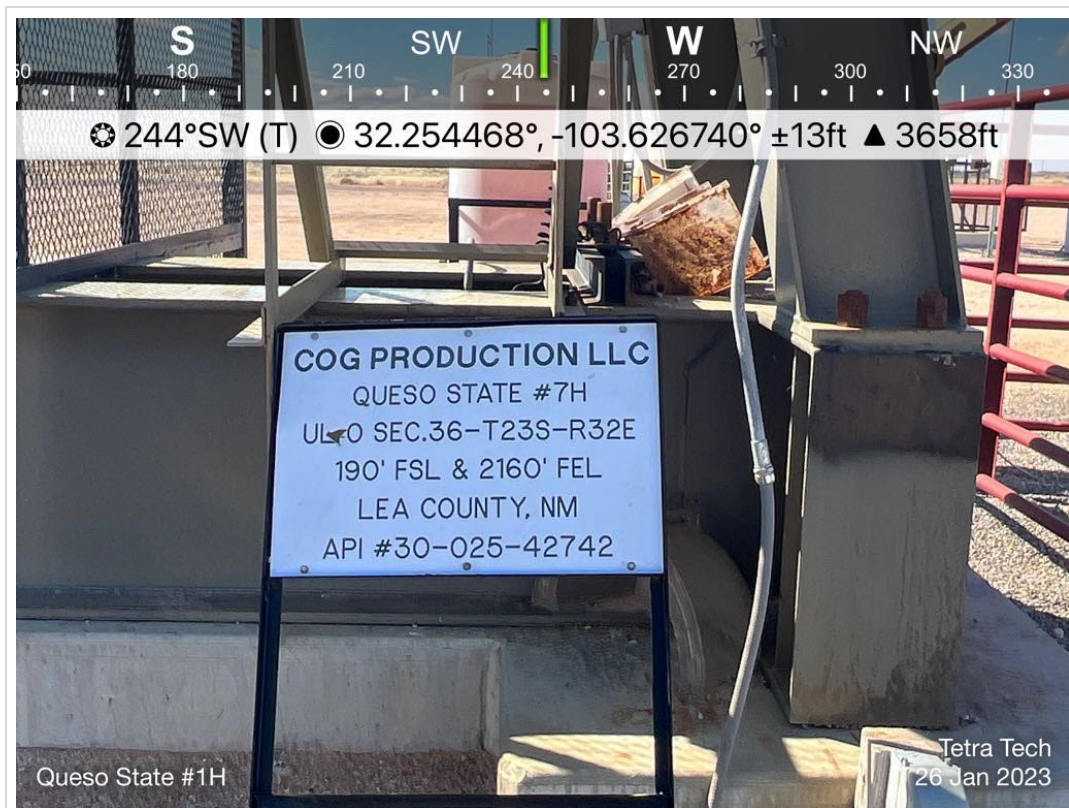
TETRA TECH, INC. PROJECT NO. 212C-MD-02985	DESCRIPTION	Queso State #007H Site Signage.	1
	SITE NAME	Queso State #007H	1/26/2023

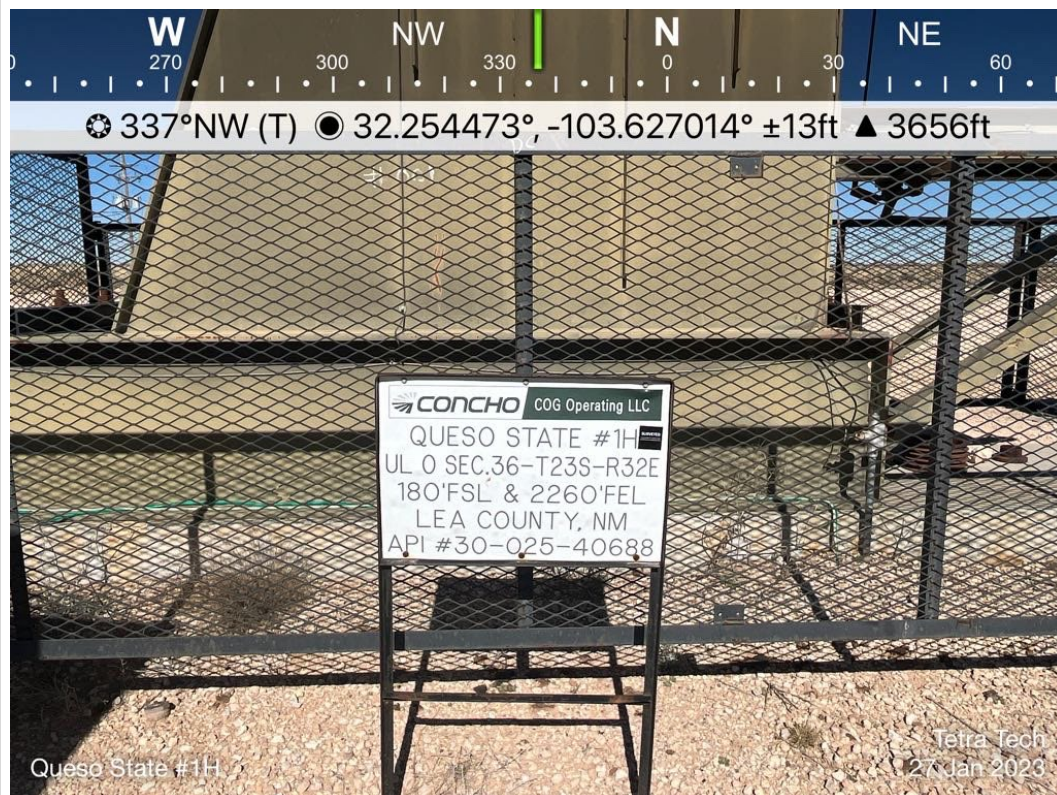
TETRA TECH, INC. PROJECT NO. 212C-MD-02985	DESCRIPTION	View northwest. View of Queso State #001H Wellhead, located to the west of Queso State #007H wellhead.	2
	SITE NAME	Queso State #007H	1/27/2023

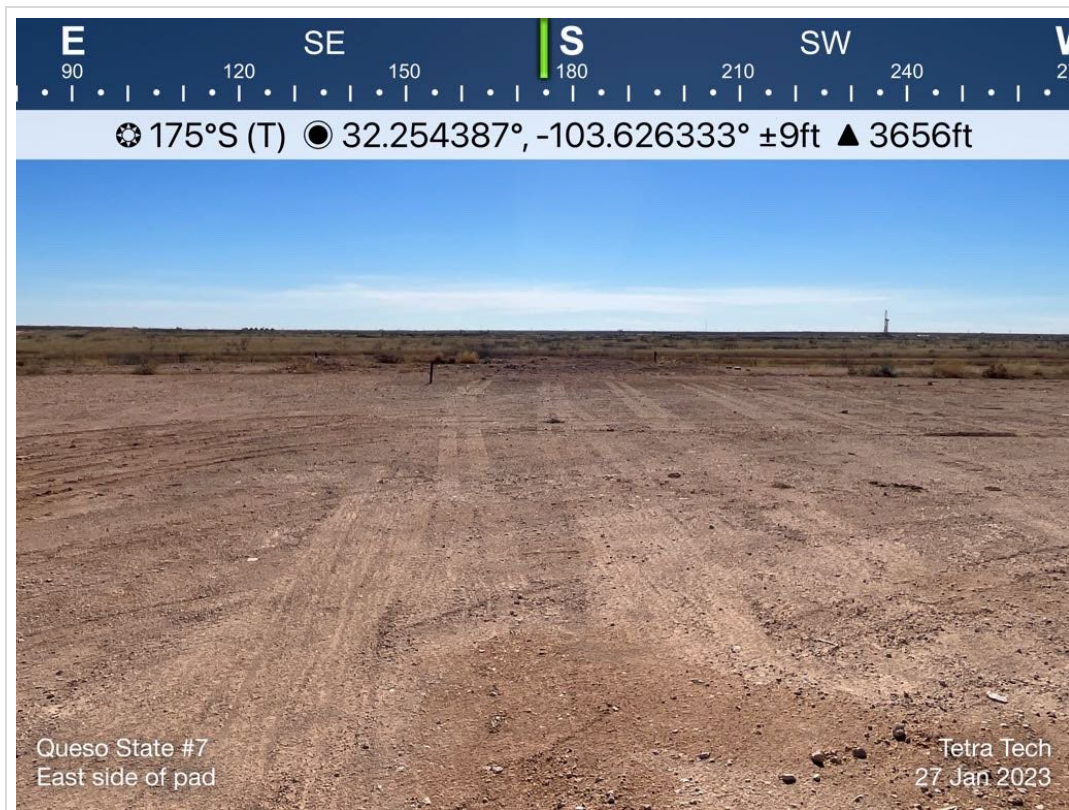
TETRA TECH, INC. PROJECT NO. 212C-MD-02985	DESCRIPTION	View south. View of inferred release extent.	5
	SITE NAME	Queso State #007H	1/27/2023
