# SOIL REMEDIATION AND FINAL CLOSURE REPORT FOR INCIDENT 2RP-3835

ENTERPRISE FIELD SERVICES LLC

PIPELINE ROW, CROSSOVER LINE

UL M, SECTION 21, T23S R31E, NMPM  
EDDY COUNTY, NM

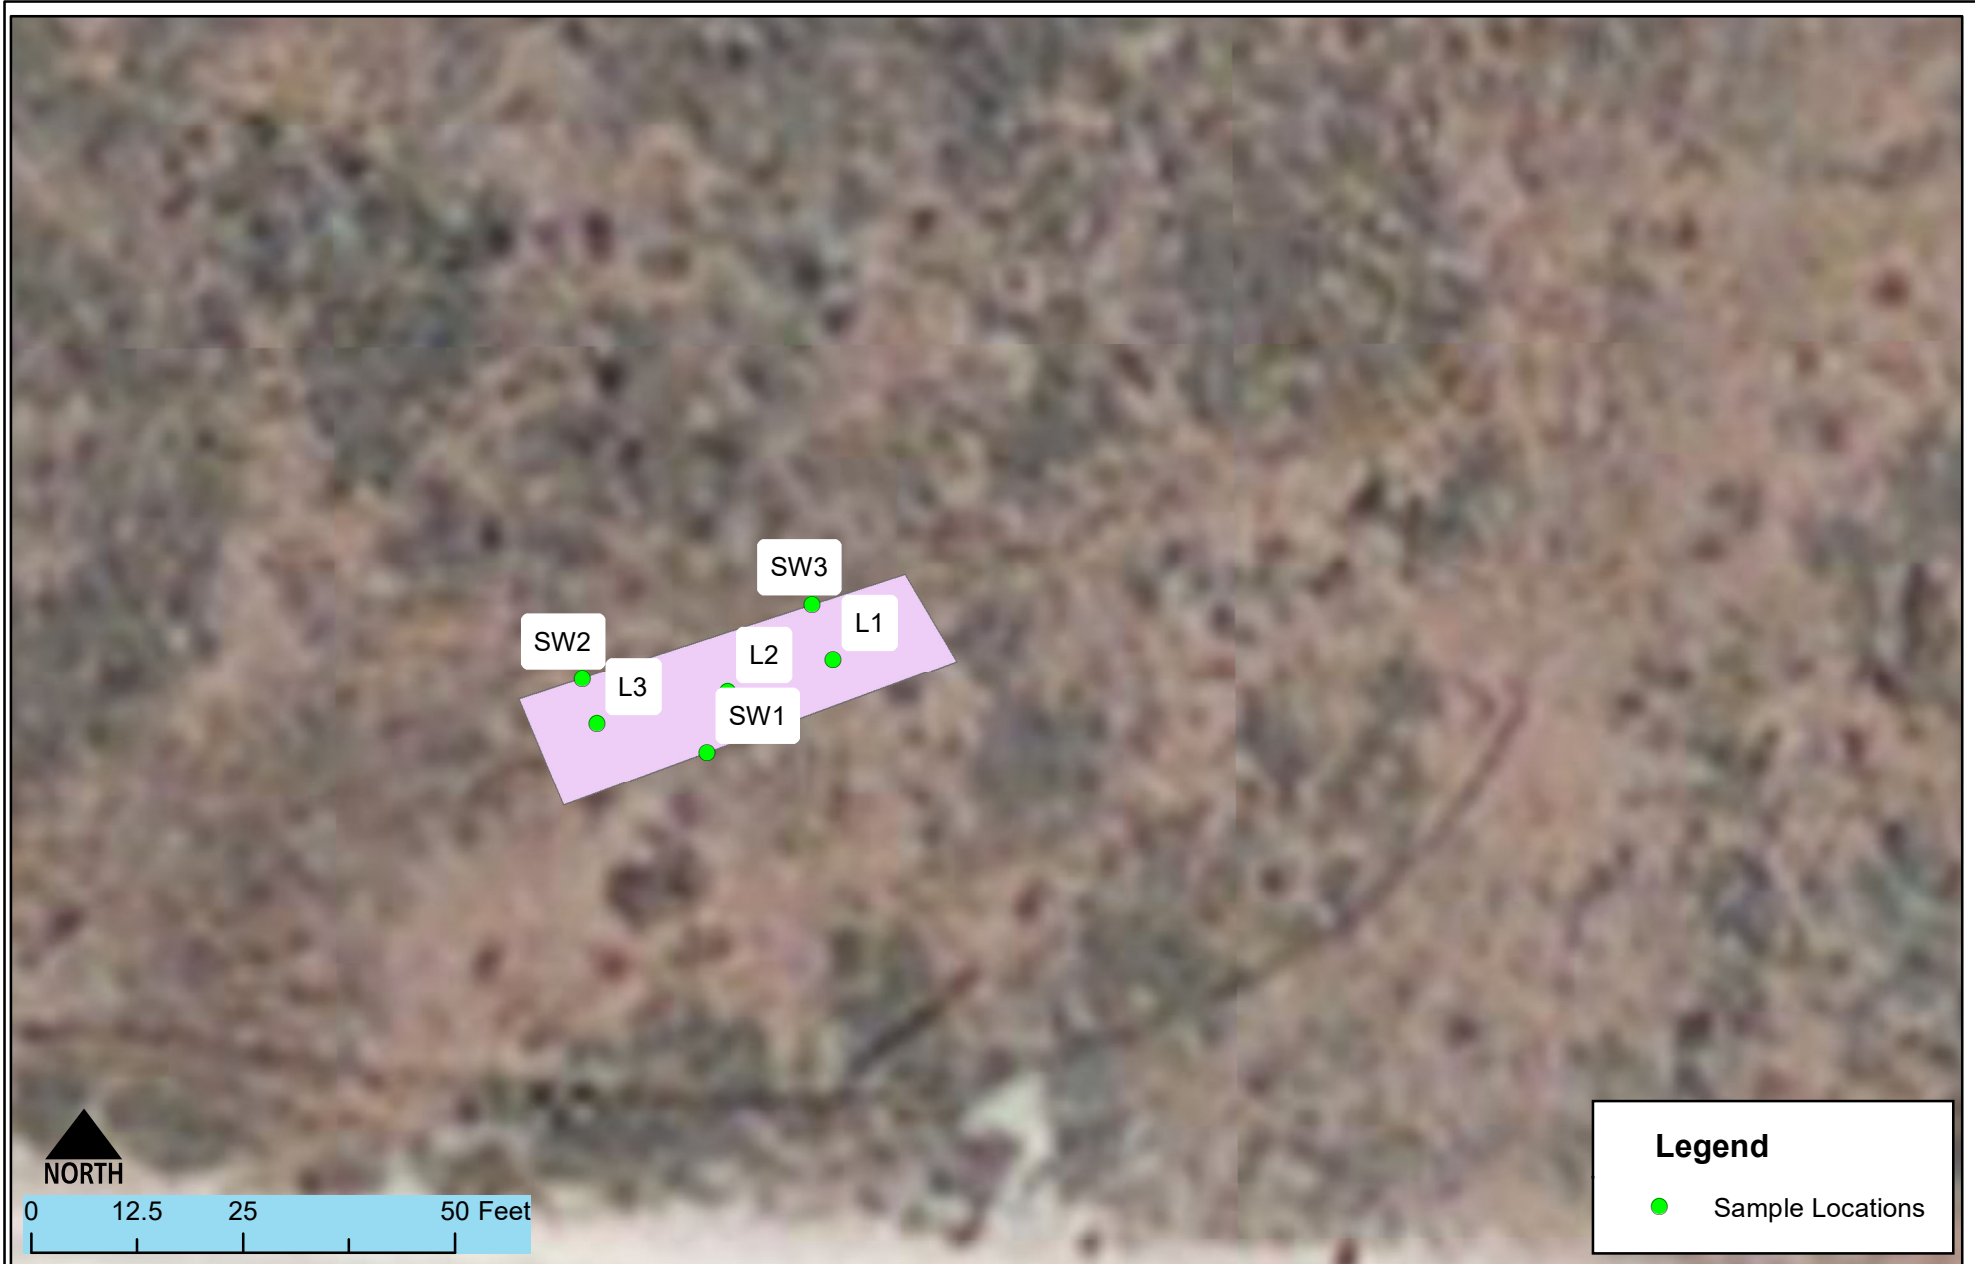
Figure 2

Detailed Sample Map  
ROW Crossover - Enterprise  
Carlsbad, New Mexico

Laboratory analytical results for all final closure samples collected were below NMOCD closure standards for Benzene, BTEX, and TPH, and are of similar chloride concentrations compared to the background sample collected. No further remedial activities are recommended. Soil contaminant concentrations are illustrated in Figure 2. A summary of laboratory analytical results is included in Table 3. Laboratory reports are included in Appendix C.

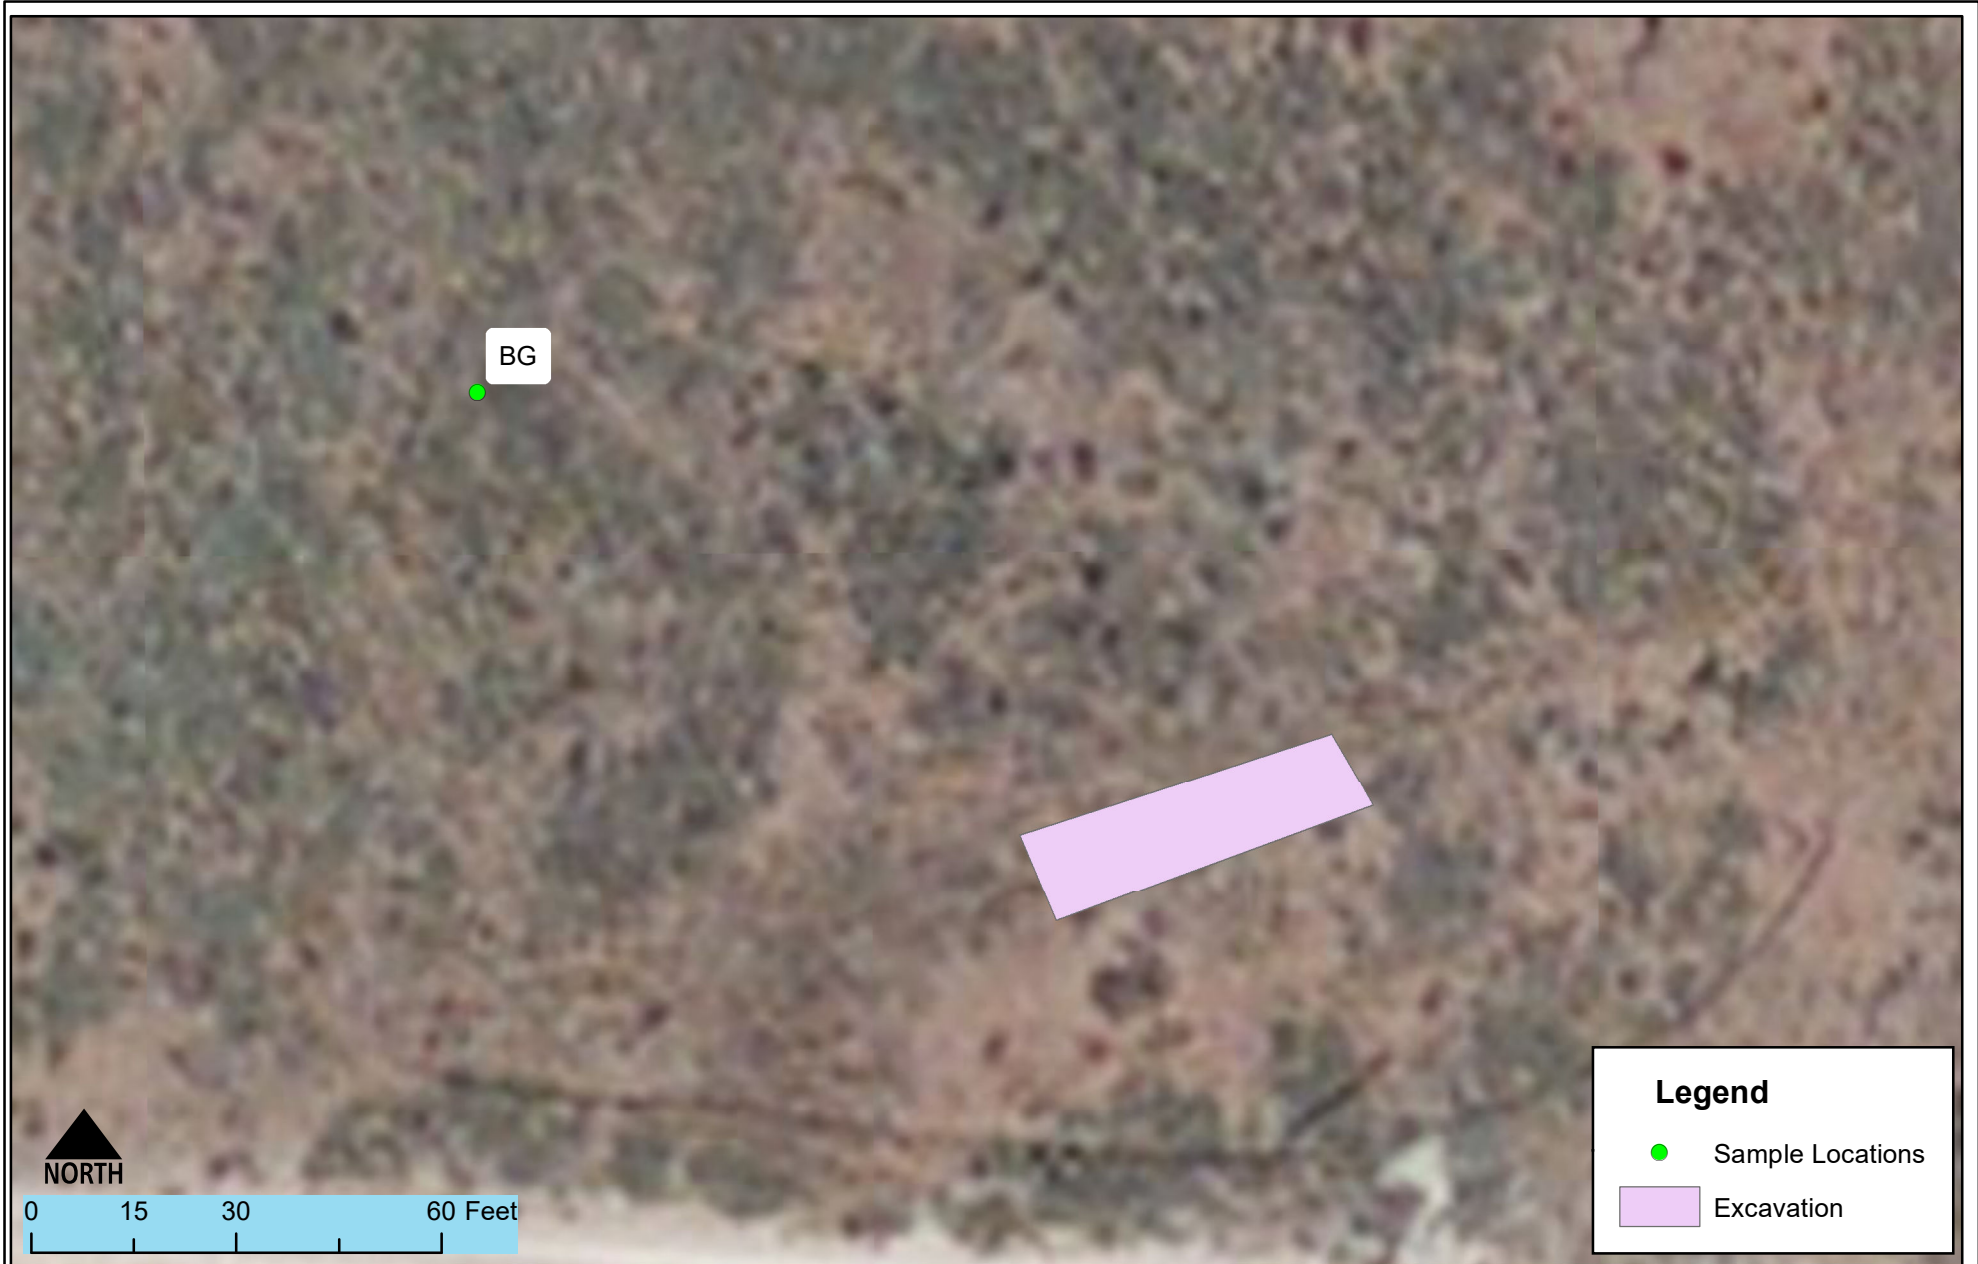
Figure 3

- Sample Locations
- █ Excavation

Background Sample Map  
ROW Crossover - Enterprise  
Loving, New Mexico
