Closure

Remediation Plan

**Re: Closure Report
Spud Muffin 31 CTB 1 (12.22.2021)
Devon Energy Production Company
Site Location: Unit N-31-23S-29E
(Lat 32.255624°, Long -104.026426°)
Eddy County, New Mexico
Incident ID: nAPP2135745913**

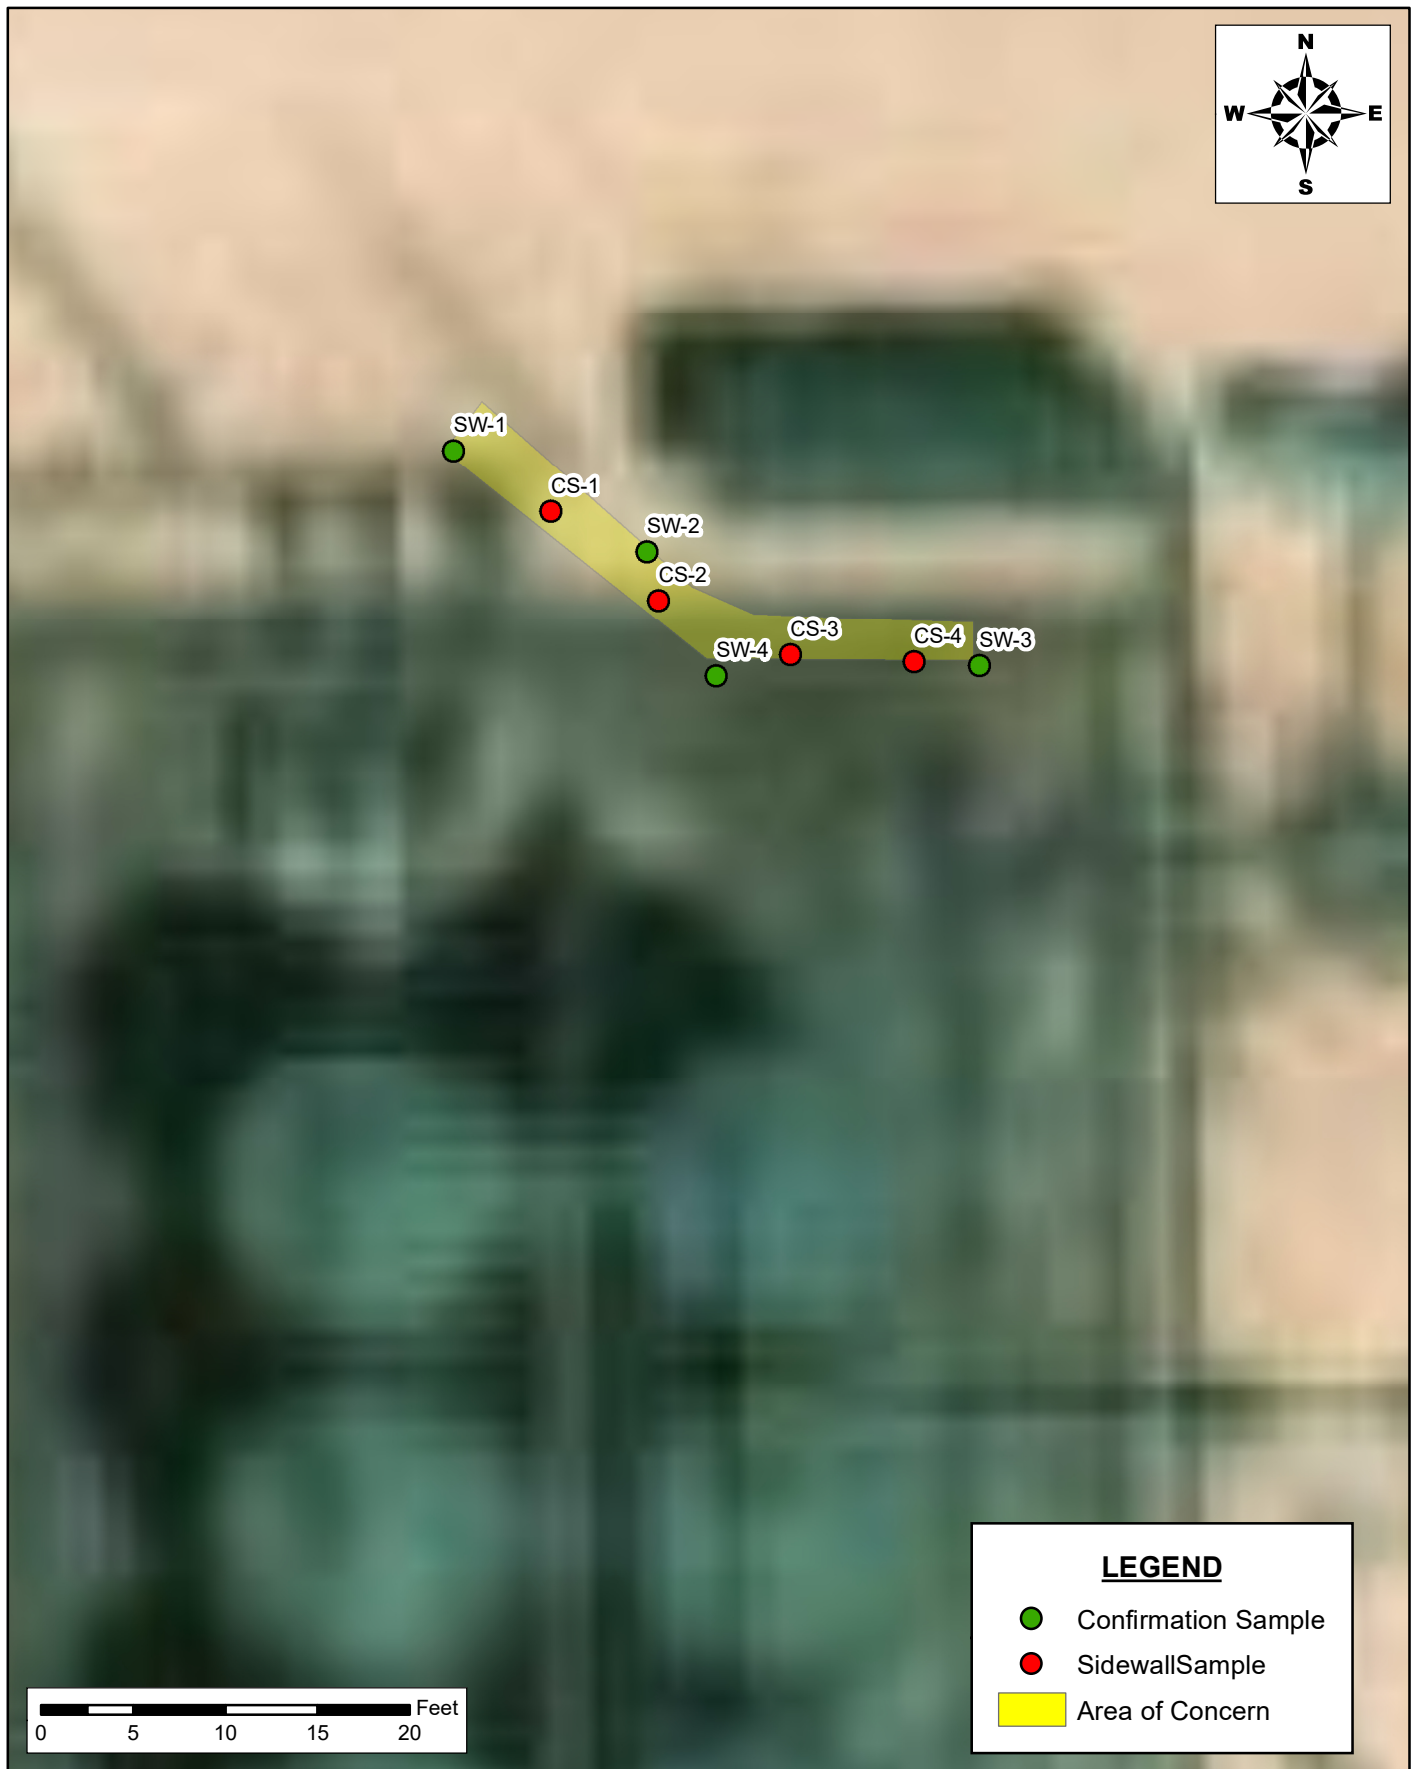
**SECONDARY CONTAINMENT MAP
DEVON ENERGY
SPUD MUFFIN 31 CTB #1
EDDY COUNTY, NEW MEXICO**

On March 4, 2022, NTGE conducted liner inspection activities to assess the liners integrity within the facility. NTGE personnel conducted a visual inspection of the liner and found the liner to be intact with no integrity issues. A photographic log documenting the condition of the liner at the time of the inspection is attached. Additionally, a copy of the 48-hour advance notification of the liner inspection activities provided to the NMOCD is also attached.

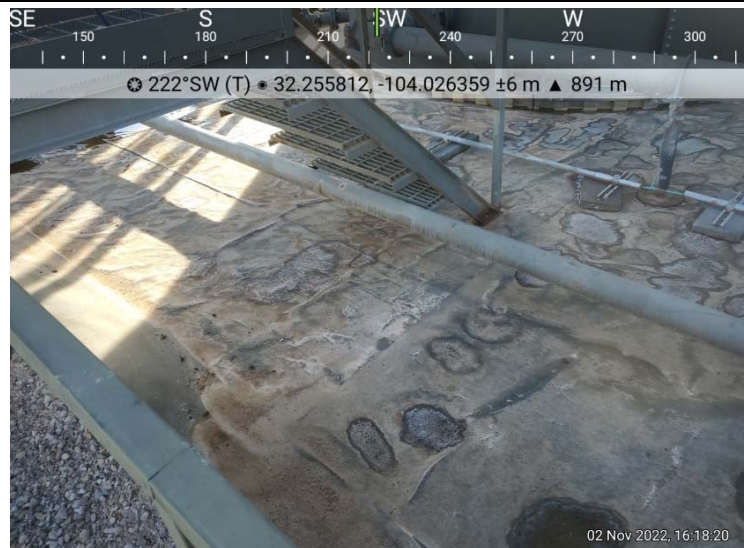
Description:
View of Liner

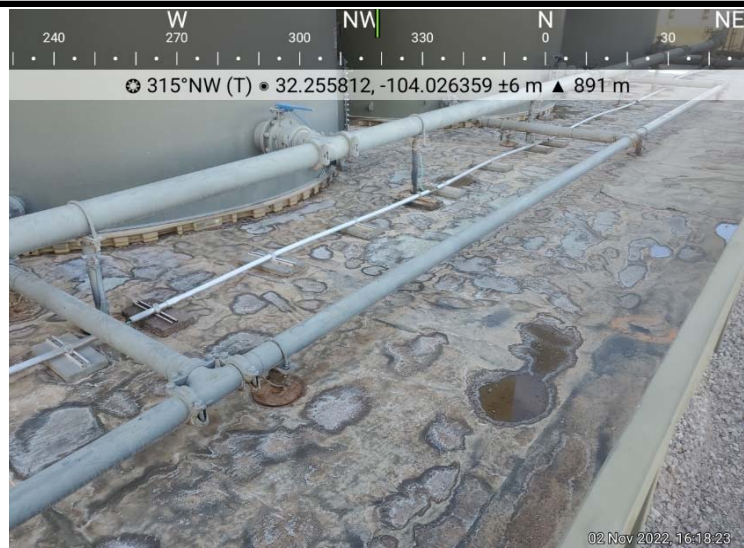
**Photograph No. 3**

Description:
View of Liner

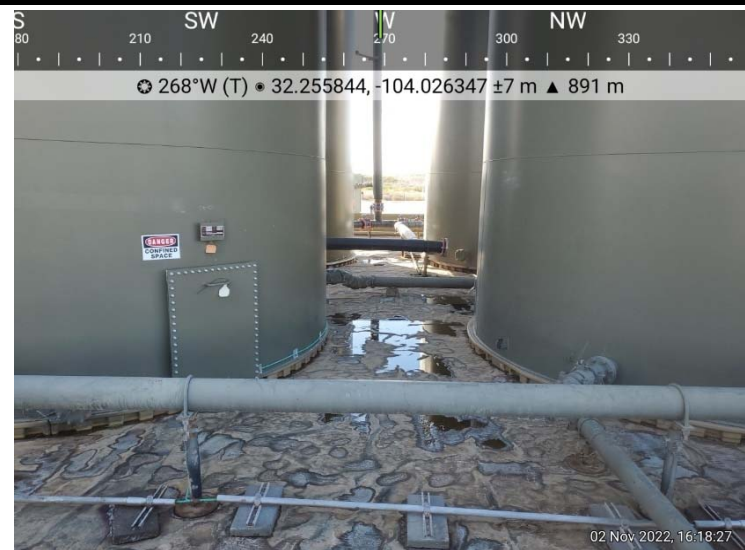
Photograph No. 5

Description:
View of Liner

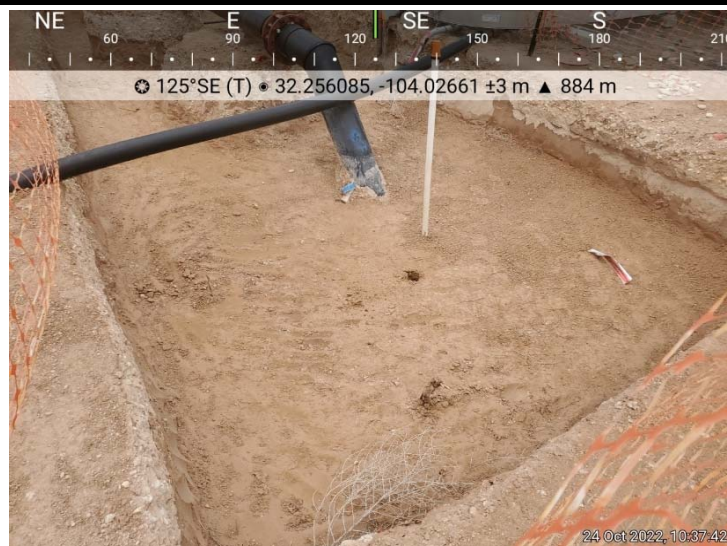
**Photograph No. 11**

Description:
View of excavation.

On October 15, 2022, NTGE along with Devon initiated excavation activities at the site to address impacts discovered during the site assessment phase of the project. The entire area of concern was excavated to a depth of 2 ft bgs. NTGE field screened the areas after completion of the excavation, noting that no impacts from chlorides appeared to be present. A 48 hour notification was submitted to NMOCD notifying them of a confirmation sampling event to take place on October 24, 2022. A total of 4 confirmation base samples were collected (CS-1 through CS-4) and 4 confirmation sidewalls collected (SW-1 through SW-4) to ensure all impacted materials have been removed from the area.
