**Subject: Closure Letter Report
ConocoPhillips
EVGSAU 3127-398 Injection Line Release
Unit Letter J, Section 31, Township 17 South, Range 15 East
Lea County, New Mexico
1RP-3235**

Corrective Action Plan

**RE: Corrective Action Plan
ConocoPhillips EVGSAU 3127-398 (1RP-3235)
UL/J sec. 31 T17S R35E
API No. 30-025-34835**

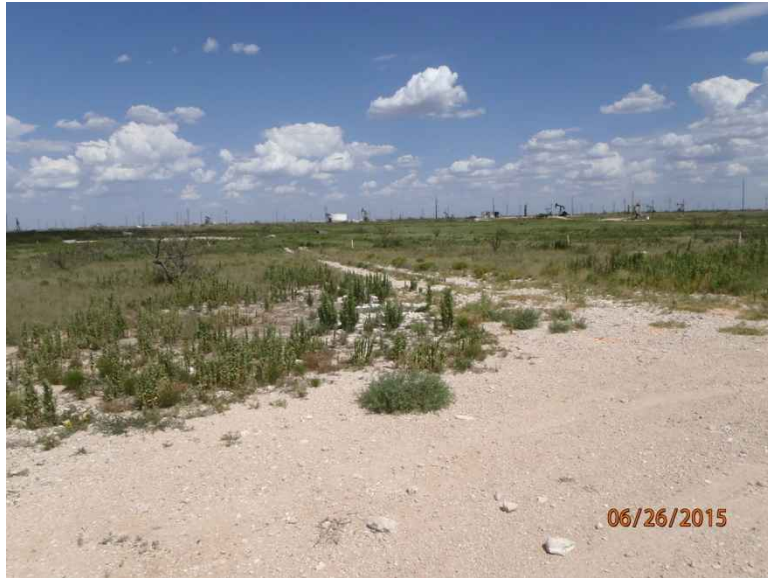
Initial release area, facing southeast

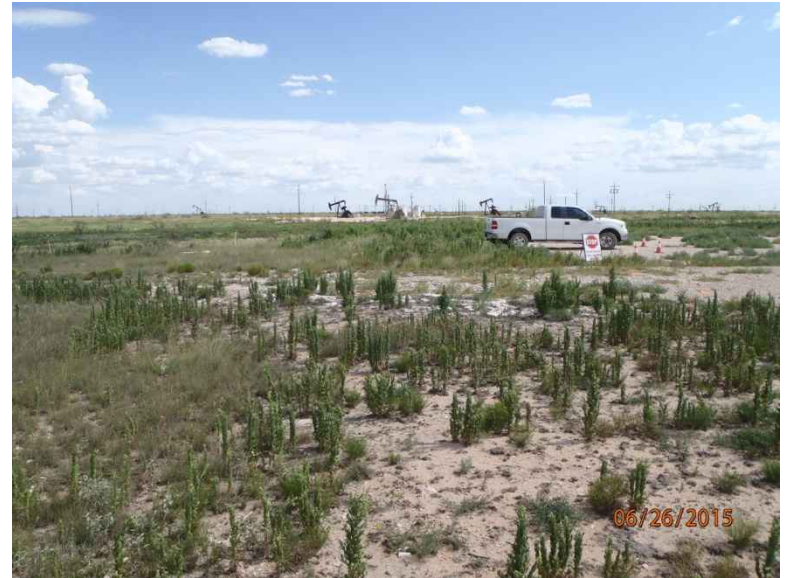
Initial release area, facing northwest

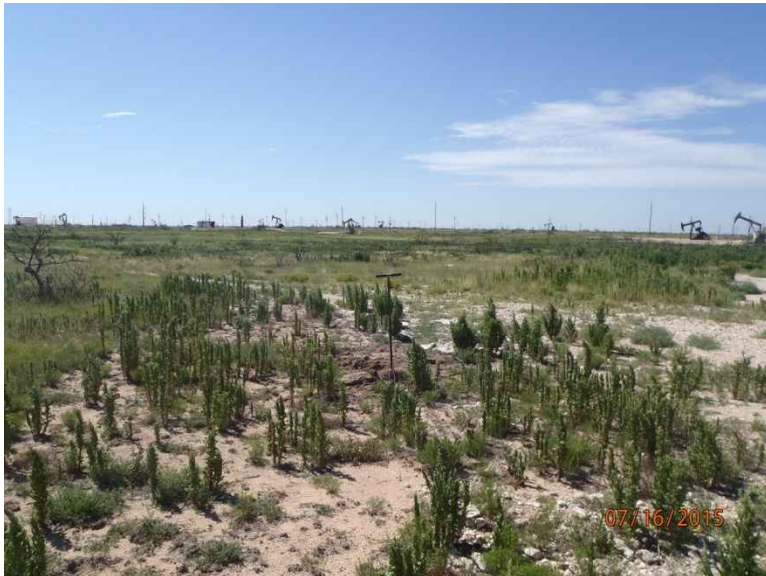
Initial release area, facing southeast
